# **KOWHAI TIMBER (1990) LIMITED**

## **REMEDIATION & VALIDATION REPORT TREATMENT PLANT AREA**

**362 MATAKANA VALLEY ROAD,  
MATAKANA**

**Prepared by:  
Groundwater and Environmental Services  
P O Box 190,  
Cambridge  
24 June 2005**

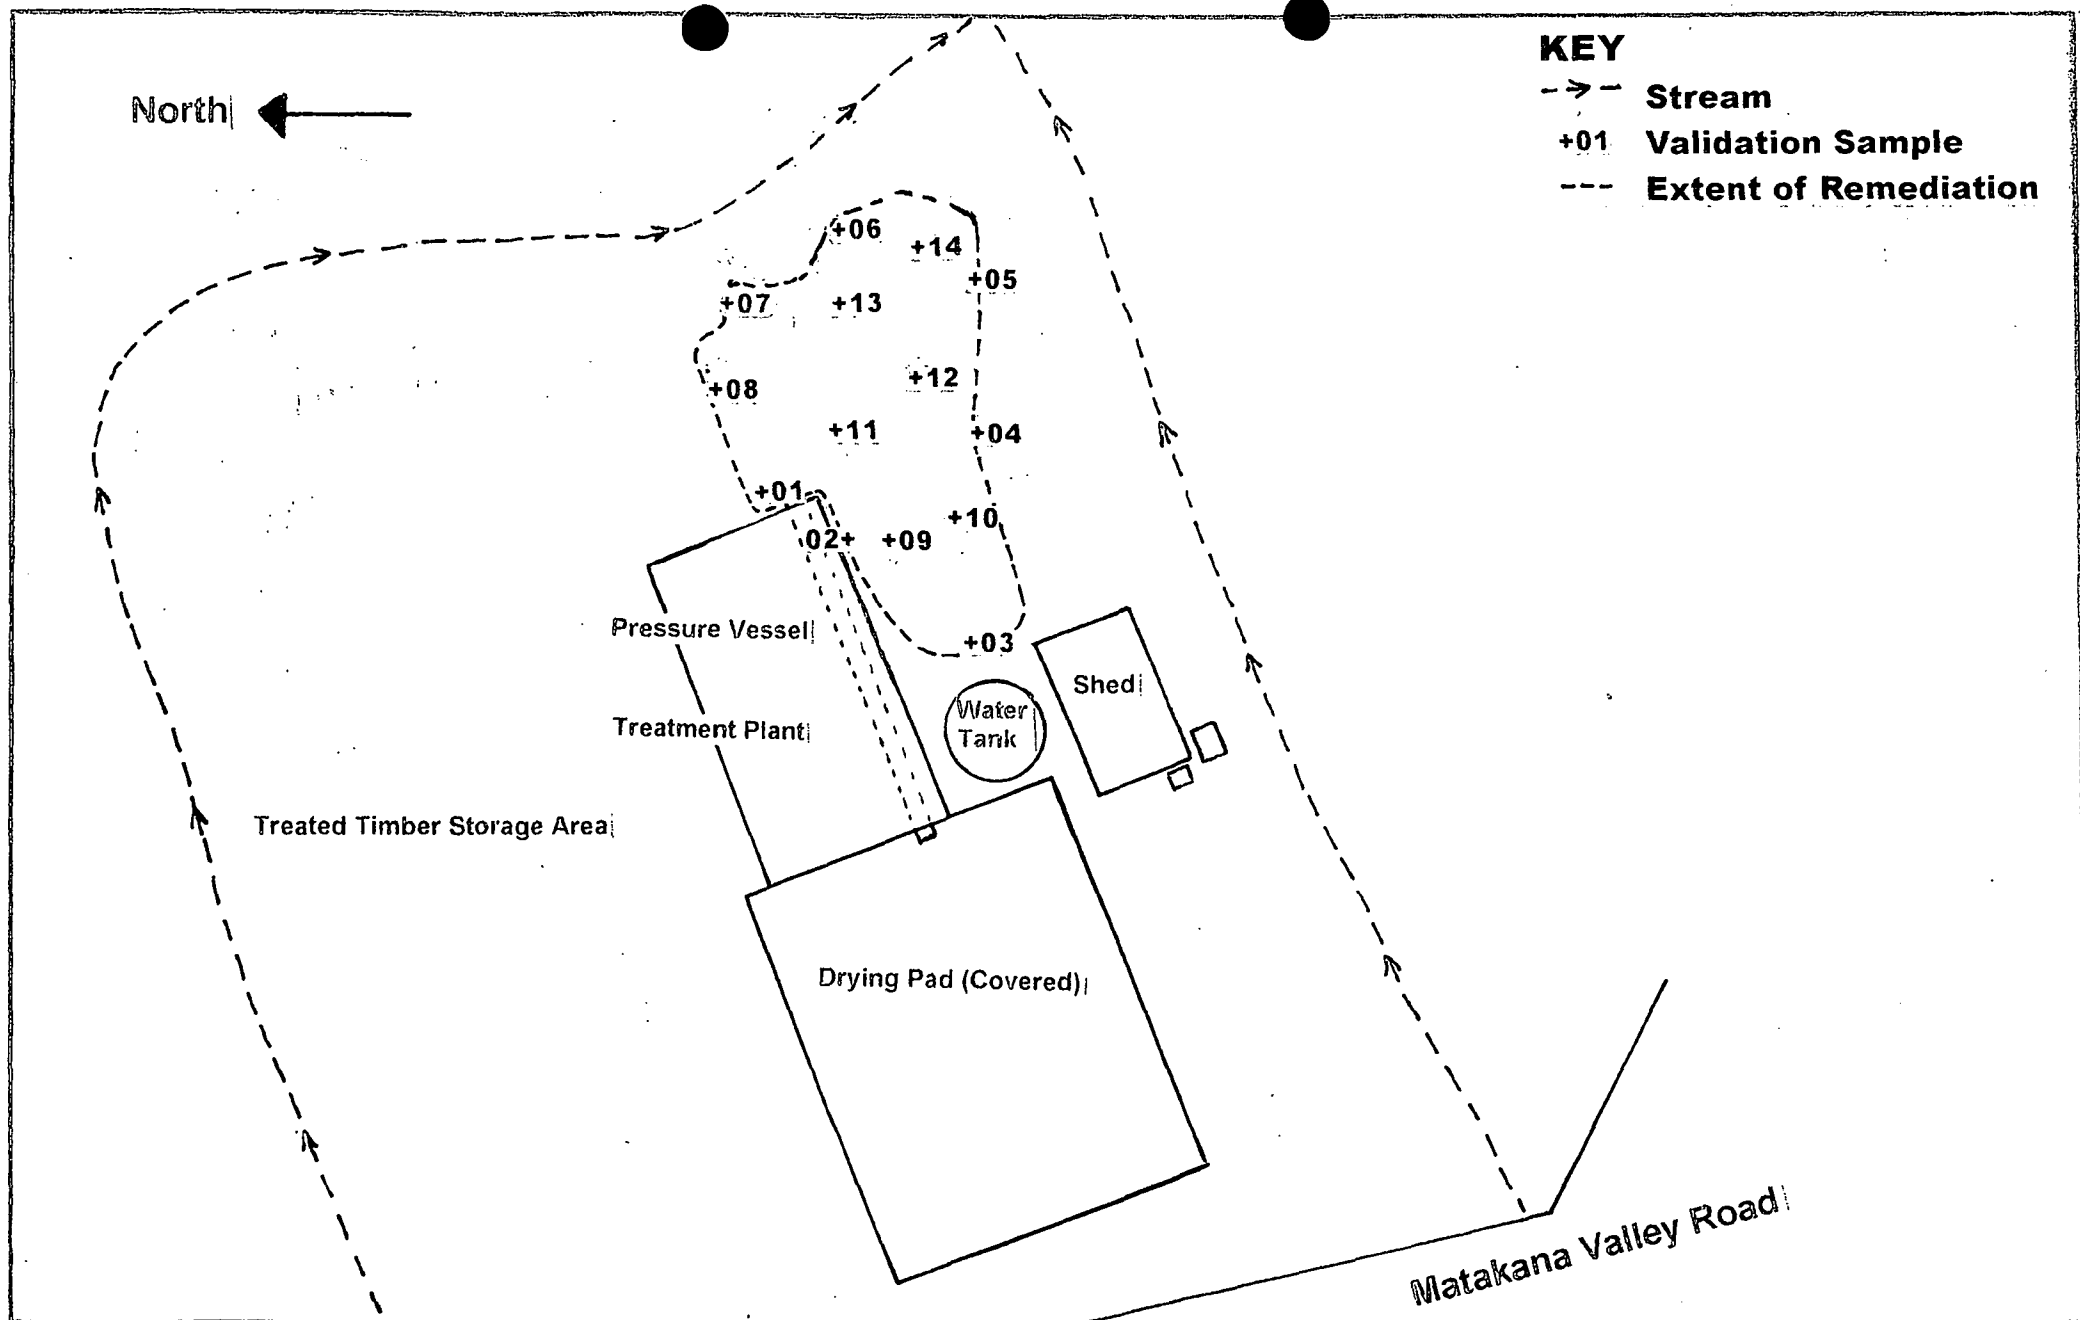
**Figure 1: Stage 1 Remediation/Validation**  
**Kowhai Timber**

The arsenic levels in the zone immediately southwest of the treatment plant (indicated on Figure 1) were significantly above the timber treatment guideline levels for the protection of human health. There was a potential risk to site workers from the high arsenic concentrations in the contaminated material. The material also presented a risk of contamination to the adjacent stream that feeds into Matakana River.

The location of the high contamination zone was within the remediation zone shown on Figure 1.

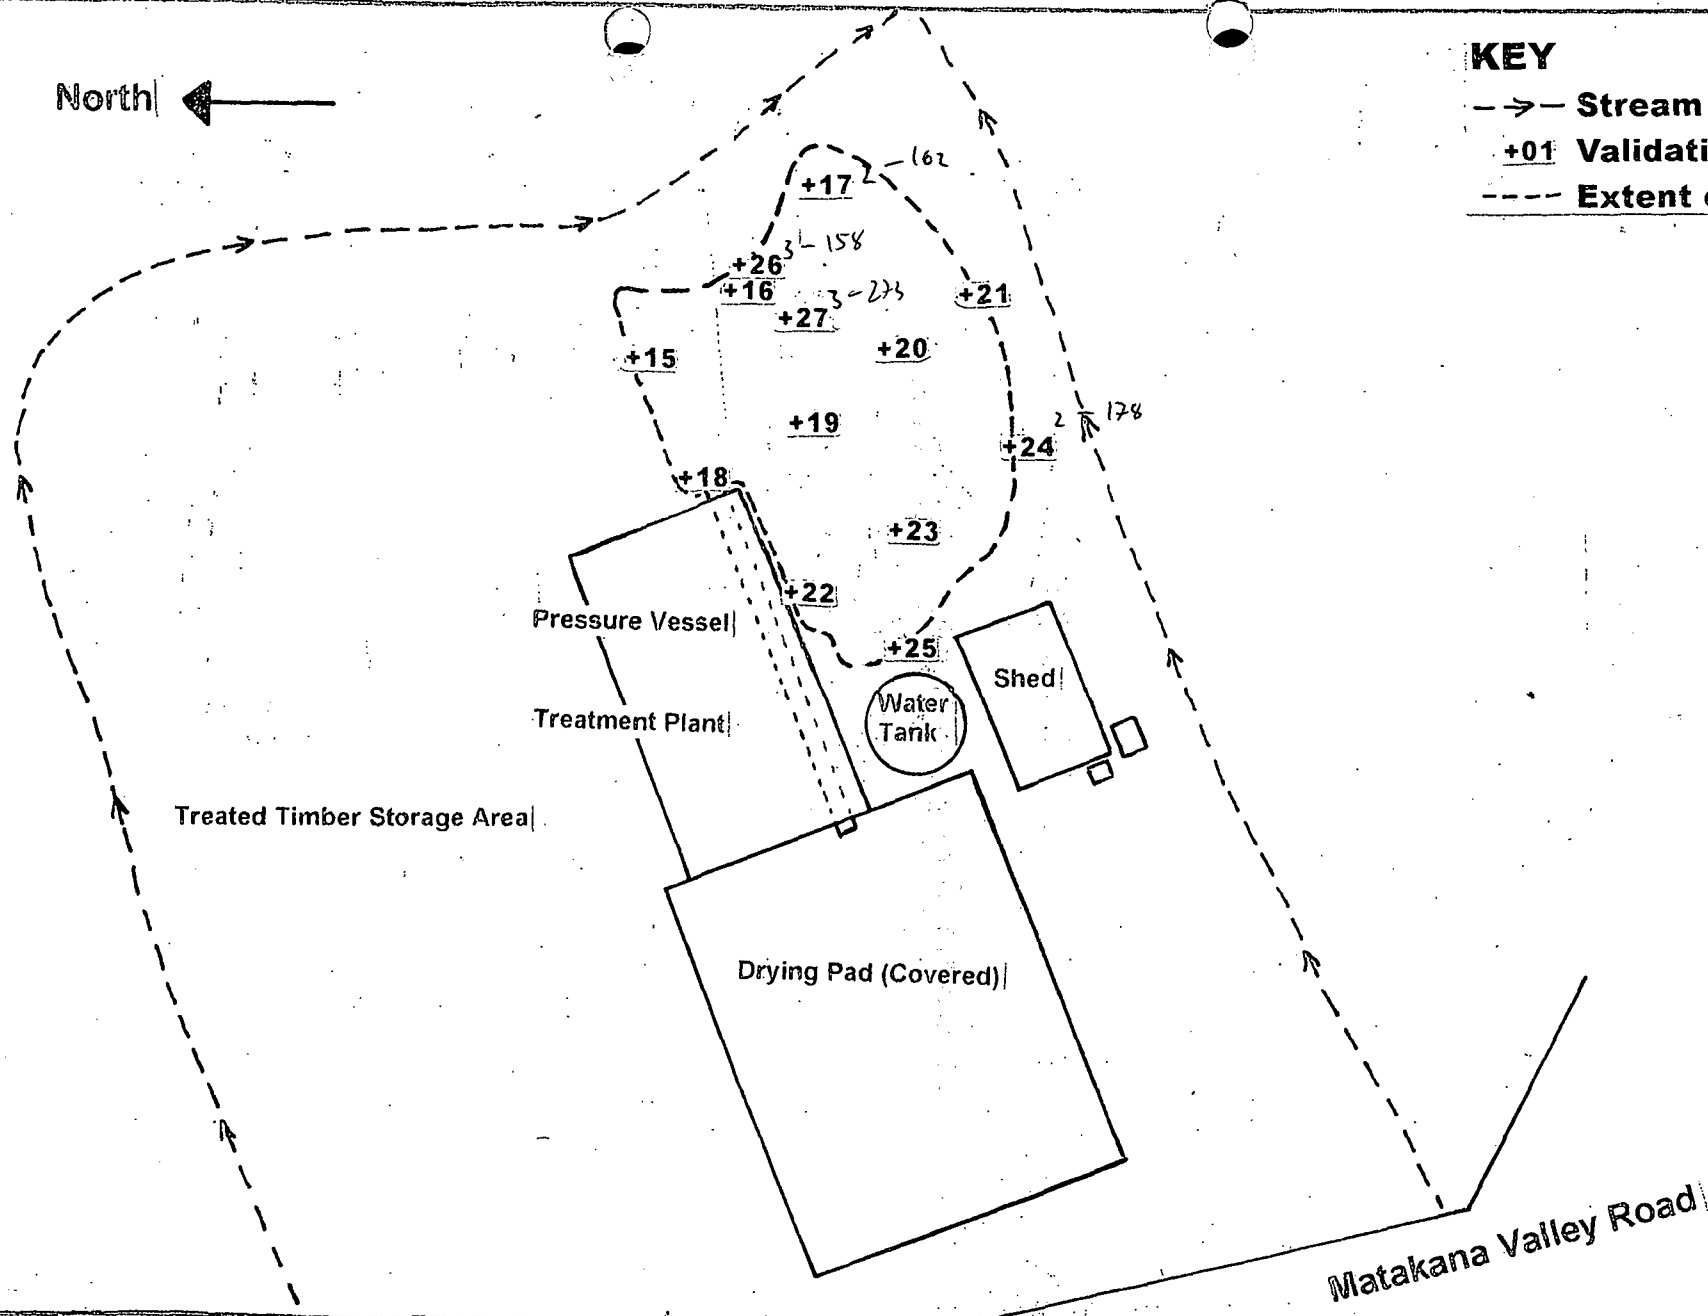
**Figure 2: Stage 2&3 Remediation/Validation**  
**Kowhai Timber**

Following the Stage 1 validation sampling of the site, the excavation depth and extent was increased to allow removal of additional contamination as found in the validation samples. The contaminated material removed in Stage 2 of the remediation did not contain any visible contamination however arsenic levels were elevated above the industrial/commercial guidelines. ✓
