78 BYRON ST – DETAILED SEISMIC ASSESSMENT REPORT  
BUILDING A – SHEER ADVENTURE WORKSHOP

Prepared For:  
STEWART FAMILY TRUST

Date: 27 June 2014  
Project No: 111702  
Revision No: 1

Holmes Consulting Group LP  
Christchurch Office

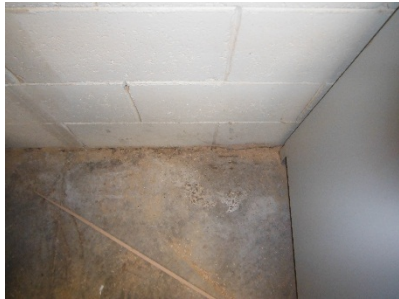
| Damaged Item | Location | Example | Recommended Repair |
|---|---|---|---|
| 1.3. Differential settlement of slab | Southern wall at internal wall junction with slab in eastern structure. | | Remove section of slab that has lifted. Re-level ground. Install new slab with epoxy dowels into adjacent slab sections. |

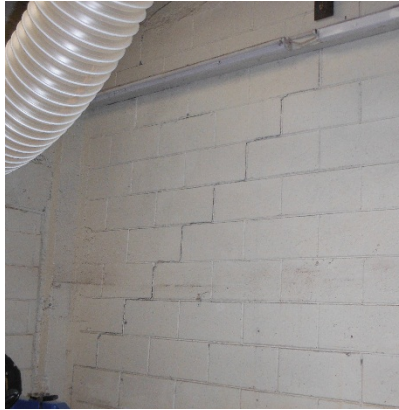
| Damaged Item | Location | Example | Recommended Repair |
|---|---|---|---|
| 2.1. Diagonal cracking along mortar joints in concrete block infill walls | Occurs along the west, south, and east walls of the original factory building (west structure) | | Repair and repoint all mortar joint cracks from both the inside and outer faces. |

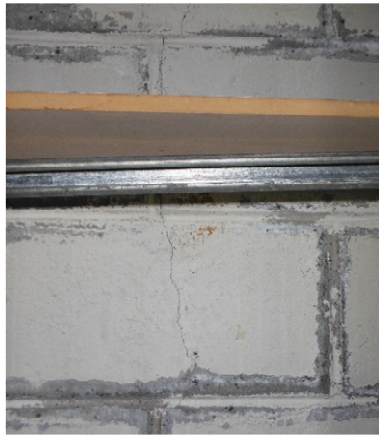
| Damaged Item | Location | Example | Recommended Repair |
|---|---|---|---|
| 2.2. Vertical cracking in concrete block work wall | Occurs in north section of west wall | | Remove and replace cracked concrete blocks. Repair and repoint cracked mortar joints. |

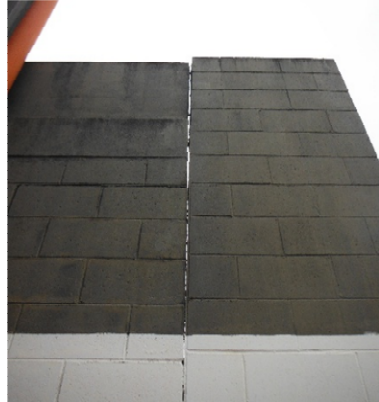
| Damaged Item | Location | Example | Recommended Repair |
|---|---|---|---|
| 2.3. External concrete block wing wall extension has moved creating a gap in the upper portion | External concrete wing wall at northwest corner of building | | Remove wing-wall extension or strengthen for face loads. Provide temporary propping while the fire requirements are confirmed and the solution for the wall is determined. |

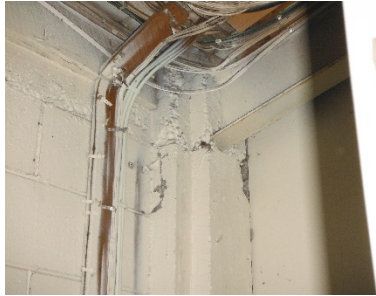
| Damaged Item | Location | Example | Recommended Repair |
|---|---|---|---|
| 3.1. Cracking and spalling of concrete column to steel beam connection | Top of west portal frame column at west boundary wall | | Remove concrete and observe beam to column connection to ensure no signs of distress. If no signs of distress, repair concrete encasement of column per repair specification. |

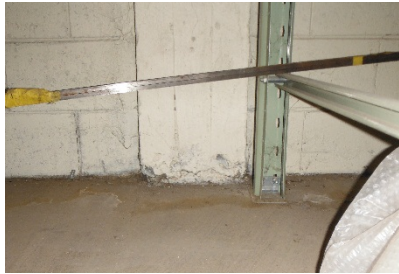
| Damaged Item | Location | Example | Recommended Repair |
|---|---|---|---|
| 3.2. Cracking and spalling of concrete column at slab level | Occurs at several locations in the western structure | | Remove concrete and observe column at base to ensure no signs of distress. If no signs of distress, repair concrete encasement of column per repair specification. |

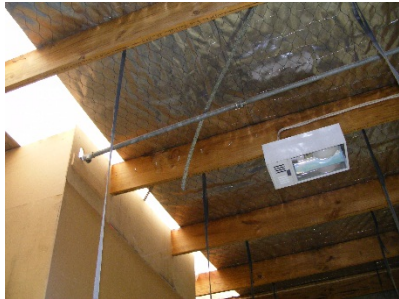
| Damaged Item | Location | Example | Recommended Repair |
|---|---|---|---|
| 4.1. Broken roof tension strap | Eastern structure | | Replace broken strapping. Refer to Section 5.2. |

In the eastern lean-to addition, a roof tension strap cross bracing member has failed in tension and snapped apart. This is likely due to the difference in stiffness of the eastern gib lined timber framed wall and the internal concrete blockwork infill walls. As determined in section 3, the capacity of the tension strap bracing is at 95% DBE.

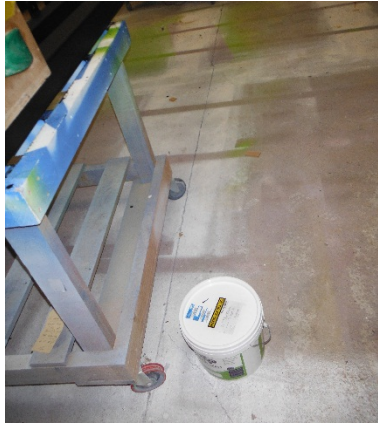
| Damaged Item | Location | Example | Recommended Repair |
|---|---|---|---|
| 1.1. Cracking and spreading at slab construction joints | <p>South section of eastern structure</p> <p>See damage map photo 1.</p> | | Chase channels each side of crack and install dowels across crack to prevent future lateral spreading of slab. |

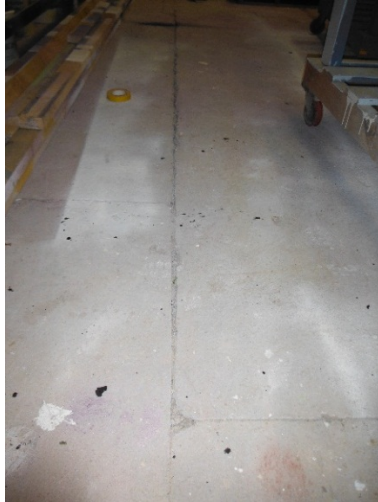
| Damaged Item | Location | Example | Recommended Repair |
|---|---|---|---|
| 1.2. Differential settlement of slab | <p>South section of eastern structure</p> <p>See damage map photo 2.</p> | | Remove section of slab that has lifted. Re-level ground. Install new slab with epoxy dowels into adjacent slab sections. |

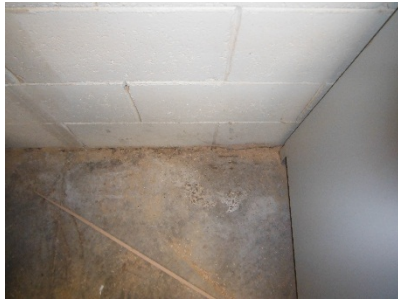
| Damaged Item | Location | Example | Recommended Repair |
|---|---|---|---|
| 1.3. Differential settlement of slab | Southern wall at internal wall junction with slab in eastern structure.<br><br>See damage map photo 3. | | Remove section of slab that has lifted. Re-level ground. Install new slab with epoxy dowels into adjacent slab sections. |

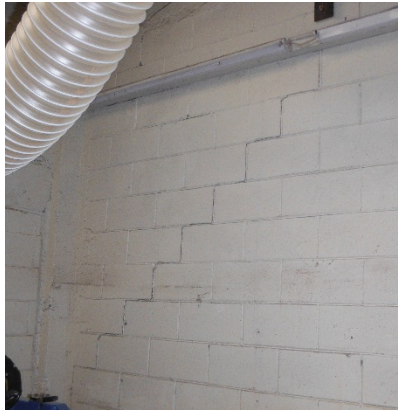
| Damaged Item | Location | Example | Recommended Repair |
|---|---|---|---|
| 2.1. Diagonal cracking along mortar joints in concrete block infill walls | Occurs along the west, south, and east walls of the original factory building (west structure)<br><br>See damage map photo 4. | | Repair and repoint all mortar joint cracks from both the inside and outer faces. |

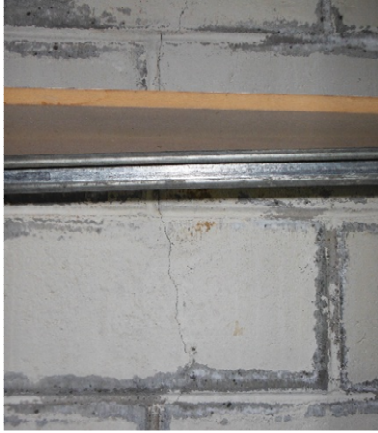
| Damaged Item | Location | Example | Recommended Repair |
|---|---|---|---|
| 2.2. Vertical cracking in concrete block work wall | Occurs in north section of west wall<br><br>See damage map photo 5. | | Remove and replace cracked concrete blocks. Repair and repoint cracked mortar joints. |

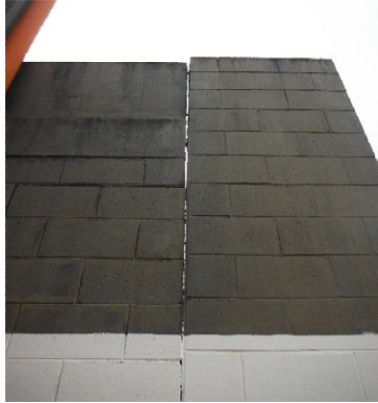
| Damaged Item | Location | Example | Recommended Repair |
|---|---|---|---|
| 2.3. External concrete block wing wall extension has moved creating a gap in the upper portion | External concrete wing wall at northwest corner of building<br><br>See damage map photo 6. | | Remove wing-wall extension or strengthen for face loads. Provide temporary propping while the fire requirements are confirmed and the solution for the wall is determined. |

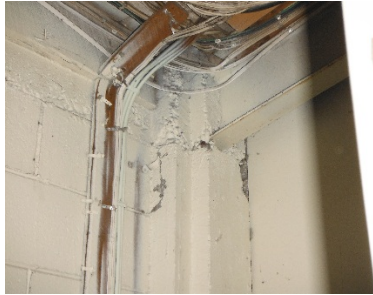
| Damaged Item | Location | Example | Recommended Repair |
|---|---|---|---|
| 3.1. Cracking and spalling of concrete column to steel beam connection | Top of west portal frame column at west boundary wall<br><br>See damage map photo 7. | | Remove concrete and observe beam to column connection to ensure no signs of distress. If no signs of distress, repair concrete encasement of column per repair specification. |

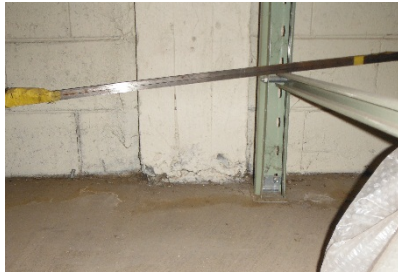
| Damaged Item | Location | Example | Recommended Repair |
|---|---|---|---|
| 3.2. Cracking and spalling of concrete column at slab level | Occurs at several locations in the western structure<br><br>See damage map photo 8. | | Remove concrete and observe column at base to ensure no signs of distress. If no signs of distress, repair concrete encasement of column per repair specification. |

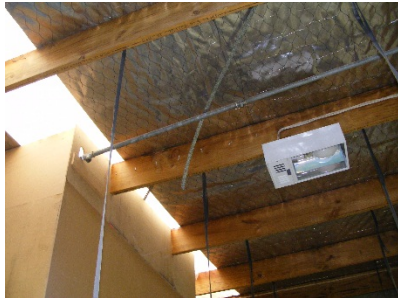
| Damaged Item | Location | Example | Recommended Repair |
|---|---|---|---|
| 4.1. Broken roof tension strap | Eastern structure<br><br>See damage map photo 9. | | Replace broken strapping. |

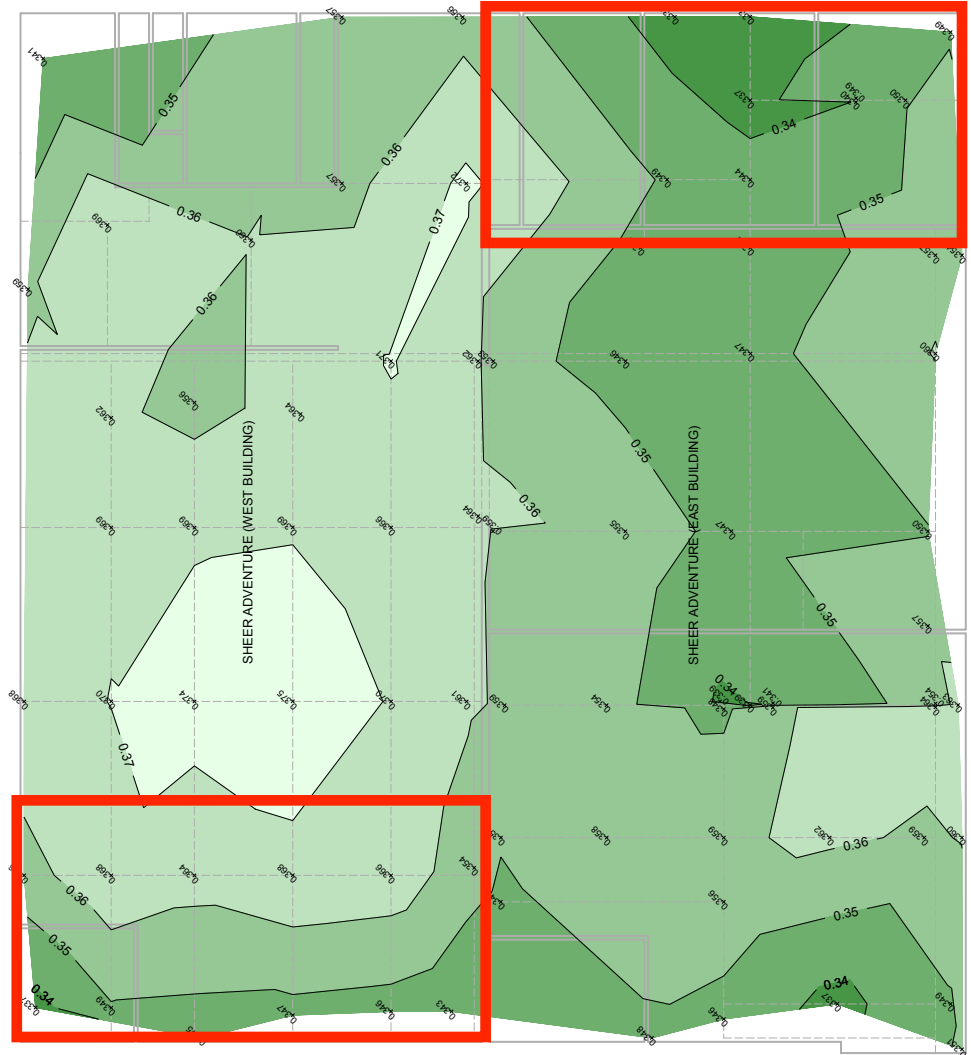
- Area of slab to be broken out and replaced with D12 starters epoxied into existing slab or foundations/walls to remain.
