| PROJECT NO | C11090.00 | DATE | 6 <sup>th</sup> June, 2011 |
| PROJECT NAME | Gary Lee Electrical | ADJUSTER: | Crawford and Company – Stuart Mintz |
| PROJECT LOCATION | 7 Elmdale Lane<br>Christchurch, New Zealand | INSURER: | Chartis |

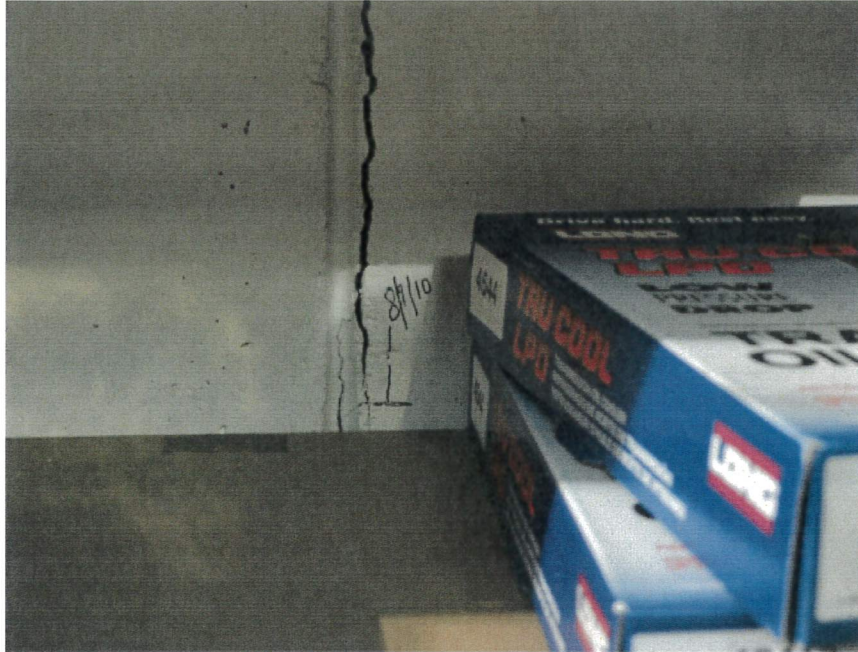
In unit 3, TT observed separation between an exterior wall panel and the adjacent half-height column (Photo 4). TT observed a separation of approximately 1mm between panels at two panel joint locations at demising walls between units (Photo 5). Markings on one of the panels indicate that some of the separation observed may have been noted after the September 2010 earthquake.

Photo 05: Separation between wall panels.

At locations where the panel sealant joints have separated, TT recommends removing the existing sealant joint between panels, and replacing it with a new backing strip and elastomeric sealant, such as Sikaflex 11FC, or similar. Where concrete spalls were observed at the exterior face of the panels, TT recommends repairing the spalls with Sika MonoTop primer in conjunction with Sika MonoTop mortar, or with similar products. The contractor should ensure that the patching material is applied only to the spalls, and not across the panel to panel joints.

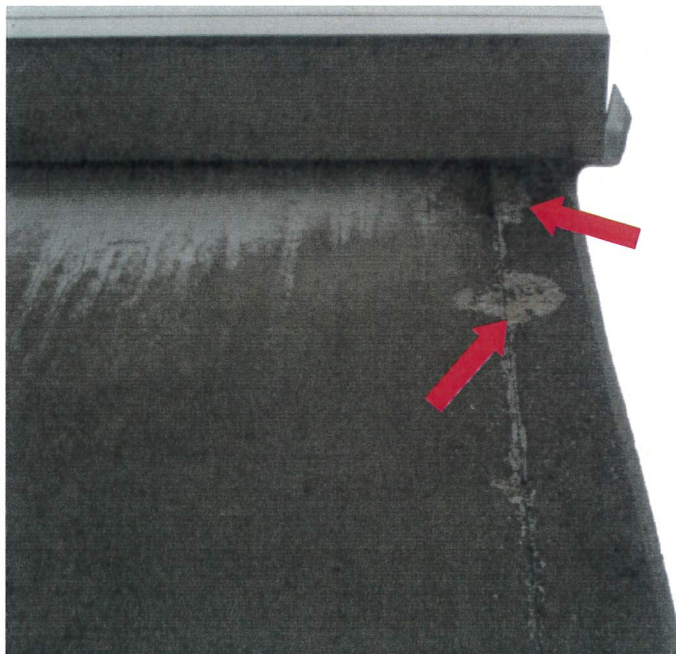
From the exterior of the building, TT observed isolated shallow spalls in the concrete wall panels. The spalls were primarily located at intersections between perpendicular wall panels (Photo 6).

Photo 06: Spalls at exterior face of panel

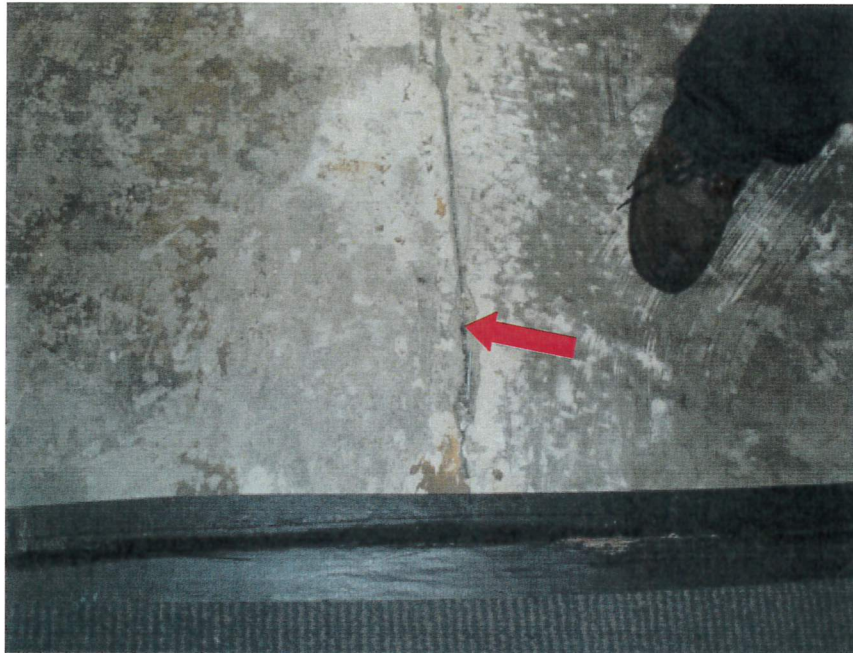
The primary type of damage observed at the building was cracks in the slab on grade (Photo 3). Although many of the cracks observed appear to be located at control joints in the slab, or at the interface between the slab and what is presumably the strip footing below a concrete tilt-up panel, TT also observed irregularly shaped cracks within the field of the slab. During the earthquake, liquefied soil reportedly flowed up through the joints and cracks, causing portions of the slab became unlevel. Soil liquefaction and the resulting cracks also caused damage to the floor finishes in units 7, 9, and a portion of unit 3. The other units observed did not have finished floors.

Photo 03: Crack at control joint in slab on grade

TT recommends that the cracks noted in the field of the slab that are not located at control joints be repaired using an epoxy injection compound. Suitable products for this repair are Sikadur Injectokit – LV for cracks between 0.2mm and 0.4mm, Sikadur Injectokit – TH for cracks between 0.2mm and 2mm, or Sikadur 52 for cracks up to 5mm wide. Products from an alternate manufacturer with similar properties may be substituted.

Cracks that occur at a control joint, gaps that occur at construction joints, or at the joint between the slab and strip footing, should be re-cut if needed, cleaned, and filled with an elastomeric sealant, such as Sikaflex 11FC, or similar, applied over a backing strip.

At locations where adjacent slab edges are uneven across a crack or joint, the high points in the slab should be ground down so they are level with the adjacent slab. Low points in the slab that are between 5mm and 30mm in depth should be primed with Sika MonoTop primer, and filled with Sika MonoTop mortar, or a similar product.

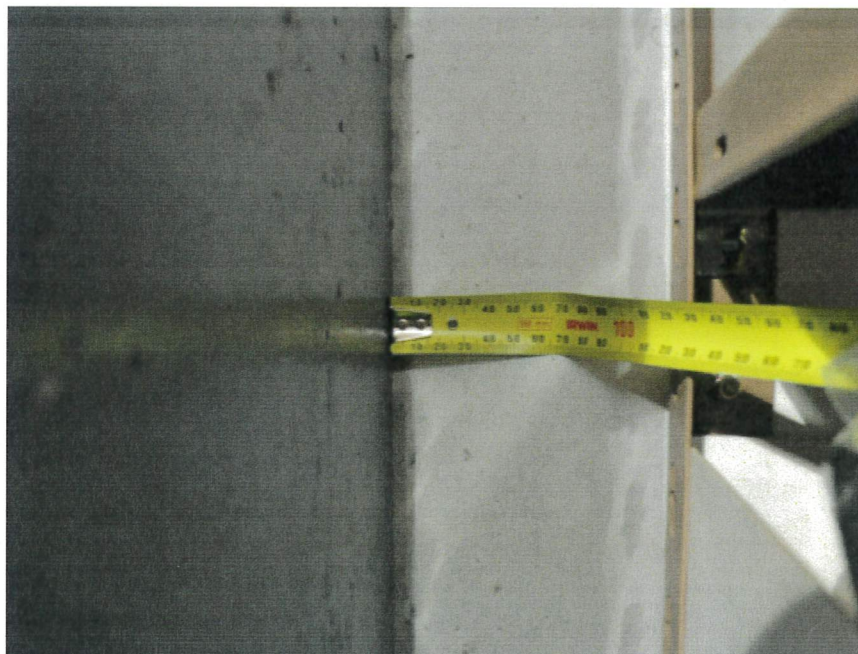
Photo 04: Separation between wall panel and concrete column

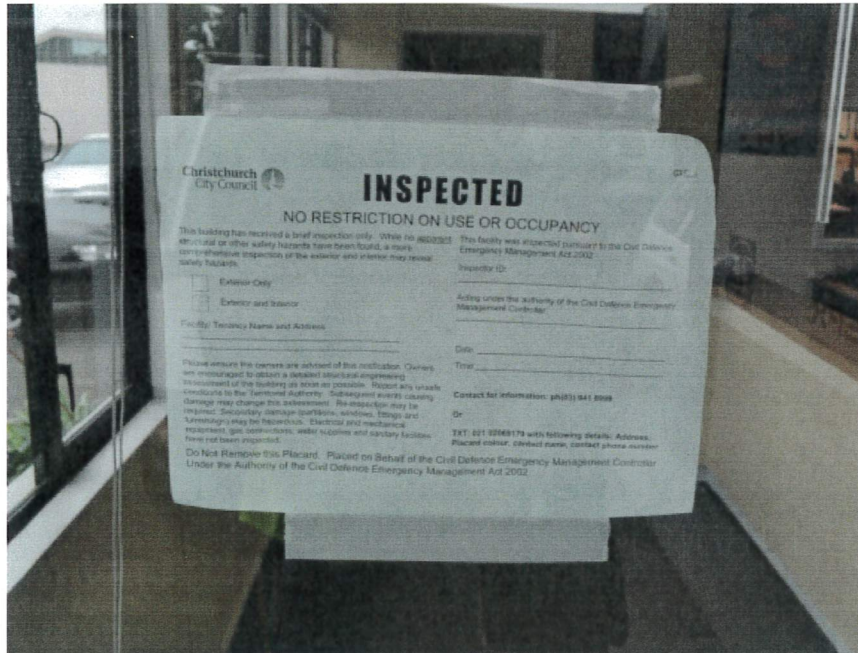
Thornton Tomasetti (TT) visited the site with Crawford and Company on 25<sup>th</sup> May 2011, to survey the building damage due to the M6.3, 22<sup>nd</sup> February earthquake. TT was able to survey the majority of the exterior of the building, and gained access to units 3, 5, 7 and 9. We did not observe units 11, 13, or 15, as we were informed that they sustained no apparent damage. At the time of our visit, the entrance to unit 3 was marked with a green placard indicating "No restriction on use or occupancy" (Photo 1).

Photo 01: Green placard at entrance to unit 3

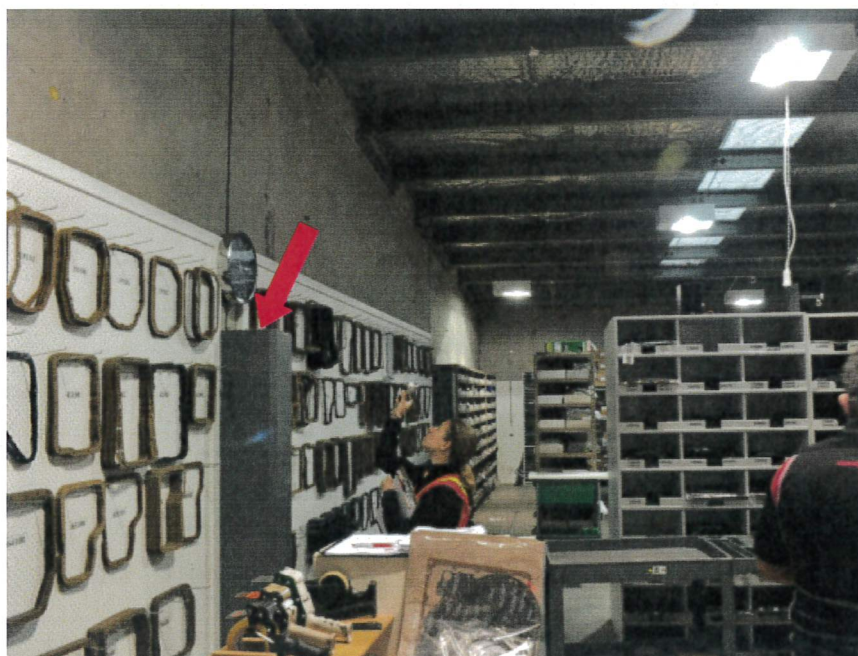
Each unit is separated by concrete tilt-up wall panels, and the majority of the exterior walls are concrete tilt-up panels. At each exterior wall panel joint observed, TT observed concrete columns, or concrete-encased steel columns, that extend to roughly half of the panel height (Photo 2). The ground floor of each unit is a concrete slab on grade. The roof structure consists of light gauge steel purlins that span in the north-south direction and are supported by steel ledger angles bolted to the tilt-up concrete walls. Lateral loads are resisted by the concrete wall panels.

Photo 02: Interior of unit 3, note half-height concrete column at panel joint
