**REPORT PREPARED FOR:  
MATAKANA SAWMILL LIMITED**

**ADDITIONAL ENVIRONMENTAL  
INVESTIGATION  
MATAKANA SAWMILL  
362 MATAKANA VALLEY ROAD,  
MATAKANA**

**Prepared by:  
Groundwater and Environmental Services  
PO Box 190  
Cambridge  
7 September 2005**

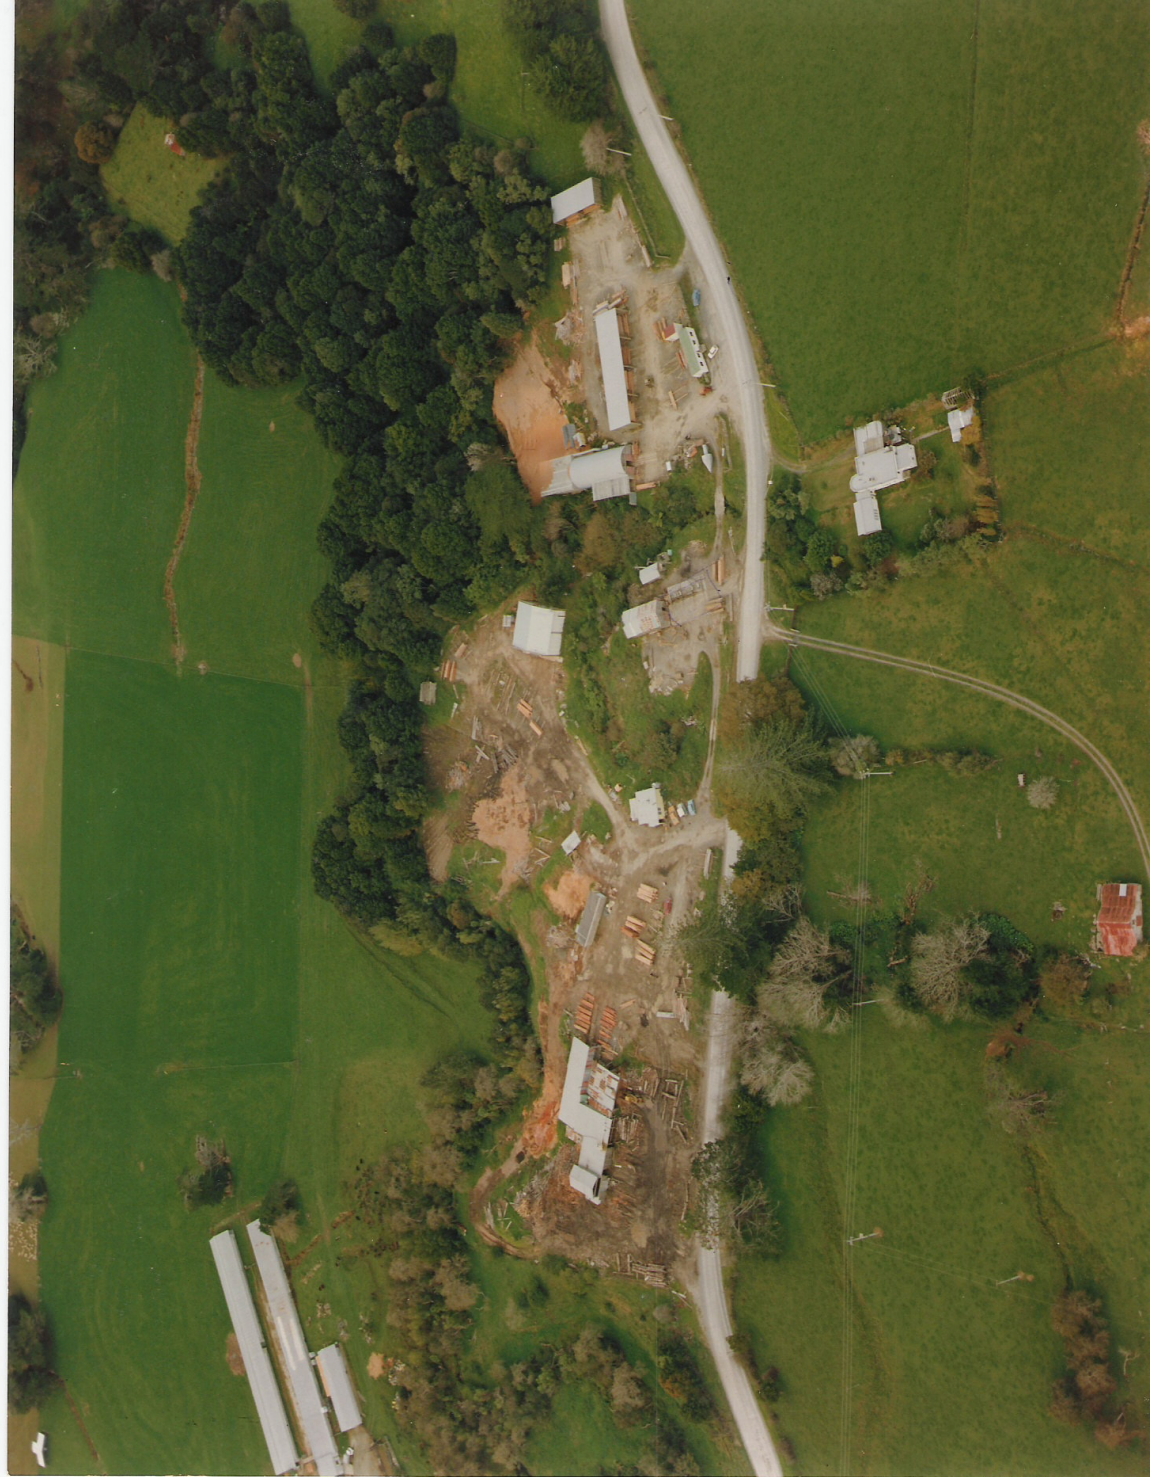
### **1990s Aerial Photograph**

- The layout of the former sawmill is clearly visible in the north of the property;
- Logs are stacked to the west and northwest of the mill site;
- Finished timber is stacked immediately south of the mill, on either side of the exit from the boric spray tunnel;

- There is a large amount of sawdust from the mill on the ground to the east of the building;
- A diesel fuel pump appears to be present on the western side of the northern part of the mill;

- There are two circular features on the ground surface next to Matakana Valley Road, at the assumed location of the underground diesel storage tank. These may be the filler and inspection caps for the tank;

- The yards and driveway areas in the northern two thirds of the site appear to be unsealed, with parts of the area appearing to be muddy;
- The CCA treatment plant is visible to the south of the cottage, between two stream gullies that discharge to the east to Matakana River;

- There is a concrete drying pad immediately west of the treatment plant and timber is stored on unsealed ground to the north and west of the pad;
- There is a small shed immediately south of the treatment plant;

- The driveways and yards are unsealed;
- There is a large amount of sawdust on the ground surface immediately southeast of the eastern end of the planing shed; and
