Christchurch Property Inspections Report

18 Sandwich Road,
Beckenham

04/06/2025

Pre-Sale Visual Non-Invasive Property Inspection

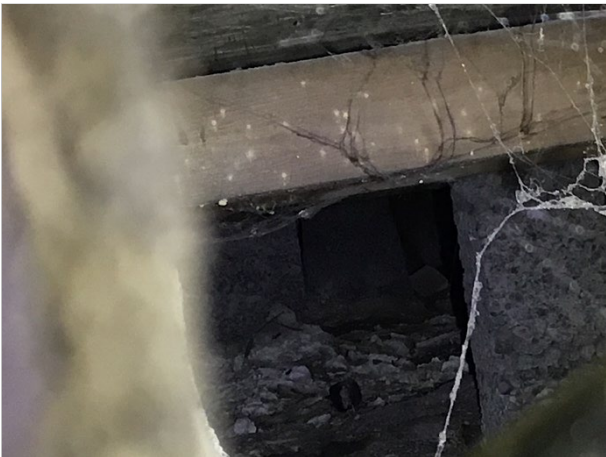
Insulation Floors	No access, viewed through foundation vents. No underfloor or moisture barrier installed.	10
Roof Structure	<p>Decramastic tiled roofing over timber sarking, purlins and rafters. Generally sound, typical for age. No significant rot or borer visible.</p> <p>NB: Due to current NZ legislation (Health & Safety at Work Act 2015) – in regard to working alone and in confined spaces; we will only provide a very limited visual inspection of the roof cavity which can be seen from a ladder at the manhole location (within a 2m radius) and/or any safe attic access space available. If you have any concerns about the quality of the structure, insulation or pest infestation we recommend further investigation by a qualified roofing/insulation/pest contractor to provide you with a specialist report.</p>	7
Moisture Tests See note below	Multiple moisture readings were taken in each room and on window sills. The readings give an overall indication of the moisture levels in the house but do not mean that there may not be areas with high moisture levels. Whilst every effort is made to detect moisture problems it is not possible to check every square metre of the interior wall space during inspection.	14-20

9. Typical pile, no subfloor moisture barrier

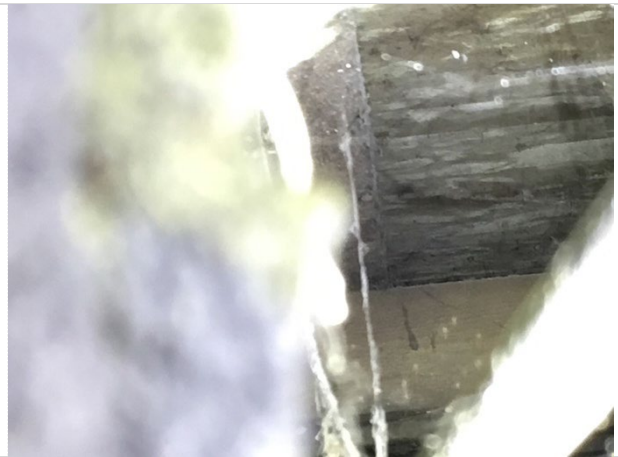
10.No subfloor insulation

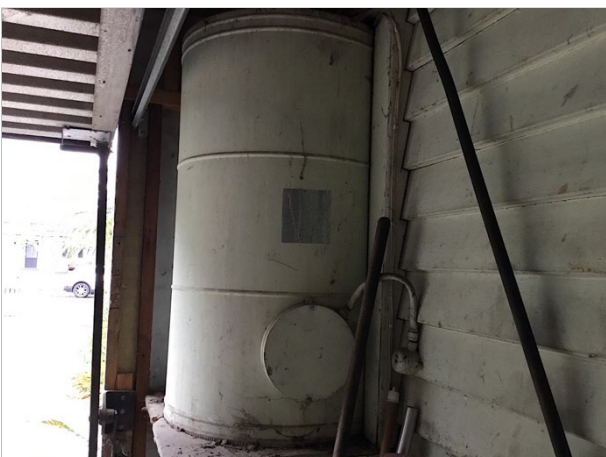
Hot Water	Low pressure electric hot water cylinder located in the garage. Generally sound, typical for age. Untested. No seismic strapping installed.	Photo 11
Electrical Services	Mini circuit breakers on original switchboard. (See switchboard photo) Power was on at time of inspection. Untested.	12
Plumbing Services	Some polybutylene pipework visible. No Qest Dux plumbing observed.	
Ventilation System	N/A.	
Smoke Alarms	N/A.	
Intruder Alarms	N/A.

11.Low pressure HWC

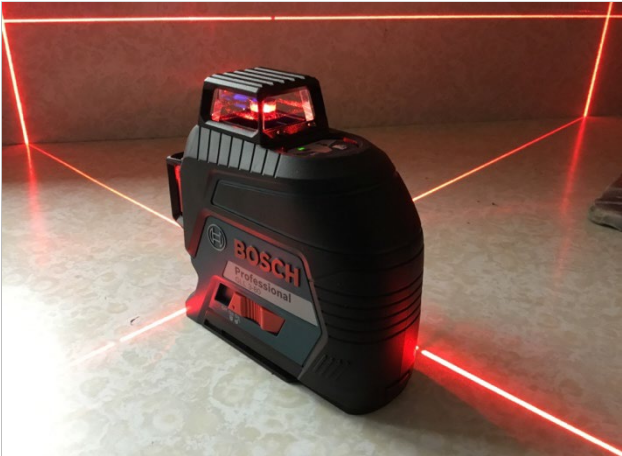
Floor Levels	<p>Spot checked throughout using a Bosch GLL 3-80 mini laser. Findings below.</p> <p>25mm variation over 10m well within guidelines below.</p> <p>MBIE GUIDELINES: 1. The floor slope between two points greater than 2m apart is less than 0.5% (1:200)</p> <p>Floor levels are spot checked using a Bosch GLL 3-80 mini laser. This is not a comprehensive floor level survey and is not designed to replace an engineer's assessment. These measurements are to be treated as indicative readings only. Floors are spot checked at different areas of the house. If a more in depth survey is required, a zip level survey should be commissioned to capture the exact floor level condition.</p>	Photo 13
Insulation Ceiling	<p>Fibreglass batts 100mm thick where installed. Generally sound, typical for age. Would benefit from installing second layer. Full height ceilings have no insulation.</p> <p>Strong smell and signs of vermin.</p>	8

13. Floor levels checked with laser level

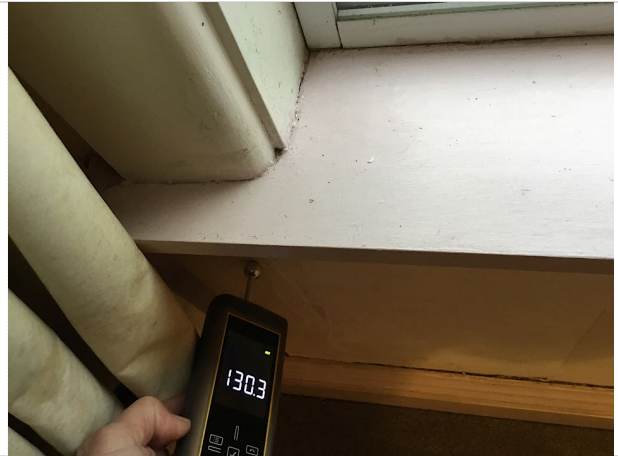
Flooring	Carpet. Appears in good condition, typical for age.	Photo
Walls	Wallpaper over lathe and plaster. Generally sound, typical for age.	
Ceiling	Acoustic panel. Generally sound, typical for age.	
Lighting	Pendant. Operational. Generally sound, typical for age.	
Doors	Paint finish. Operational. Generally sound, typical for age.	
Windows	Timber single glazed. Operational. Generally sound, typical for age.	
Wardrobe	Double slider. Built in. Operational. Generally sound, typical for age.	
Architrave/ Skirting	Paint finish. Generally sound, typical for age.	
Heating	N/A.	
Moisture Levels	Tested high at time of inspection.	14

14. High moisture reading in bedroom 2

There are a few maintenance issues mentioned in report. High moisture readings need further investigation to determine source of moisture. I recommend underfloor access being installed to view subfloor.

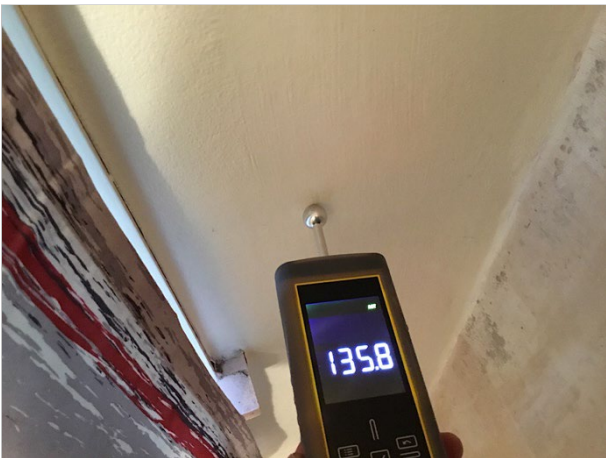
Flooring	Carpet. Appears in good condition, typical for age.	Photo
Walls	Wallpaper over lathe and plaster. Generally sound, typical for age.	
Ceiling	Painted pinex tiles. Generally sound, typical for age.	
Lighting	Pendant. Operational. Generally sound, typical for age.	
Doors	Paint finish. Operational. Generally sound, typical for age.	
Windows	Timber single glazed. Operational. Generally sound, typical for age.	
Wardrobe	Single door. Built in. Operational. Generally sound, typical for age. Needs wall repairs.	
Architrave/ Skirting	Paint finish. Generally sound, typical for age.	
Heating	N/A.	
Moisture Levels	Tested high at time of inspection.	15

15. High reading bedroom 3

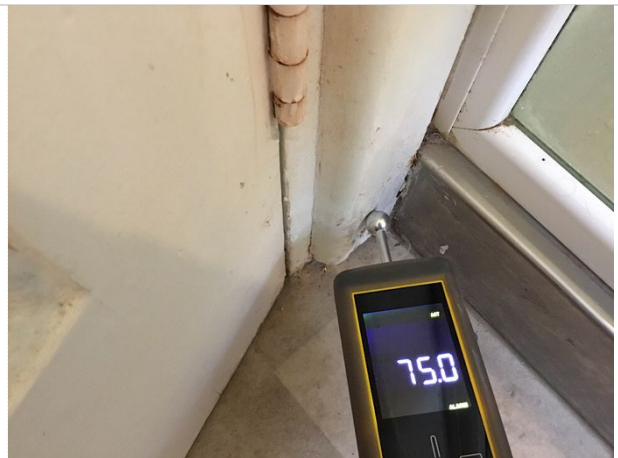
16. Beside shower

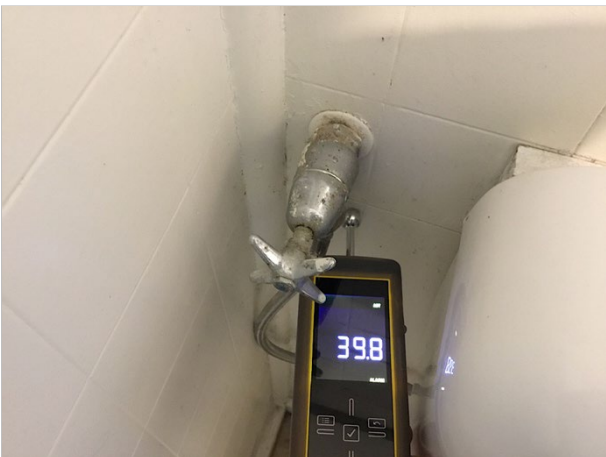
17. Beside toilet water supply

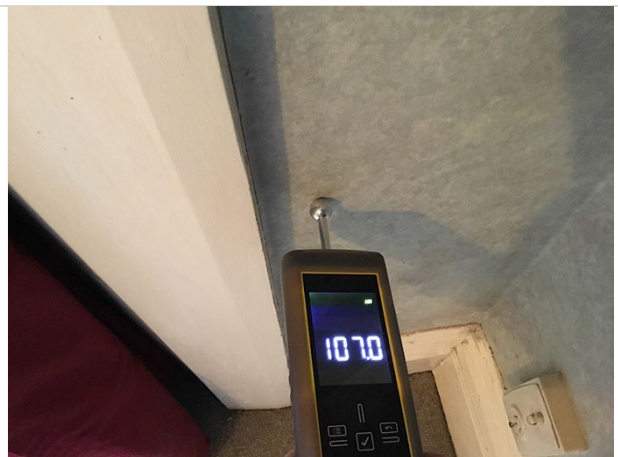
Architrave/ Skirting	Paint finish. Generally sound, typical for age.	
Heating	N/A.	
Moisture Levels	Tested high on several walls, external and internal at time of inspection.	18

18. High reading in living

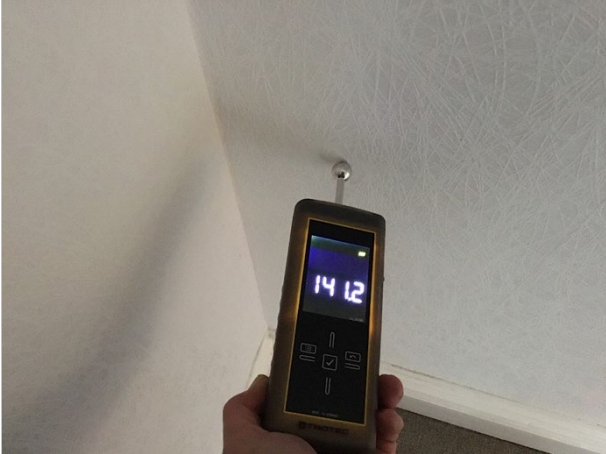
Flooring	Carpet. Appears in good condition, typical for age.	Photo
Walls	Wallpaper over lathe and plaster. Generally sound, typical for age.	
Ceiling	Lining paper over lathe and plaster. Generally sound, typical for age.	
Lighting	Pendant. Operational. Generally sound, typical for age.	
Doors	Paint finish. Operational. Generally sound, typical for age.	
Windows	Timber single glazed. Operational. Generally sound, typical for age.	
Storage	Operational. Generally sound, typical for age.	
Architrave/ Skirting	Paint finish. Generally sound, typical for age.	
Heating	Haier high wall heat pump. Generally sound, typical for age. Powered up but not operating.	
Moisture Levels	Tested high on walls at time of inspection.	19

19. High reading in entrance

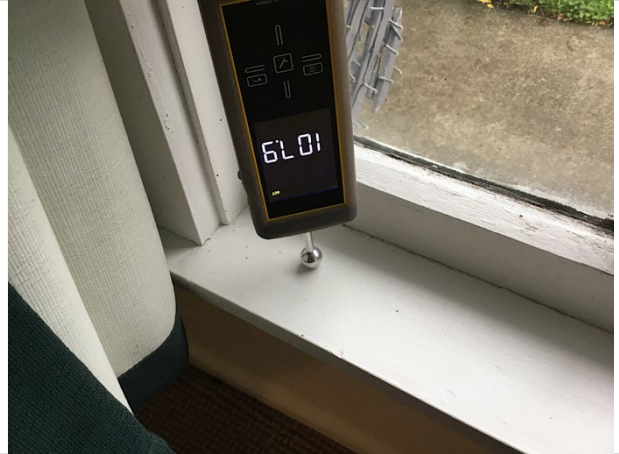
Heating	N/A.	
Moisture Levels	Tested high on window sill.	20

20. High reading in sleepout

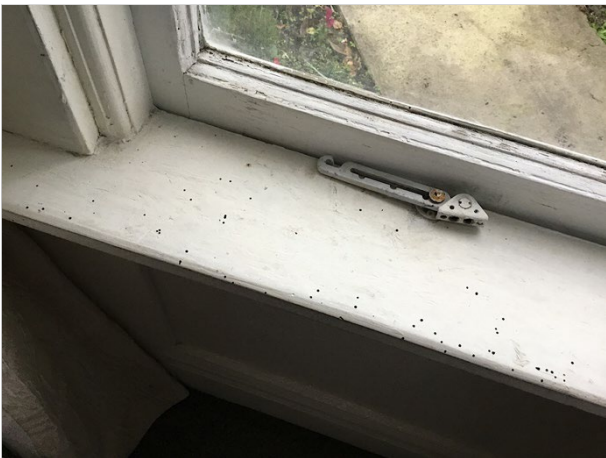
21. Borer in bedroom 1

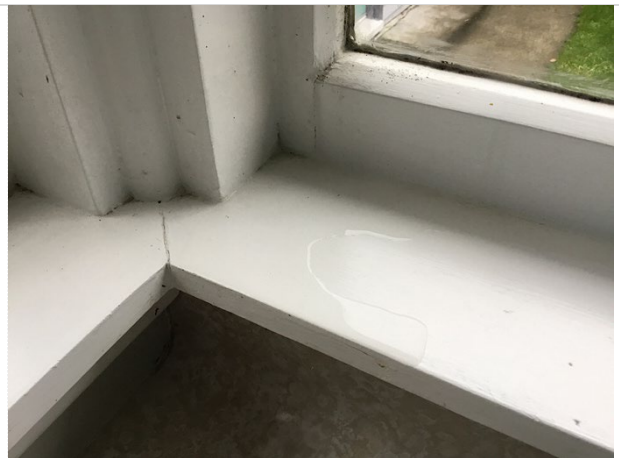
Benchtop	Formica. At end of life, due for replacement.	Photo
Cabinets	Painted timber. Generally sound, typical for age.	
Sink & Waste	Stainless steel. Generally sound, typical for age.	
Plumbing Fittings	PVC waste water pipe and braided water feed pipes, good pressure no leaks. Generally sound, typical for age.	
Oven	Freestanding 600mm unbranded. Generally sound, typical for age. Untested. Check with vendors immediately prior to property settlement that all oven and hob functions are fully operational.	
Hob	4 electric ring top. Generally sound, typical for age. Untested.	
Range Hood	N/A	
Fridge Space	650mm x 1850mm.	
Windows	Timber single glazed. Operational. Generally sound, typical for age. Several opening sashes not working. Windows leaking, water on sills and benchtop.	22
Doors	Paint finish. Operational. Generally sound, typical for age.

22. Water in kitchen from windows

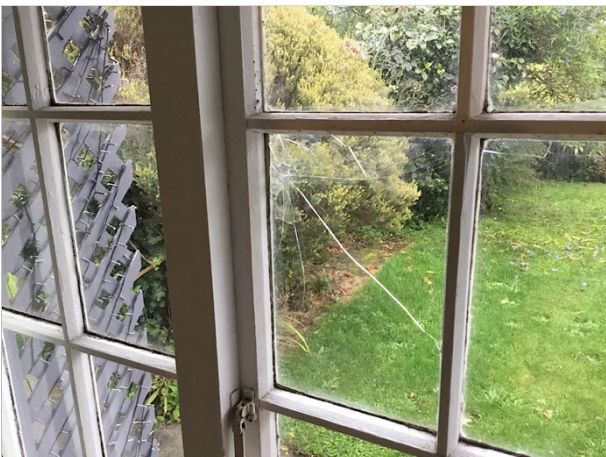
Flooring	Carpet. Appears in good condition, typical for age.	Photo
Walls	Painted plasterboard. Generally sound, typical for age.	
Ceiling	Painted plasterboard. Generally sound, typical for age.	
Cladding	Timber weatherboard. Generally sound, typical for age. Some painting due.	28
Roof	Painted corrugate Generally sound, typical for age	
Guttering	PVC. Generally sound, typical for age.	
Downpipes	PVC. Generally sound, typical for age.	
Lighting	Downlights. Operational. Generally sound, typical for age.	
Door	Timber single glazed. Operational. Generally sound, typical for age.	
Windows	Timber single glazed. Generally sound, typical for age.	23
Architrave/ Skirting	Paint finish. Generally sound, typical for age.

23. Broken sleepout window

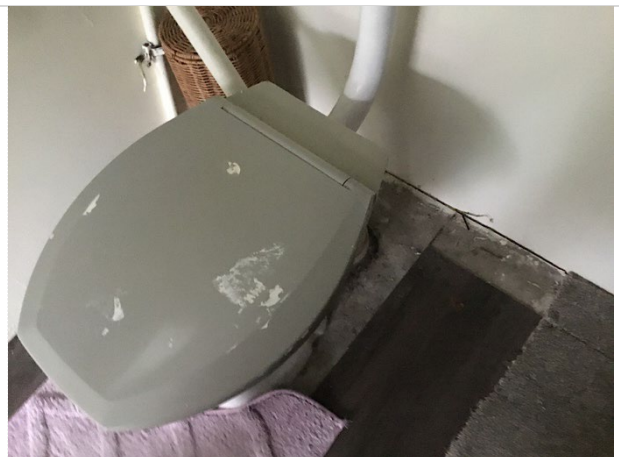
24. Unfinished flooring in sleepout toilet

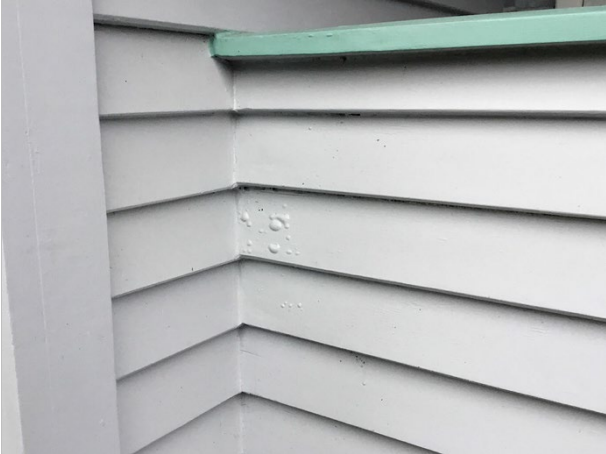
Soffits	Painted T&G. Generally sound, typical for age.	
Painting	<p>Generally sound, typical for age.</p> <p>Note: Regular painting as mentioned will help maintain the cladding in a good condition.</p>	25
Fascia	Painted timber. Generally sound, typical for age.

25. Some paint needs attention

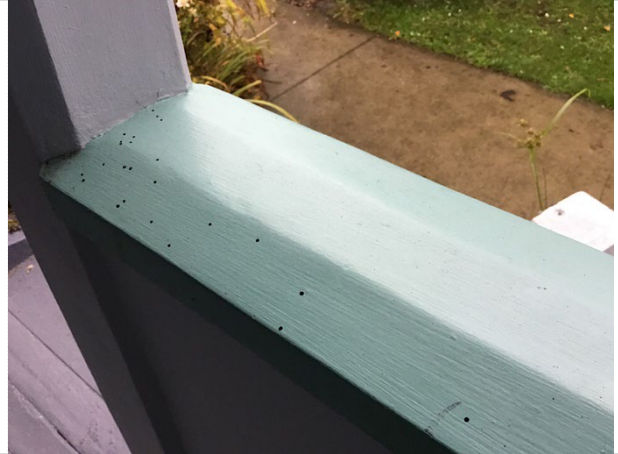
26. Borer on front porch

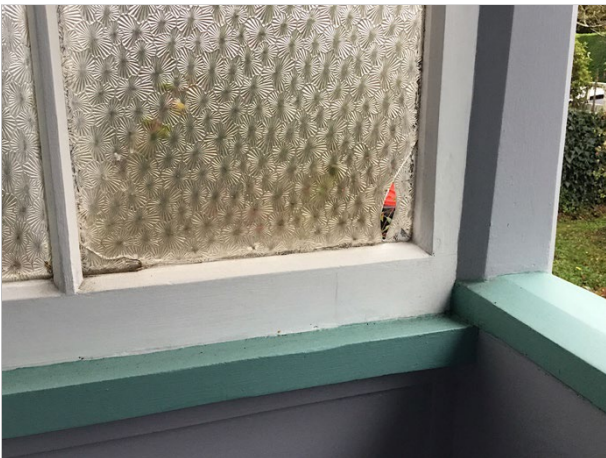
Windows	<p>Timber single glazed. Generally sound, typical for age.</p> <p>Several opening sashes not working, need easing.</p> <p>Broken glass on front porch</p>	27

27. Broken glass on front porch

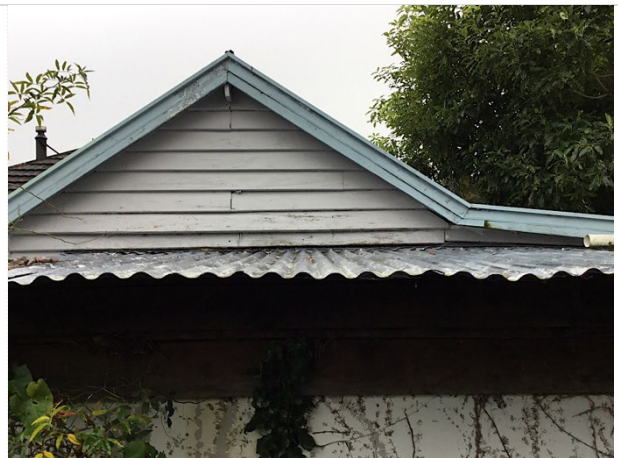
28. Sleepout gable needs painting

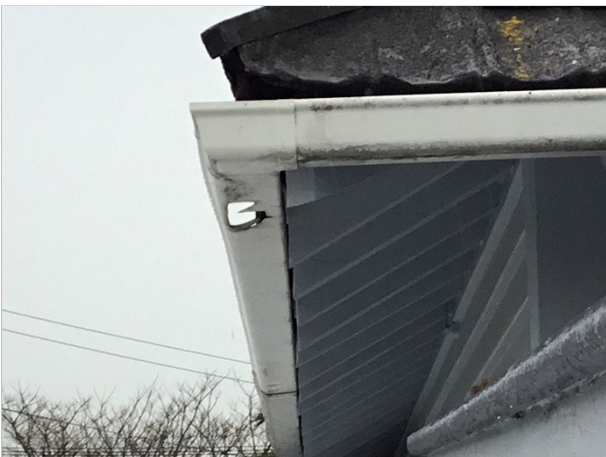
29. Damaged gutter above garage
