Date: 21 July 2020

Novare Project No. 3048

### ***INITIAL SEISMIC ASSESSMENT OF 8A HORNER STREET***

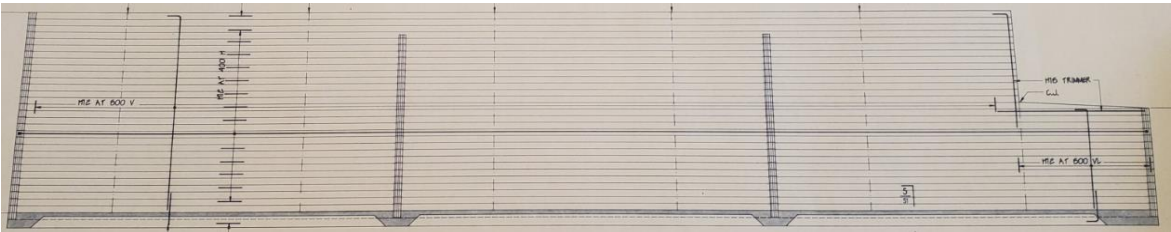
There is a step-down to the 1st floor at unit 3

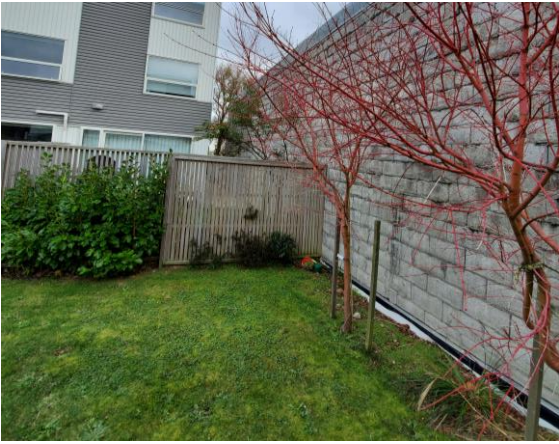
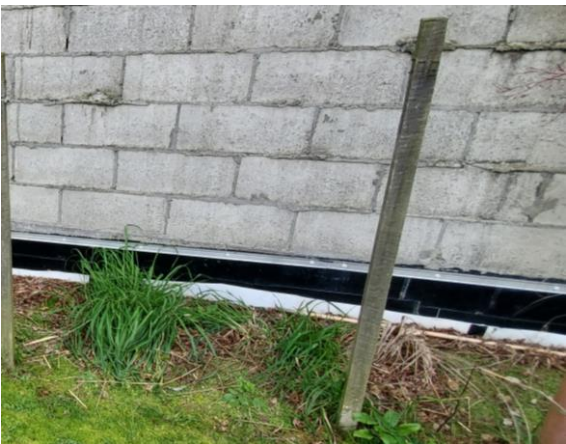
During the exterior inspection it was noted that there appears to be approximately 1.5 meters worth of retained soil without any visual clues to how the seismic earth pressures are resisted. It may or may not be loading the wall of this assessed building. There appears to be a moisture barrier installed to avoid the reinforced concrete blockwork from absorbing water, however, if there are any additional seismic soil actions, these may impose some additional stresses to the rear-wall out-of-plane for earthquake induced soil pressures. Earth retaining methods may have been engineered during the neighbour's development, we strongly recommend that this is confirmed.

There appears to be approximately 1.5 meters worth of soil retained at the rear of the property without any visual clues to how the seismic earth pressures are resisted. Earth retaining methods may have been engineered during the neighbour's development. We recommend that this is confirmed as it may impose some additional stresses to the rear-wall out-of-plane for earthquake induced soil pressures.

Backfill at the development behind 8 Horner Street appears to be loading directly against the masonry wall boundary.
