# EARTHQUAKE RECOVERY (EQR) DOCUMENTATION

## Scope of Works

## Assessment of Property at 15A CLYDE ROAD, ILAM, CHRISTCHURCH 8041 on 8/10/2011

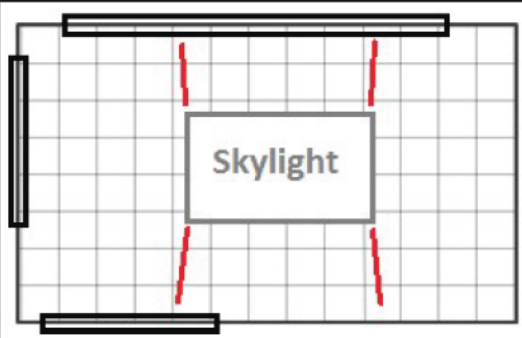
| EQC<br>Covered<br>Damage: | X | Yes | Length (m): 3.2 | Width (m): 3.2 | | Name: Sunroom | |
| | | | | | | Ceiling - 4m Cracking to plasterboard lining | |
