CASH SETTLED CLAIM(S)

Statement of Claim Checklist / Repair Strategy

CLM/2010/101159

RF BREMNER
 31 TODD AVENUE
 BISHOPDALE
 CHRISTCHURCH
 H [REDACTED]
 W [REDACTED]
 M [REDACTED]

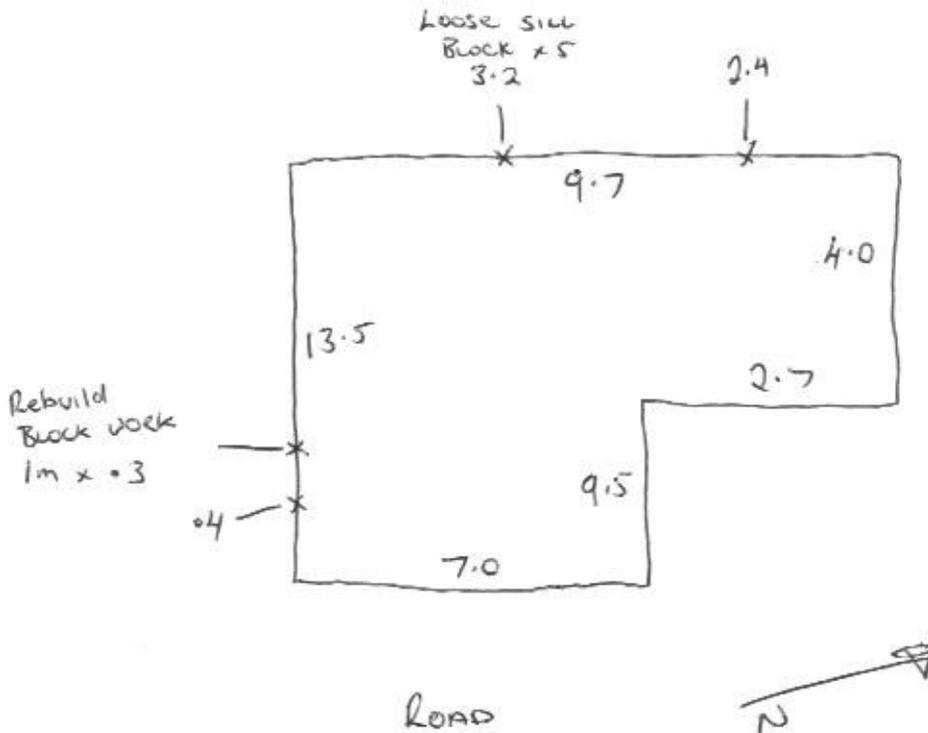
HOUSE FOOTPRINT

Area m ² :	126
Stud Heights:	2.4
Wall Finish:	Wallpaper Plastered <u>Paint finish</u>
Other	
Services:	Specify damage:
Chimneys: No	Construction type: Height: Damage description: Above Roof Below Roof Total Repair
Foundations Damage: No	Timber <u>Concrete Ring</u> Concrete Slab Other (Specify): Minor Moderate Severe House moved off foundations?: No Concrete slab cracked? Crack width: Crack length:.....
Roof:	<u>Framed</u> Trussed Type: Clay Tiles Concrete tiles Metal tiles <u>Rolled Metal</u> Other Damage:
Cladding Type:	Weatherboard <u>Brick Veneer</u> Hardiplank Other
