| <b>IAG Claim Number</b> | LG07645067 | <b>Date/Time</b> | 15 November 2017 |
| <b>Address</b> | 34B Upland Rd, Kelburn | <b>Loss Adjuster</b> | Sam Bell |

## DAMAGED PROPERTY SITE SURVEY

**Customer:** Wallcork Upland Ltd  
**Address:** 34B Upland Rd, Kelburn

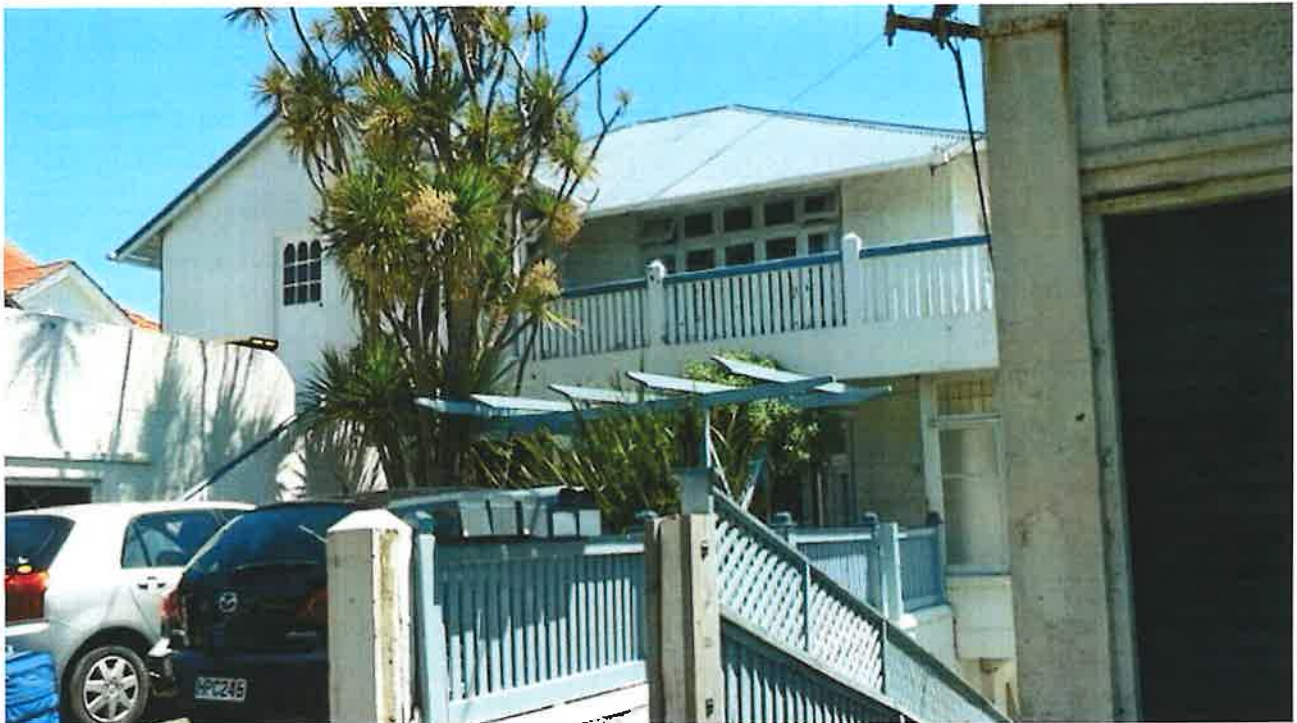
Front elevation of the multi unit building. 34 Upland road

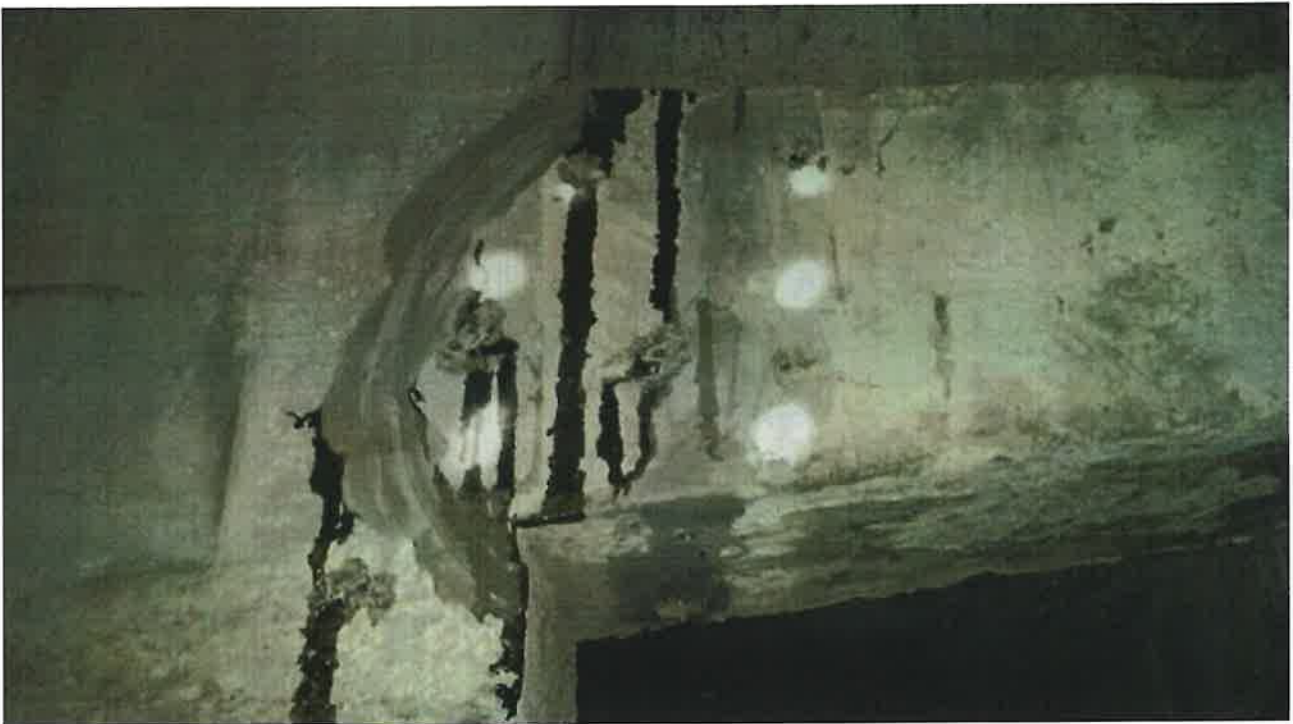
EQ repairs carried out

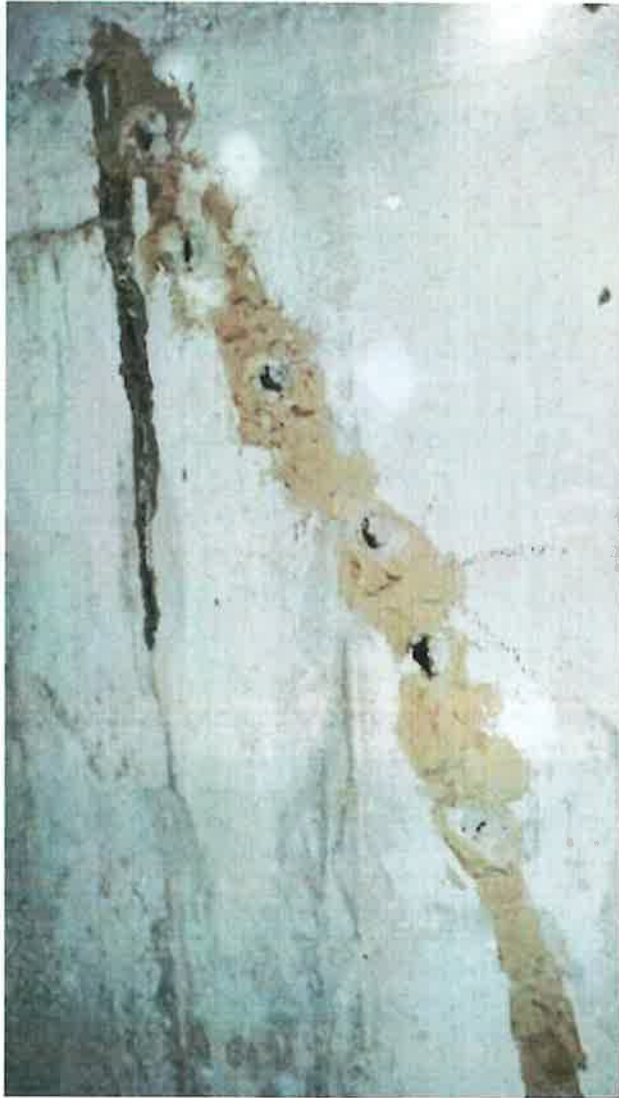
EQ repairs carried out

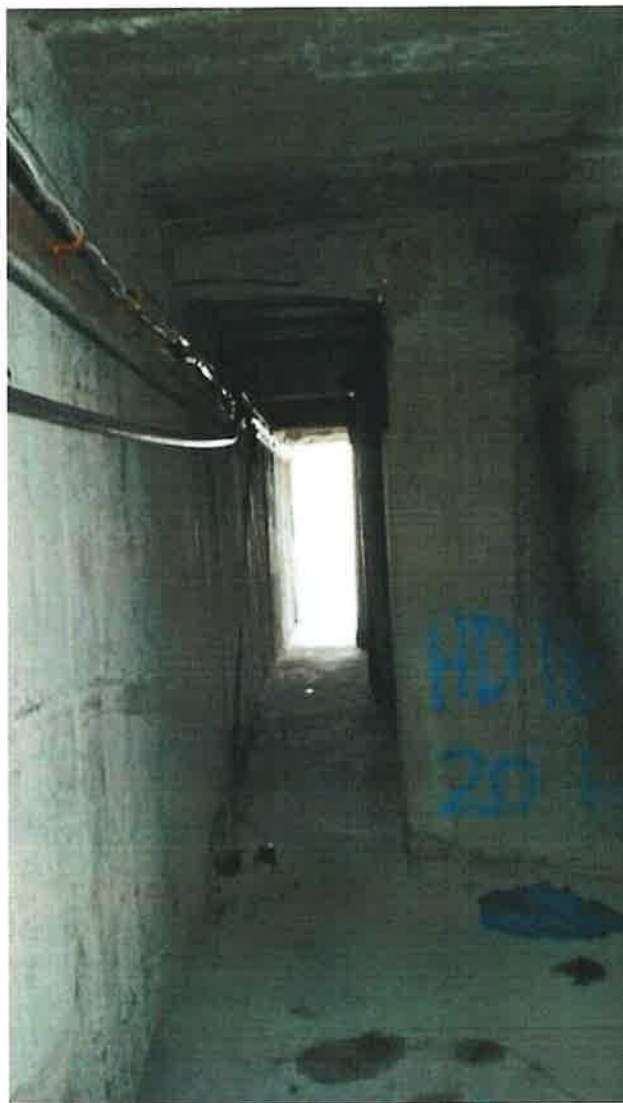
Sub floor area of multi dwelling flats

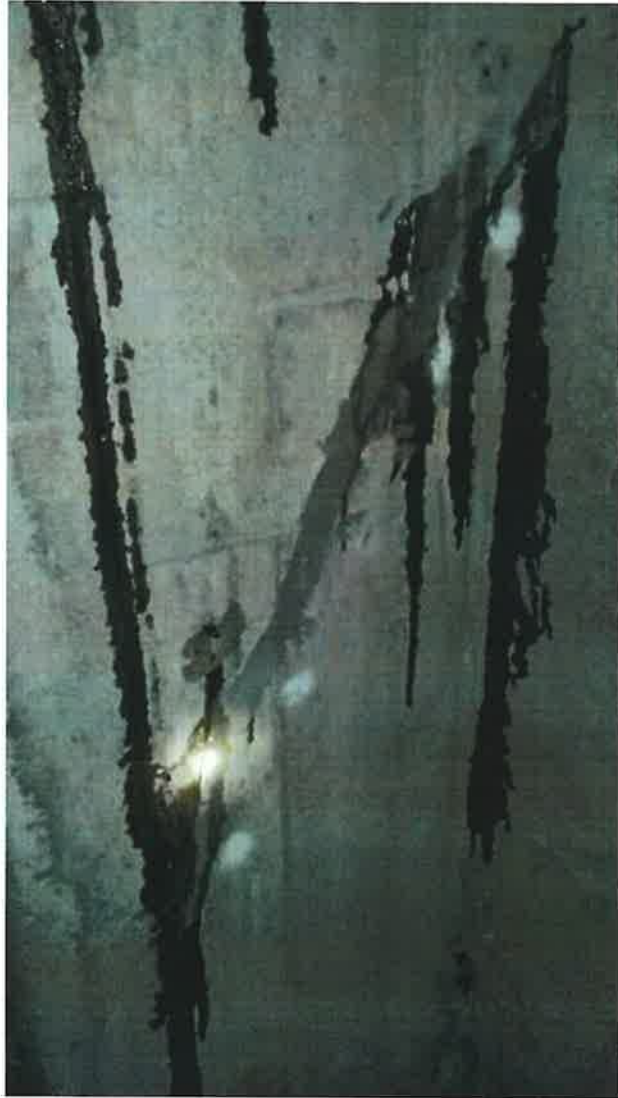
EQ repairs carried out

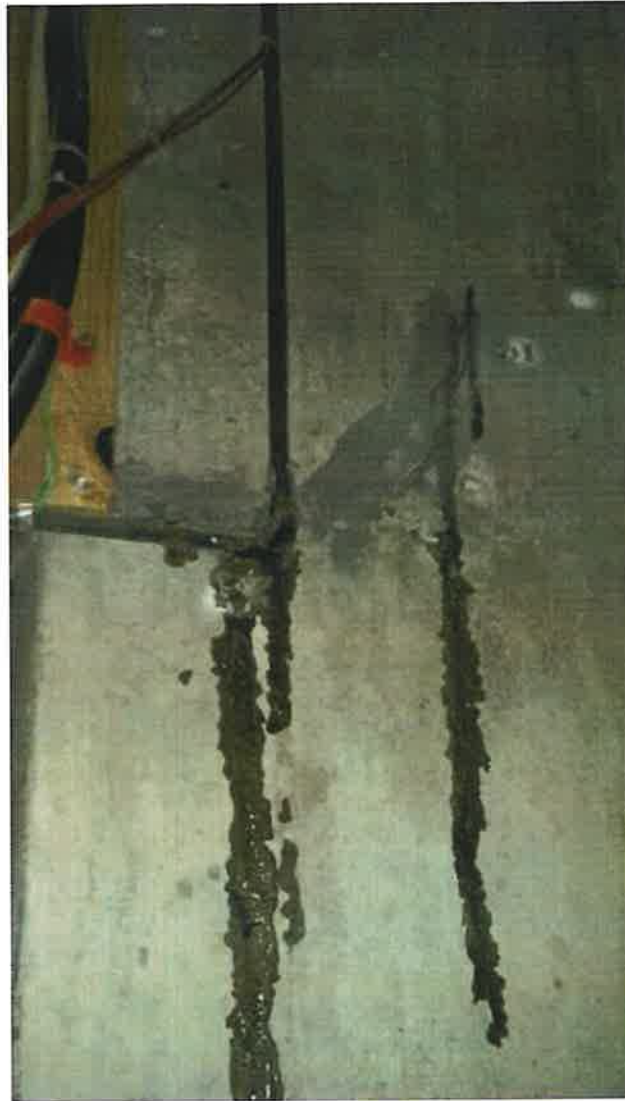
EQ repairs carried out

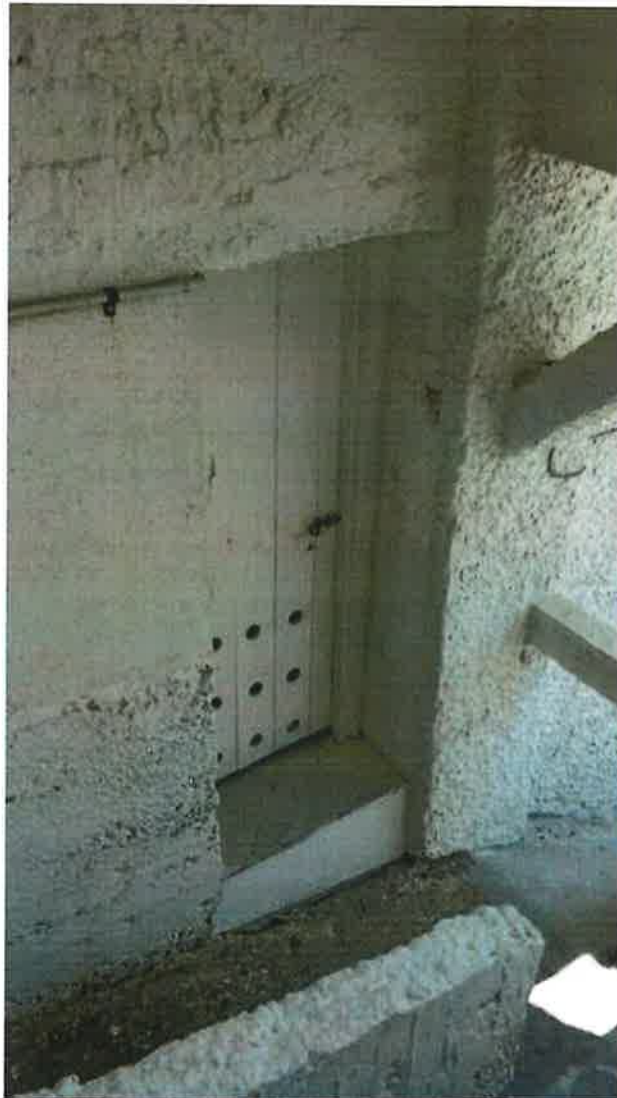
Trap door to subfloor repairs

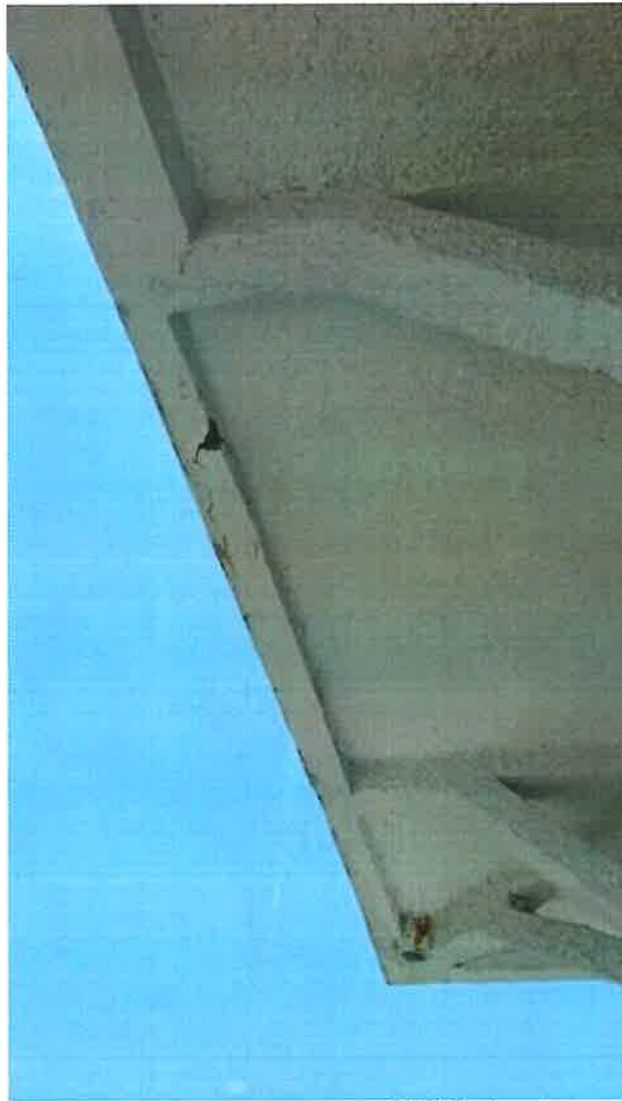
Concrete deck underneath flat B fractured

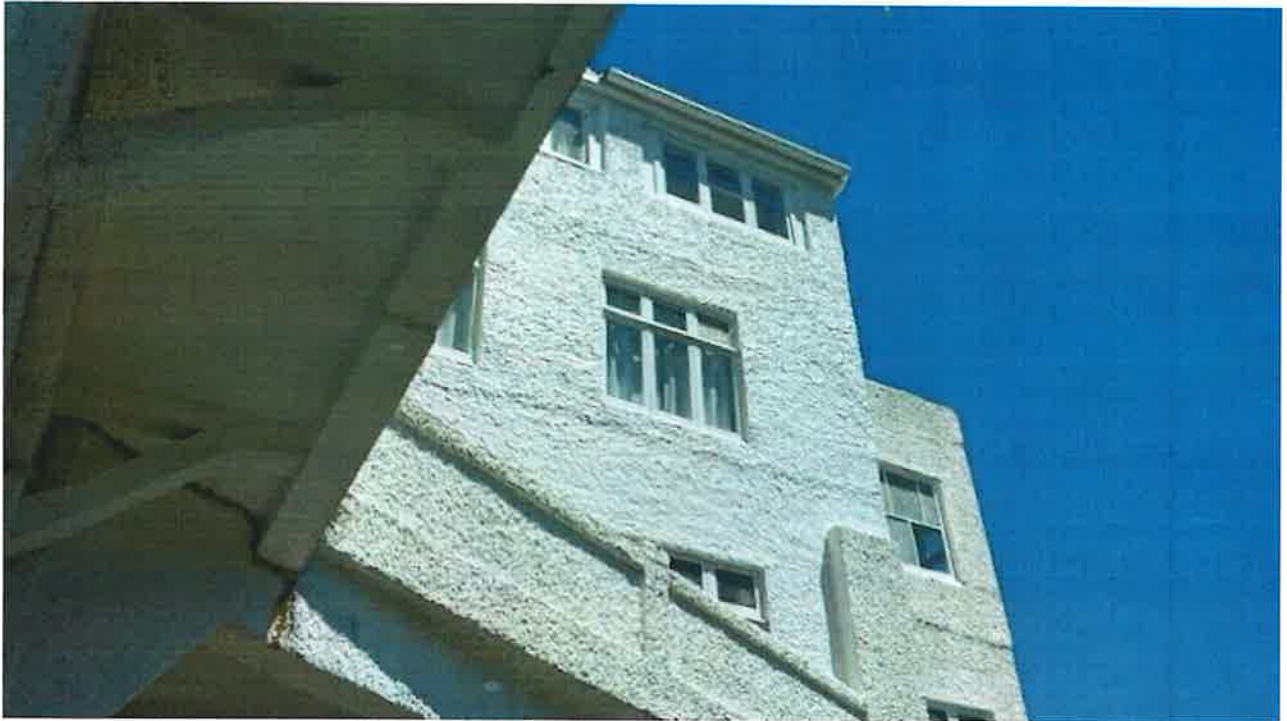
Multi complex building, damage assessed on flat B only

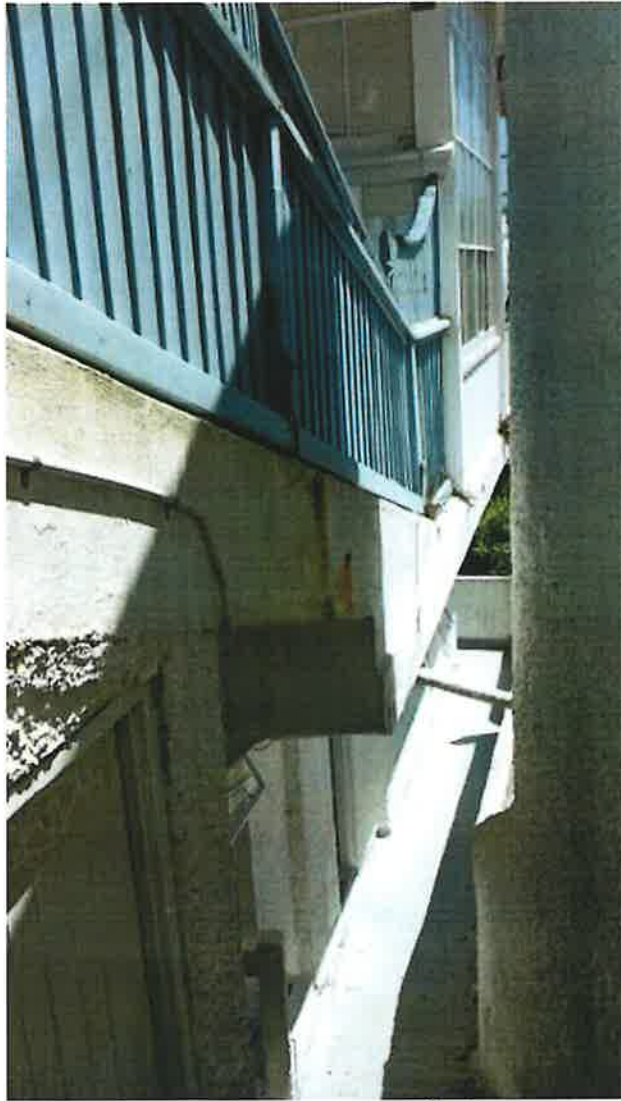
Side elevation of flat B and where concrete fractures were repaired

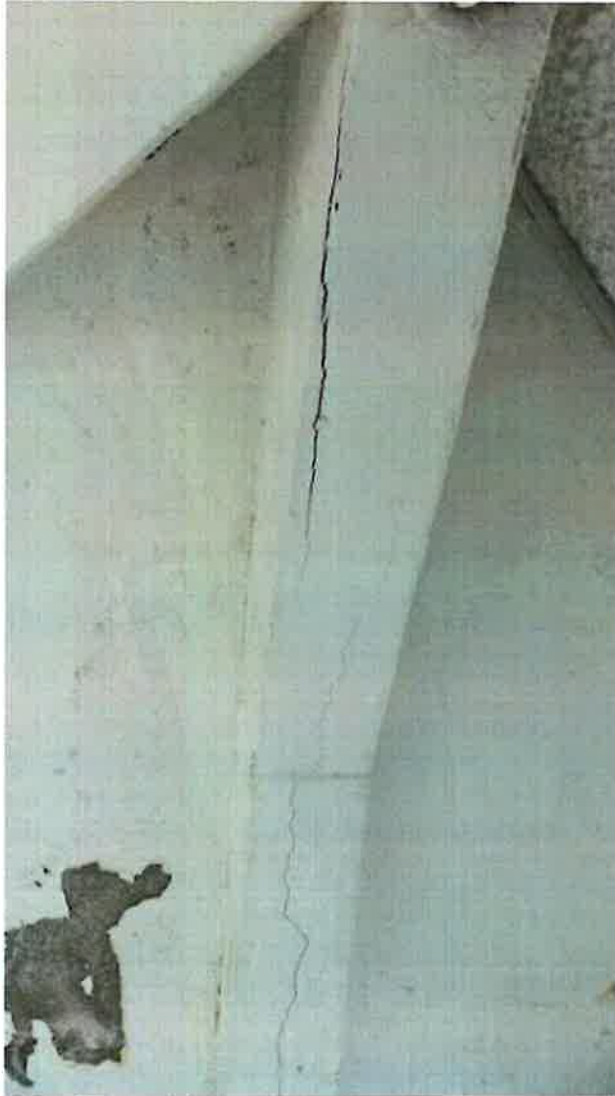
| Area | Enter O if there is no visible damage |
|---|---|
| Exterior cladding | Concrete fractures require epoxy repairs. |

Concrete fracture to flat B entry, epoxy crack injection required.

| Exterior cladding | | | | | |
|---|---|---|---|---|---|
| Additional Item | Epoxy crack injection - LM | Additional Item | 2 | \$185.00 | \$370.00 |

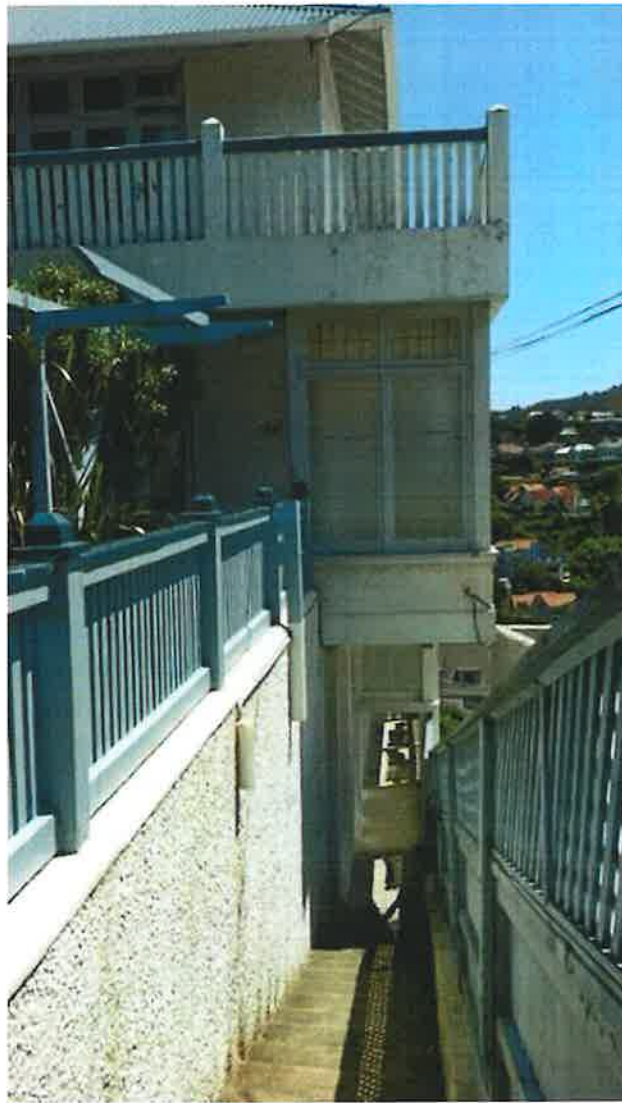
Access to 34b

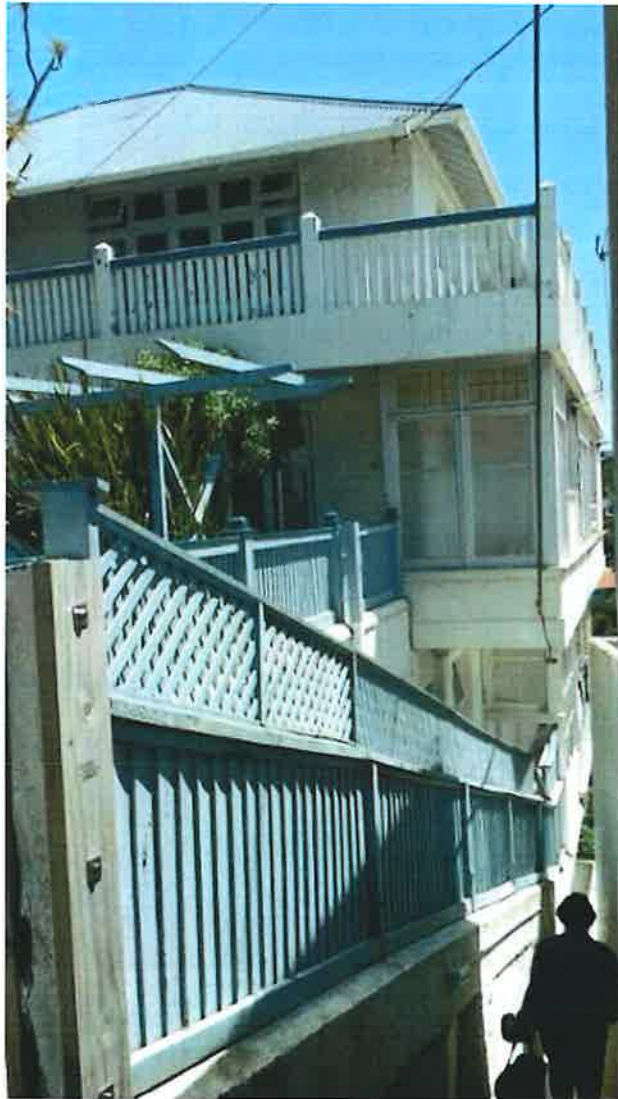
4 story multi unit building

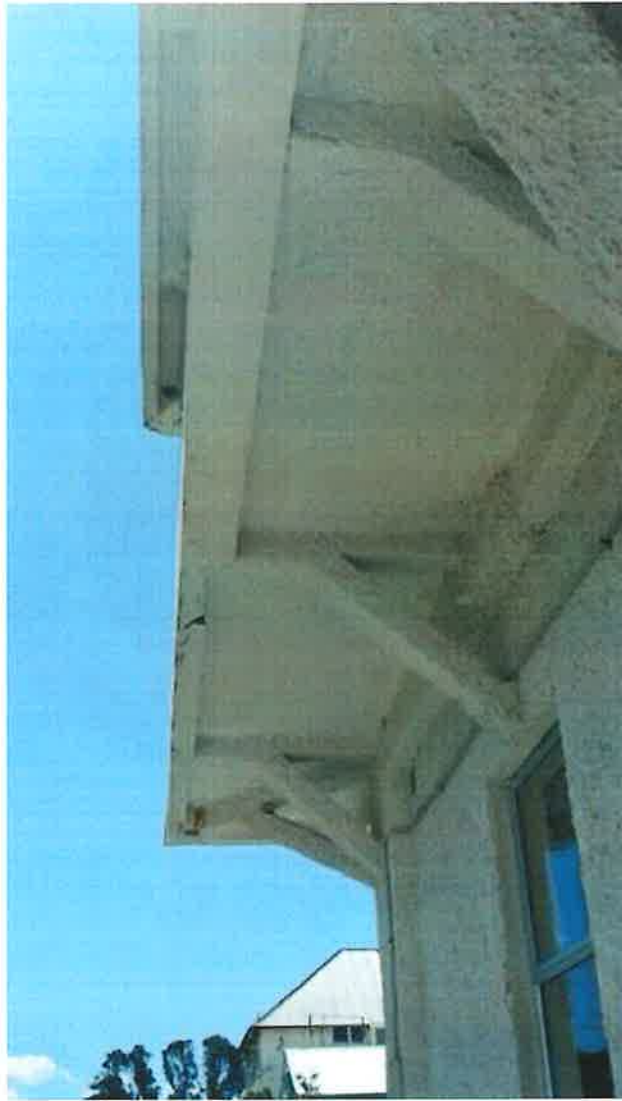
Concrete deck underneath flat B fractured

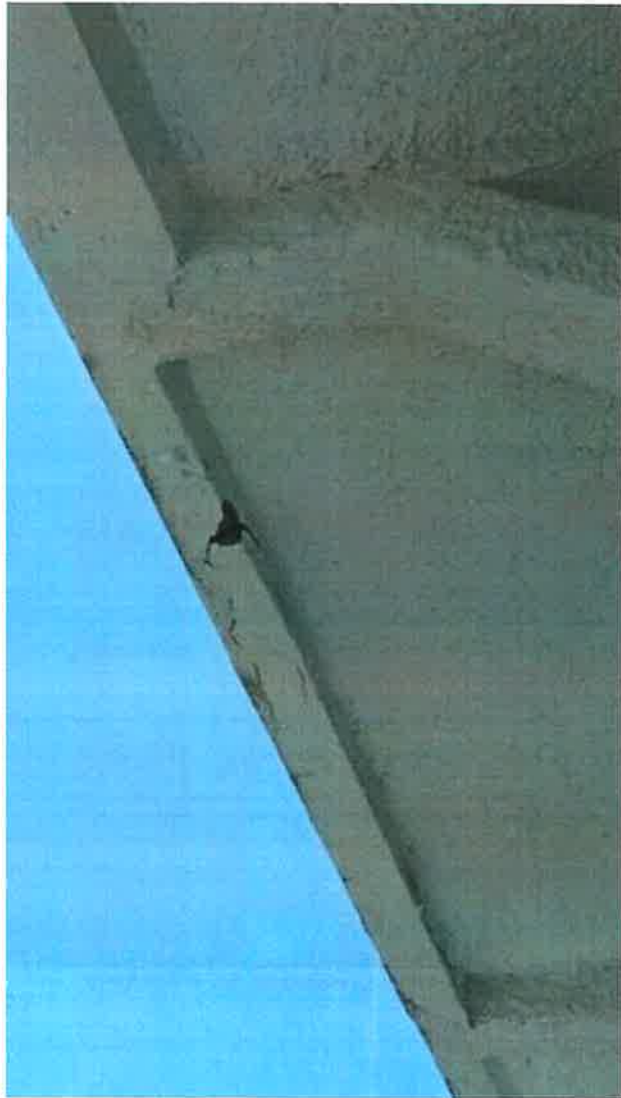
Concrete deck underneath flat B fractured
