## Earthquake repairs to Elmdale Lane - Unit 7

# **STAKE CONSULTING LTD**

**Job Reference: 7 ELMDALE LANE**

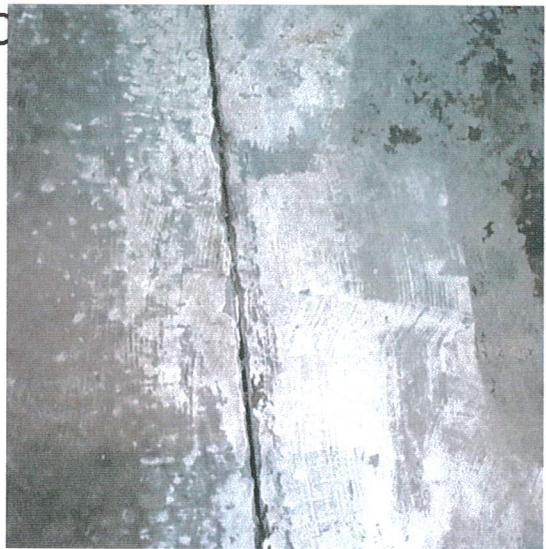
PHOTO : 1

EPOXY GFI FLOOR INJECTION

LOCATION: FLOOR

FLOOR CRACKING

TOTAL 12m

REPAIR CODE SST

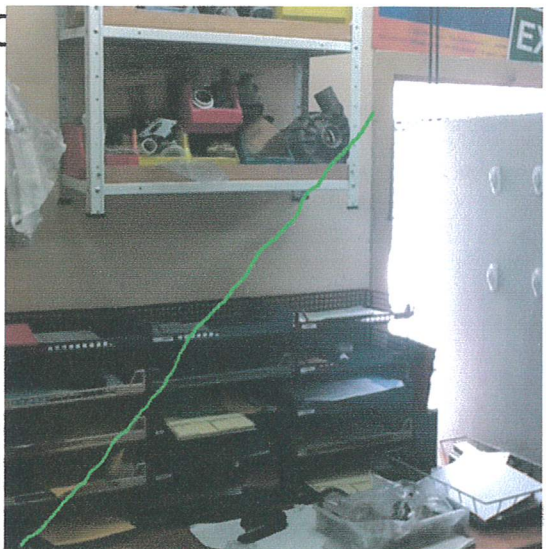
PHOTO : 2

EPOXY SST PANEL INJECTION

LOCATION: BACK WALL

FLOOR CRACKING

TOTAL 2.6m

REPAIR CODE SST

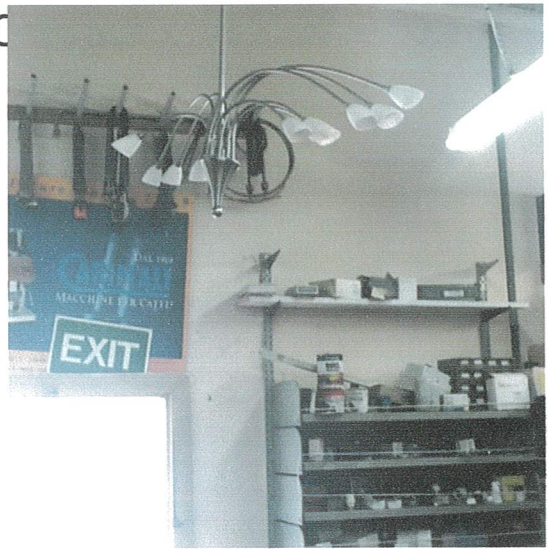
PHOTO : 3

EPOXY GFI FLOOR INJECTION

LOCATION: BACK WALL

FLOOR CRACKING

TOTAL 2.2m

REPAIR CODE SST
