**REPORT PREPARED FOR:  
MATAKANA SAWMILL LIMITED**

**ADDITIONAL ENVIRONMENTAL  
INVESTIGATION  
MATAKANA SAWMILL  
362 MATAKANA VALLEY ROAD,  
MATAKANA**

**Prepared by:  
Groundwater and Environmental Services  
PO Box 190  
Cambridge  
7 September 2005**

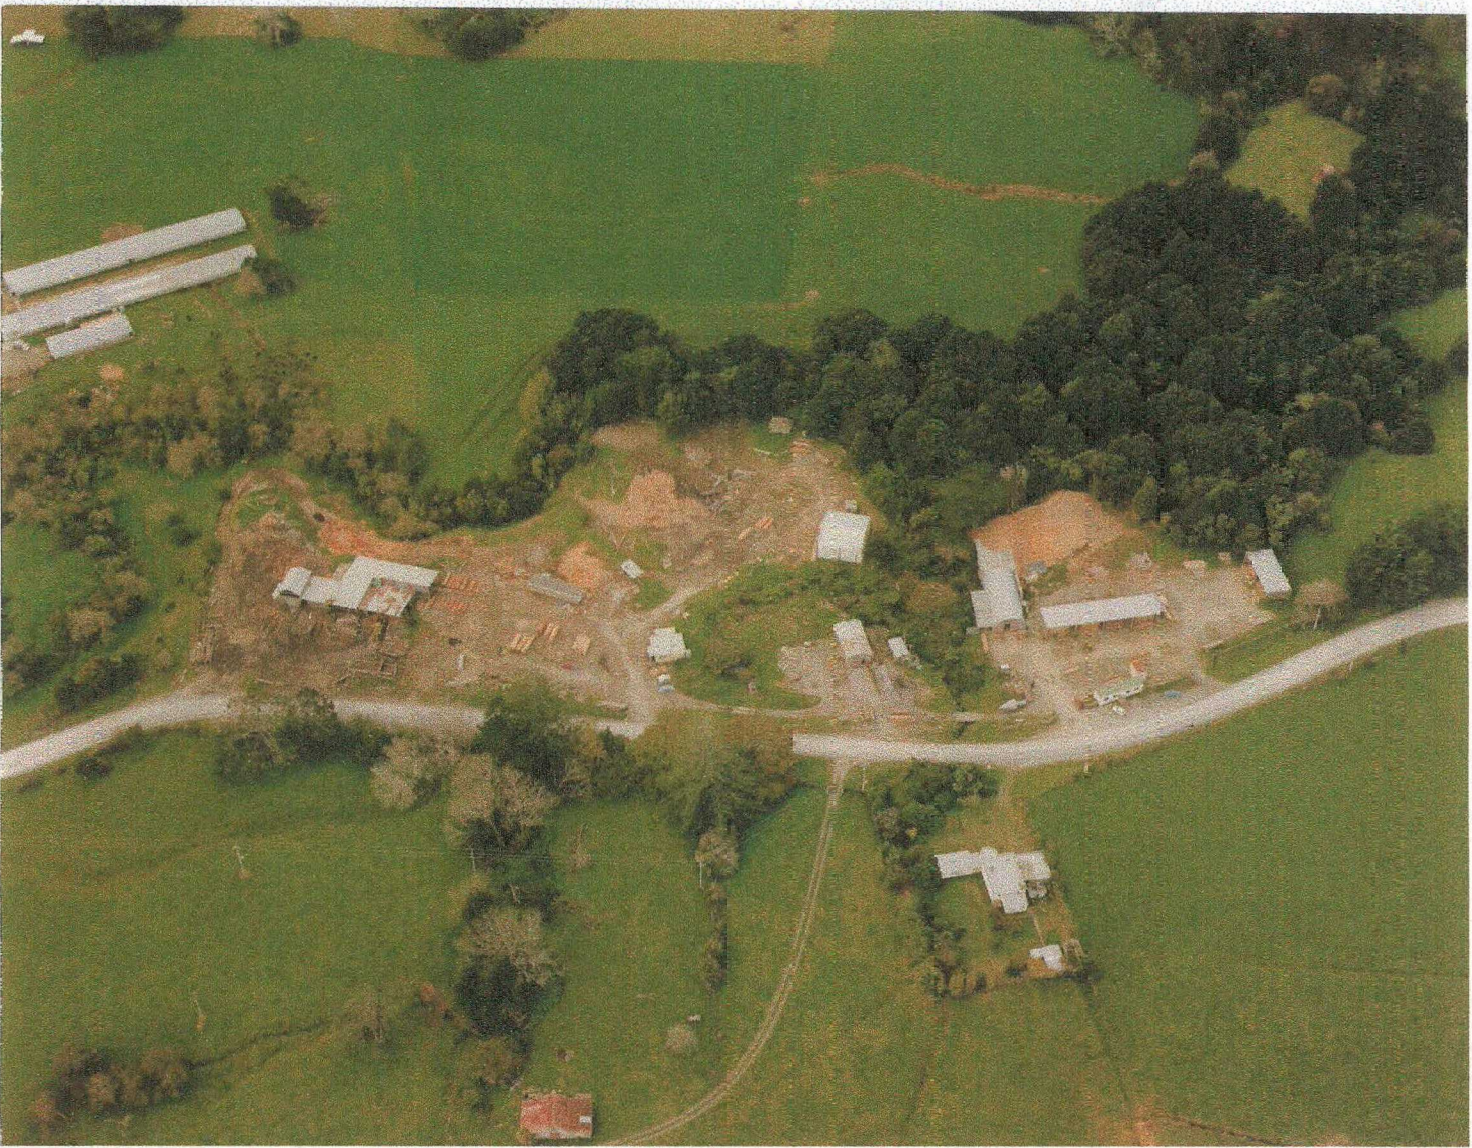
1990s Aerial Photograph

- The layout of the former sawmill is clearly visible in the north of the property;
- Logs are stacked to the west and northwest of the mill site;
- Finished timber is stacked immediately south of the mill, on either side of the exit from the boric spray tunnel;

- There is a large amount of sawdust from the mill on the ground to the east of the building;
- A diesel fuel pump appears to be present on the western side of the northern part of the mill;

- There are two circular features on the ground surface next to Matakana Valley Road, at the assumed location of the underground diesel storage tank. These may be the filler and inspection caps for the tank;

- The yards and driveway areas in the northern two thirds of the site appear to be unsealed, with parts of the area appearing to be muddy;
- The CCA treatment plant is visible to the south of the cottage, between two stream gullies that discharge to the east to Matakana River;

- There is a concrete drying pad immediately west of the treatment plant and timber is stored on unsealed ground to the north and west of the pad;
- There is a small shed immediately south of the treatment plant;

- The driveways and yards are unsealed;
- There is a large amount of sawdust on the ground surface immediately southeast of the eastern end of the planing shed; and
