# **KOWHAI TIMBER (1990) LIMITED**

**SOIL CONTAMINATION INVESTIGATION  
MATAKANA VALLEY ROAD ROAD,  
MATAKANA**

**Prepared by:  
Groundwater and Environmental Services  
PO Box 17273  
Greenlane  
Auckland 1005  
10 November 2003**

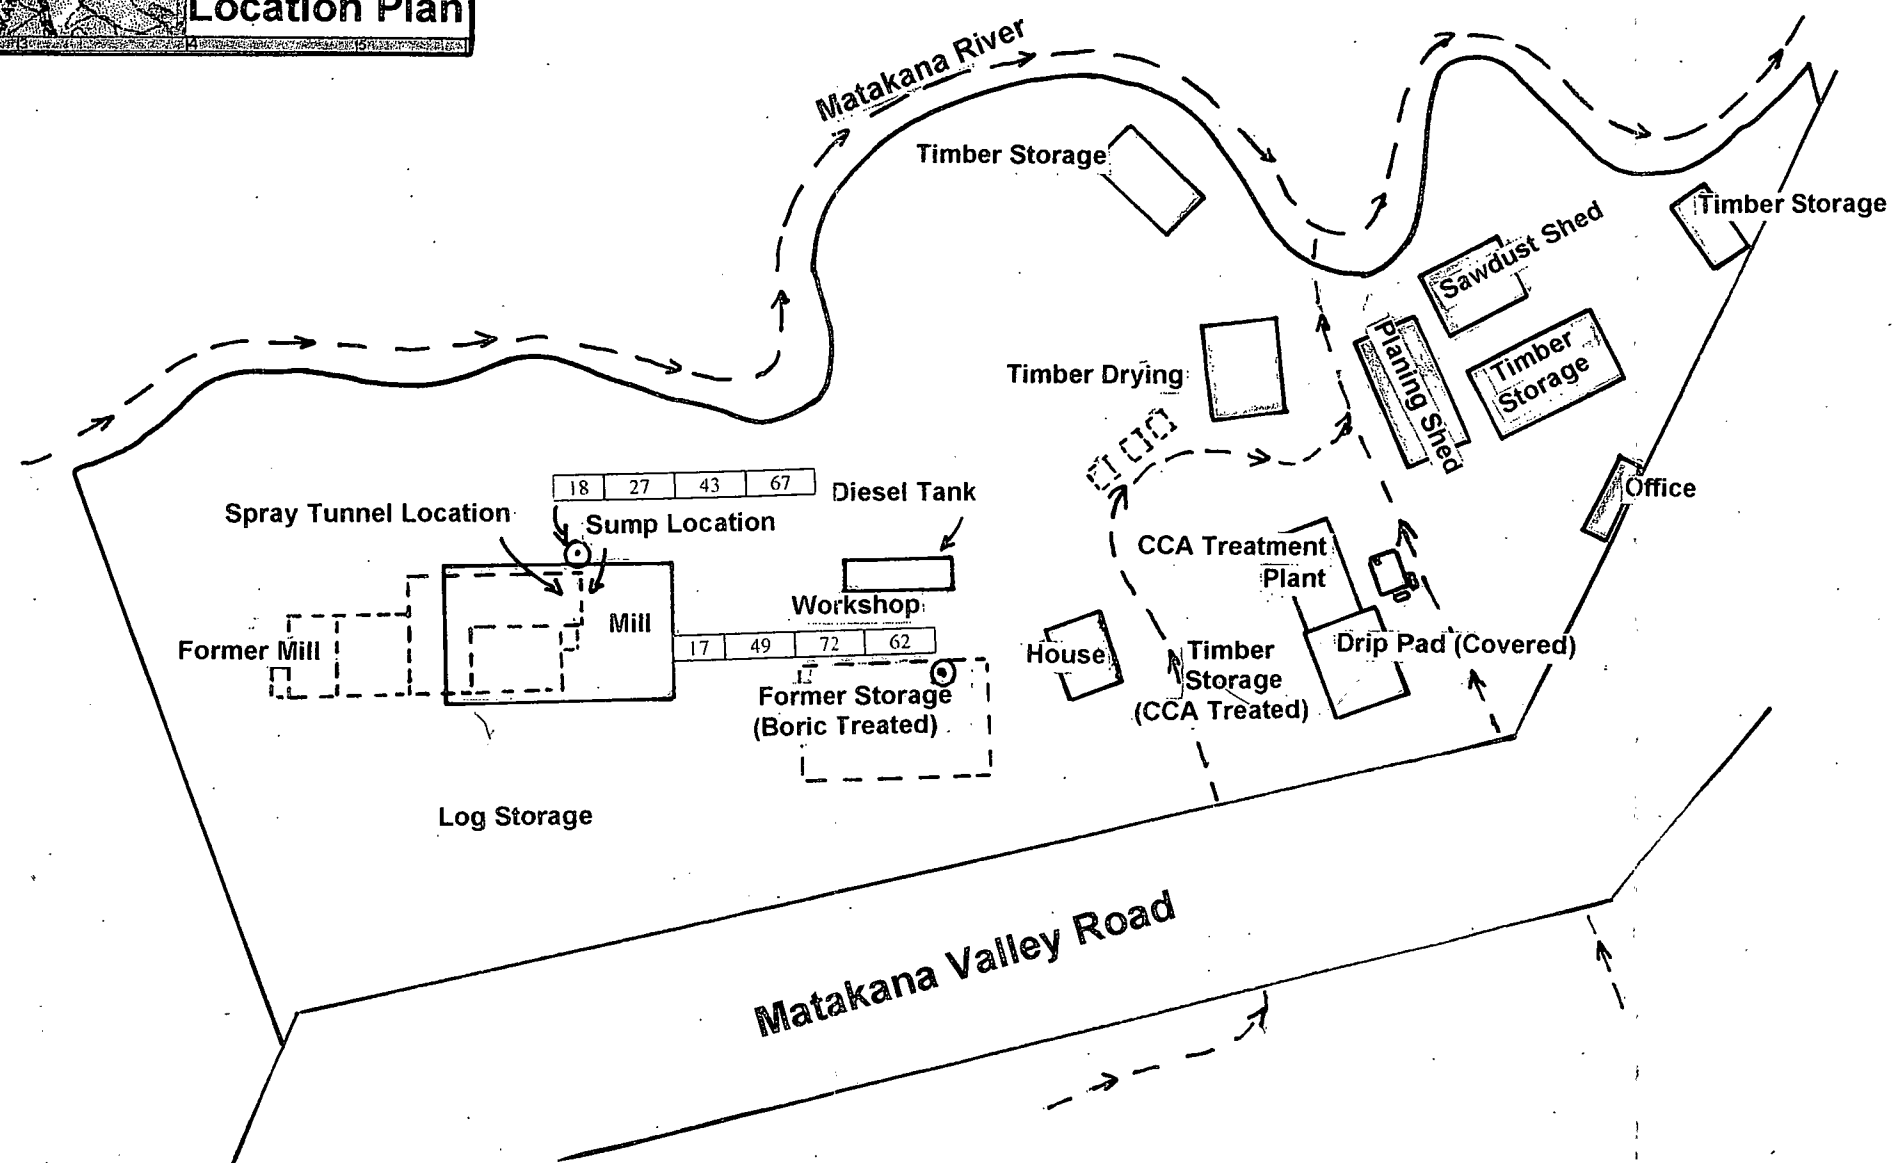
**Figure 1 Site Layout and Location - Kowhai Timber**  
362 Matakana Valley Road, Matakana

considered the most likely existing source of contamination on the property. The layout of the property is shown on Figure 1.

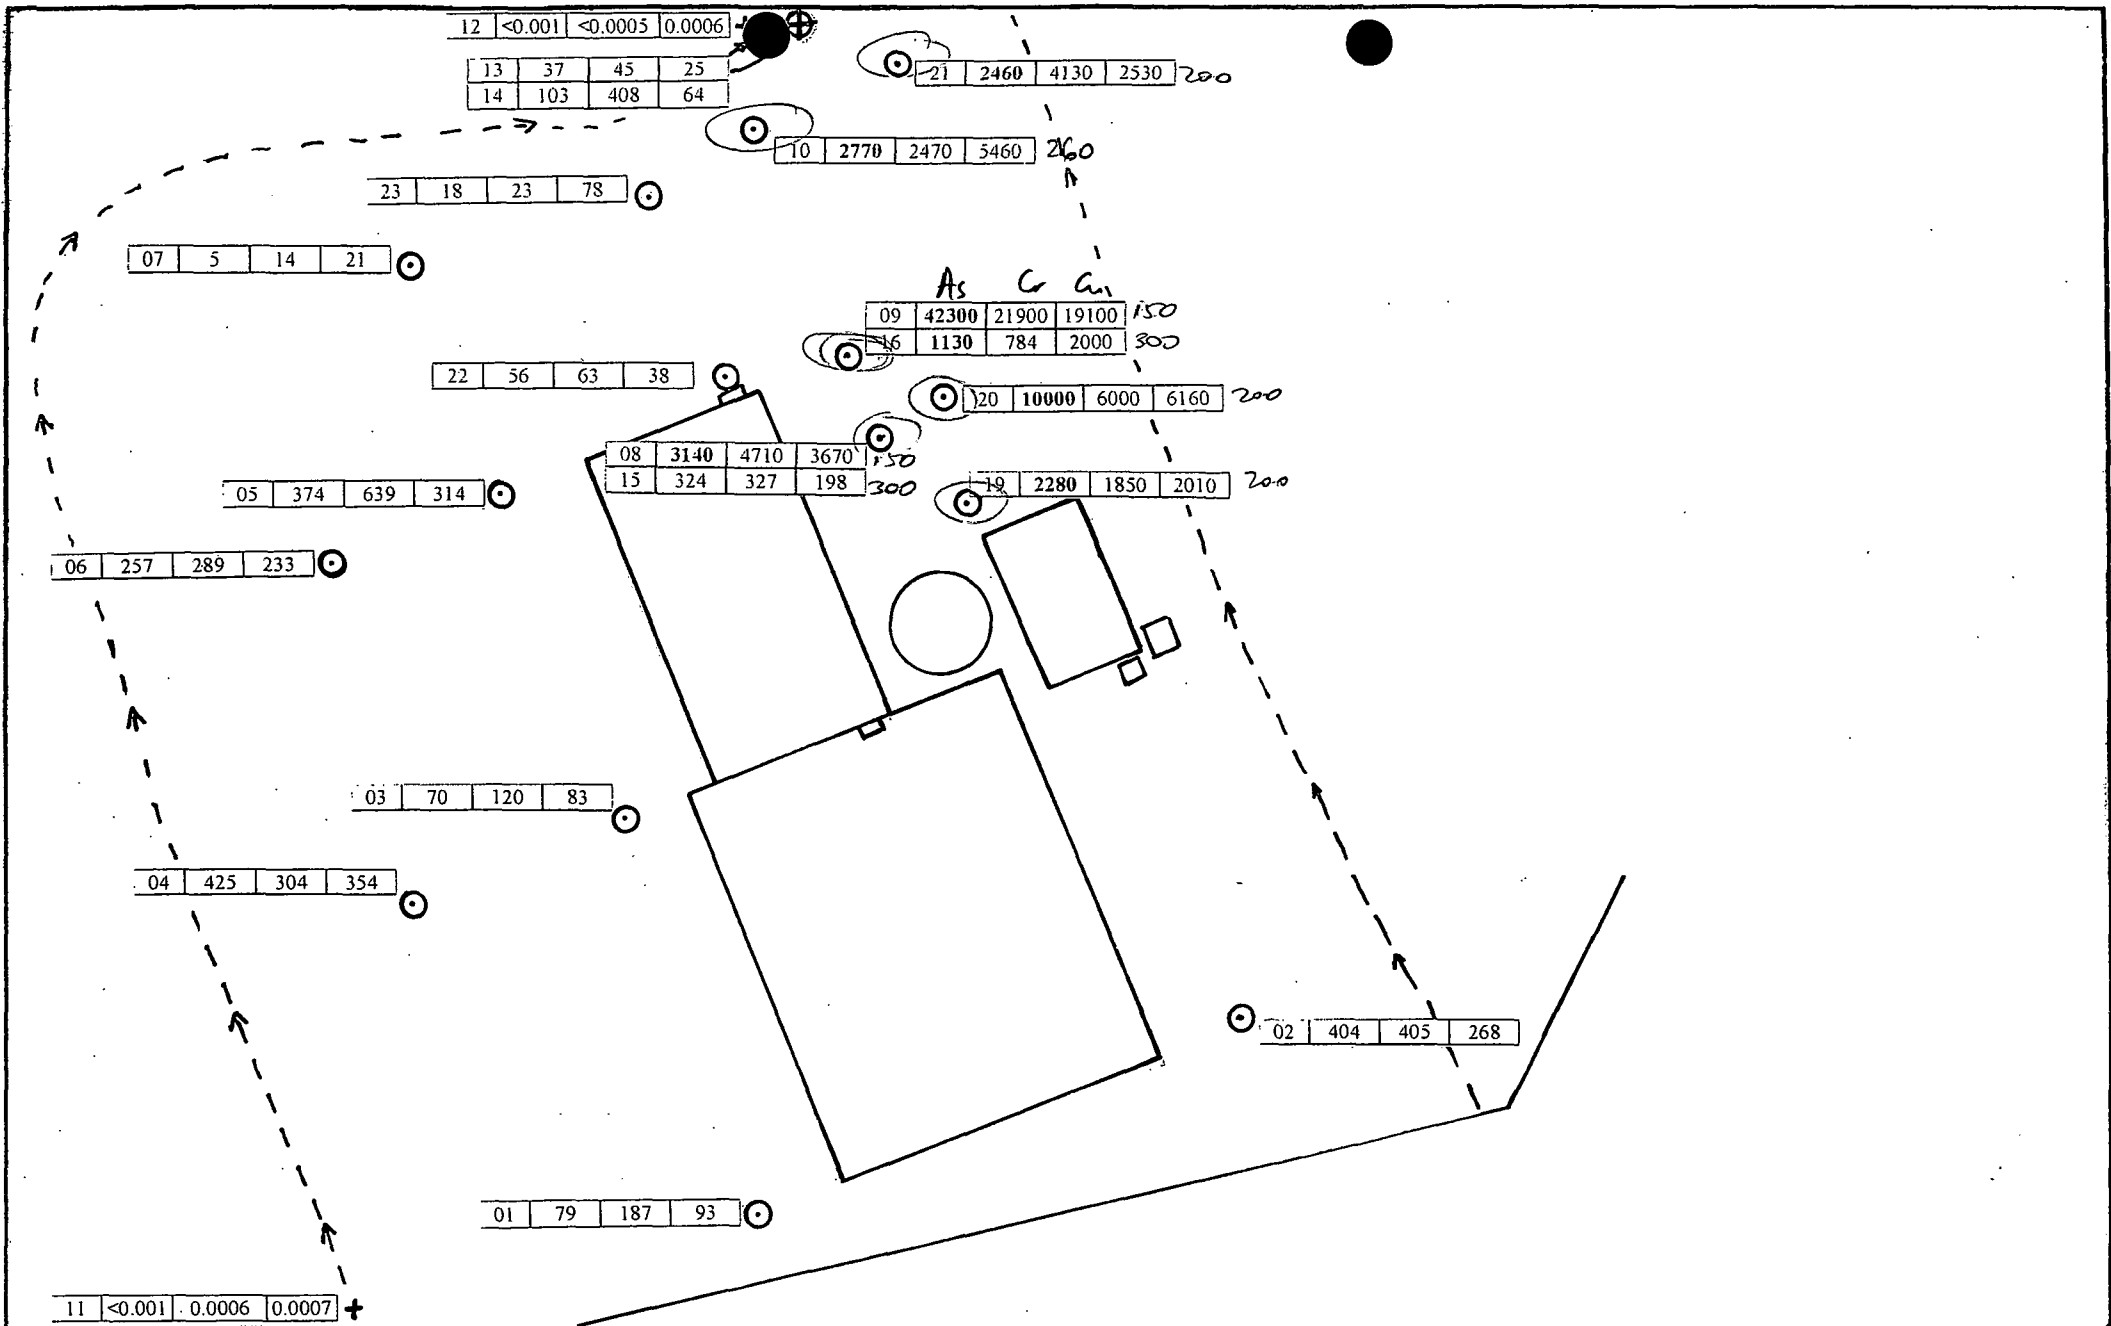
Figure 2 Treatment Plant Sampling Locations  
Kowhai Timber

| 9 | 0-150 | KTL03009 | Southeast of treatment plant<br>Minor dark brown topsoil over green-stained, weakly clayey sand. Clay increases with depth. Minor refuse mixed with the sandy material |

Two samples were taken from the stream immediately east of the highly contaminated zone identified above. The samples were from the same location with KTL03013 representing the upper depth range (sediment surface to 170 mm below) and KTL03014 representing the lower depth range (170 mm to 350 mm). The concentrations observed in the stream sediments were significantly lower than those in the area immediately to the west. Arsenic was elevated above the normal background in both the shallow and deep samples, with the deep sample having the higher concentration. Chromium was elevated above the normal background in only the deeper of the samples. The copper concentrations were within the normal background range.

1. Excavation and removal of the most highly contaminated material and refuse from the zone southwest of the treatment plant in the area of samples KTL03008, KTL03009, KTL03010, KTL03019, KTL03020, and KTL03021. This zone is shown on Figure 2.
2. Disposal of the excavated material at a licensed hazardous waste facility.
3. Validation sampling of the remediated area. Following removal of the most contaminated soil, soil samples would be taken at the edges and base of the excavations to check the concentrations of contaminants. Recommendations for additional soil removal, if necessary, would be made at this time.

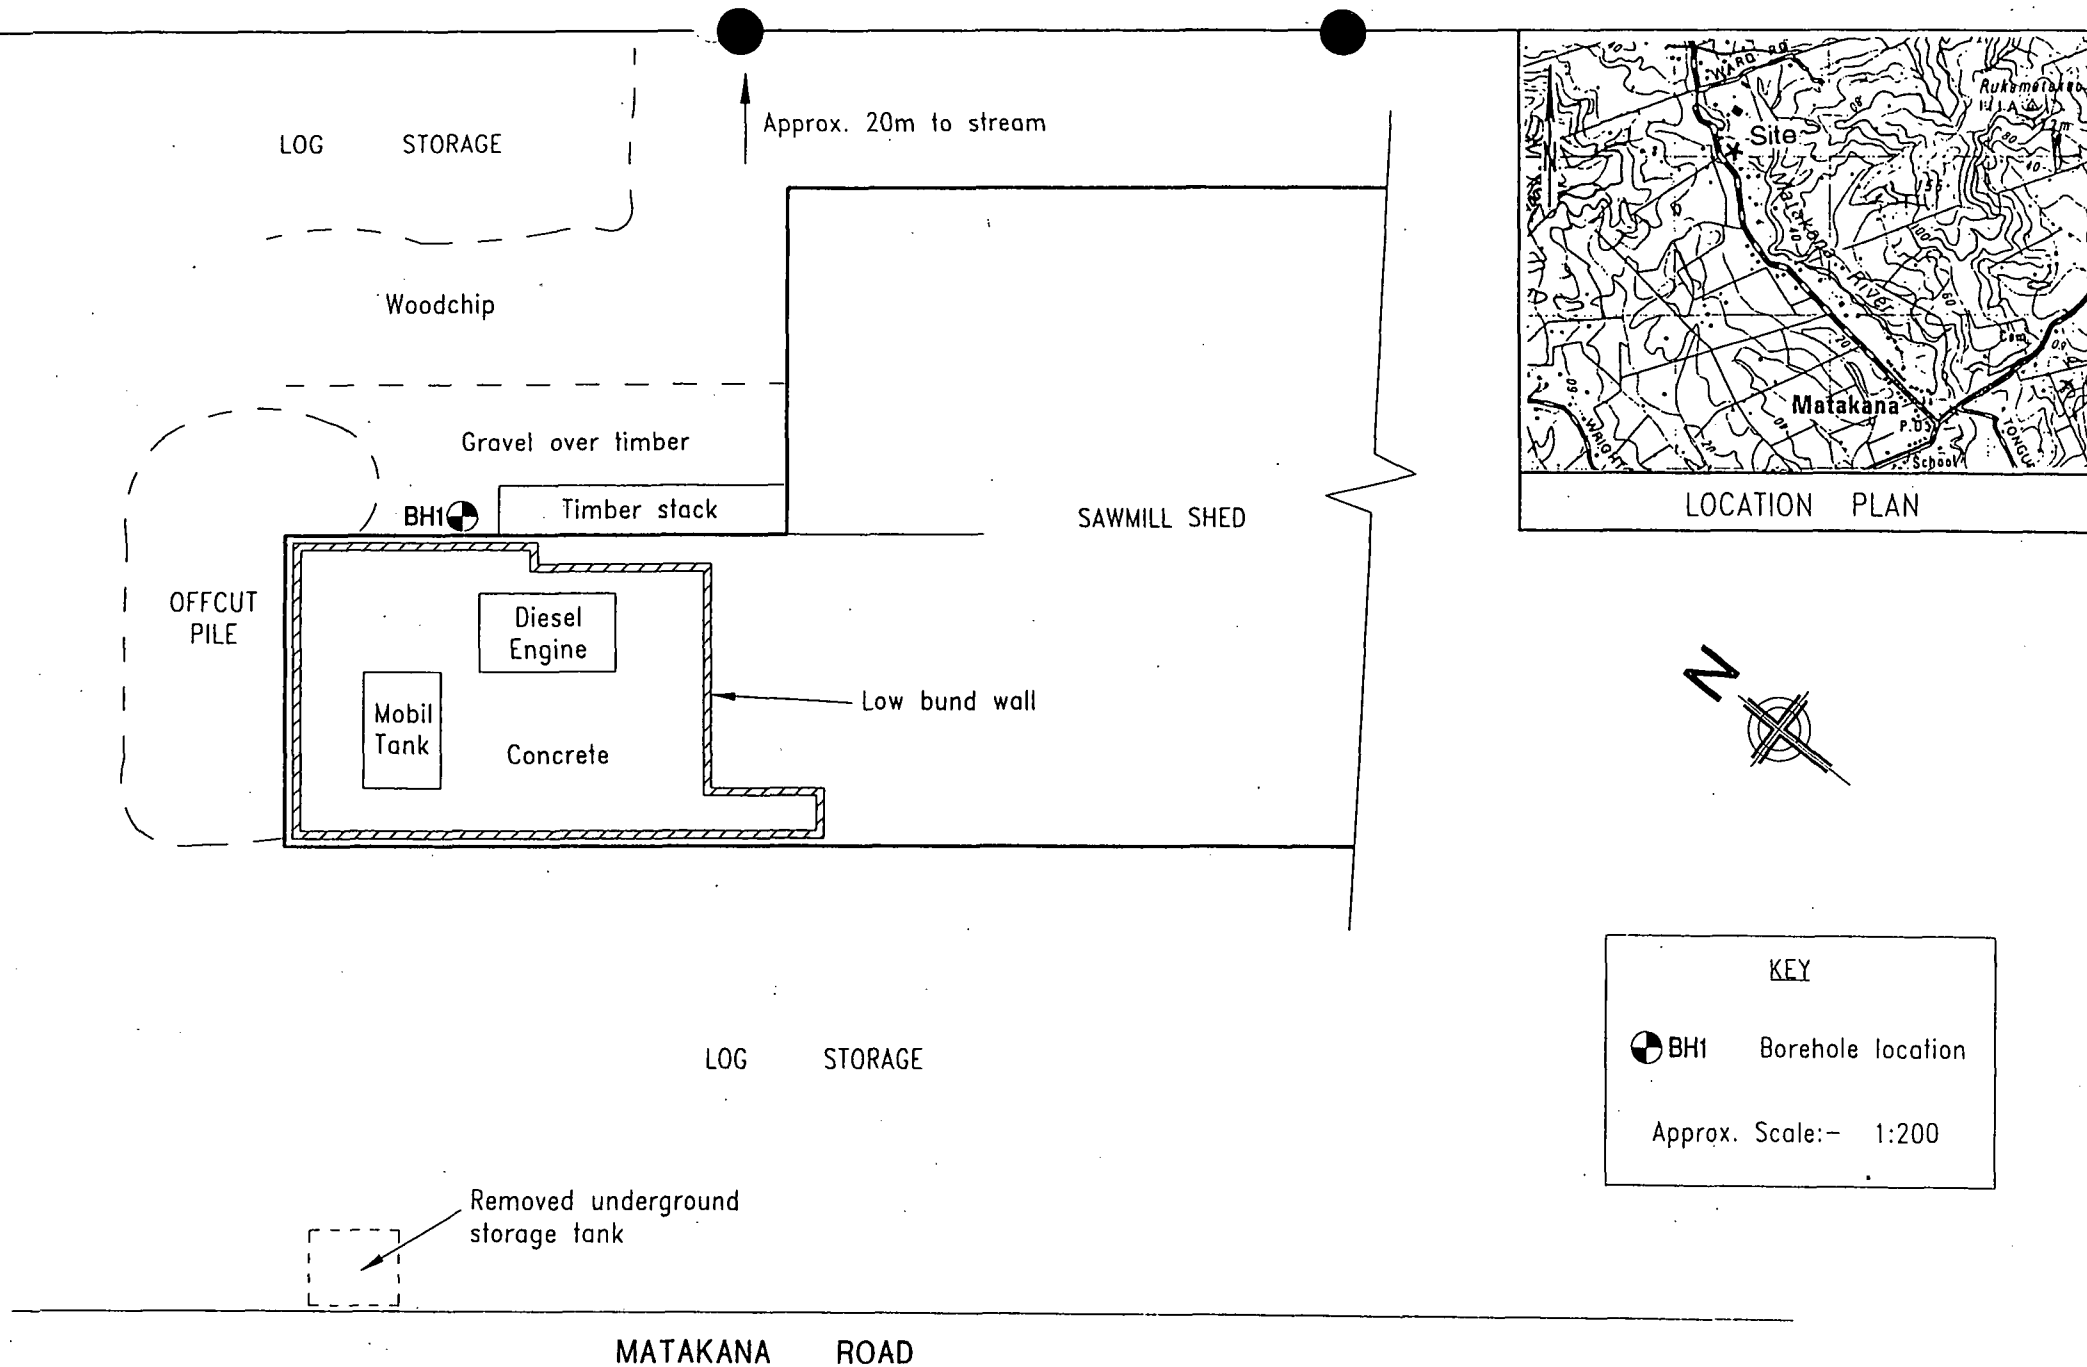
Figure 1 : SITE PLAN

On 9 April 1997, a 4,500L diesel underground storage tank was removed from near the sawmill, adjacent to Matakana Valley Road (Figure 1). According to the Mobil tank removal report, the tank was in good condition with paint still intact. The soil profile in the tankpit was described as clay. Total petroleum hydrocarbon (TPH) concentrations were below detection limits in two soil samples taken from the base of the tankpit by the Mobil engineer. (Mobil, 1996)

The site investigation was focussed around the end of the sawmill containing the diesel engine and the Mobil storage tank (Figure 1). The area beneath the diesel engine and Mobil tank was unsurfaced prior to the April 9 excavation. At the time of the PDP site visit, the area was sealed with a concrete floor. A bund, 60 to 300mm high, surrounds the concrete floor (Figure 1). Hydrocarbon staining was noted on the concrete beneath the diesel engine (Photo 3). The engine appeared to be leaking a small amount of diesel and possibly lubricating oil. The concrete beneath the Mobil storage tank appeared clean.

According to the Mobil tank removal report, the tankpit excavation, approximately 15m from the sawmill (Figure 1), was excavated in clay. The clay extended to the base of the tankpit at about 2.5m depth. No groundwater was observed in the tankpit. It is expected that similar geological conditions exist beneath the sawmill.
