## RE: KOWHAI TIMBER, MATAKANA

**REPORT ON**  
**SITE RECONNAISSANCE**  
**KOWHAI TIMBERS**  
**MATAKANA**

**Prepared for**  
**MOBIL OIL (NZ) LIMITED**  
**WELLINGTON**

**Reference A497**  
**June 1997**

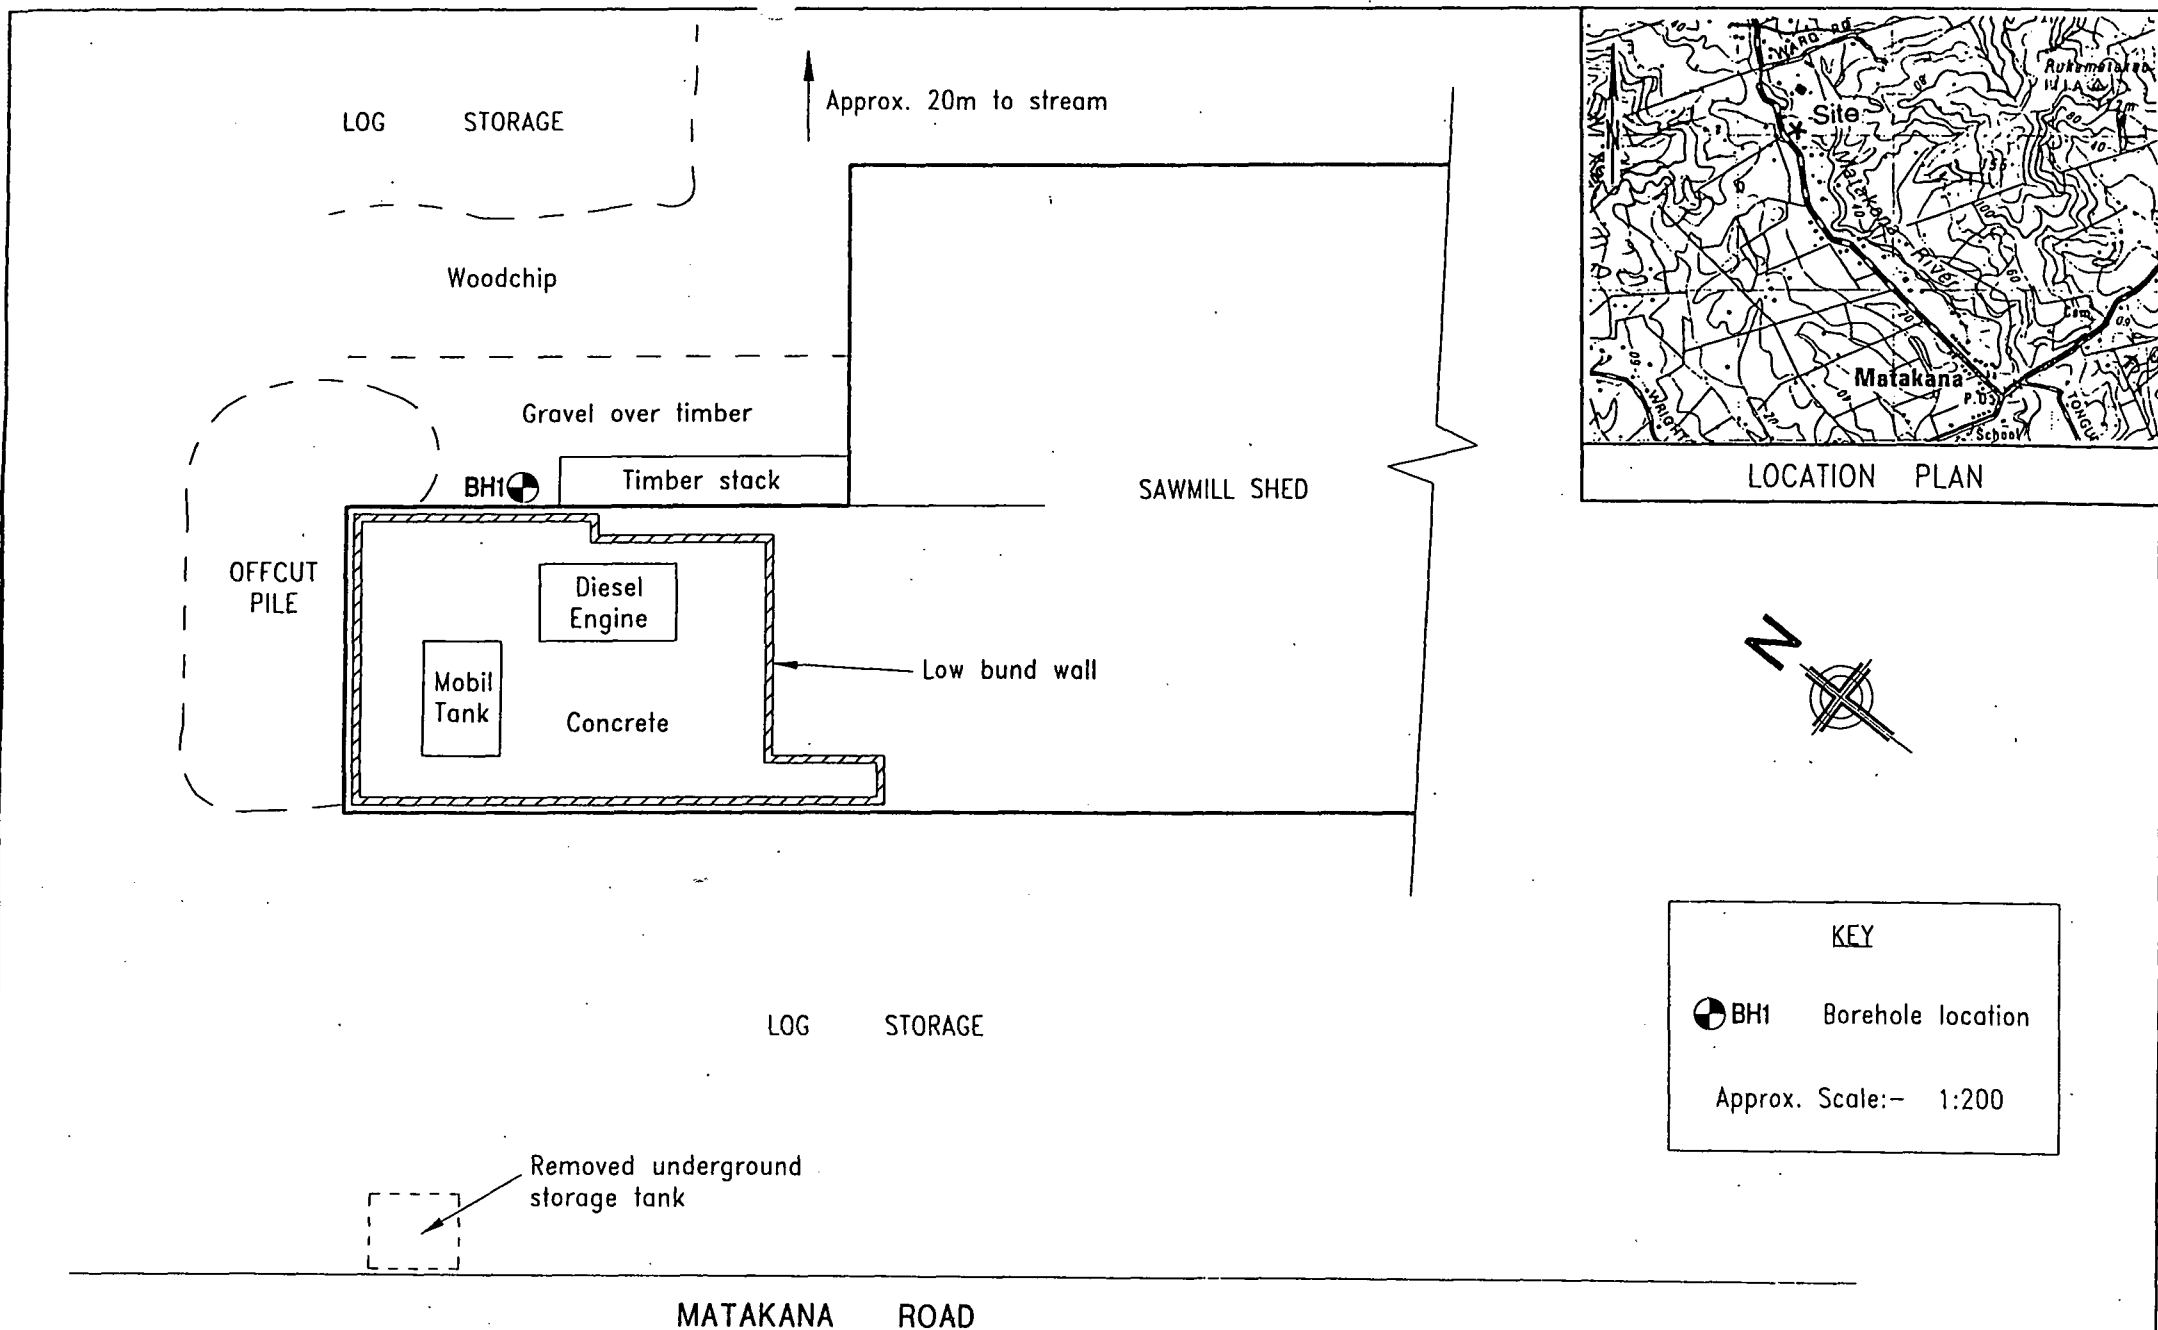
Figure 1 : SITE PLAN

Figure 1 shows the area around the northwestern end of the mill shed. An above ground diesel storage tank (Photo 2) and a diesel engine (Photo 3) are contained within a bunded concrete area inside the shed.

The site investigation was focussed around the end of the sawmill containing the diesel engine and the Mobil storage tank (Figure 1). The area beneath the diesel engine and Mobil tank was unsurfaced prior to the April 9 excavation. At the time of the PDP site visit, the area was sealed with a concrete floor. A bund, 60 to 300mm high, surrounds the concrete floor (Figure 1). Hydrocarbon staining was noted on the concrete beneath the diesel engine (Photo 3). The engine appeared to be leaking a small amount of diesel and possibly lubricating oil. The concrete beneath the Mobil storage tank appeared clean.

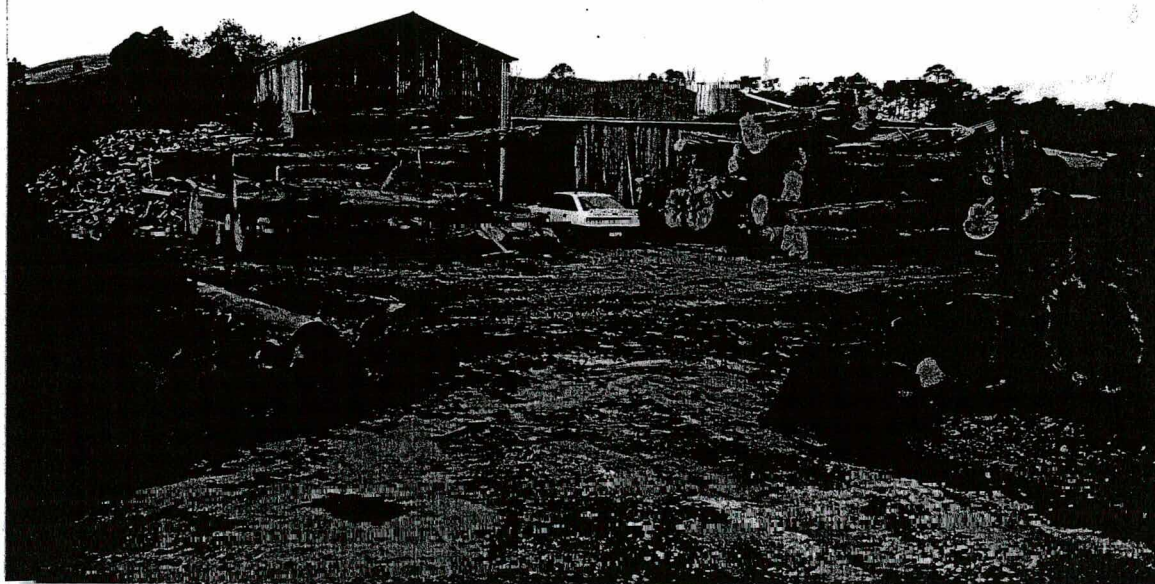
The sawmill shed is located towards the northwestern end of the site, within a log storage area (Photo 1). Matakana Valley Road is located about 15m to the southwest of the shed and Matakana River is located approximately 30m to the northeast of the shed. The river surface is about 8 to 10m below the ground surface at the shed. Matakana River discharges into Kawau Bay approximately 8km to the southeast.

Photograph 1: Sawmill Shed Facing East.

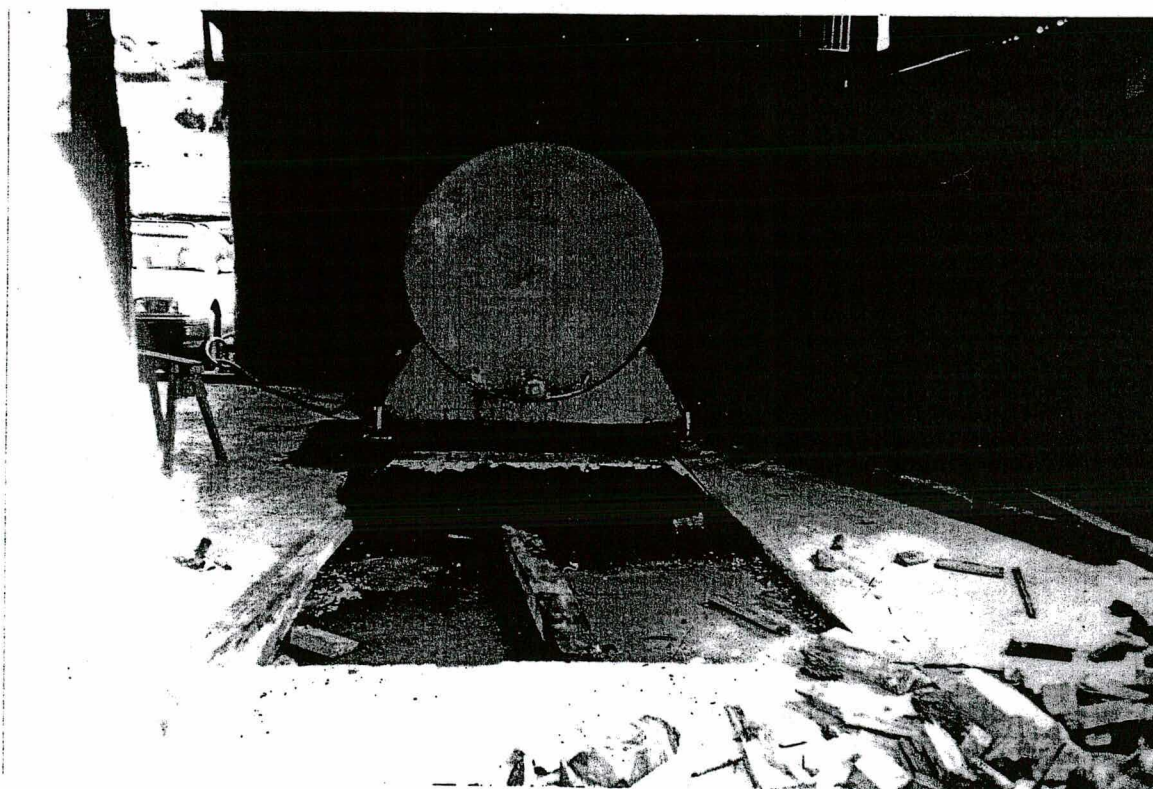
Photograph 2: Storage Tank in Sawmill.

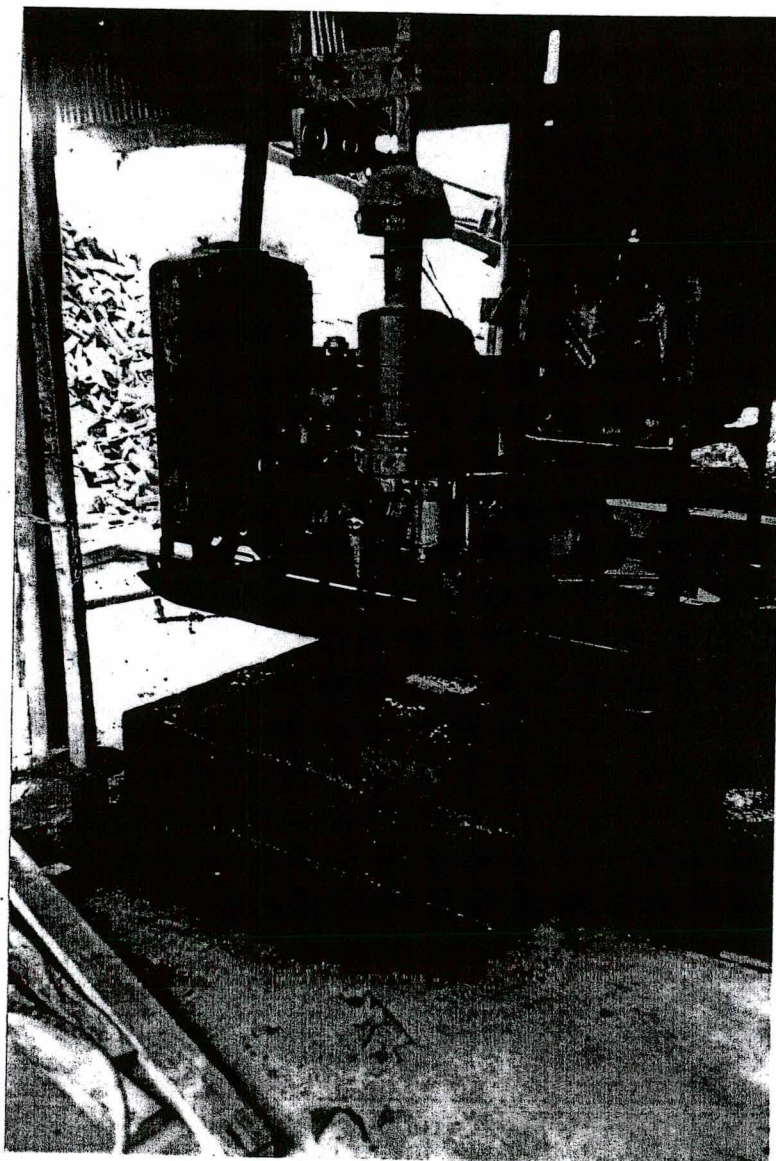
In addition to the removal of the tank from near the sawmill, approximately 13m<sup>3</sup> of hydrocarbon impacted soil was excavated from around the tank and engine inside the sawmill (it is understood that the fuel pump on the diesel engine had been leaking over an extended period, contributing to the petroleum residues in the ground). The excavation ranged down to 500mm in depth and the excavated soil was removed off site for disposal. Subsequently, the excavation was backfilled with gravel, then concreted and bunded.

Photograph 3: Diesel Engine in Sawmill.

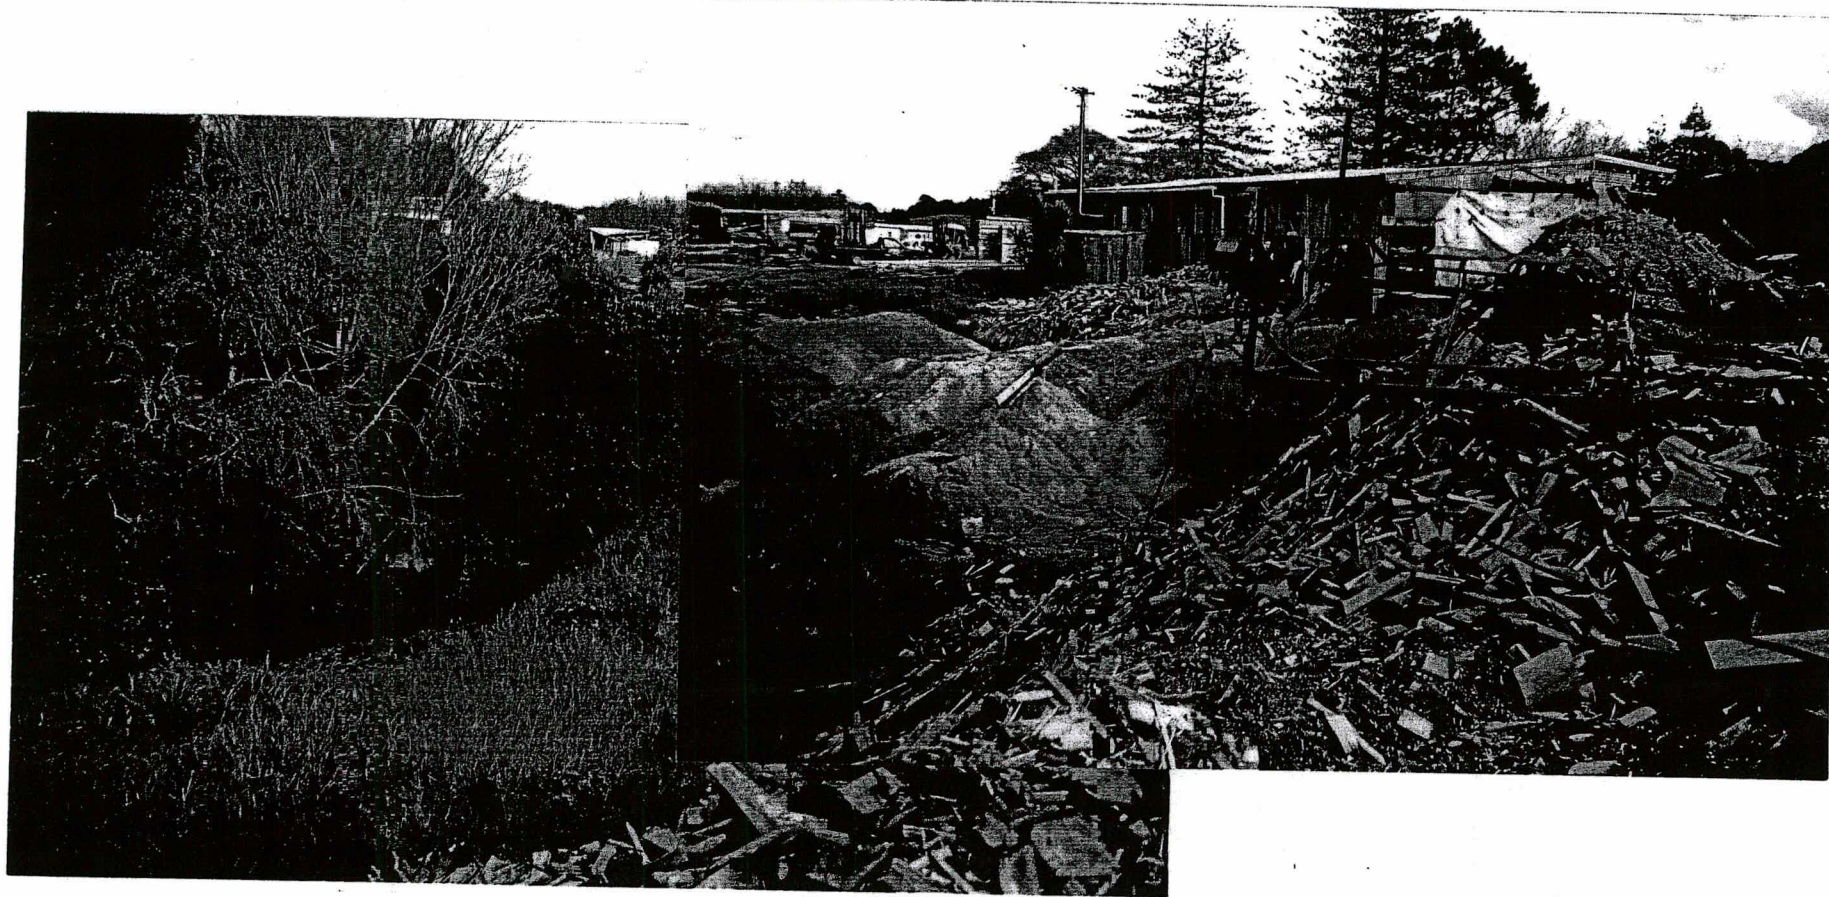
Any petroleum residues in surface runoff in the past are likely to have been significantly attenuated by the sawdust and woodchip piles between the sawmill and the river. No evidence of hydrocarbon impacts was noted on the surface near the sawmill. In addition, although the roof of the sawmill probably leaks to some extent, the cover provided by the roof will have minimised runoff from around the diesel engine area. The concrete bunding will contain any minor product spills and prevent runoff from impacted soil in the future.

Photograph 4: Rear of Sawmill Shed and Matakana River.
