**GEOTECHNICAL INVESTIGATION REPORT FOR
PROPOSED RESIDENTIAL SUBDIVISION,
184 KOUTU LOOP ROAD, WHIRINAKI**

Project Reference: 18655
3 December 2020

LDE LTD

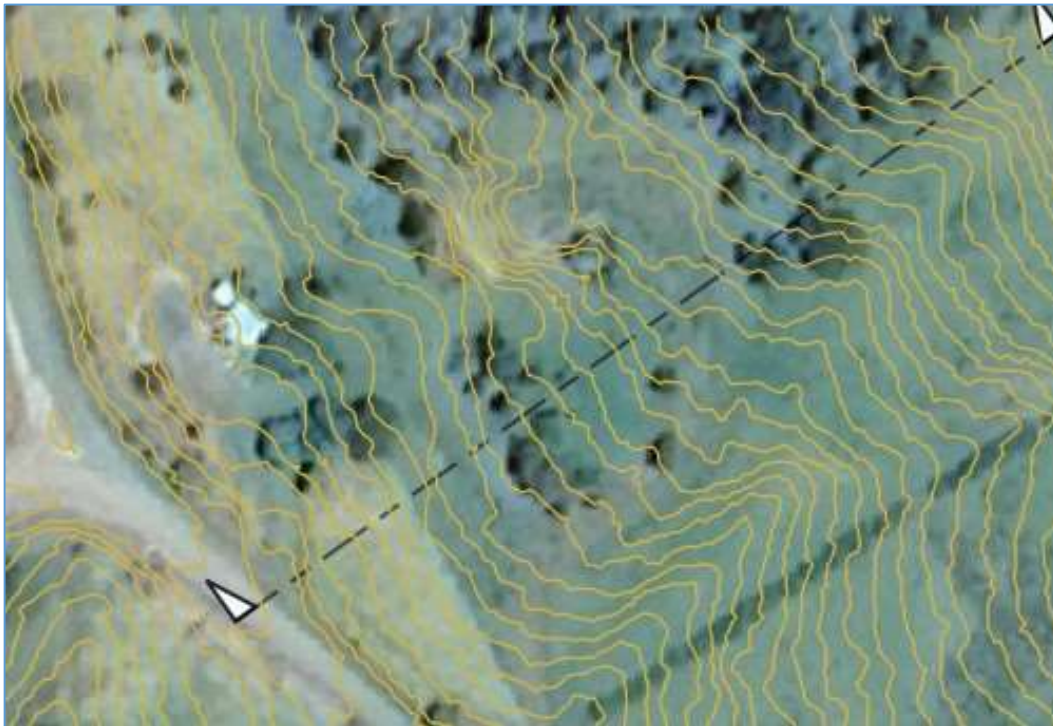
Figure 4. Cross section for stability analysis through Lot 2.

The location of the cross section is shown on the investigation plan in Figure 4 below and printouts of the stability analyses are attached to this report in Appendix C.

The property is located on a north-easterly facing slope with an average gradient of 12°, with a fairly consistent gradient down the slope.

The assessed cross section was developed perpendicular to the contour through the proposed building platform. The elevation profile for the cross section was developed based on Lidar data. The analysis assumes a 10kPa vertical surcharge from the weight of the proposed building.

Both analyses met the minimum FoS values outlined above in Table 2. The shallow soft rock of the unweathered Allochthon, observed within the old quarry and the cut platform at Lot 1 indicate high strength material at a shallow depth along the ridgeline. This shallow rock provides fundamental stability to the slopes near the top of the ridgeline. Although the ground surface was observed to be hummocky, this is likely due to shallow creep of the surface soils, and manmade disturbance of the natural ground, from the access to, and extraction of material from the quarry.

It should be noted that the analysis has been limited a global assessment based on ground investigation data from the proposed building platform only. Further analysis of the slope will be required at building consent stage once the building platform location/access/parking has been confirmed, the foundation type is known, and the cut and fill areas of the proposed development are known. Specifically designed retaining walls may be necessary to achieve the required FoS.

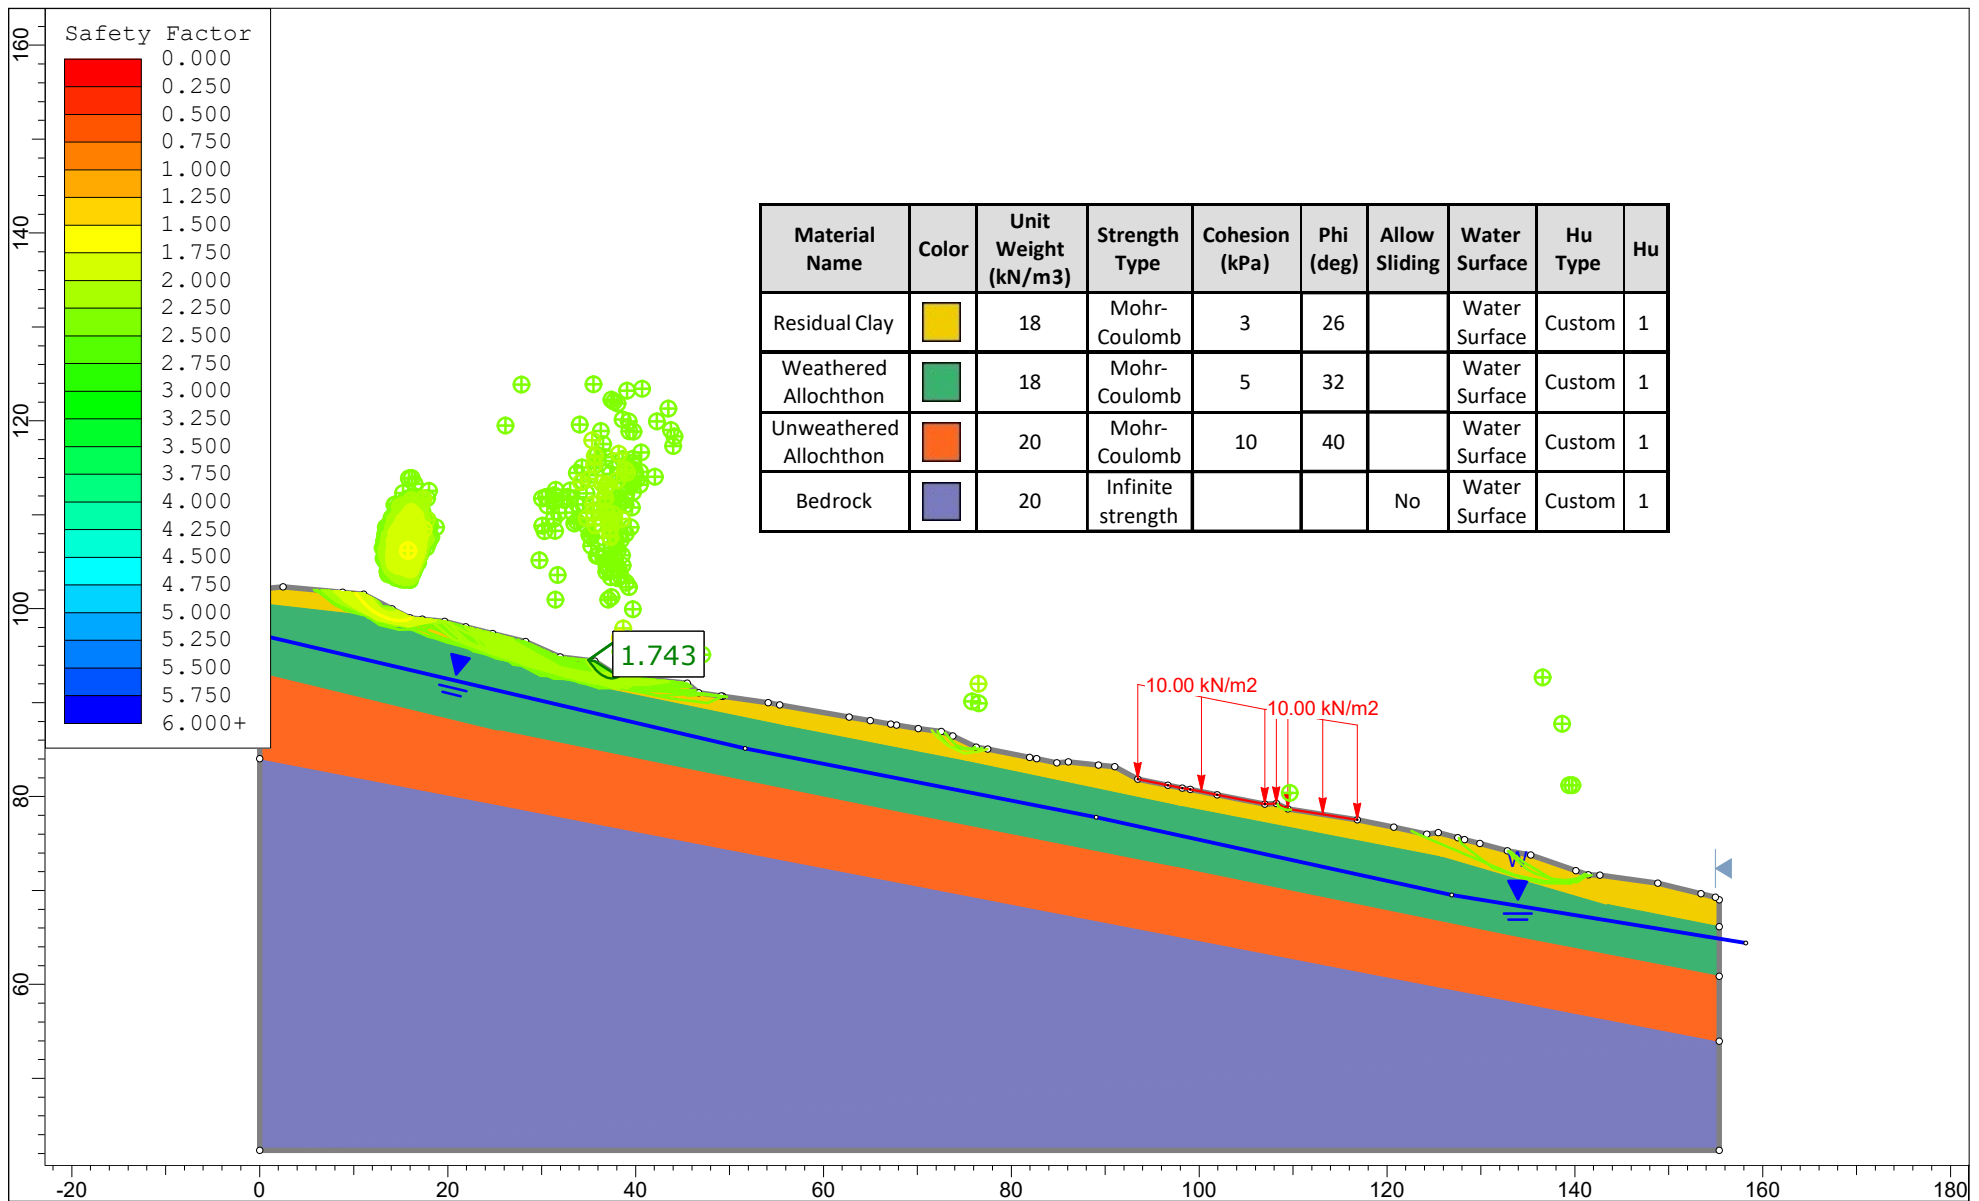
Project				Geotechnical Investigation for Proposed Subdivision			
Scenario		Lot 2		Scenario		Normal groundwater conditions	
Drawn By		G Harding		Company		LDE Ltd	
Date		03/12/2020		File Name		18655 - 184 Koutu Loop Road, Whirinaki.slmd

Analyses	Minimum Factor of Safety required	Actual FoS results
Long-term Groundwater	1.5	1.74
Extreme Groundwater	1.3	1.68
