# EARTHQUAKE RECOVERY (EQR) DOCUMENTATION

**Information request – CLM/2011/193540 - 257 Cathedral Road, Domett, 7383**

# ~~EQC~~ Property Overview Report 1982

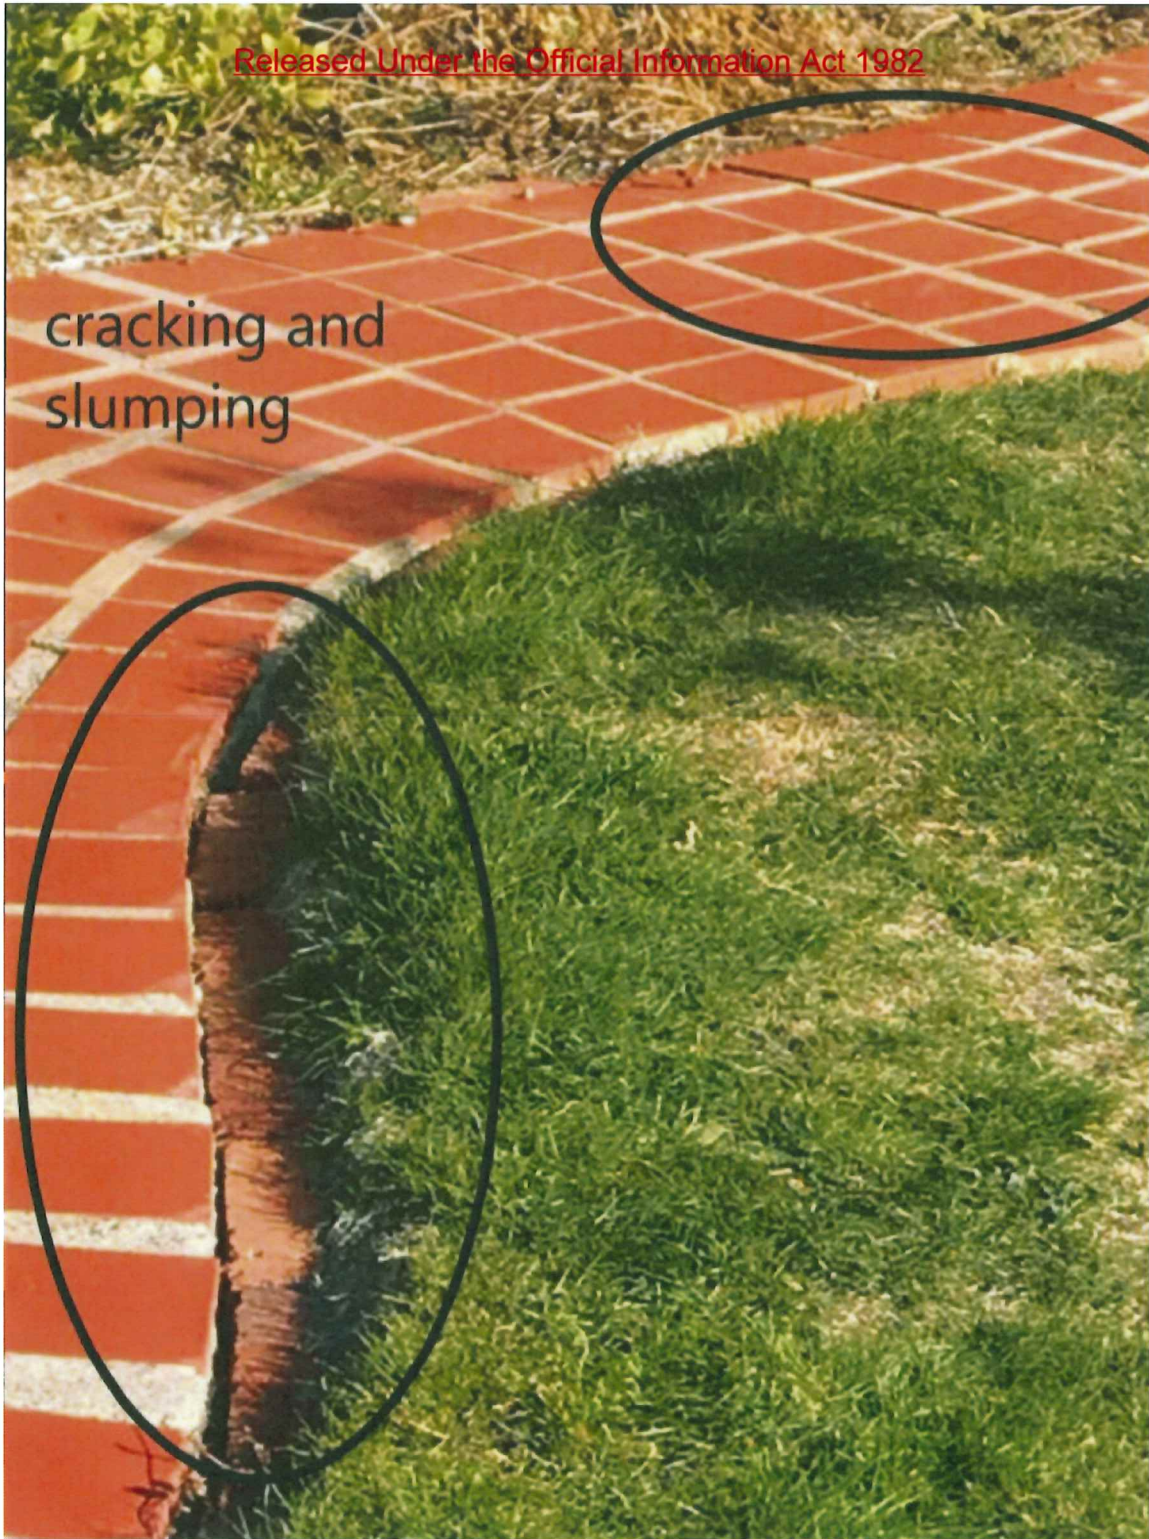
cracking and  
slumping
