# **KOWHAI TIMBER (1990) LIMITED**

**ADDITIONAL REMEDIATION & VALIDATION REPORT  
TREATMENT PLANT AREA  
KOWHAI TIMBER  
362 MATAKANA VALLEY ROAD,  
MATAKANA**

**Prepared by:  
Groundwater and Environmental Services  
P O Box 190,  
Cambridge  
3 April 2006**

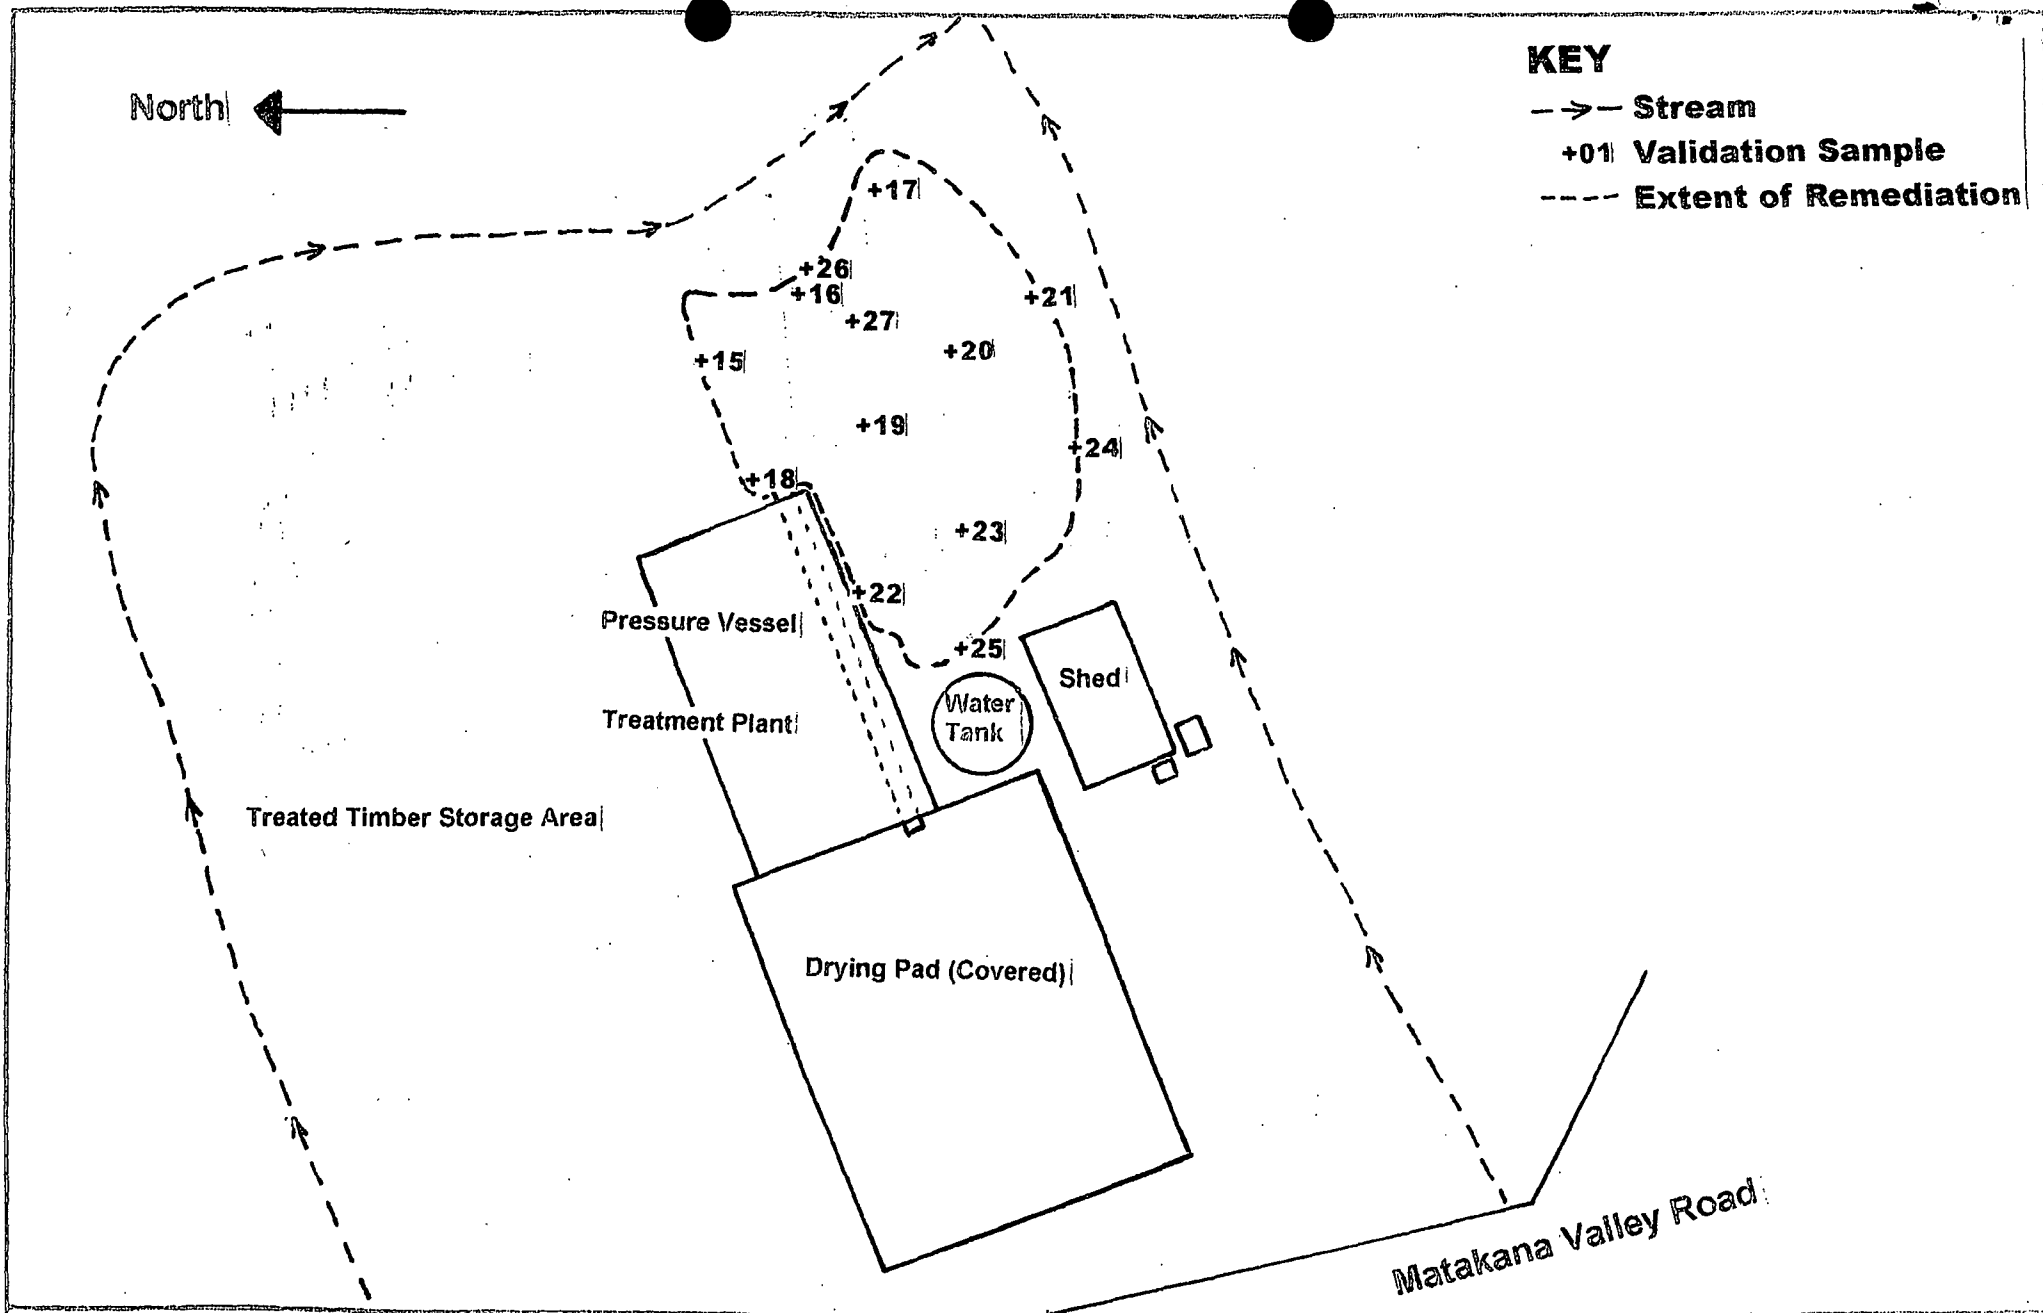
**Figure 1: Site Layout, Remediation Area  
& Previous Sample Locations**

The remaining contamination that was dealt with in this phase of remediation was restricted to elevated chromium levels in the east of the original remediation area. These were restricted to the zone around KTL05026 and KTL05027.

The location of the original remediation zone and the previous samples is shown on Figure 1.

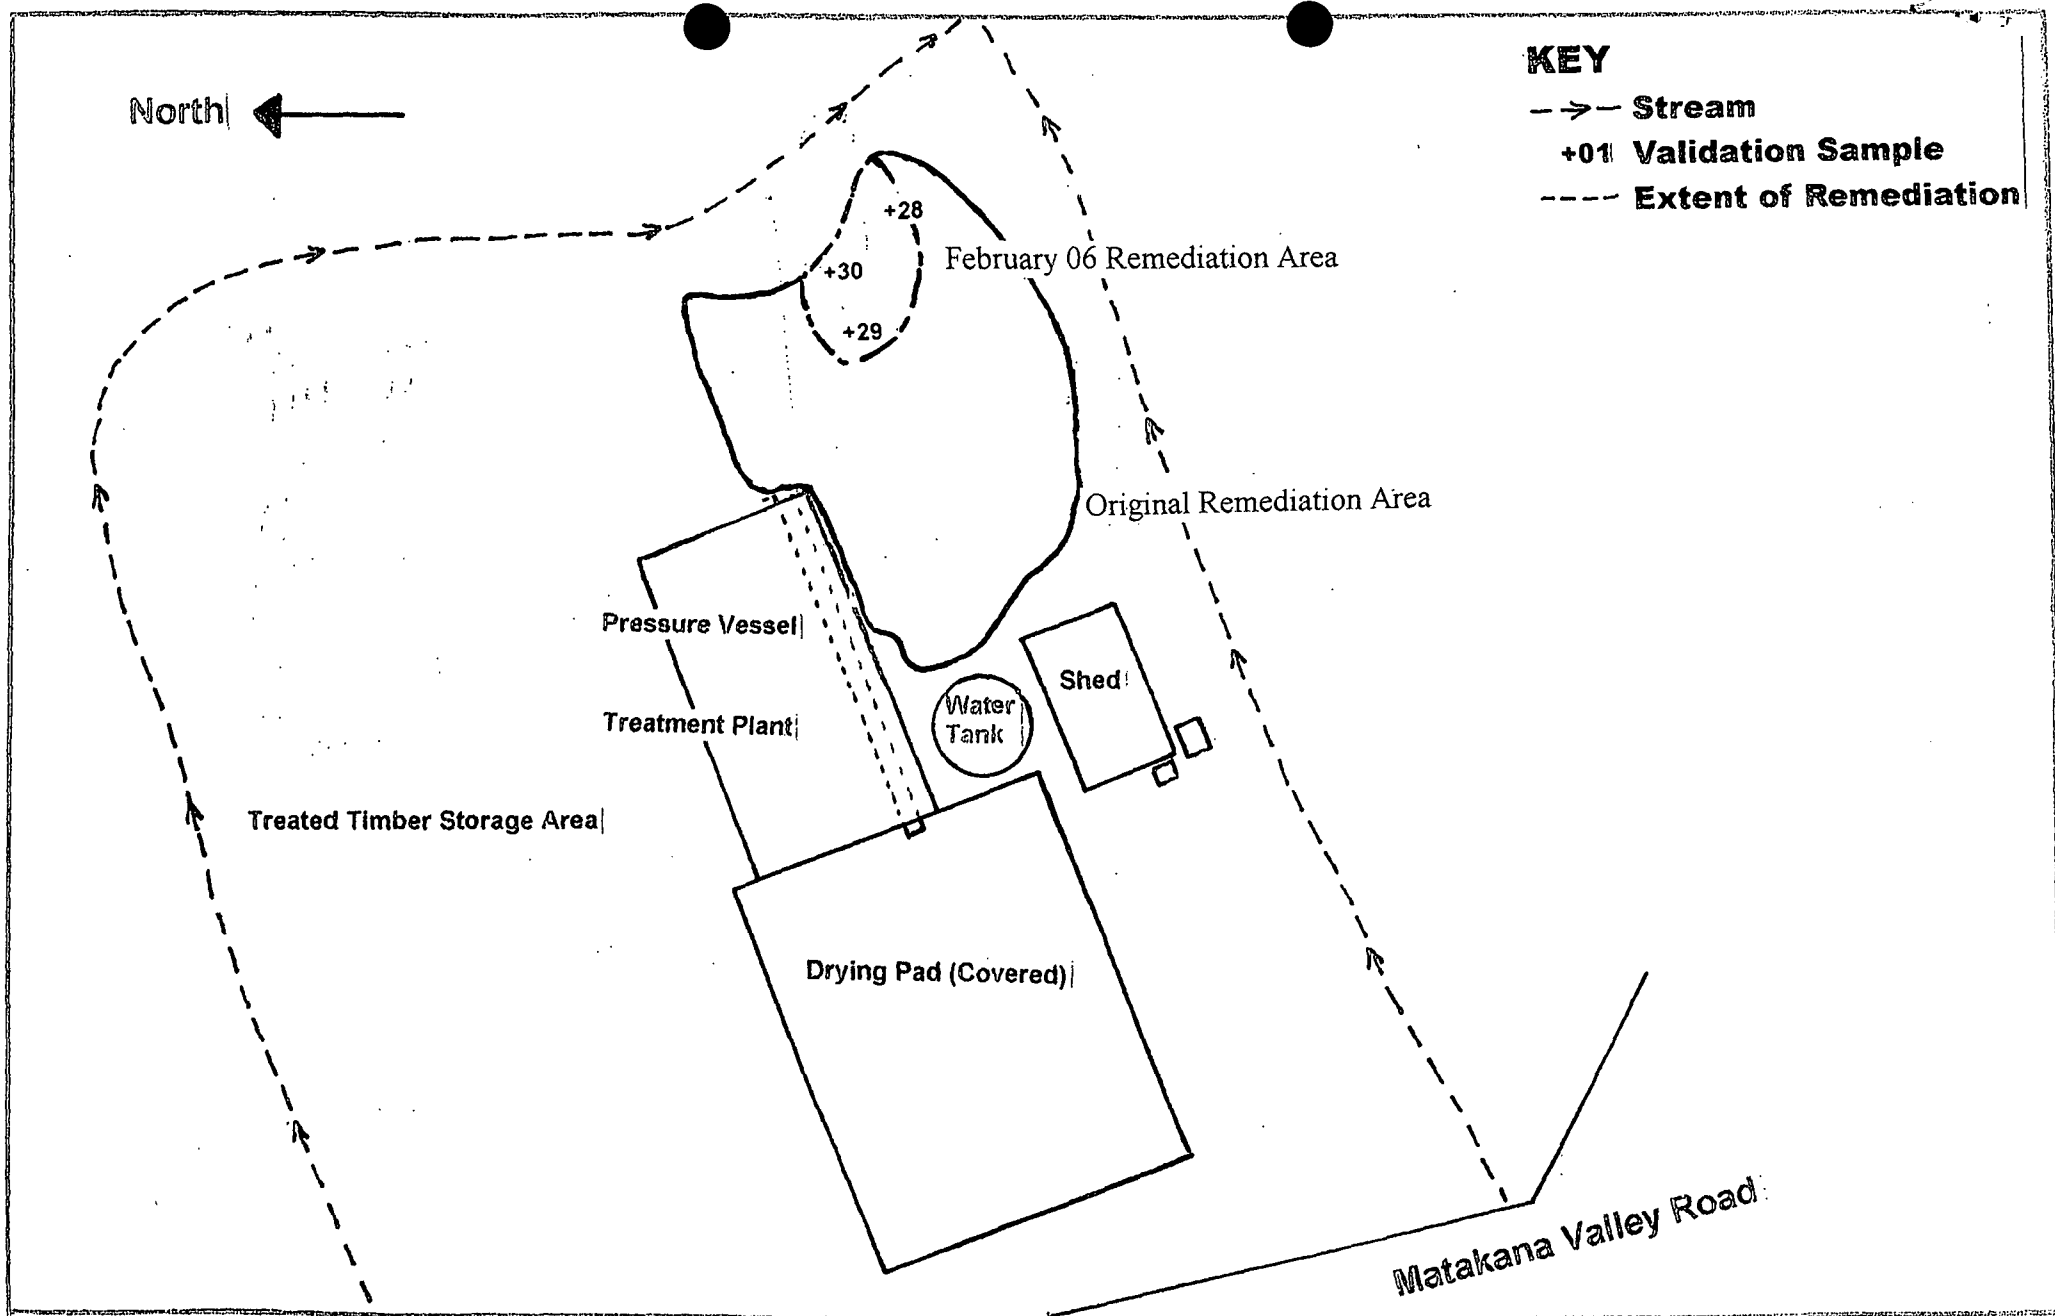
**Figure 2: February 06 Remediation Area  
& Sampling Locations**

Figure 2 shows the February 2006 remediation area.

The analytical results for the validation contained chromium at levels between 84 and 115 mg/kg. The analytical results are included on Table 1 and the validation sample locations are shown on Figure 2.

The layout and extent of the remediated area is provided on Figure 2.

No further remediation is recommended for this area.
