## DETAILED ENGINEERING EVALUATION

123 BLENHEIM ROAD

ISSUE 2

14<sup>th</sup> Oct 2014

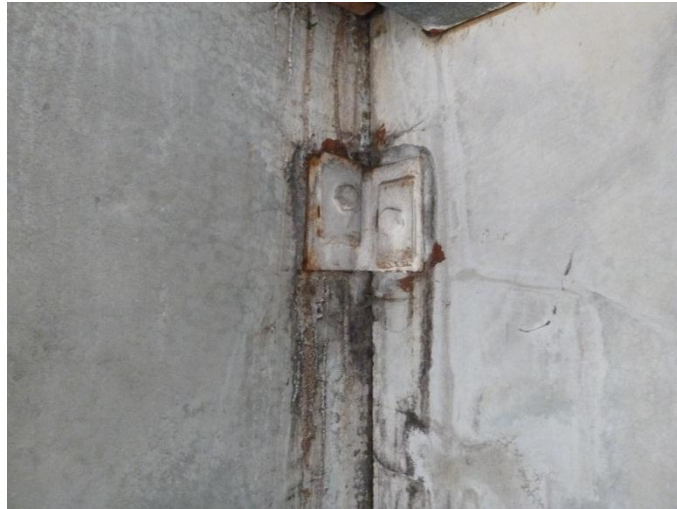
**Photo 1.1**

| LOCATION | DAMAGE | RECOMMENDED REPAIR |
|---|---|---|
| <b>Roof:</b> | The roof structure appears in sound structural condition. Purlin connections appear well connected. Weathering of a panel connection where a leak has occurred was observed to the south west corner of the building.<br><b>Photo 1.1</b> | It is recommended that the leak is investigated by a competent roofer. |

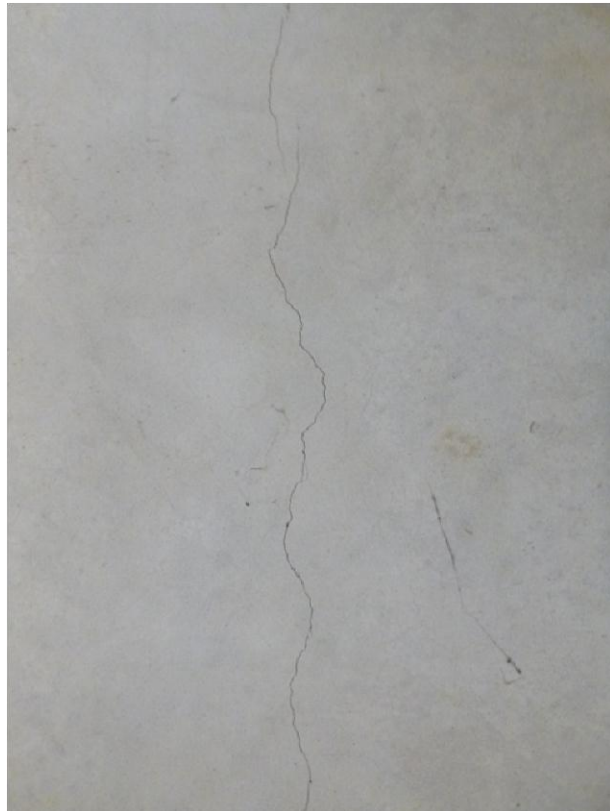
**Photo 2.1**

| LOCATION | DAMAGE | RECOMMENDED REPAIR |
|---|---|---|
| <b>Walls</b> | Significant cracking of the wall panels has been observed throughout the property.<br>Cracks are typically between 0.1-0.5mm wide.<br>Panel no.5 has displaced horizontally at the mid-span location by approximately 18mm due to out of plane face loading.<br><b>Photos 2.1, 2.2, 2.3,2.4</b><br><br>Internal damage has occurred at the junctions where lightweight wall linings have moved relative to the precast panels.<br><b>Photos 3.1</b> | Inject panel cracks between 0.2 to 5mm with Sikadur-52 epoxy or similar. It is recommended this process is monitored to ensure the repair is carried out to a high standard.<br><br>Patch repair areas internally. |
