# DETAILED SEISMIC ASSESSMENT (QUANTITATIVE)

**1473 MAIN NORTH ROAD  
WAIKUKU 7473**

Sanderson China & Pottery

4<sup>th</sup> October 2022  
JN 220173A

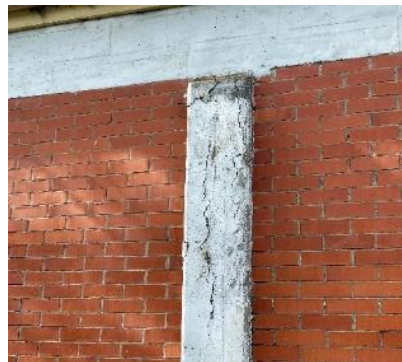
However, there was cracking through some of the concrete columns in Building 4A's confined masonry walls, refer to Figure 2 below. As the cracks were vertical cracks parallel with the longitudinal reinforcing in the concrete column, it is likely the cracking is due to induced stresses from the reinforcing expanding from rust. To ensure the damage doesn't become more significant leading to structural issues, the corroded steel should be repaired. Figure 3 below show a standard procedure to repair corroded reinforcing steel.

FIGURE 2 – BUILDING 4A CONCRETE COLUMN CRACKS

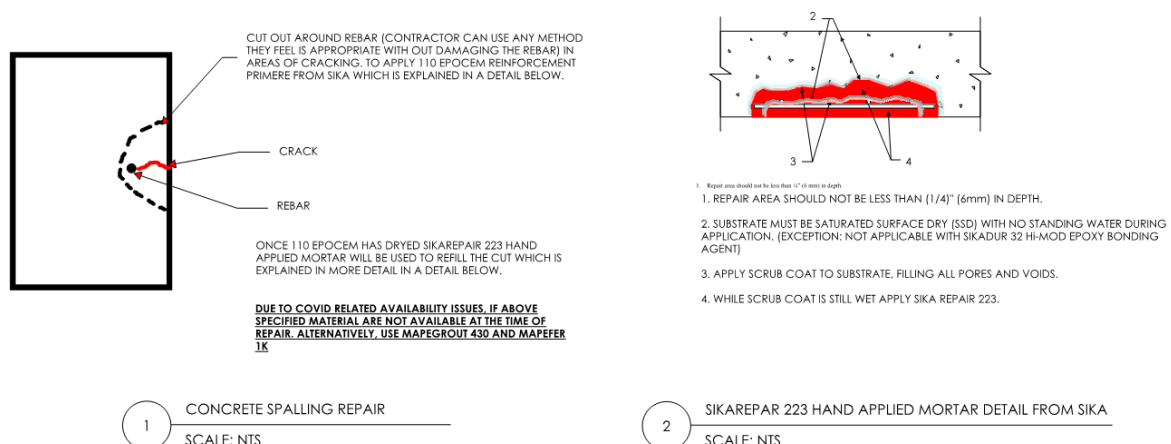
FIGURE 3 – REINFORCING CORROSION REPAIR
