# LONG TERM MAINTENANCE PLAN UPDATE

GRACEFIELD BUSINESS PARK  
BODY CORPORATE

4 NOVEMBER 2020

50 Gracefield Road, Wellington

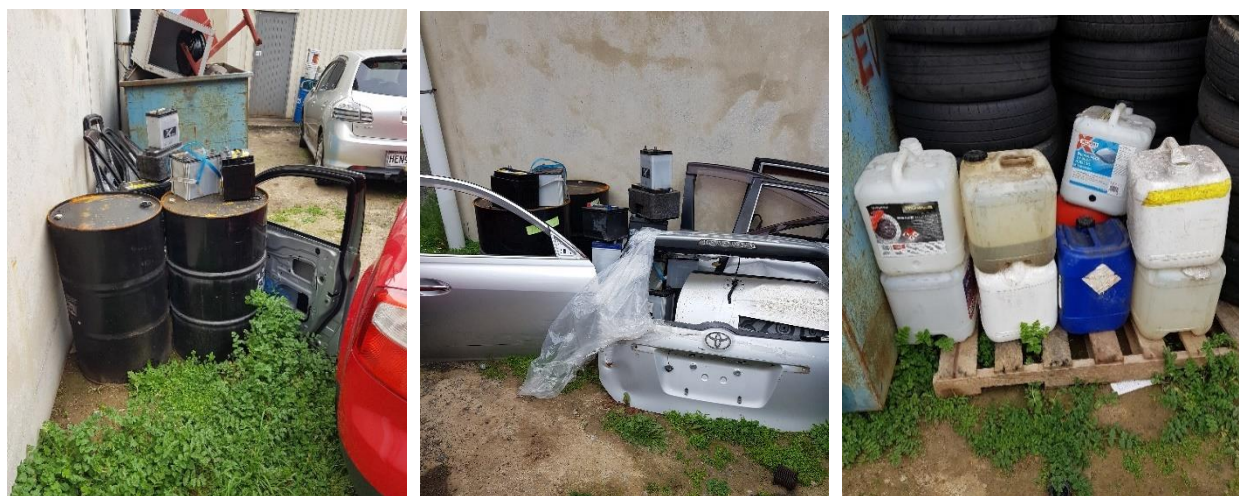
We have noted behind the Northern block (the mechanical garage) their flammable chemicals and batteries are stored outside. We recommend these be stored in a flammable good storage or disposed of correctly.

*Figure 3: Hazardous goods stored behind the Southern Block*

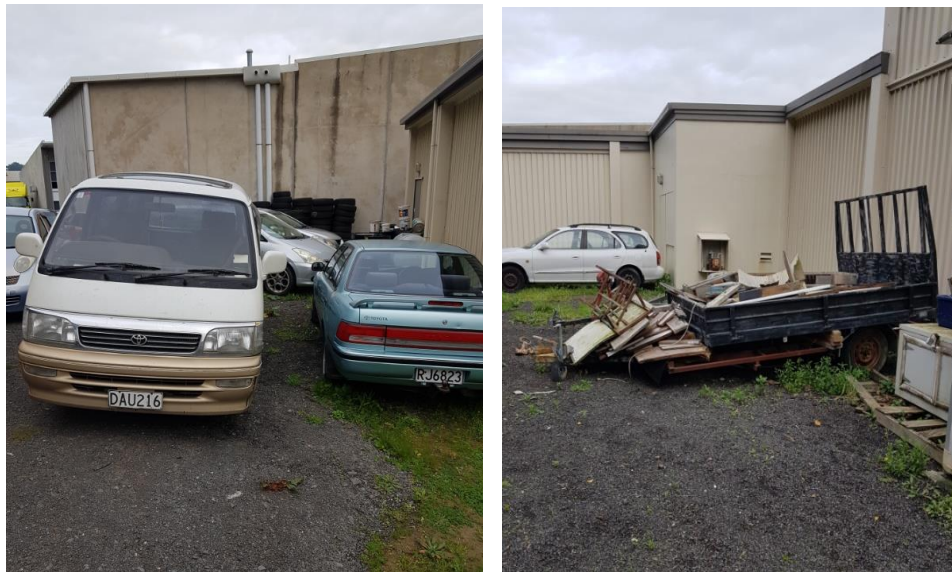
We have also noted that during the site survey the ground behind the mechanical garage was soft under foot which could indicate insufficient drainage or other issues to the area; but this would require further investigation to confirm. A lot of vehicles and car parts were stored in this area which is blocking the driveways between the North and Central Blocks.

*Figure 4: Vehicles in the Northern Block yard*

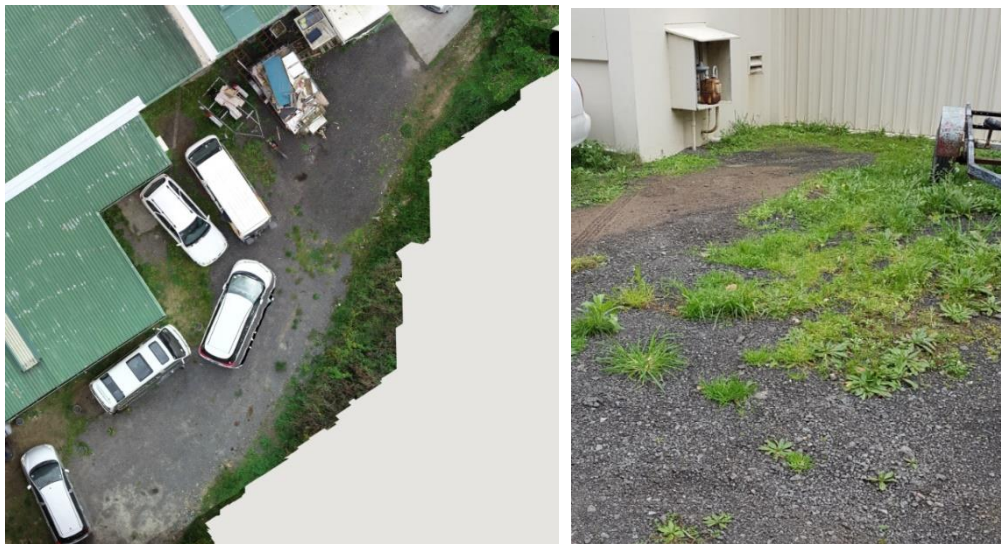
*Figure 5: Conditions of grounds at the Northern Block yard*

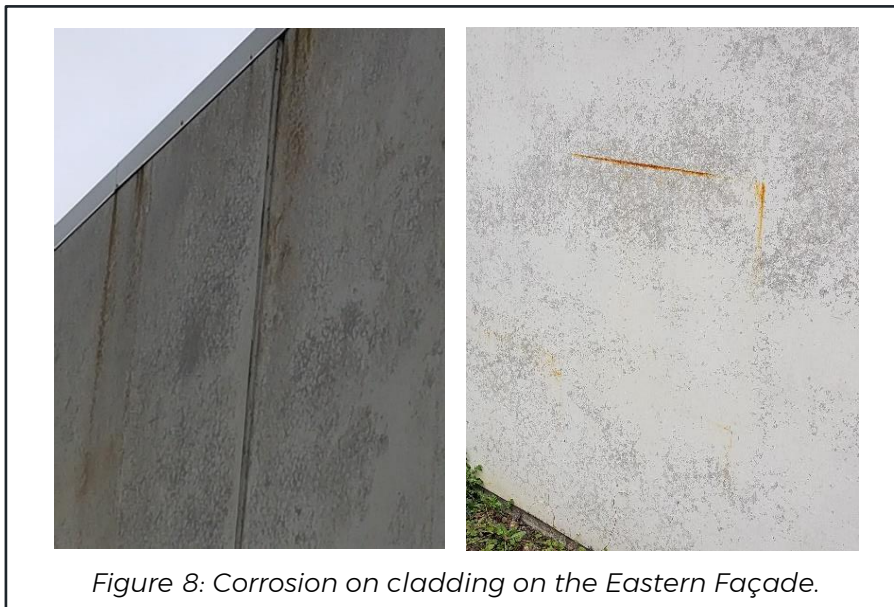
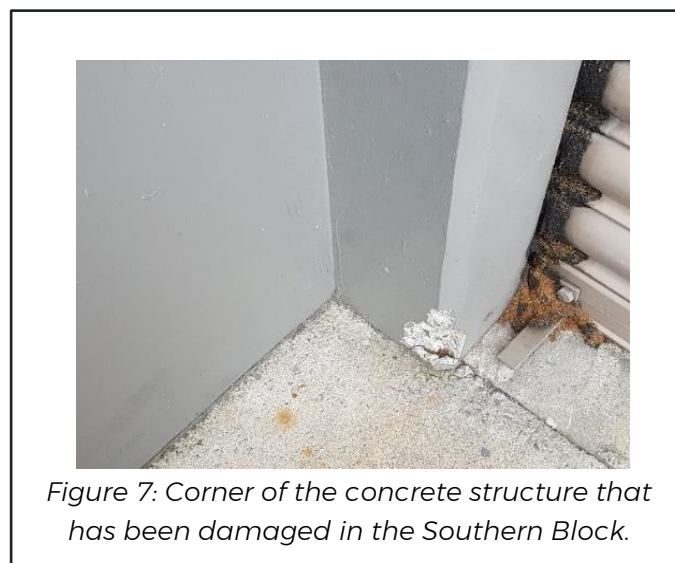
The unpainted concrete cladding on the Eastern Facade appears to be in satisfactory condition, however there are some signs of corrosion from the bolts along the beam box which should be addressed. Some areas are also wearing quickly due to orientation against prevailing weather conditions which may require earlier recoating.

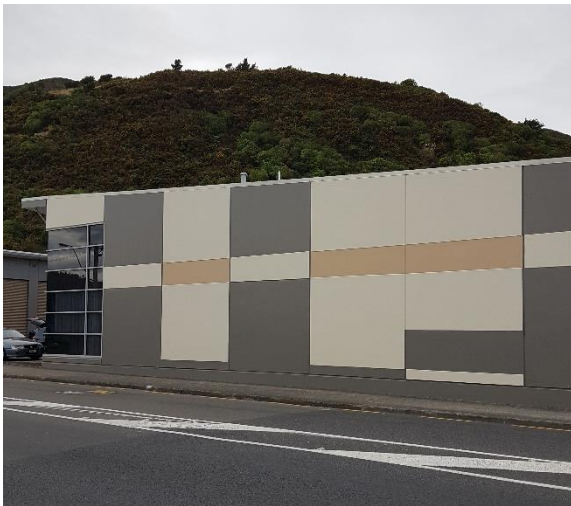
The Southern block was repainted in 2018 and appear to be in excellent condition, the paint cycle for the walls is approximately 10 years. The facades would greatly benefit from an annual building wash which would maintain the integrity of the cladding as it is close to a marine environment.

*Figure 10: Paint in excellent condition on the Western facade.*

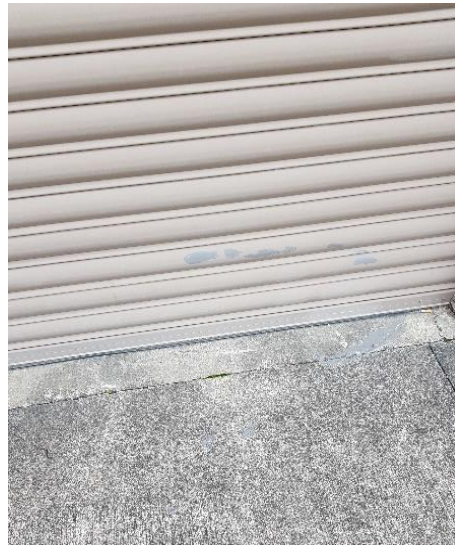
The soffits and garage doors appear to also be in excellent condition, we have allowed for these to be painted in the same cycle as the cladding. The next paint cycle is planned for 2028 and we have included an allowance in the Maintenance Plan for the erection of scaffolding and mechanical access around the fire escape stairwell as a provision in the exterior painting costs.

*Figure 9: Minor paint chipping on the garage on the North Facade.*

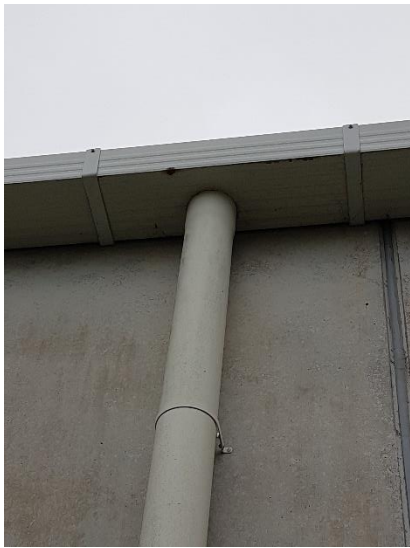
*Figure 13: Edge of the beam box on the Southern Facade showing signs of corrosion.*

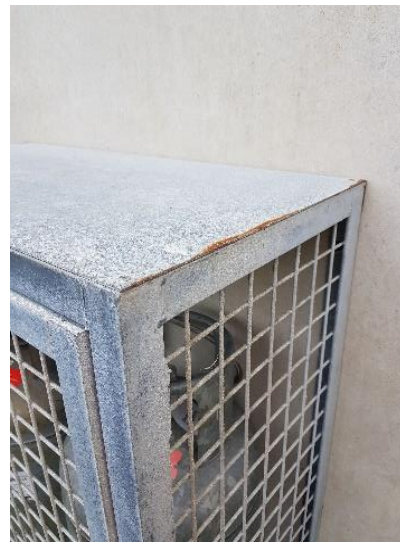
*Figure 12: Gas cage located on the Southern facade showing signs of corrosion. (Tenant owned)*

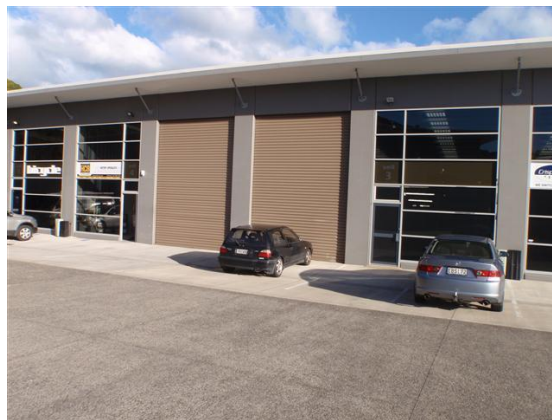
There are 17 carparks between the Southern and Central blocks, the carpark markings appear to be satisfactory condition. We have made an allowance for these to be repainted on a 5-year cycle from 2022.

*Figure 14: Carpark lines between Southern and Central Block appear to be satisfactory*

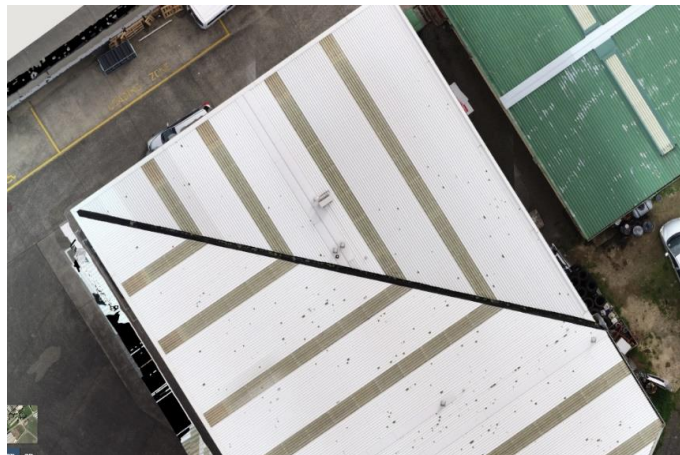
From our review there are visual signs of lichen growth. An annual wash cycle is recommended. However, a full roof and spouting replacement has been allowed for in 2033.

*Figure 15: The roof of the Central block appears to be in good condition.*

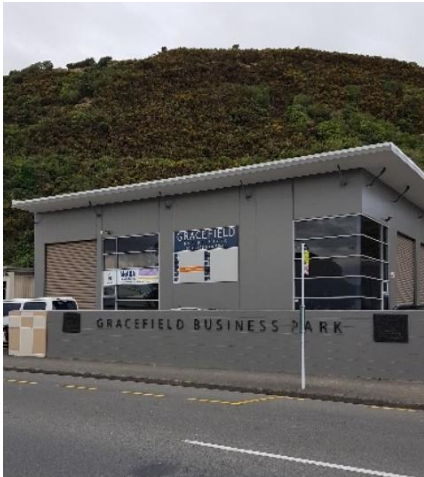
*Figure 17: The Central block recently painted in excellent condition.*

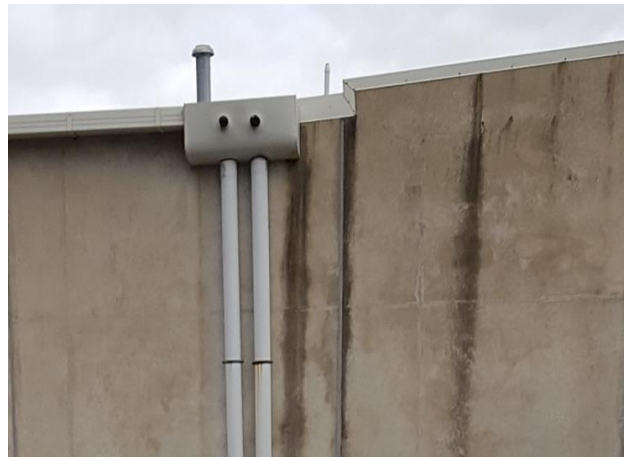
The unpainted cladding on the Northern Façade appear to be in satisfactory condition, with visible water stains running down the walls. We recommend giving the panels an annual wash to maintain the integrity of the cladding.

*Figure 16: The northern facade of the Central block with visible water stains on the cladding.*

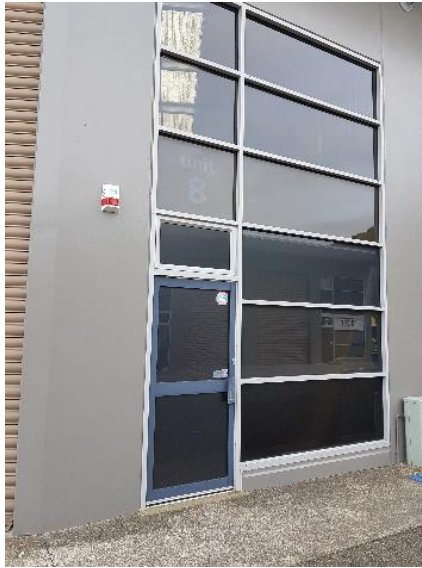
The windows in the Central Block are single glazed aluminium in concrete surround. These windows have been detailed well; on the day of our inspection we did not observe any evidence of leaking.

*Figure 18: Windows from Central Block appears to be in good condition.*

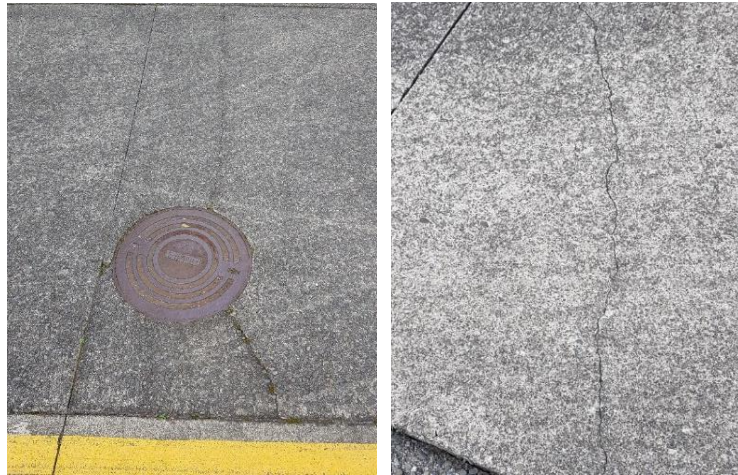
Generally, the hard surface improvements around Central Block are in satisfactory condition. However, there are some areas that have minor cracks that will need remedial work. We have made an allowance to repair the surface layer on a 5-year basis starting from 2022.

*Figure 20: Concrete near Central Block showing some minor cracks.*

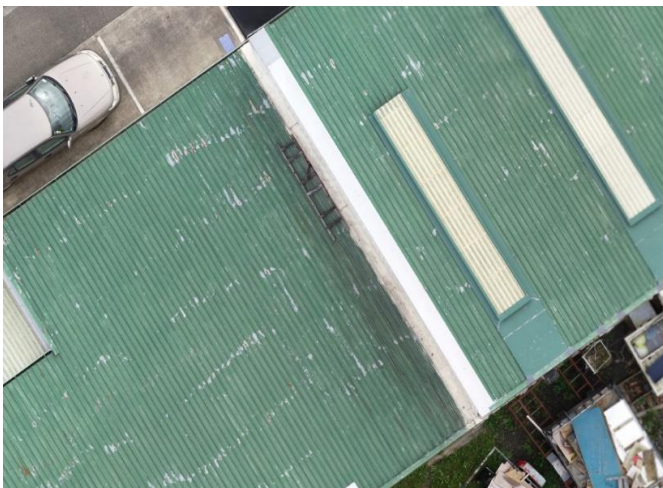
The profiled iron roof appears to be in poor condition, where there are areas of paint peeling there are also signs of corrosion. We expect the condition of the roof will progressively deteriorate if left unaddressed. We can also see an old ladder has been left on the roof, we recommend disposing of this properly next time you have access to the roof. We have allowed for a repaint of the roof in 2021 and a full roof replacement in 2033.

*Figure 21: The Northern block roof is showing signs of deterioration, but the skylight panels appear to be in satisfactory condition.*

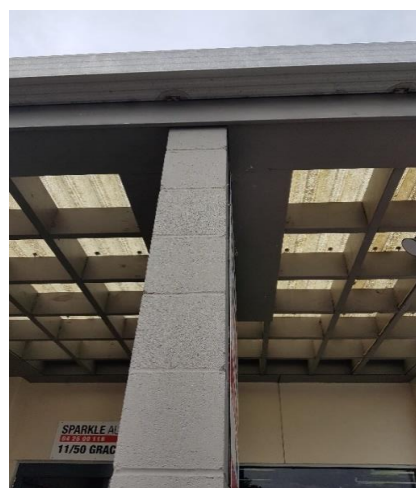
The corrugated iron overhang roof on the Western façade and the skylight panels appear to be in satisfactory condition but would benefit from a regular wash cycle. Based on our visit we are unable to determine if there are any leaks present in the corrugated iron roof, as a full invasive inspection has not been allowed for or carried out.

*Figure 22: The overhang roof on the Western facade is in satisfactory condition but would benefit from a wash.*

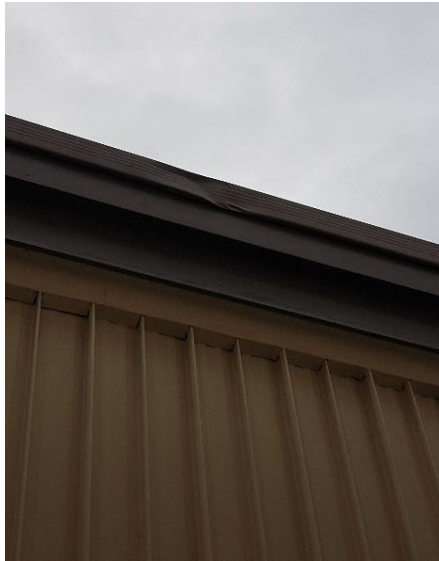
*Figure 23: Box guttering with a dent in the Northern block.*

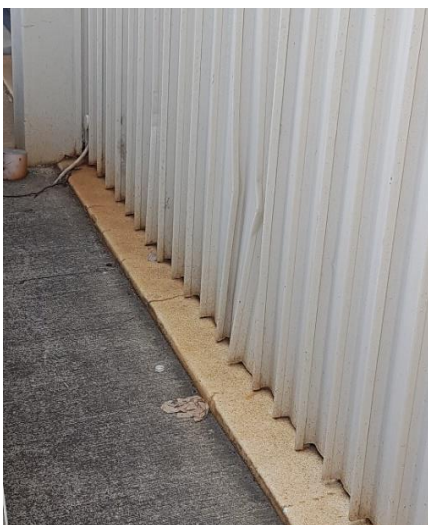
The exterior walls are a mixture of Hardiflex Panels, concrete and profiled iron cladding. The integrity of the cladding itself is in satisfactory condition but have noted some paint peeling; there is an allowance in the plan to repaint in 2028. We have also noted corrosion to specific areas of the cladding; we suggest remedial action be taken to prevent further corrosion to this area.

*Figure 24: The Northern Block showing the profile iron cladding which is dented and signs of rusting at the bottom.*

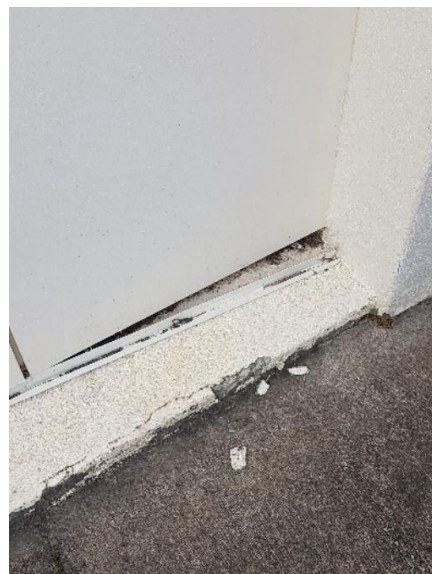
*Figure 25: Damaged titan board on the Western façade.*

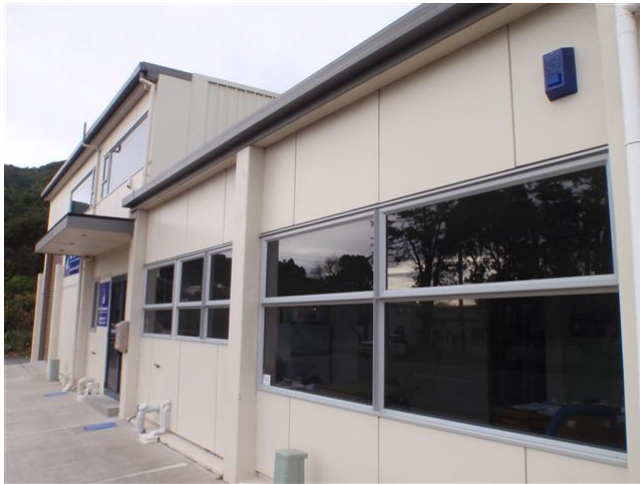
The windows in the Northern Block are single glazed aluminium in Hardiflex surround. These windows have been detailed well and we do not expect them to be leaking. The front door situated on the western façade of the block appears to also be in good condition and operating well. However, there are signs of corrosion on the hinges which may need to be addressed. The windows and doors are the responsibility of the unit owners in the building and as such we have not allowed for replacement for these windows within the 15-year plan.

Figure 28: *Single glazed aluminium framed window on the West Façade. Windows are in good condition and were detailed well during construction.*

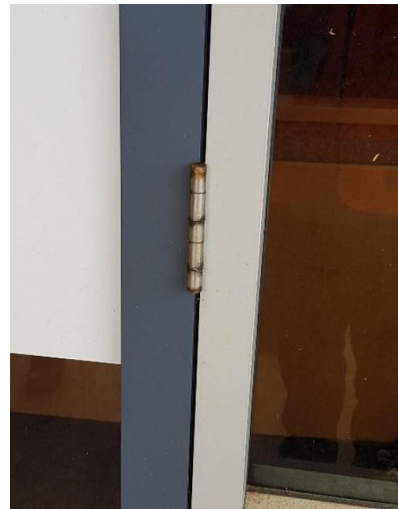
Figure 27: *The front door located on the Western facade with signs of corrosion to the hinges.*

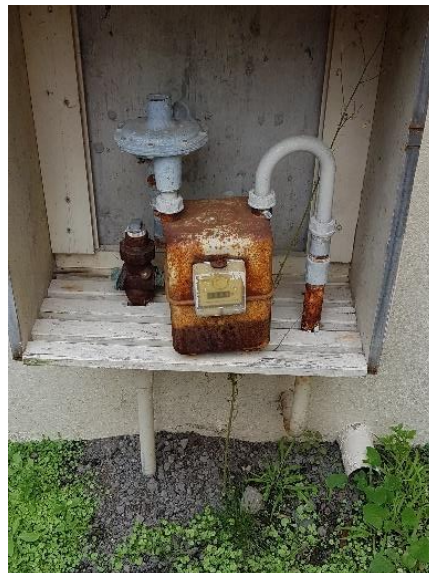
We observed localised corrosion on the pipework and gas meter as shown below. While we note the utility service looks to be disconnected, the meter should be removed, and the area tidied up.

Figure 29: *Rusty meter to be removed*
