### **Additional Earthquake repairs to Elmdale Lane – Unit 3**

### **Additional Earthquake repairs to Elmdale Lane – Unit 5**

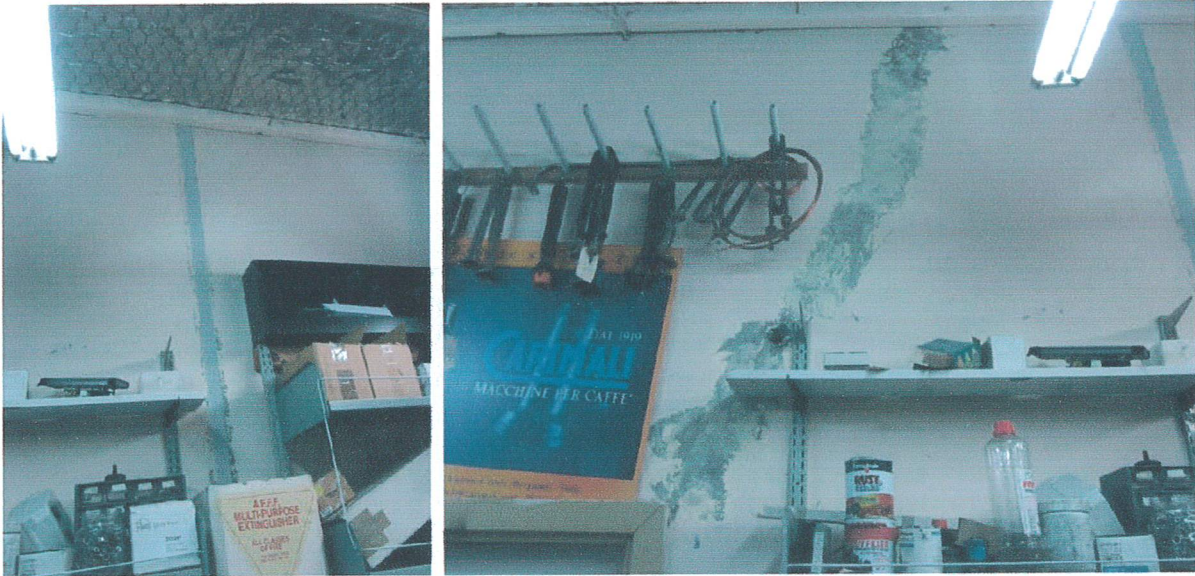
Unit 7 additional wall repairs.

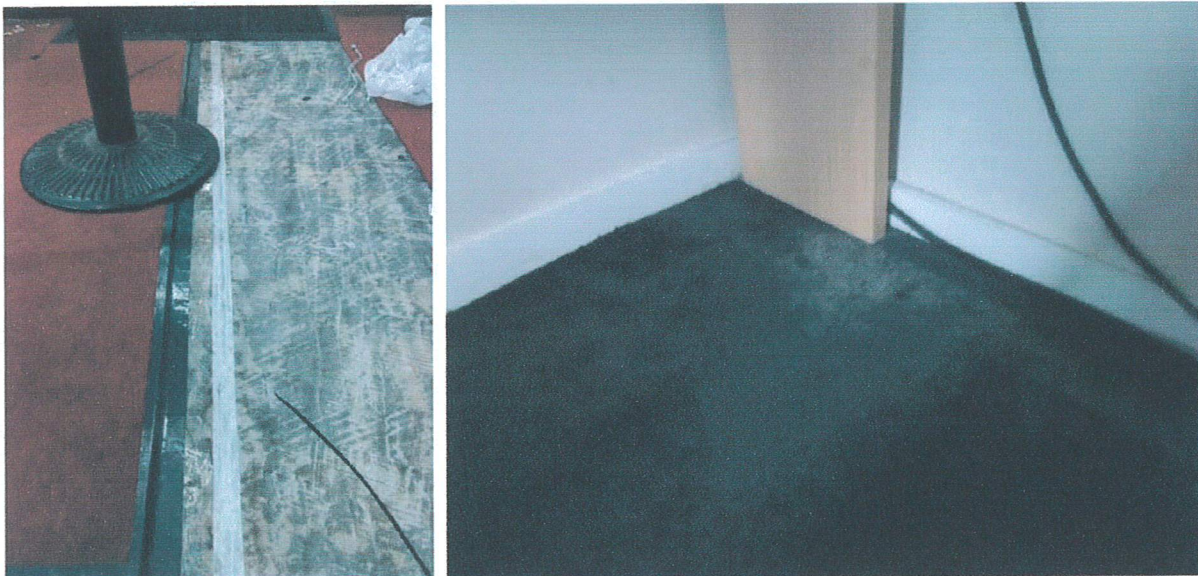
Unit 7 floor banding and liquefaction to existing carpet.

- Epoxy injection concrete floor crack repairs – 23.3 lineal metres
- Banding of floor expansion joints – 17.2 lineal metres
- Floor leveling, uplift existing carpet & lay new carpet to office 1 & rear workshop due to damage from liquefaction – 31 m2
- Interior repainting – 19 m2

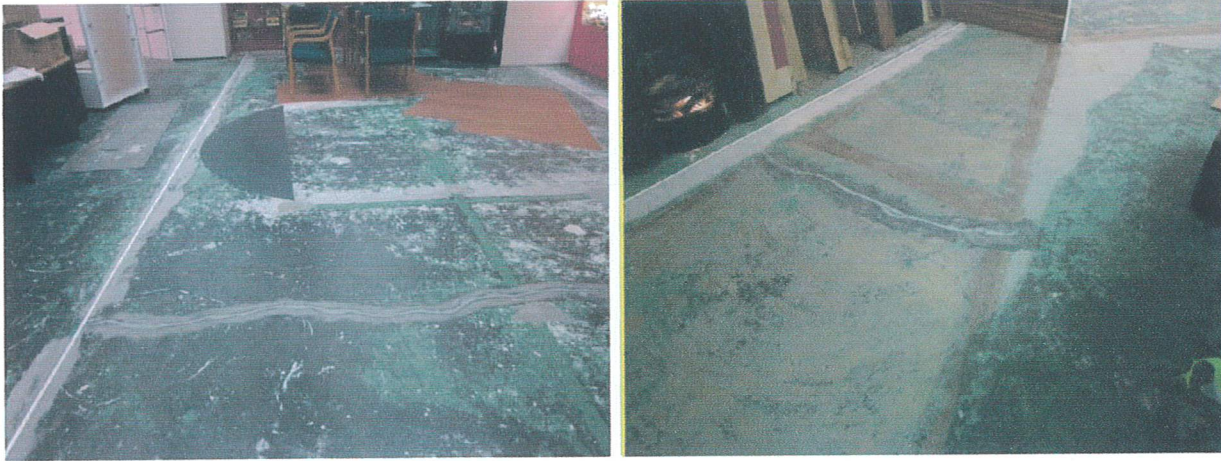
**Unit 9 additional floor repairs.**

- Epoxy injection concrete floor crack repairs – 16.2 lineal metres
- Epoxy injection concrete wall crack repairs – 5 lineal metres
- Banding of floor expansion joints – 15.65 lineal metres
- Floor leveling, uplift existing carpet & lay new carpet to showroom/hallway due to damage from liquefaction – 64 m2
- Exterior repainting – 75 m2

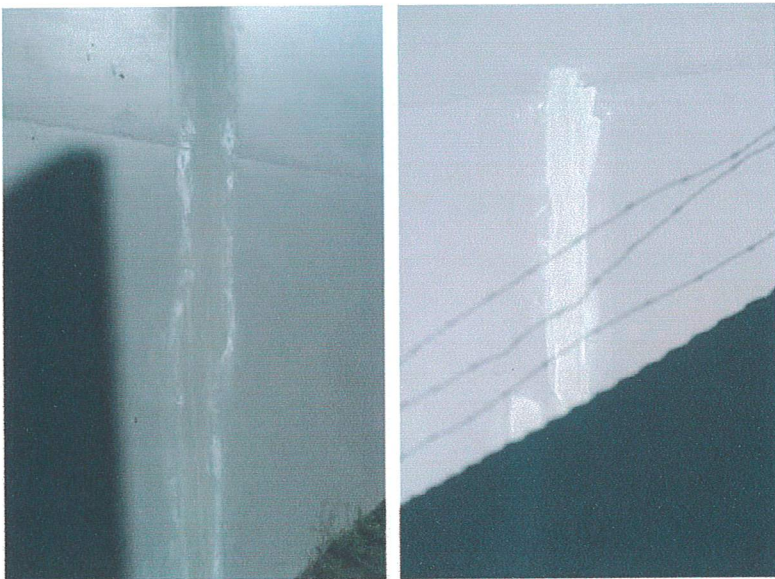
**Unit 9 additional wall repairs.**
