PN513156
86 Wellington - H
Plan 99

Marlborough District Council

ASSET INSTALLATION/MAINTENANCE REPORT

Stormwater Realignment - Aldan Lodge, Wellington Street, Picton

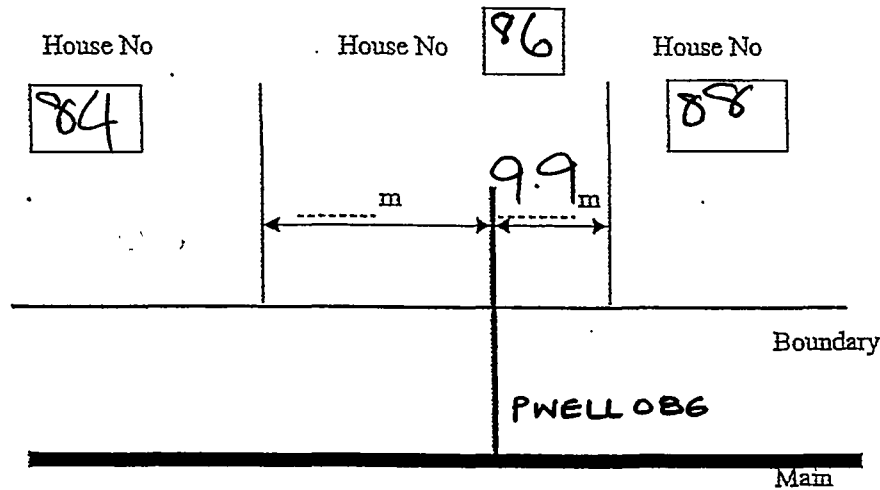
LEAKING TAP

Water Quality	<input type="checkbox"/>
Blockage	<input type="checkbox"/>
Overflow	<input type="checkbox"/>
Leak	<input checked="" type="checkbox"/>
Low Pressure	<input type="checkbox"/>
Private	<input type="checkbox"/>
Other	<input type="checkbox"/>

Materials/Fittings Used
1 x LXM 204
