## Earthquake repairs to Elmdale Lane - Unit 5

# **STAKE CONSULTING LTD**

**Job Reference: ELMDALE LANE UNIT 5**

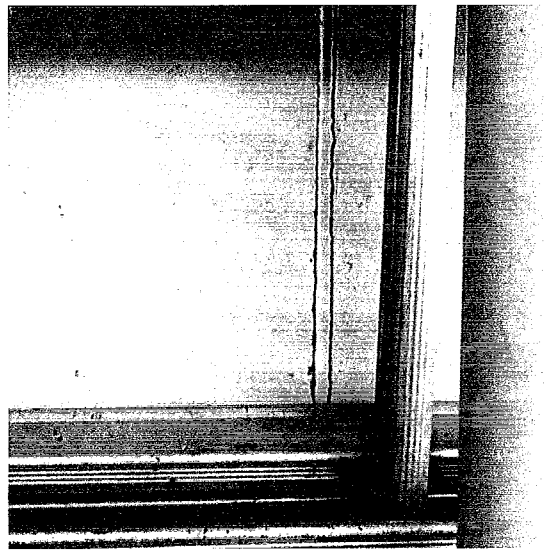
PHOTO 1

## EPOXY SST PANEL INJECTION

LOCATION: NORTH WALL PANEL

TOTAL METRES 4

REPAIR CODE SST

SCAFFOLD REQUIRED

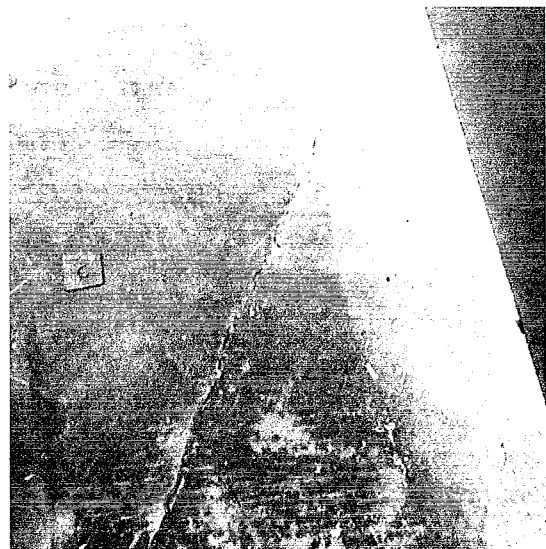
PHOTO 2

## EPOXY GFI PANEL INJECTION

LOCATION: WAREHOUSE FLOOR

TOTAL METRES 24.7

REPAIR CODE GFI
