## SITE NOTICE

Consent No: **20172013** Date Printed: **7 February 2020**  
Applicant: **Spaghetti Junction Limited**  
Site Address: **80 Byron Street Sydenham**  
Legal Description: **Lot 1 DP 449853**  
Work Type: **Addition to Factory - New Offices, Meeting and Store Room**  
Email To: **todd@morelconstruction.co.nz**

Inspection Type: **210 - Commercial - Final**  
Inspection Outcome: **Fail**  
Inspected By: **Brian Abrahams**  
Inspection Date: **7 February 2020**

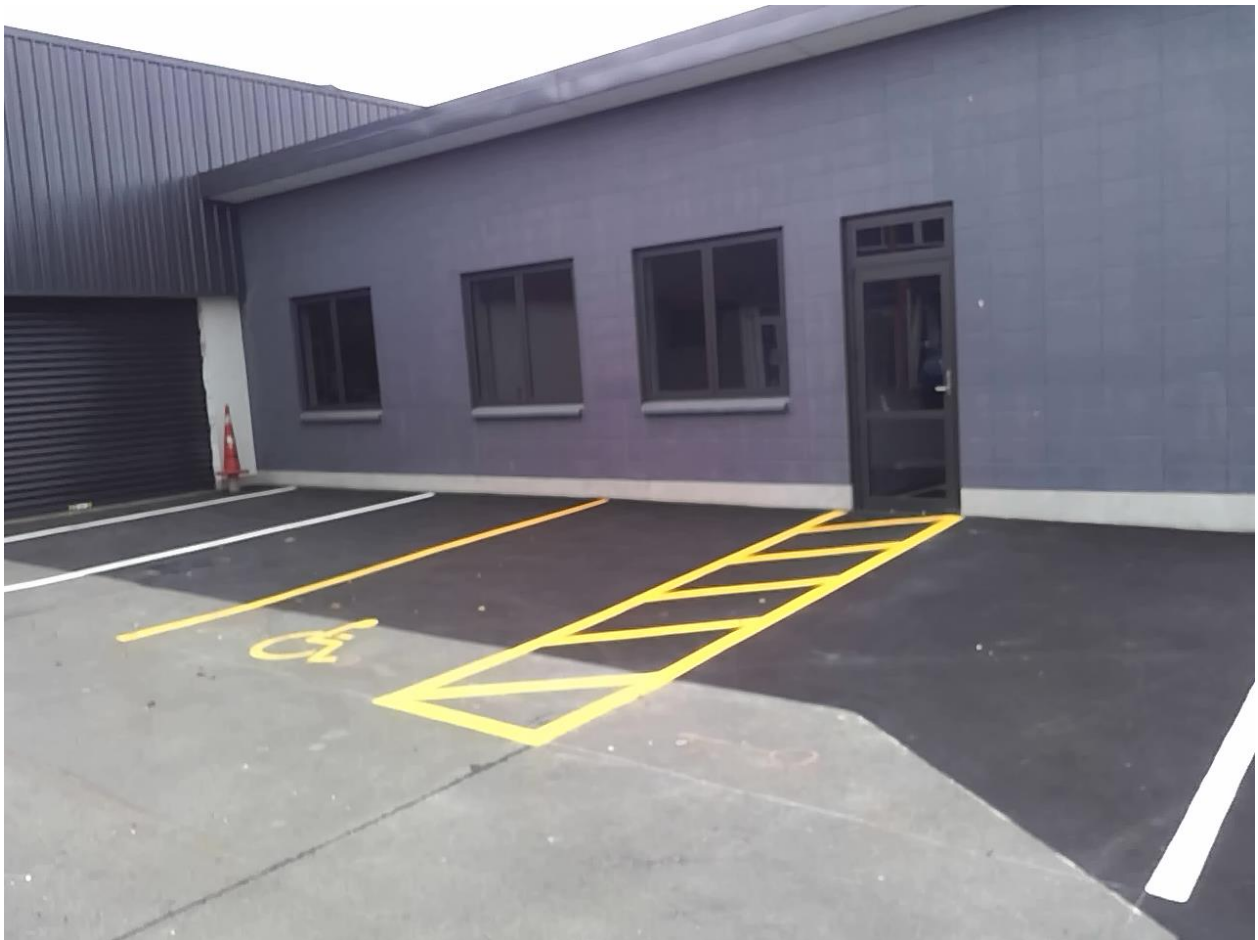
**ISA symbols have not been installed as per F8/AS1**

**Accessible routes and facilities for persons with disabilities - (ISA) has not been installed**

**ISA sign required**  
Taken at 8:35 AM on Friday 7/02/2020

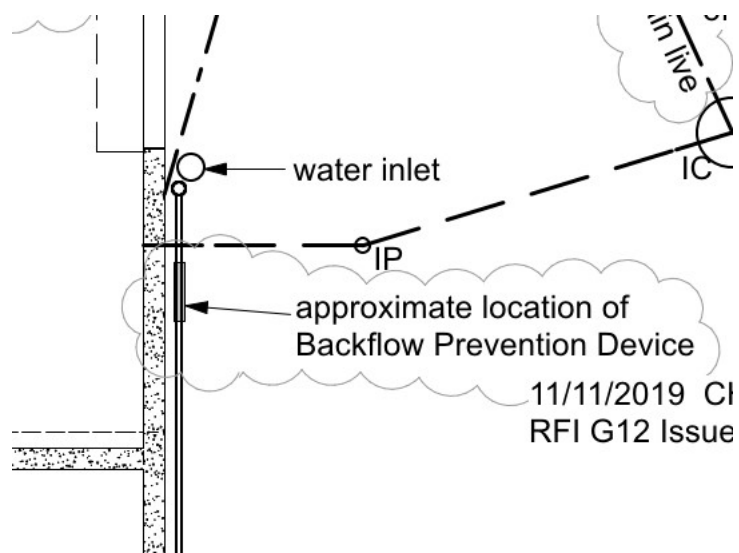
**Backflow prevention device**  
Taken at 11:14 AM on Friday 7/02/2020

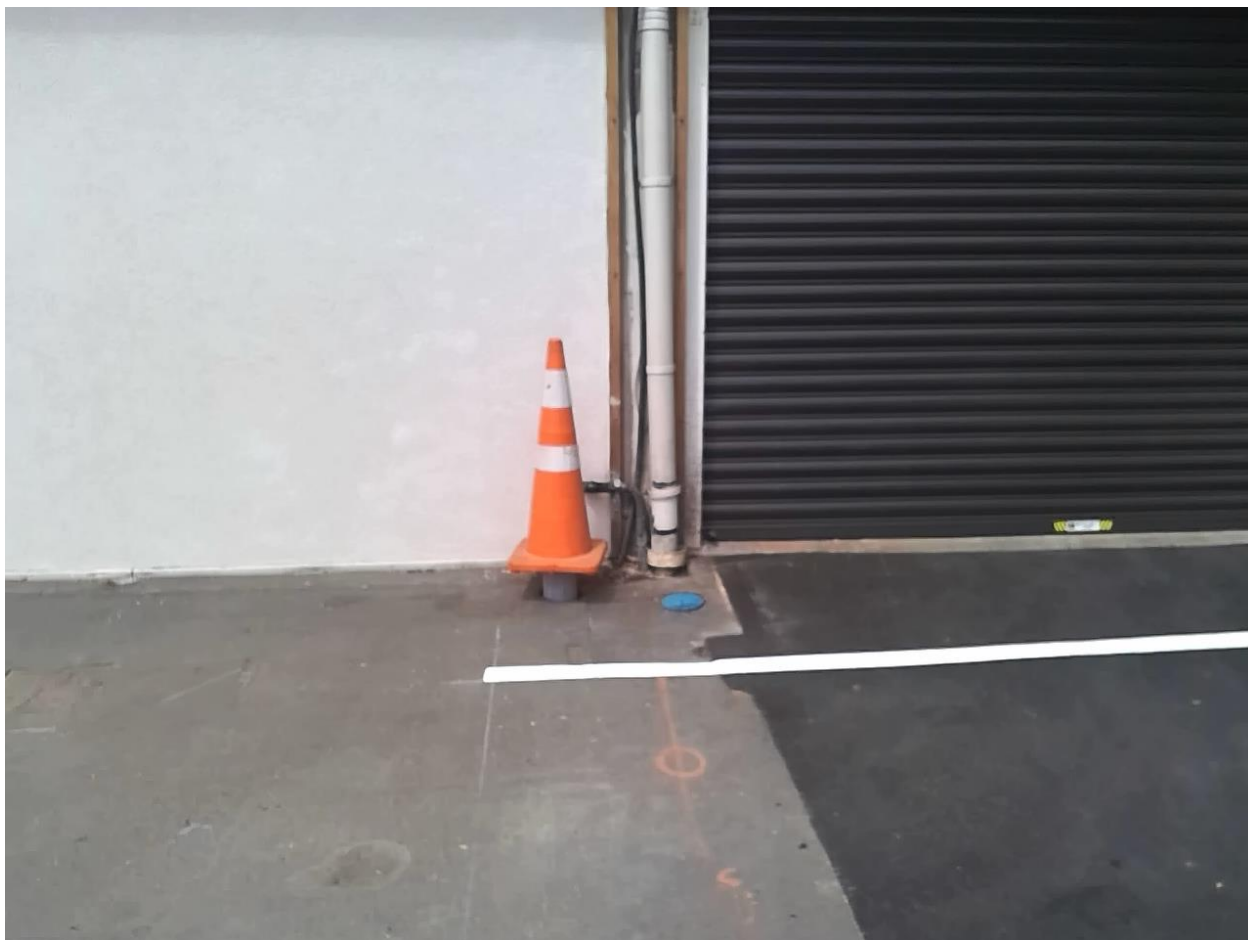
- 1. Kerb & channel to be completed.**
- 2. ISA signage required.**
- 3. UV protection required @ lagging @ gas mixer.**
- 4. Soffit to be sealed/painted.**
- 5. Owner's written approval required for change in building paper as requested in 253 inspection.**
- 6. Backflow prevention device required..see attached photos.**

**Proposed position of new backflow preventing device not installed yet**
