# Asbestos Management Survey

Petone Club  
Ministry for Primary Industries  
40 Bouverie Street  
Petone  
Lower Hutt  
5012

Report Number: S-16625/44636 Rev 1

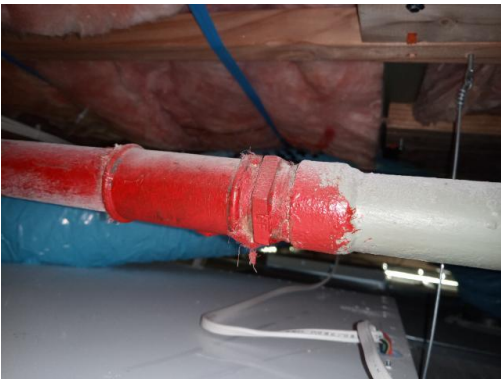
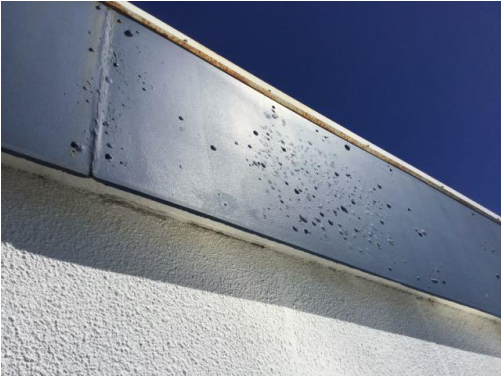
Building / Floor	Ministry for Primary Industries / Void	
	Location	016	Roof void

Sample Number	S012/44647	
	Item / Position	Sealant to screwed pipework joints	
	Material	Textile	
	Extent (approx.)	4 lin m	
	Product Type	AIB, textiles, gaskets, ropes, paper etc.	2
	Condition	Medium damage - significant breakage of materials or several small areas where material has been damaged revealing loose asbestos fibres	2
	Surface Treatment	Unsealed AIB, textiles or encapsulated lagging and sprays	2
	Asbestos Type	<b>Chrysotile</b>	1
	Material Assessment	<b>Medium</b>	<b>7</b>
	Recommendation	Label & Manage	
Comments	Material should not be disturbed through actions such as sanding, cutting, drilling etc. without appropriate measures taken to suppress fibre release.

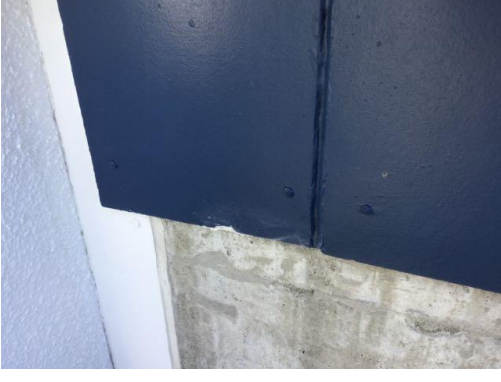
Building / Floor	Ministry for Primary Industries / 2nd Floor	
	Location	001	External

Sample Number	S010/44645	
	Item / Position	Cladding around perimeter of building at top of wall	
	Material	Cement Product	
	Extent (approx.)	90 m <sup>2</sup>	
	Product Type	Composites (plastics, resins, mastics, roofing felts, vinyl floor tiles, paints, decorative finishes, cement etc.)	1
	Condition	Low damage - A few scratches or surface marks, broken edges on boards, tiles etc.	1
	Surface Treatment	Enclosed sprays and lagging, AIB with exposed face painted or encapsulated, asbestos cements sheets etc	1
	Asbestos Type	<b>Amosite, Chrysotile</b>	2
	Material Assessment	<b>Low</b>	<b>5</b>
	Recommendation	Label & Manage	
Comments	Material should not be disturbed through actions such as sanding, cutting, drilling etc. without appropriate measures taken to suppress fibre release.

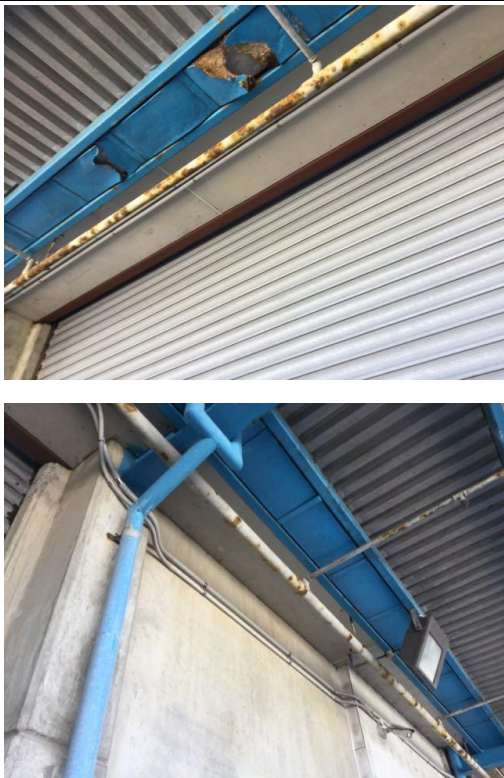
Building / Floor	Ministry for Primary Industries / External	
	Location	001	External
	Sample Number	S028/44662	
	Item / Position	Soffit to garage building	
	Material	Cement Product	
	Extent (approx.)	12 m <sup>2</sup>	
	Product Type	Composites (plastics, resins, mastics, roofing felts, vinyl floor tiles, paints, decorative finishes, cement etc.)	1
	Condition	Low damage - A few scratches or surface marks, broken edges on boards, tiles etc.	1
	Surface Treatment	Enclosed sprays and lagging, AIB with exposed face painted or encapsulated, asbestos cements sheets etc	1
	Asbestos Type	<b>Amosite, Chrysotile</b>	2
	Material Assessment	<b>Low</b>	<b>5</b>
Recommendation	Label & Manage		
Comments	Material should not be disturbed through actions such as sanding, cutting, drilling etc. without appropriate measures taken to suppress fibre release.

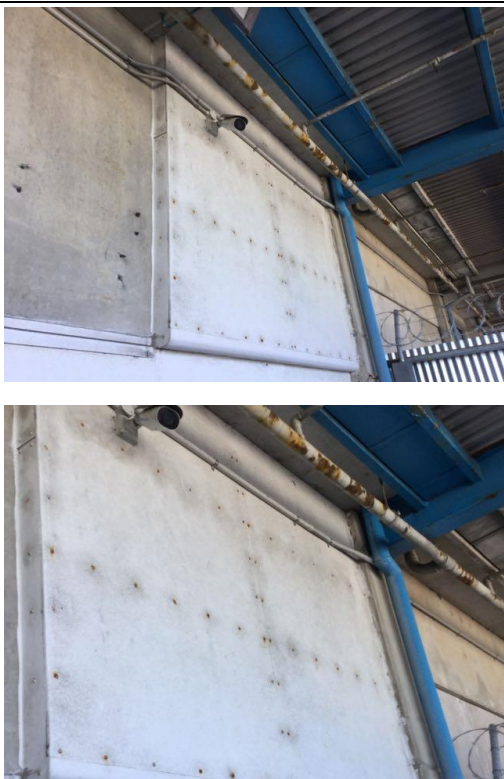
Building / Floor	Ministry for Primary Industries / External	
	Location	001	External
	Sample Number	S029/44663	
	Item / Position	High level wall cladding to rear of garage	
	Material	Cement Product	
	Extent (approx.)	6 m <sup>2</sup>	
	Product Type	Composites (plastics, resins, mastics, roofing felts, vinyl floor tiles, paints, decorative finishes, cement etc.)	1
	Condition	Low damage - A few scratches or surface marks, broken edges on boards, tiles etc.	1
	Surface Treatment	Enclosed sprays and lagging, AIB with exposed face painted or encapsulated, asbestos cements sheets etc	1
	Asbestos Type	<b>Amosite, Chrysotile</b>	2
	Material Assessment	<b>Low</b>	<b>5</b>
Recommendation	Label & Manage		
Comments	Material should not be disturbed through actions such as sanding, cutting, drilling etc. without appropriate measures taken to suppress fibre release.

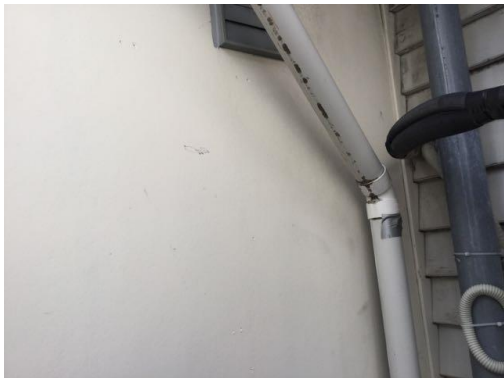
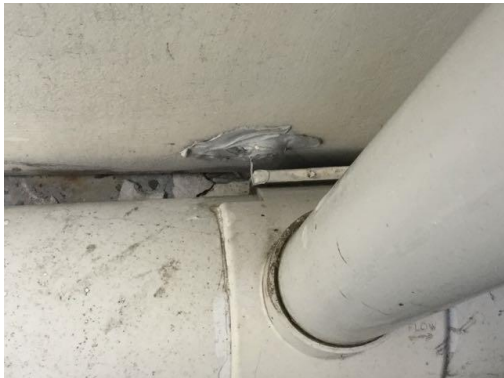
Building / Floor	Ministry for Primary Industries / 2nd Floor	
	Location	012	Light well
	Sample Number	S007/44642	
	Item / Position	Wall lining - Small amount of debris is present where a cable penetration has been made, the panel has been sealed however small amount of debris remain, this debris needs to be removed.	
	Material	Insulation board	
	Extent (approx.)	6 m <sup>2</sup>	
	Product Type	AIB, textiles, gaskets, ropes, paper etc.	2
	Condition	Low damage - A few scratches or surface marks, broken edges on boards, tiles etc.	1
	Surface Treatment	Enclosed sprays and lagging, AIB with exposed face painted or encapsulated, asbestos cements sheets etc	1
	Asbestos Type	<b>Chrysotile</b>	1
	Material Assessment	<b>Low</b>	<b>5</b>
	Recommendation	Label & Manage	
	Comments	Material should not be disturbed through actions such as sanding, cutting, drilling etc. without appropriate measures taken to suppress fibre release.

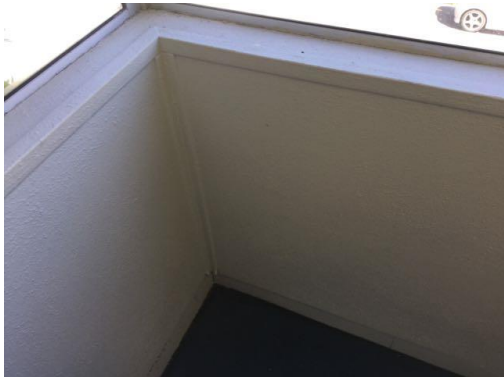
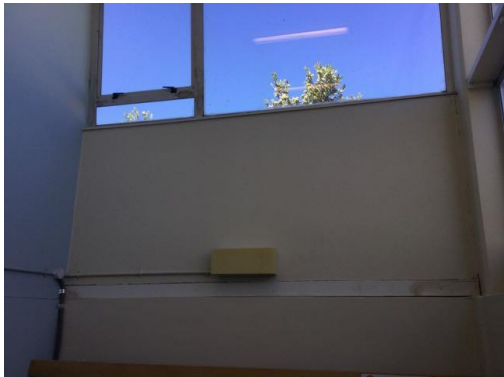
Building / Floor	Ministry for Primary Industries / Stairwell	
	Location	018	Stairwell (main)
	Sample Number	S016/44651	
	Item / Position	Wall cladding - Insulating board with a render coating	
	Material	Insulation board	
	Extent (approx.)	10 m <sup>2</sup>	
	Product Type	AIB, textiles, gaskets, ropes, paper etc.	2
	Condition	Low damage - A few scratches or surface marks, broken edges on boards, tiles etc.	1
	Surface Treatment	Enclosed sprays and lagging, AIB with exposed face painted or encapsulated, asbestos cements sheets etc	1
	Asbestos Type	<b>Chrysotile</b>	1
	Material Assessment	<b>Low</b>	<b>5</b>
	Recommendation	Label & Manage	
	Comments	Material should not be disturbed through actions such as sanding, cutting, drilling etc. without appropriate measures taken to suppress fibre release.

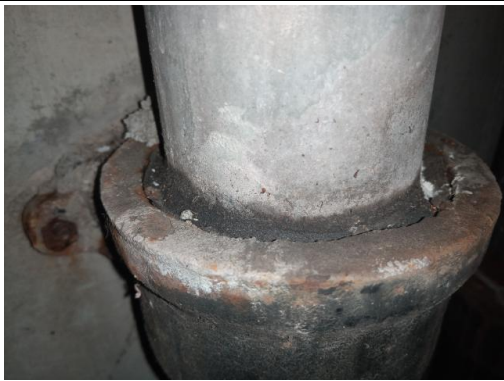
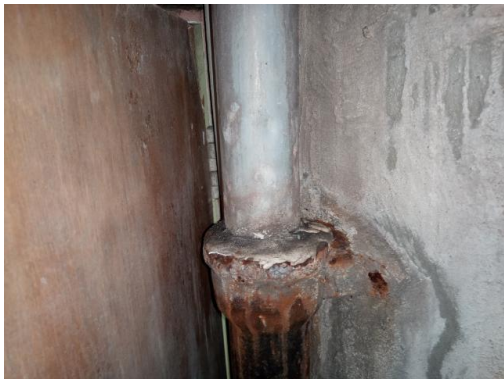
Building / Floor	Ministry for Primary Industries / Riser	
	Location	012	Lightwell
	Sample Number	S032/44666	
	Item / Position	Seal to downpipe cuffs	
	Material	Mastic	
	Extent (approx.)	1 lin m	
	Product Type	Composites (plastics, resins, mastics, roofing felts, vinyl floor tiles, paints, decorative finishes, cement etc.)	1
	Condition	Low damage - A few scratches or surface marks, broken edges on boards, tiles etc.	1
	Surface Treatment	Composite materials containing asbestos - reinforced plastics, resins, vinyl tiles	0
	Asbestos Type	<b>Chrysotile</b>	1
	Material Assessment	<b>Very Low</b>	<b>3</b>
	Recommendation	Label & Manage	
Comments	Material should not be disturbed through actions such as sanding, cutting, drilling etc. without appropriate measures taken to suppress fibre release.

Riser	012	Lightwell	Seal to downpipe cuffs - Mastic	1 lin m	Low damage - A few scratches or surface marks, broken edges on boards, tiles etc.	Composite materials containing asbestos - reinforced plastics, resins, vinyl tiles	S032/44666	Chrysotile	3	Label & Manage

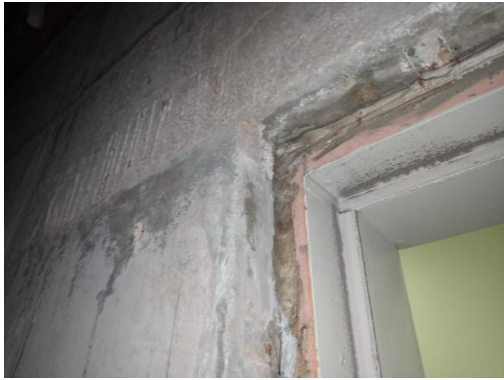
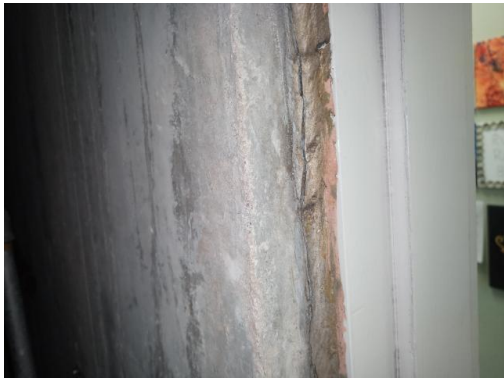
Building / Floor	Ministry for Primary Industries / Riser	
	Location	012	Lightwell
	Sample Number	S033/44667	
	Item / Position	Sealant to door frame	
	Material	Mastic	
	Extent (approx.)	2 lin m	
	Product Type	Composites (plastics, resins, mastics, roofing felts, vinyl floor tiles, paints, decorative finishes, cement etc.)	1
	Condition	Low damage - A few scratches or surface marks, broken edges on boards, tiles etc.	1
	Surface Treatment	Composite materials containing asbestos - reinforced plastics, resins, vinyl tiles	0
	Asbestos Type	<b>Chrysotile</b>	1
	Material Assessment	<b>Very Low</b>	<b>3</b>
	Recommendation	Label & Manage	
Comments	Material should not be disturbed through actions such as sanding, cutting, drilling etc. without appropriate measures taken to suppress fibre release.

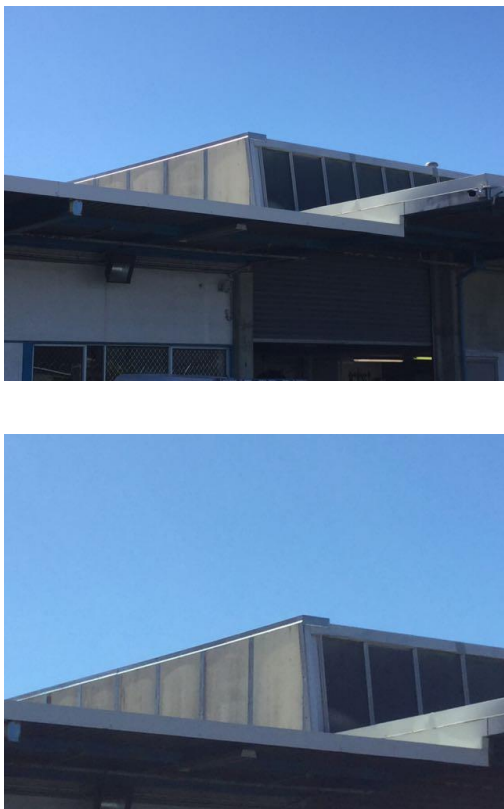
Building / Floor	Ministry for Primary Industries / External	
	Location	001	External
	Sample Number	X029/44663	
	Item / Position	High level cladding - Appear to be visual similar to cladding sample at rear of garage area, if any doubts arise acquire a sample with use of high-level access equipment.	
	Material	Cement Product	
	Extent (approx.)	40 m <sup>2</sup>	
	Product Type	Composites (plastics, resins, mastics, roofing felts, vinyl floor tiles, paints, decorative finishes, cement etc.)	1
	Condition	Low damage - A few scratches or surface marks, broken edges on boards, tiles etc.	1
	Surface Treatment	Enclosed sprays and lagging, AIB with exposed face painted or encapsulated, asbestos cements sheets etc	1
	Asbestos Type	<b>Amosite, Chrysotile</b>	2
	Material Assessment	<b>Low</b>	<b>5</b>
	Recommendation	Label & Manage	
Comments	Material should not be disturbed through actions such as sanding, cutting, drilling etc. without appropriate measures taken to suppress fibre release.

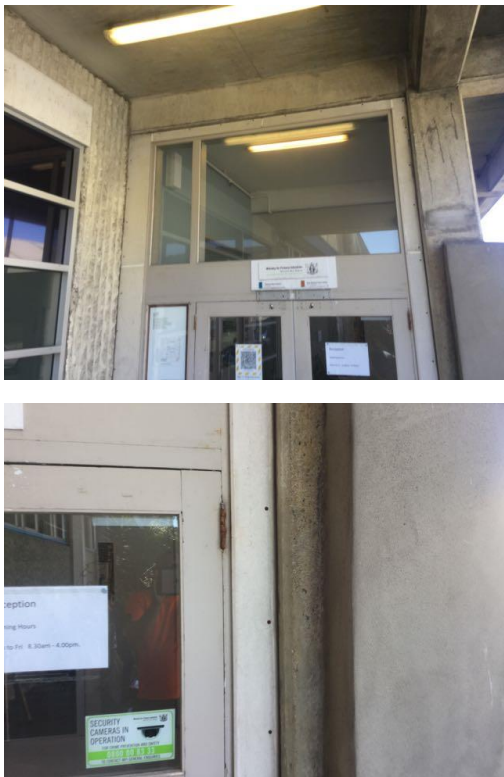
Building / Floor	Ministry for Primary Industries / External	
	Location	001	External
	Sample Number	X029/44663	
	Item / Position	Cladding around man doors	
	Material	Cement sheet	
	Extent (approx.)	5 m <sup>2</sup>	
	Product Type	Composites (plastics, resins, mastics, roofing felts, vinyl floor tiles, paints, decorative finishes, cement etc.)	1
	Condition	Low damage - A few scratches or surface marks, broken edges on boards, tiles etc.	1
	Surface Treatment	Enclosed sprays and lagging, AIB with exposed face painted or encapsulated, asbestos cements sheets etc	1
	Asbestos Type	<b>Amosite, Chrysotile</b>	2
	Material Assessment	<b>Low</b>	<b>5</b>
	Recommendation	Label & Manage	
Comments	Material was encapsulated by McMahon Services NZ Ltd. Material should not be disturbed through actions such as sanding, cutting, drilling etc. without appropriate measures taken to suppress fibre release.

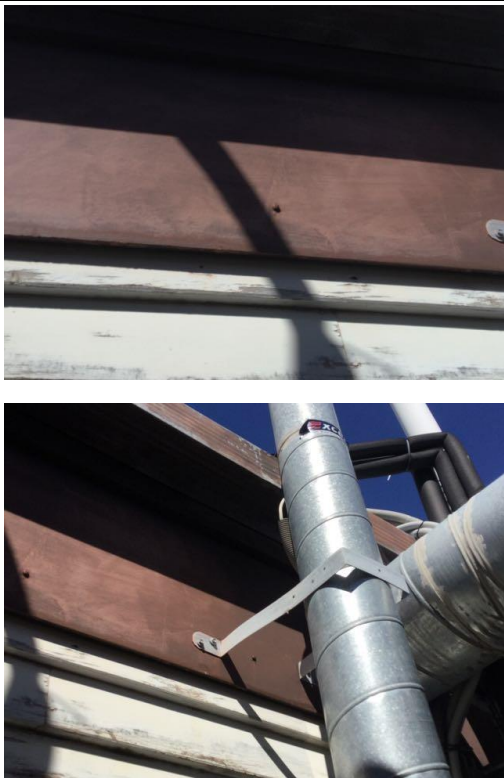
Building / Floor	Ministry for Primary Industries / 2nd Floor	
	Location	012	Light well
	Sample Number	X010/44645	
	Item / Position	Cladding at top of wall at roof level	
	Material	Cement Product	
	Extent (approx.)	6 m <sup>2</sup>	
	Product Type	Composites (plastics, resins, mastics, roofing felts, vinyl floor tiles, paints, decorative finishes, cement etc.)	1
	Condition	Low damage - A few scratches or surface marks, broken edges on boards, tiles etc.	1
	Surface Treatment	Enclosed sprays and lagging, AIB with exposed face painted or encapsulated, asbestos cements sheets etc	1
	Asbestos Type	<b>Amosite, Chrysotile</b>	2
	Material Assessment	<b>Low</b>	<b>5</b>
Recommendation	Label & Manage		
Comments	Material should not be disturbed through actions such as sanding, cutting, drilling etc. without appropriate measures taken to suppress fibre release.

2nd Floor	012	Light well	Cladding at top of wall at roof level - Cement Product	6 m <sup>2</sup>	Low damage - A few scratches or surface marks, broken edges on boards, tiles etc.	Enclosed sprays and lagging, AIB with exposed face painted or encapsulated, asbestos cements sheets etc	X010/44645	Amosite, Chrysotile	5	Label & Manage

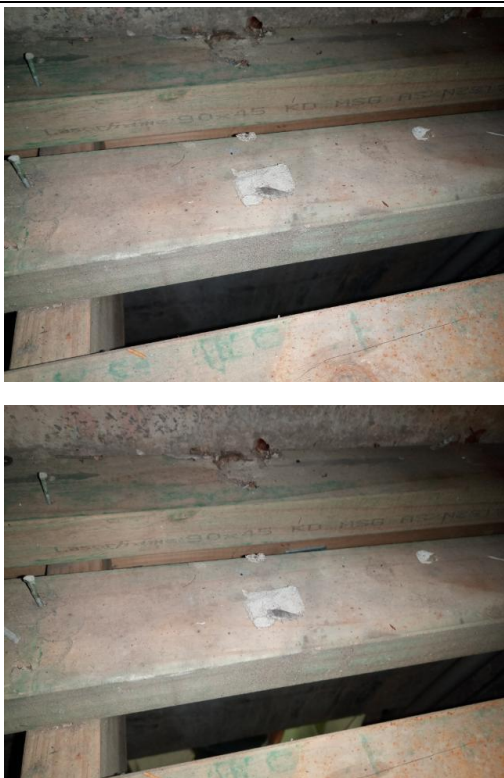
Building / Floor	Ministry for Primary Industries / Riser	
	Location	012	Lightwell
	Sample Number	R031	
	Item / Position	Loose debris on framed walkway 1st floor level -	
	Material	Cement Product	
	Extent (approx.)	0.1 m <sup>2</sup>	
	Product Type	Composites (plastics, resins, mastics, roofing felts, vinyl floor tiles, paints, decorative finishes, cement etc.)	1
	Condition	High damage or delamination of materials, sprays, and thermal insulation. Visible asbestos debris.	3
	Surface Treatment	Enclosed sprays and lagging, AIB with exposed face painted or encapsulated, asbestos cements sheets etc	1
	Asbestos Type	<b>Amosite, Chrysotile</b>	2
	Material Assessment	<b>N/A</b>	<b>0</b>
Recommendation	Removed		
Comments	Material was removed by McMahon Services NZ Ltd.

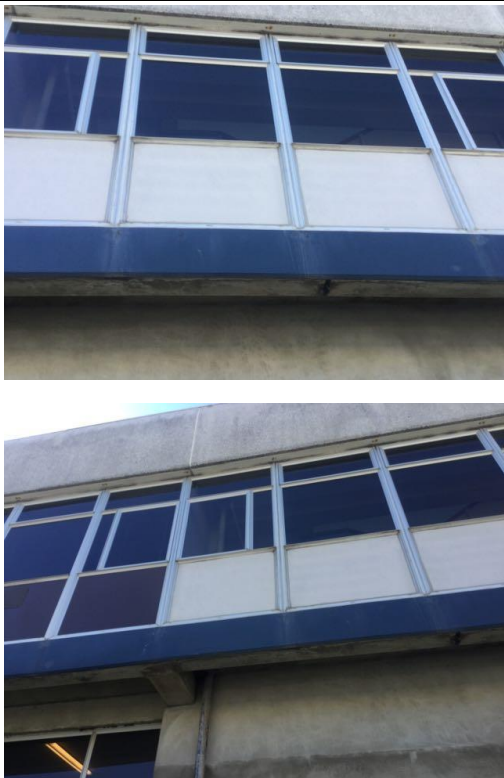
Building / Floor	Ministry for Primary Industries / External	
	Location	001	External
	Sample Number	SP001	
	Item / Position	Panels beneath windows	
	Material	Cement Product	
	Extent (approx.)	24 m <sup>2</sup>	
	Product Type	Composites (plastics, resins, mastics, roofing felts, vinyl floor tiles, paints, decorative finishes, cement etc.)	1
	Condition	Low damage - A few scratches or surface marks, broken edges on boards, tiles etc.	1
	Surface Treatment	Enclosed sprays and lagging, AIB with exposed face painted or encapsulated, asbestos cements sheets etc	1
	Asbestos Type	<b>Presumed 3</b>	3
	Material Assessment	<b>Low</b>	<b>6</b>
	Recommendation	Label & manage. Sample prior to conducting any work.	
Comments	Material should not be disturbed through actions such as sanding, cutting, drilling etc. without appropriate measures taken to suppress fibre release.
