EARTHQUAKE COMMISSION

Statement of Claim Checklist / Repair Strategy

Claim No: 2010 / 015789

Situation of Loss: 77a FRANKLEIGH ST.

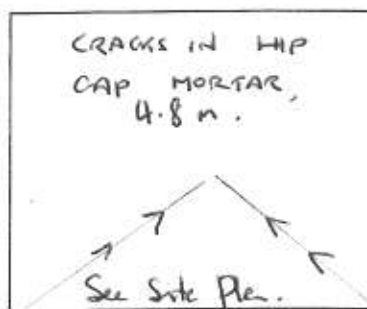
Item		Event Damage Y / N	
Roof		Y	CRACKING IN MORTAR TO HIP TILES (UPLIFT + REMORTAR (4.8m)
EXTERNAL WALLS	North	Y	STAIRCASE CRACKING IN MORTAR + BRICK (.300) (GRINDOUT + REPOINT)
	South	Y	STAIRCASE CRACKING IN MORTAR + BRICK (1.5m) (GRINDOUT + REPOINT).
	East	Y	STAIRCASE CRACKING IN MORTAR + BRICK (1.4m) (GRINDOUT + REPOINT). 1x LOOSE BRICK (REMOVE CLEAN + RELAY).
	West	Y	STAIRCASE CRACKING IN MORTAR + BRICK (.800) GRINDOUT + REPOINT).
Decks		N.	
CHIMNEY	Base	NA	
	Ceiling Cavity	NA	
	Above Roof	NA	
	Fireplace	NA.
