PROJECT: Clip n Climb EQ Strengthening and Extension  
FILE No: 16175CC  
DATE: 04 November 2016  
SHEET: 1 of 1

## Proposed EQ Strengthening and Office Extension 80 Byron St Fire Strategy Report

**Issue B: Consent**  
**November 2016**  
**Reference: 16175CC**

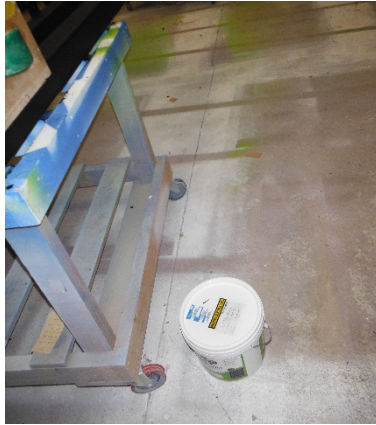
| Damaged Item | Location | Example | Recommended Repair |
|---|---|---|---|
| 1.1. Cracking and spreading at slab construction joints | South section of eastern structure | | Chase channels each side of crack and install dowels across crack to prevent future lateral spreading of slab. |

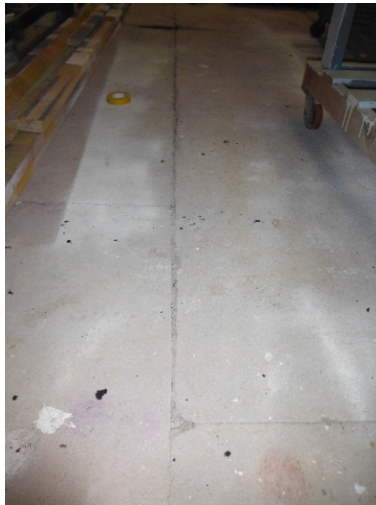
| Damaged Item | Location | Example | Recommended Repair |
|---|---|---|---|
| 1.2. Differential settlement of slab | South section of eastern structure | | Remove section of slab that has lifted. Re-level ground. Install new slab with epoxy dowels into adjacent slab sections. |

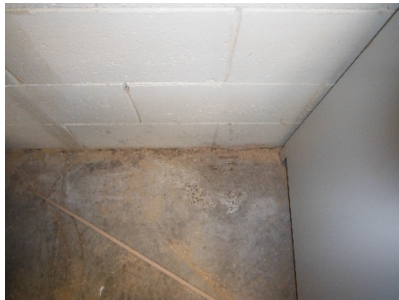
| Damaged Item | Location | Example | Recommended Repair |
|---|---|---|---|
| 1.3. Differential settlement of slab | Southern wall at internal wall junction with slab in eastern structure. | | Remove section of slab that has lifted. Re-level ground. Install new slab with epoxy dowels into adjacent slab sections. |

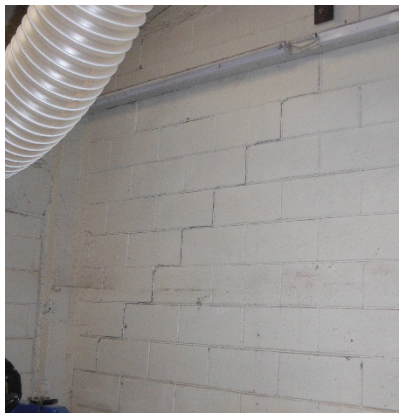
| Damaged Item | Location | Example | Recommended Repair |
|---|---|---|---|
| 2.1. Diagonal cracking along mortar joints in concrete block infill walls | Occurs along the west, south, and east walls of the original factory building (west structure) | | Repair and repoint all mortar joint cracks from both the inside and outer faces. |

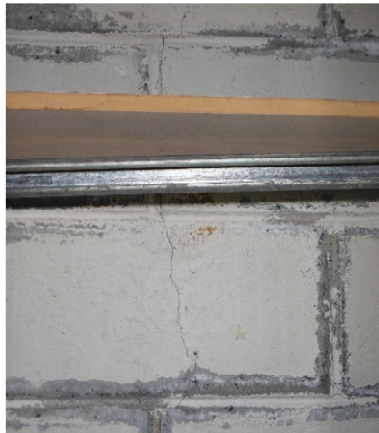
| Damaged Item | Location | Example | Recommended Repair |
|---|---|---|---|
| 2.2. Vertical cracking in concrete block work wall | Occurs in north section of west wall | | Remove and replace cracked concrete blocks. Repair and repoint cracked mortar joints. |

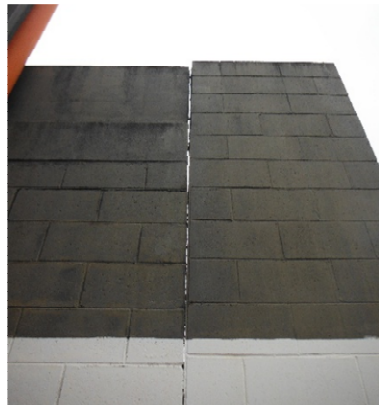
| Damaged Item | Location | Example | Recommended Repair |
|---|---|---|---|
| 2.3. External concrete block wing wall extension has moved creating a gap in the upper portion | External concrete wing wall at northwest corner of building | | Remove wing-wall extension or strengthen for face loads. Provide temporary propping while the fire requirements are confirmed and the solution for the wall is determined. |

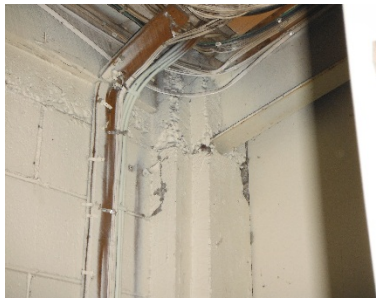
| Damaged Item | Location | Example | Recommended Repair |
|---|---|---|---|
| 3.1. Cracking and spalling of concrete column to steel beam connection | Top of west portal frame column at west boundary wall | | Remove concrete and observe beam to column connection to ensure no signs of distress. If no signs of distress, repair concrete encasement of column per repair specification. |

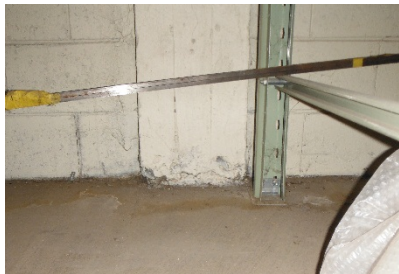
| Damaged Item | Location | Example | Recommended Repair |
|---|---|---|---|
| 3.2. Cracking and spalling of concrete column at slab level | Occurs at several locations in the western structure | | Remove concrete and observe column at base to ensure no signs of distress. If no signs of distress, repair concrete encasement of column per repair specification. |

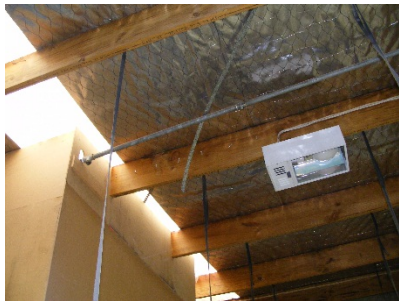
| Damaged Item | Location | Example | Recommended Repair |
|---|---|---|---|
| 4.1. Broken roof tension strap | Eastern structure | | Replace broken strapping. Refer to Section 5.2. |

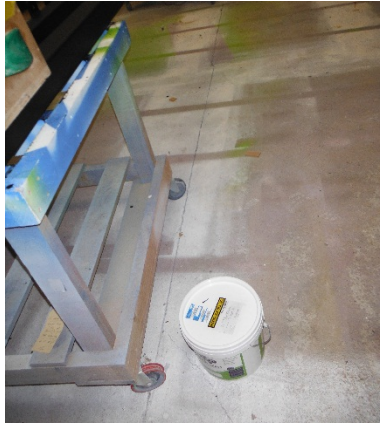
| Damaged Item | Location | Example | Recommended Repair |
|---|---|---|---|
| 1.1. Cracking and spreading at slab construction joints | South section of eastern structure<br><br>See damage map photo 1. | | Chase channels each side of crack and install dowels across crack to prevent future lateral spreading of slab. |

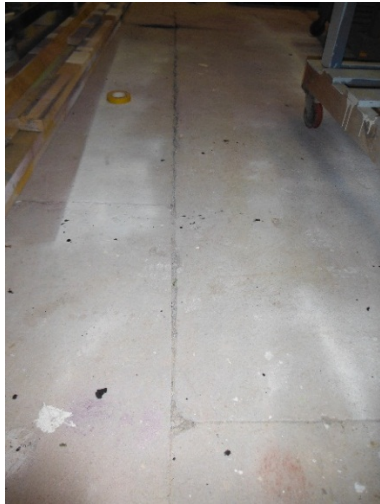
| Damaged Item | Location | Example | Recommended Repair |
|---|---|---|---|
| 1.2. Differential settlement of slab | South section of eastern structure<br><br>See damage map photo 2. | | Remove section of slab that has lifted. Re-level ground. Install new slab with epoxy dowels into adjacent slab sections. |

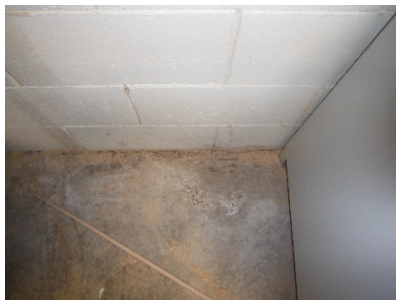
| Damaged Item | Location | Example | Recommended Repair |
|---|---|---|---|
| 1.3. Differential settlement of slab | Southern wall at internal wall junction with slab in eastern structure.<br><br>See damage map photo 3. | | Remove section of slab that has lifted. Re-level ground. Install new slab with epoxy dowels into adjacent slab sections. |

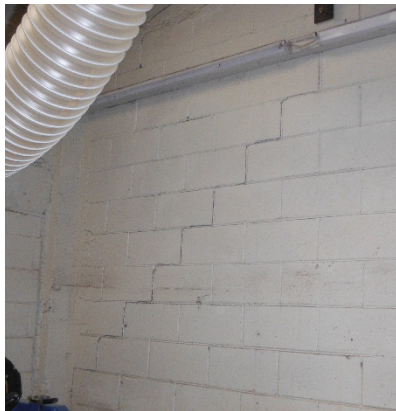
| Damaged Item | Location | Example | Recommended Repair |
|---|---|---|---|
| 2.1. Diagonal cracking along mortar joints in concrete block infill walls | Occurs along the west, south, and east walls of the original factory building (west structure)<br><br>See damage map photo 4. | | Repair and repoint all mortar joint cracks from both the inside and outer faces. |

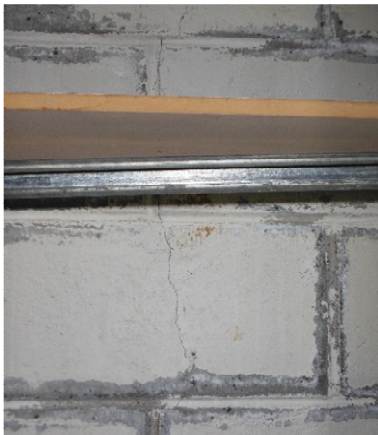
| Damaged Item | Location | Example | Recommended Repair |
|---|---|---|---|
| 2.2. Vertical cracking in concrete block work wall | Occurs in north section of west wall<br><br>See damage map photo 5. | | Remove and replace cracked concrete blocks. Repair and repoint cracked mortar joints. |

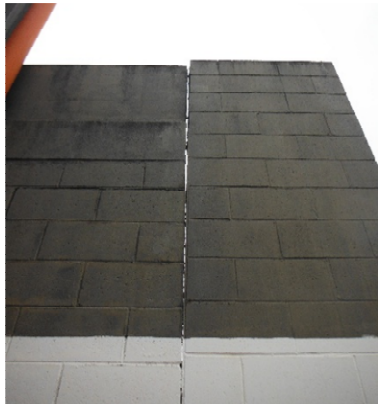
| Damaged Item | Location | Example | Recommended Repair |
|---|---|---|---|
| 2.3. External concrete block wing wall extension has moved creating a gap in the upper portion | External concrete wing wall at northwest corner of building<br><br>See damage map photo 6. | | Remove wing-wall extension or strengthen for face loads. Provide temporary propping while the fire requirements are confirmed and the solution for the wall is determined. |

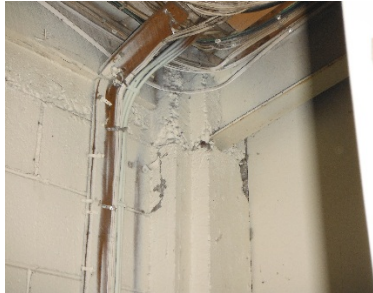
| Damaged Item | Location | Example | Recommended Repair |
|---|---|---|---|
| 3.1. Cracking and spalling of concrete column to steel beam connection | Top of west portal frame column at west boundary wall<br><br>See damage map photo 7. | | Remove concrete and observe beam to column connection to ensure no signs of distress. If no signs of distress, repair concrete encasement of column per repair specification. |

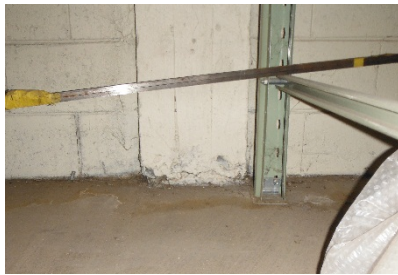
| Damaged Item | Location | Example | Recommended Repair |
|---|---|---|---|
| 3.2. Cracking and spalling of concrete column at slab level | Occurs at several locations in the western structure<br><br>See damage map photo 8. | | Remove concrete and observe column at base to ensure no signs of distress. If no signs of distress, repair concrete encasement of column per repair specification. |

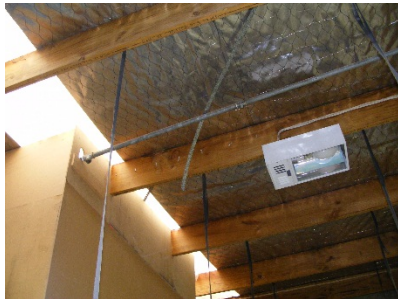
| Damaged Item | Location | Example | Recommended Repair |
|---|---|---|---|
| 4.1. Broken roof tension strap | Eastern structure<br><br>See damage map photo 9. | | Replace broken strapping. |
