433 PUKEHINA PARADE EASTERN

Land Information Memorandum

Repair No. 1 – Laundry bulkhead

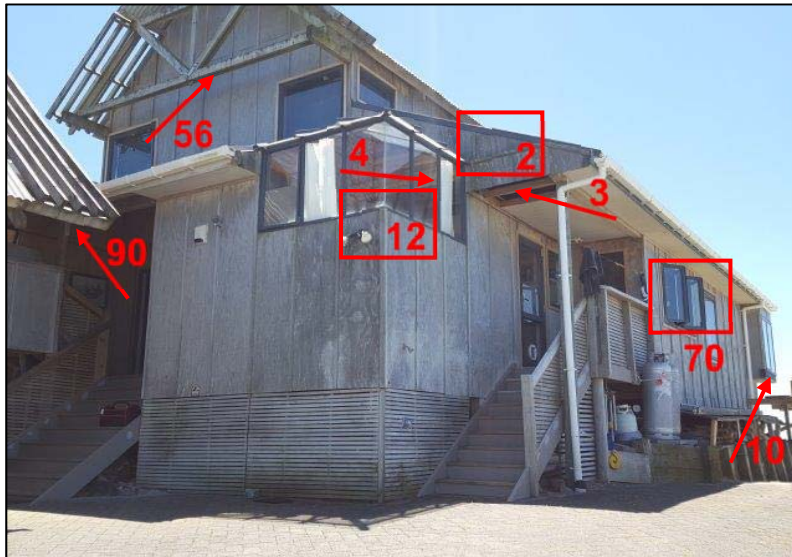
Photo 1: South aspect. Refer laundry bulkhead investigation in following photos, location indicated

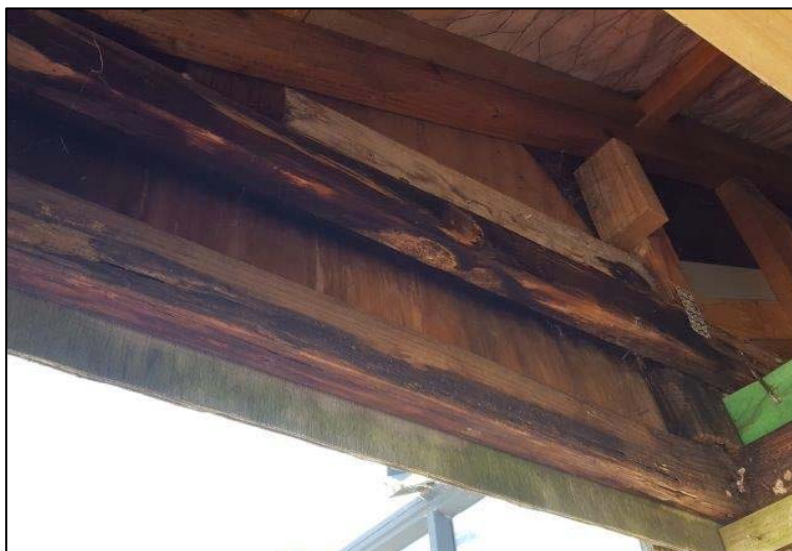
Photo 3: Damaged bulkhead framing. Refer to Dodd report investigation photos 9-13 and Dodd drawings for planned remediation (Repair No. 1)

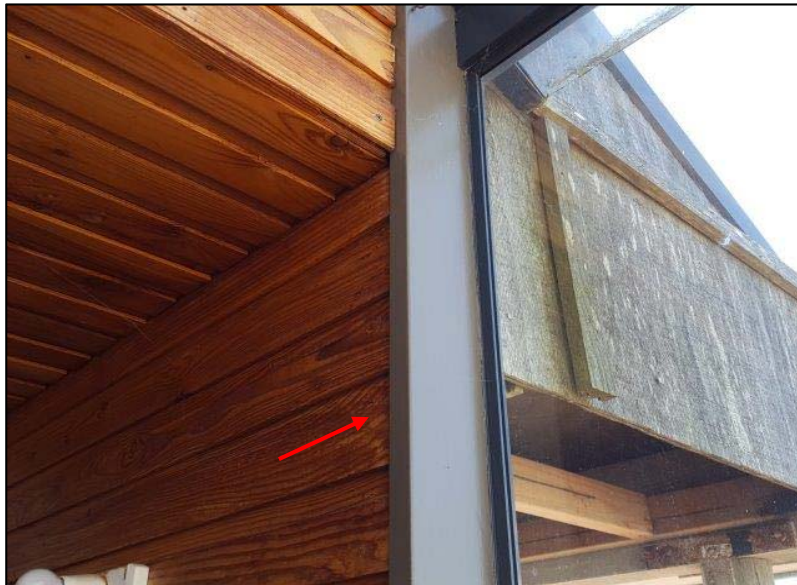
Photo 4: View of bulkhead from bathroom interior. No indication of any moisture penetration to the interior walls below the bulkhead was noted. Cladding below the bulkhead will need to be removed to check for any wall damage below

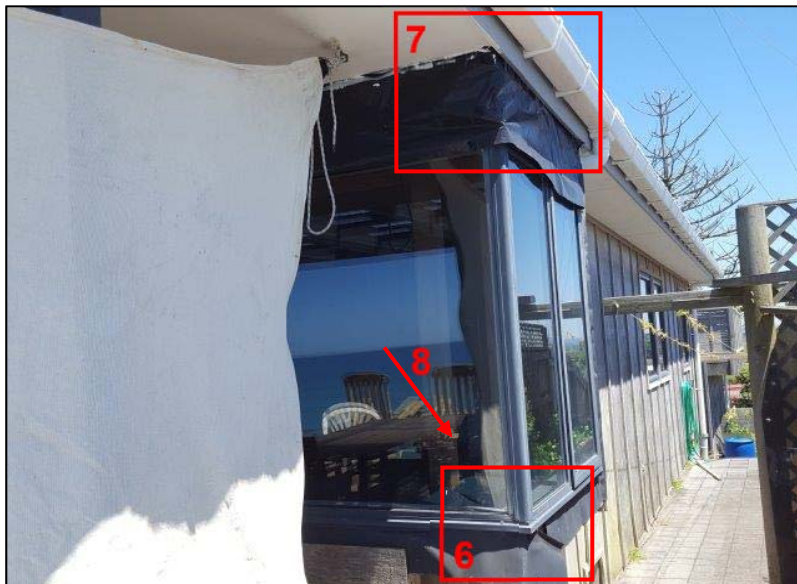
Photo 5: North boxed window (cladding removed by others). Locations of following photos indicated

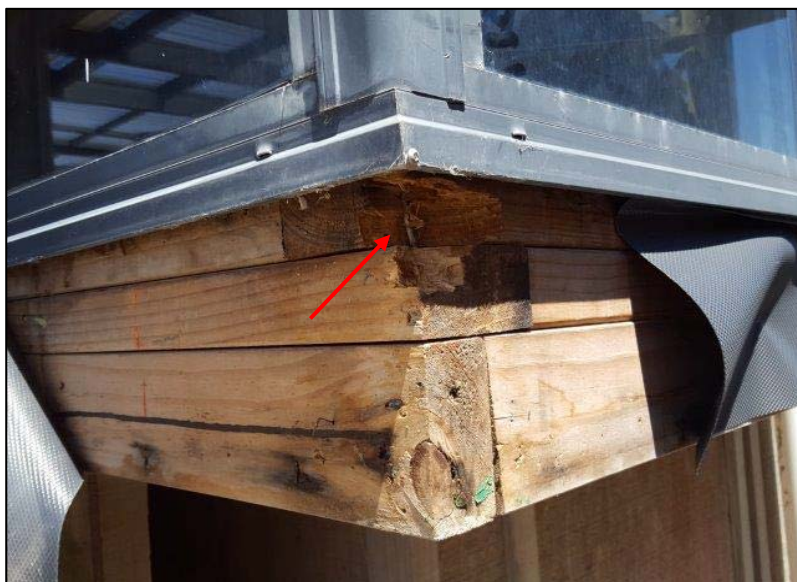
Photo 6: Visibly decayed timber framing below north boxed window (cladding removed by others). Cause of failure may be related to lack of external corner moulds (refer photos 14, 18 & 20). Photographs on page 90 of the Dodd cladding weathertightness report dated 17/12/15 indicated that the timber cover battens (assumed in this location) were in poor condition. Refer to Dodd drawings for planned remediation (Repair No. 2)

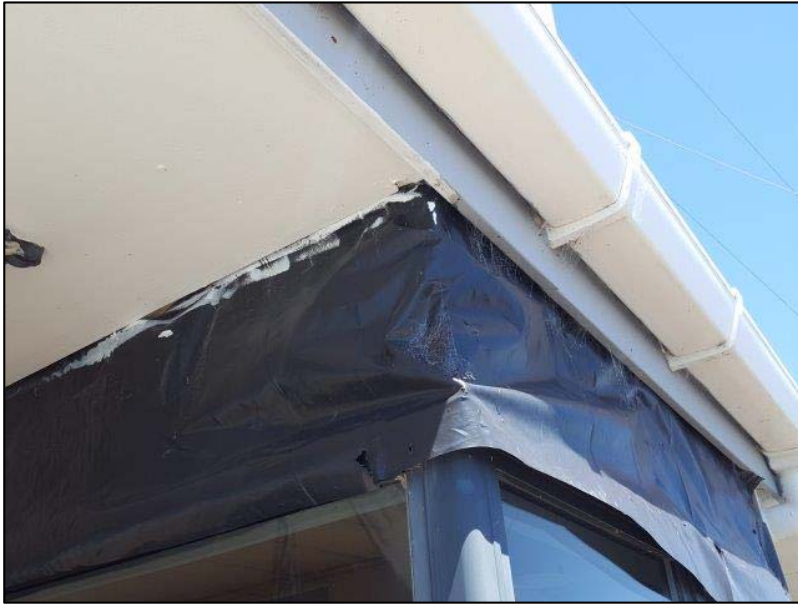
Photo 7: Cladding removed above north boxed window (by others). Refer to Dodd drawings for planned remediation (Repair No. 2)

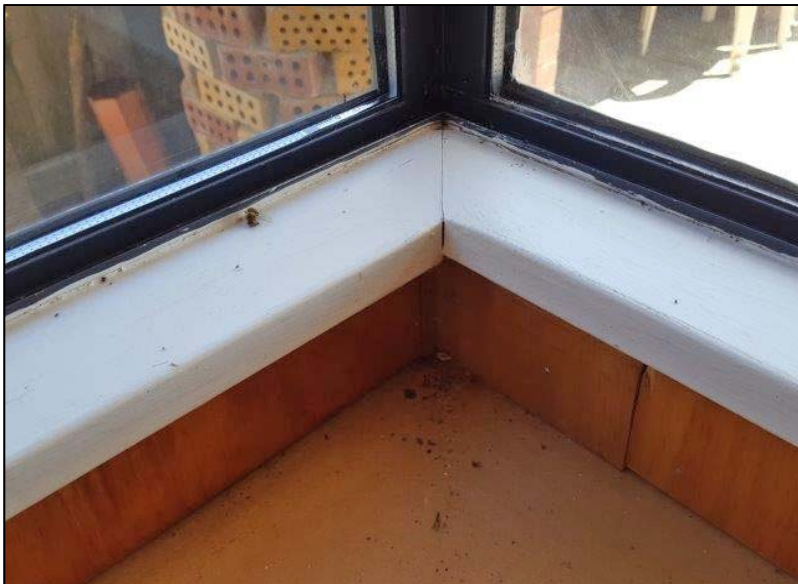
Photo 8: Interior view of seat below window junction. No indication of any moisture penetration to the interior

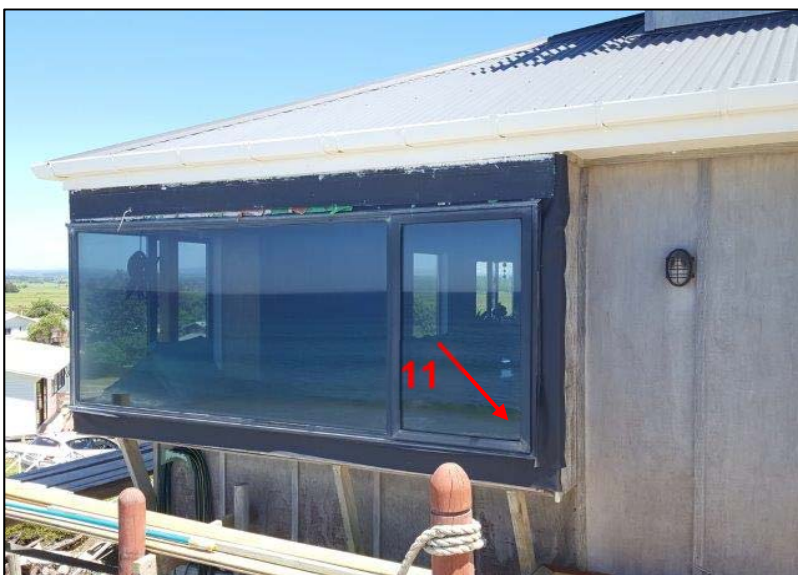
Photo 9: East boxed window (NE elevation, cladding removed by others). Refer to Dodd drawings for planned remediation (Repair No. 2)

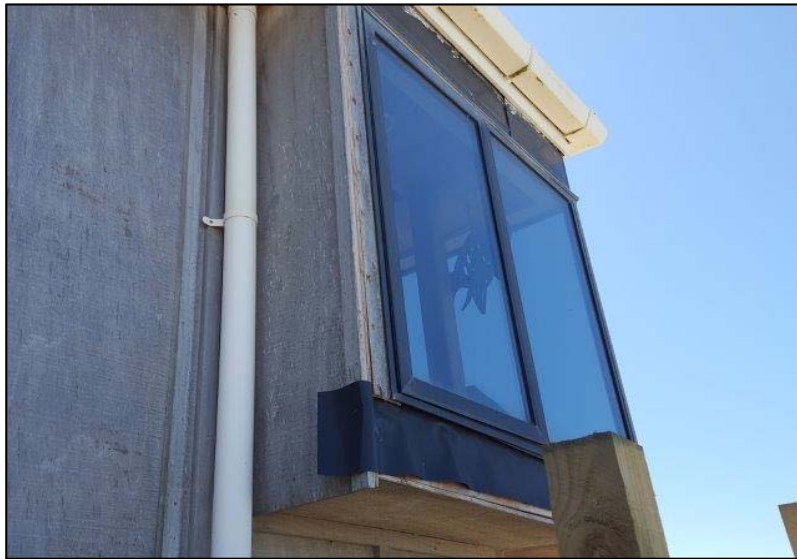
Photo 10: East boxed window (SE elevation, cladding removed by others). Refer to Dodd drawings for planned remediation (Repair No. 2)

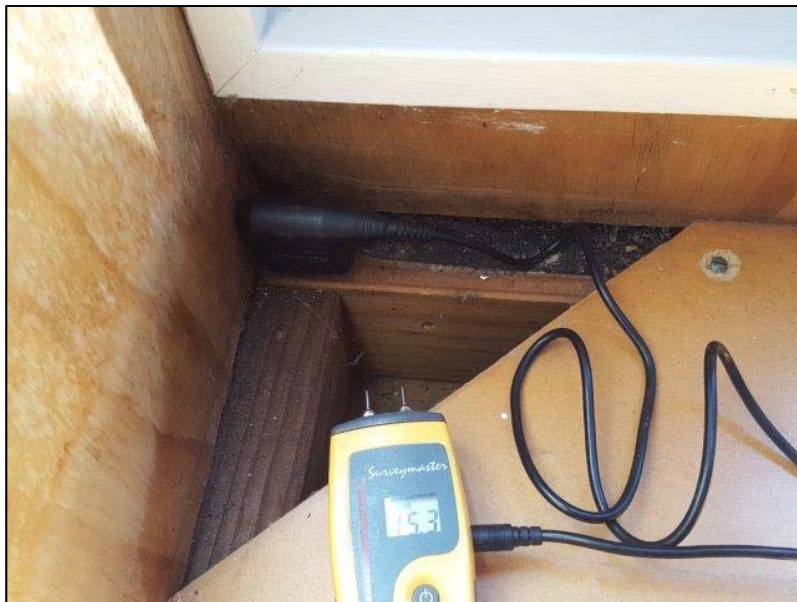
Photo 11: Interior view of seat below end of window, NE elevation. Corner of window seat has been cut out by others. Timber is waterstained, MC 15% currently normal moisture reading taken

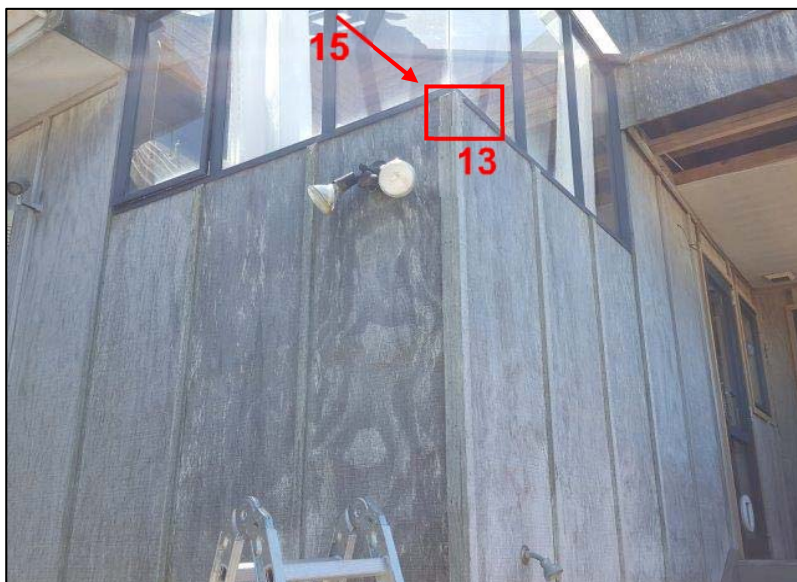
Photo 12: Bathroom at south corner of house. External corner cladding is at similar risk to boxed windows on NE elevation. Refer to photo 1 for location

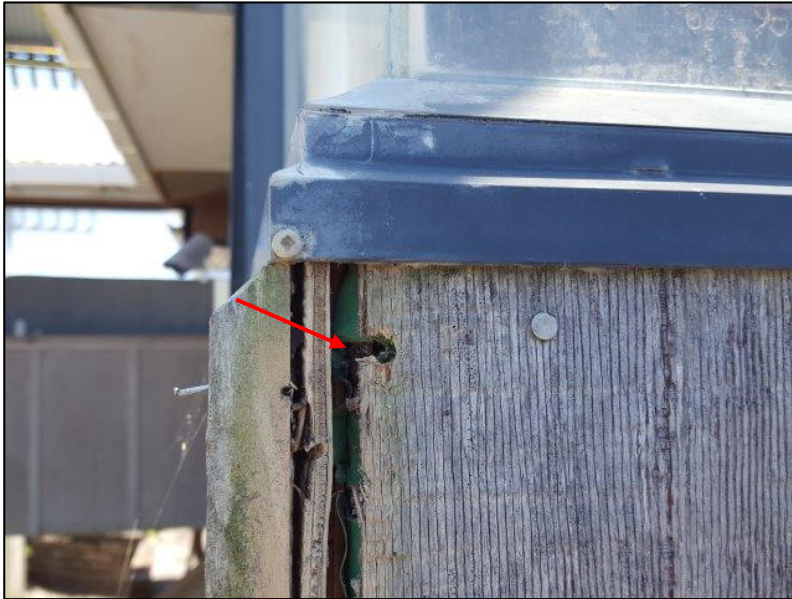
Photo 13: Bathroom external corner. The cover batten was loose and there are gaps in the building paper (indicated). The gap between the cladding sheets is larger than the 2-3mm expansion gap required by the manufacturer. No corrosion issues were noted with the cladding fixings. Refer next photo

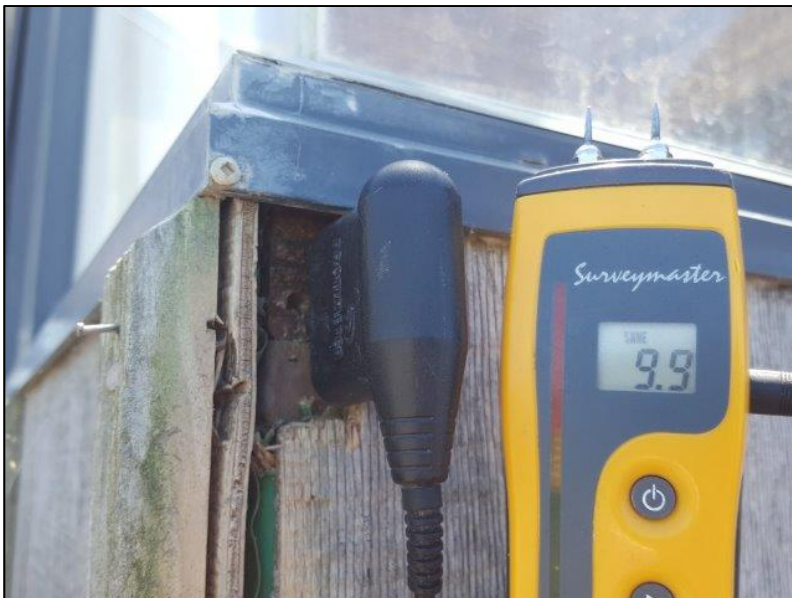
Photo 14: Cladding cutout at external corner. No galvanised steel flashing was installed over the building wrap (recommended by BRANZ). Framing was dark and ants were present (indicating nearby moisture source), MC 9% normal moisture reading taken. Refer next photo for interior view

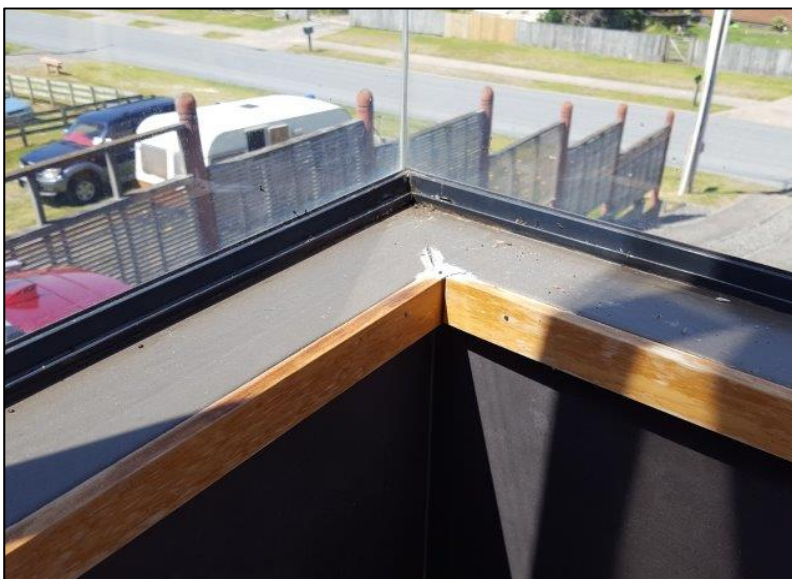
Photo 15: Bathroom window sill at south corner. No indication noted of any external moisture penetration

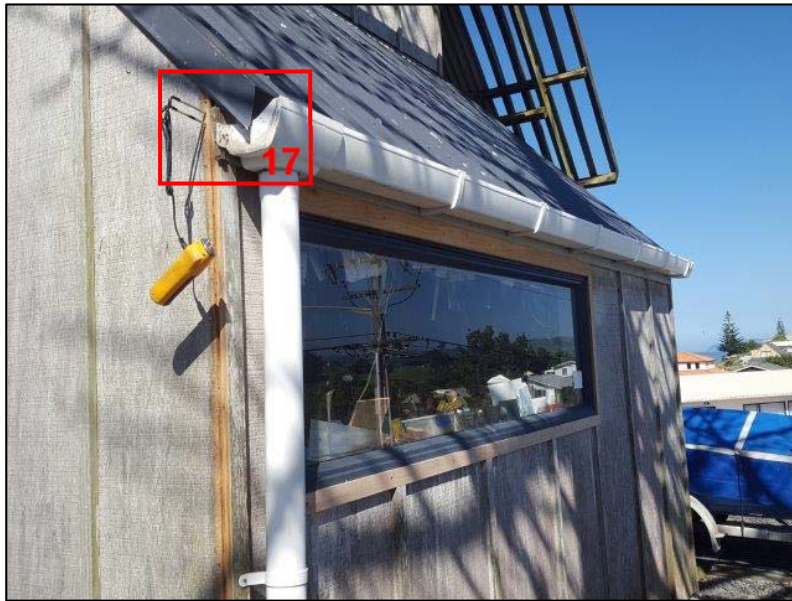
Photo 16: External corner junction with cover batten removed at top plate, west corner of workshop. Refer following photos

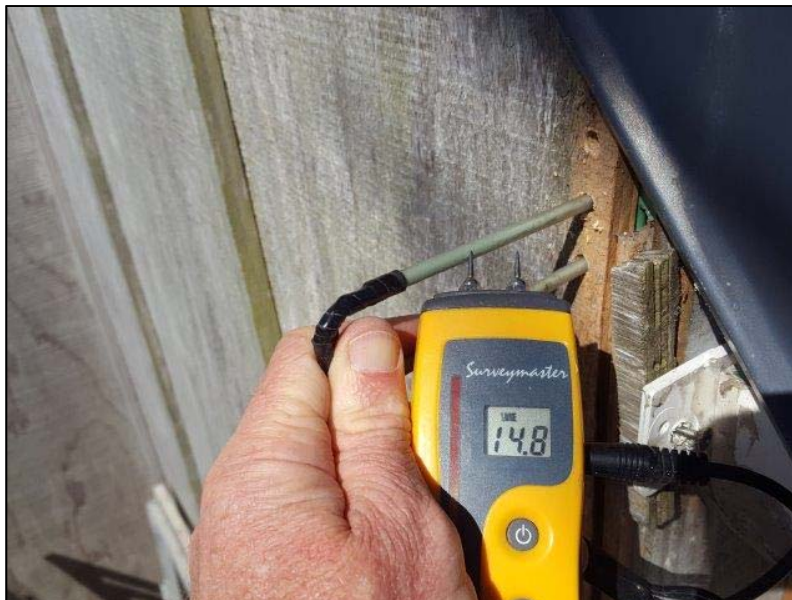
Photo 17: MC 14% normal moisture reading taken in framing at workshop external corner. Refer next photo

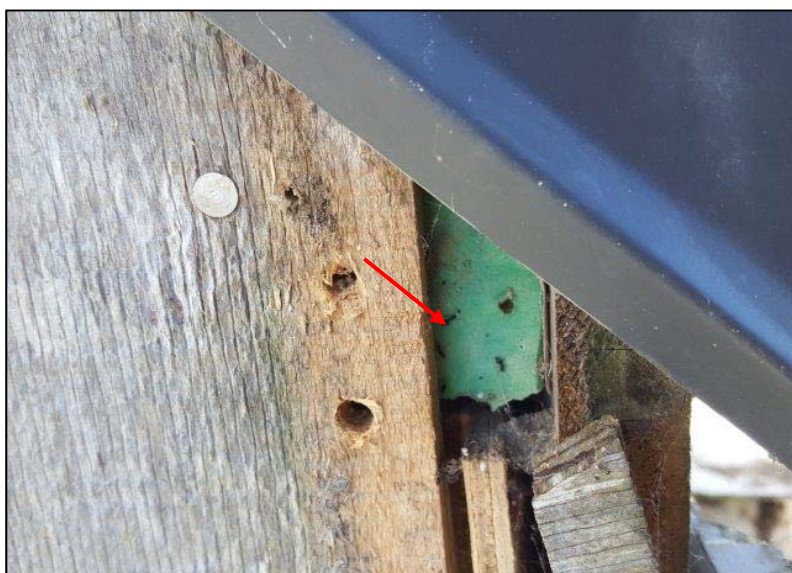
Photo 18: Lots of ants present at workshop external corner. No galvanised steel flashing was installed. Refer following photos for investigation at bottom plate level

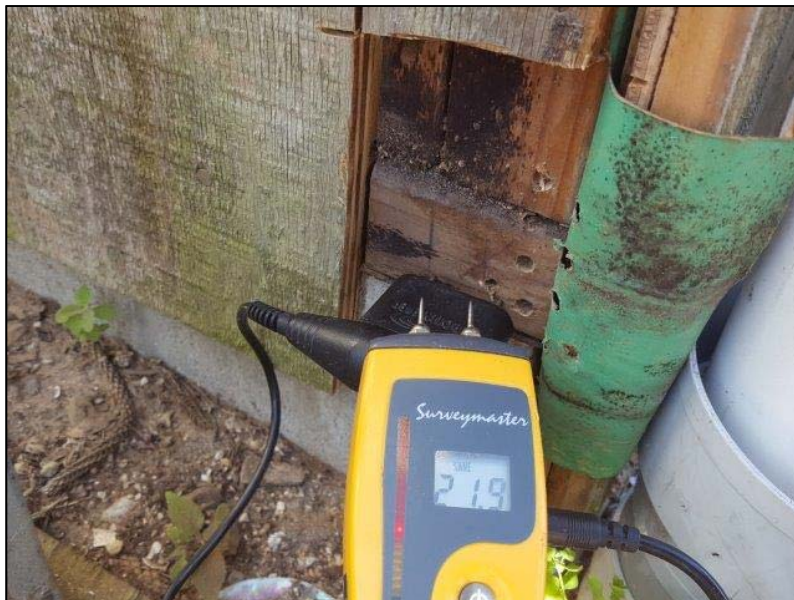
Photo 20: MC 21% elevated moisture reading at workshop external corner. Bottom plate is dark. No galvanised steel flashing was installed. Ground clearance is approximately 130mm from floor slab to unfinished ground level (225mm required to meet Acceptable Solution). Refer Dodd drawings (Minor Alterations 2)

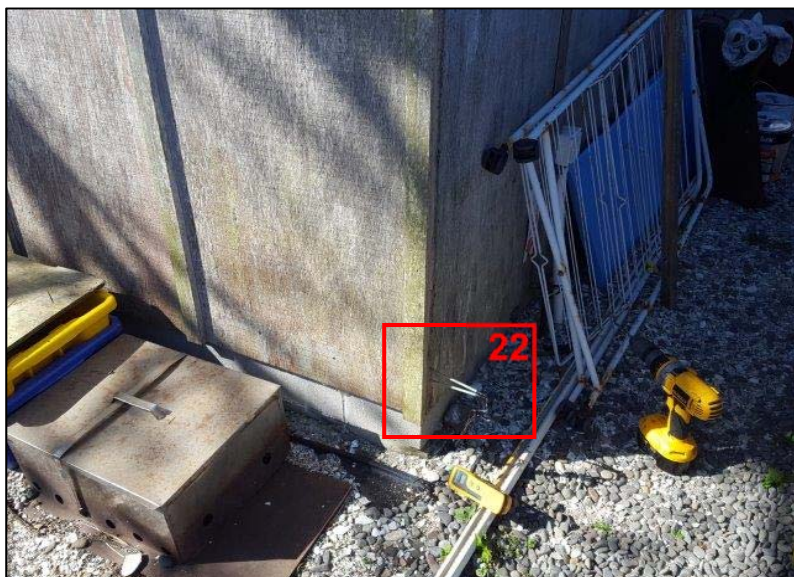
Photo 21: South corner workshop with cover batten removed. Refer next photo

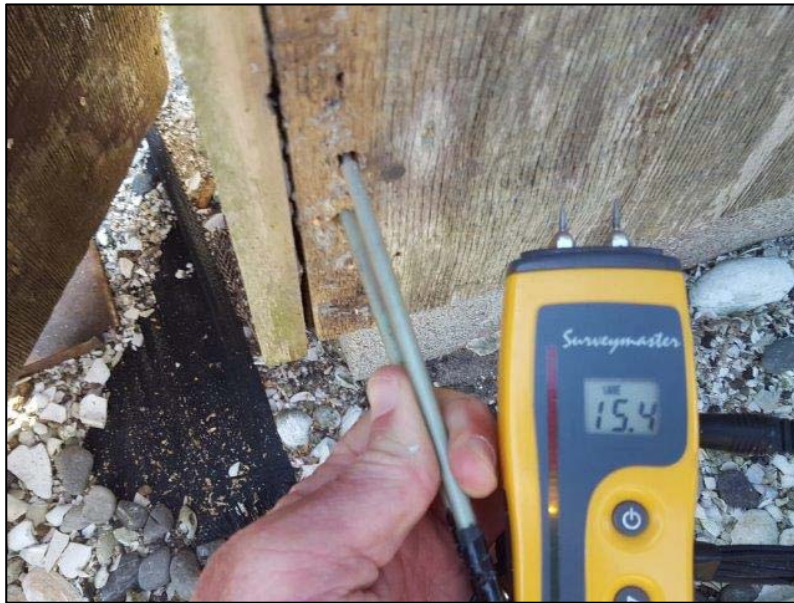
Photo 22: MC 15% normal moisture reading taken at workshop south corner. Ground clearance is approximately 200mm from floor slab to unfinished ground level (225mm required to meet Acceptable Solution). Refer Dodd drawings (Minor Alterations 2)

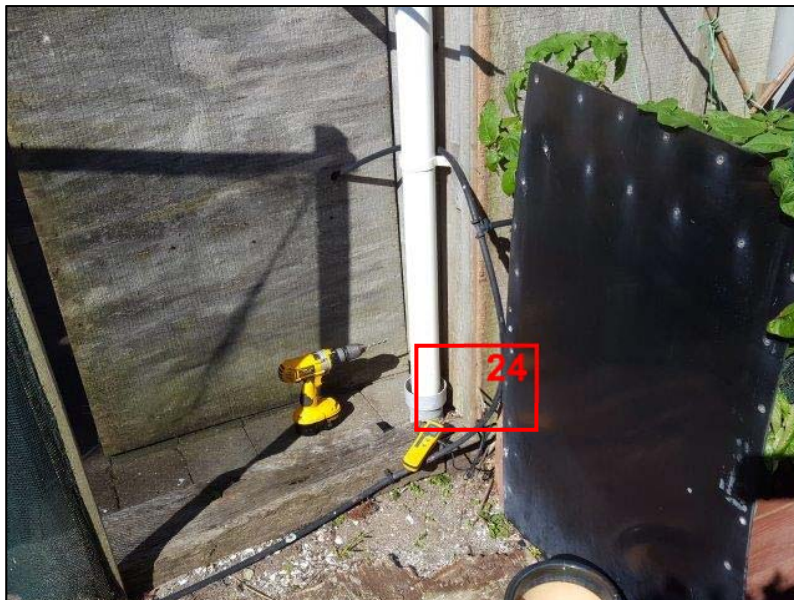
Photo 23: West corner of garage with cover batten removed. Refer next photo

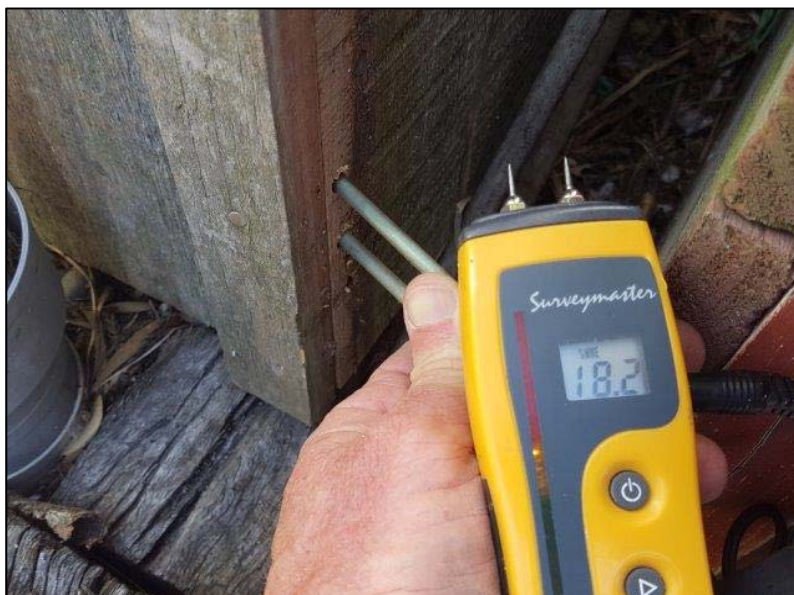
Photo 24: MC 18% slightly elevated moisture reading at west corner of garage. Ground clearance is less than 225mm required to meet Acceptable Solution. Refer Dodd drawings (Minor Alterations 2)

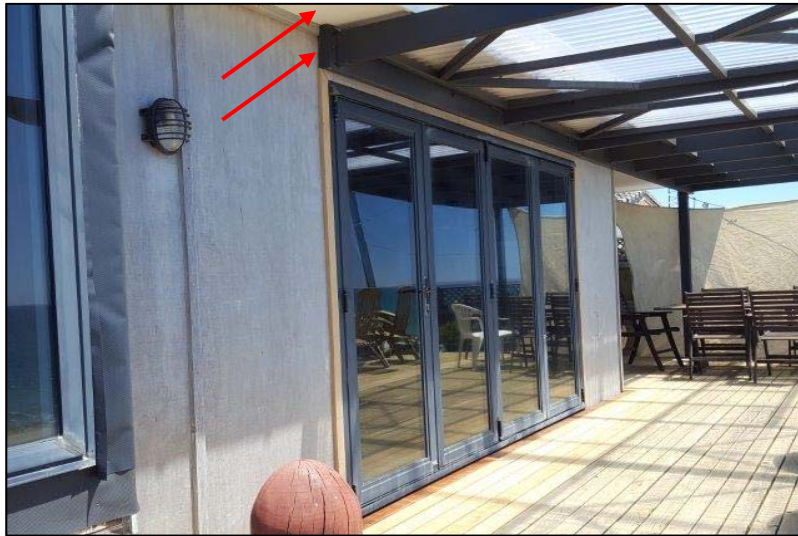
Photo 25: Pergola on NE elevation has been spaced off cladding as per Dodd drawings (Minor Alterations 1). 550mm eaves protection (including gutter) is provided on the NE elevation (except where reduced by the boxed window projections)

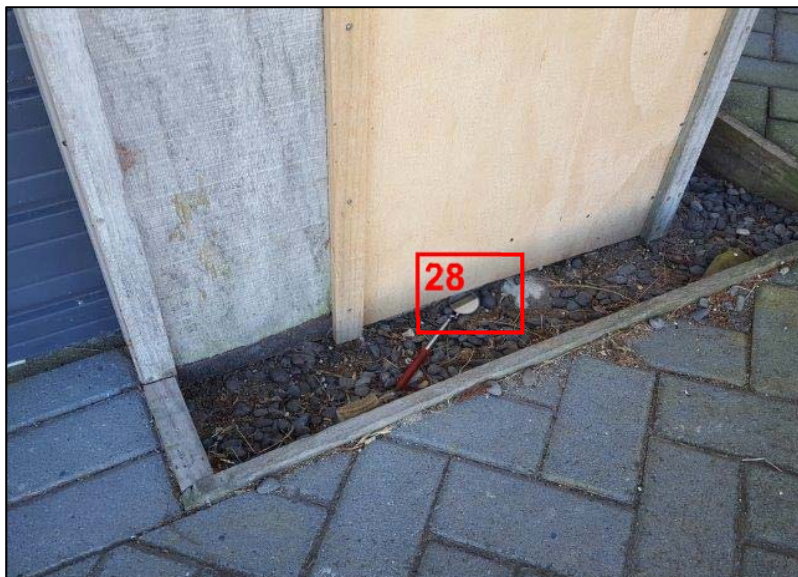
Photo 27: Plywood cladding has been replaced on SE garage elevation. Refer Dodd drawings (Minor Alterations 2). Ground clearances don't comply with drawings or meet Acceptable Solution. Refer Appendix C for photograph of bottom plate framing taken by builder. It appears the condition of the timber wasn't independently verified by the building surveyor

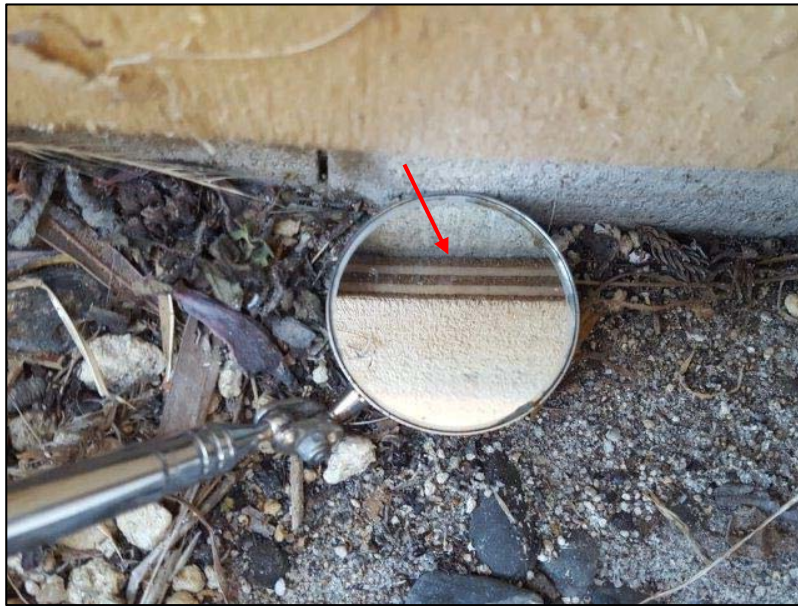
Photo 28: New cladding is fixed hard against garage slab. Dodd drawings specified existing framing to be straightened and packed out if required to provide 6mm clearance between cladding and concrete slab of garage. Note the cladding appears to be generally clear of the concrete slab elsewhere on the garage and workshop. Refer following photos

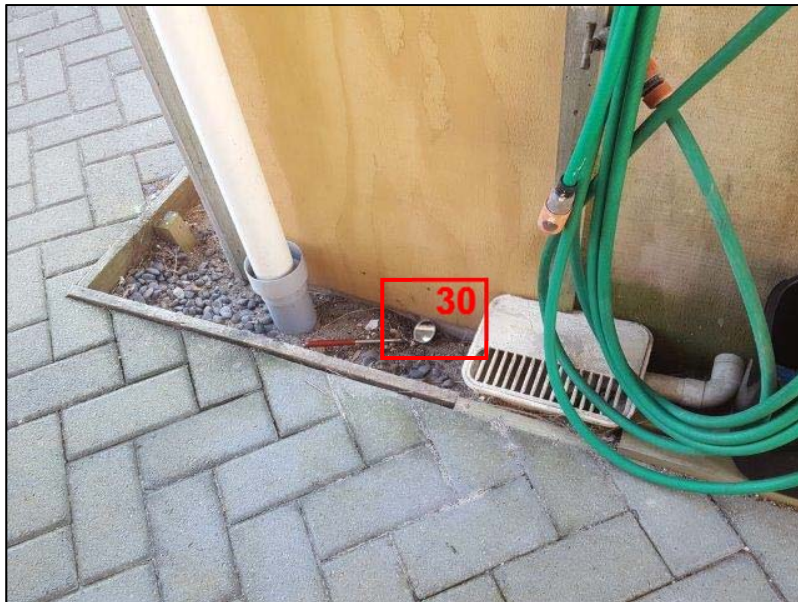
Photo 29: Plywood cladding has been replaced on NE garage elevation. Refer Dodd drawings (Minor Alterations 2). No independent verification provided of timber condition. Refer next photo

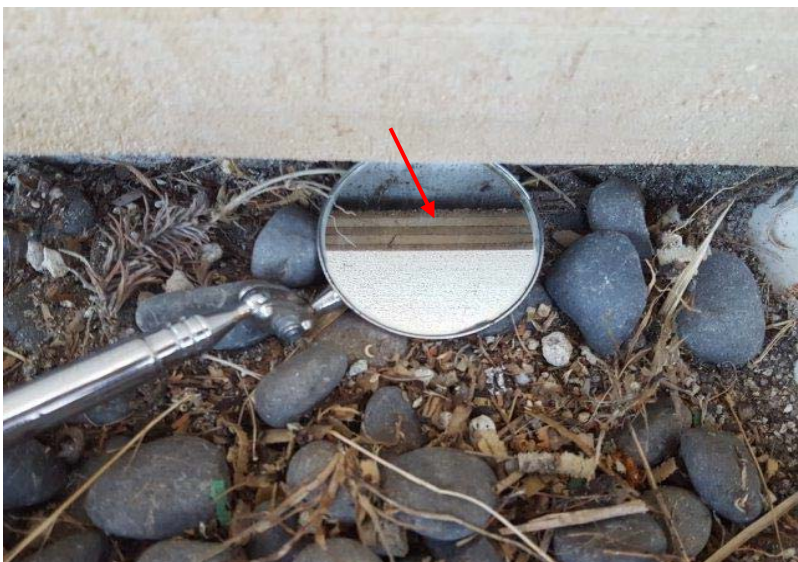
Photo 30: Adequate gap provided between cladding and concrete slab. Note ground clearances don't meet Acceptable Solution

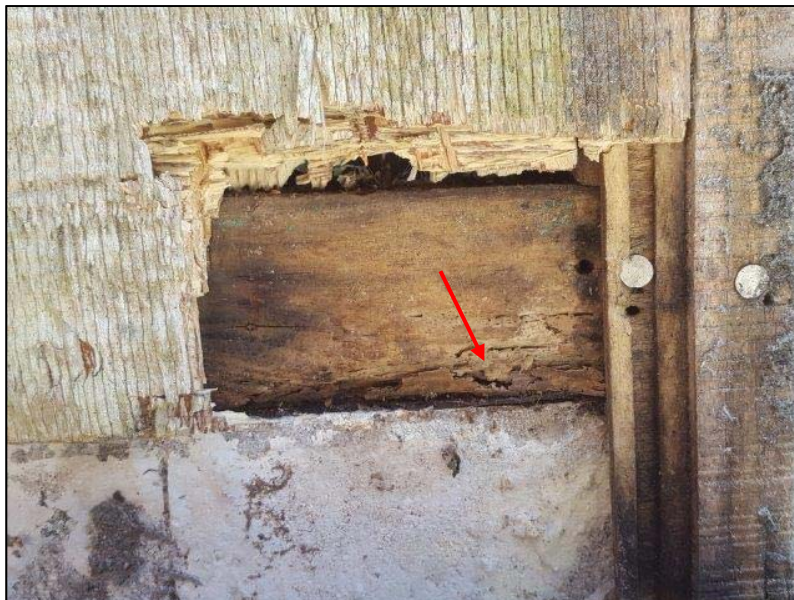
Photo 32: Visibly decayed bottom plate, garage NE elevation. Refer next photo

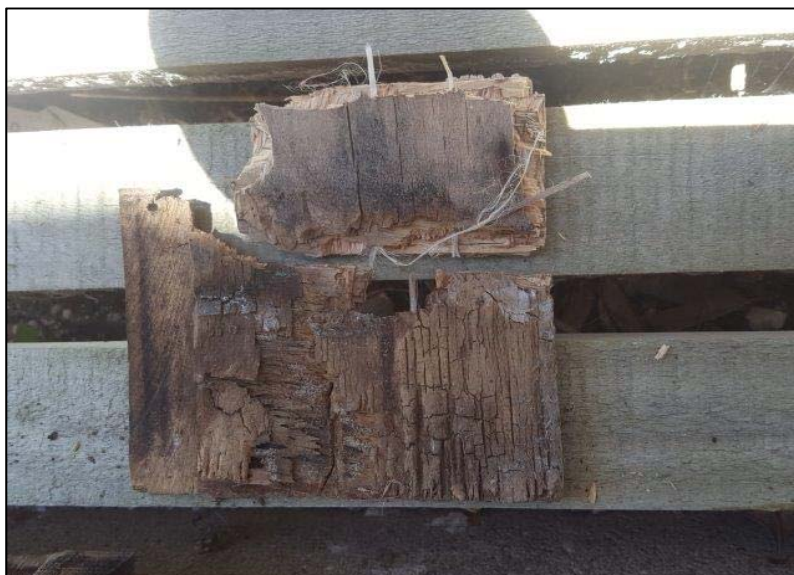
Photo 33: Visibly decayed cladding (rear face) from cutout. The Ecoply technical manual in 1999 stated that H3 treated plywood is not ground contact treated and must be kept at least 150mm away from ground contact

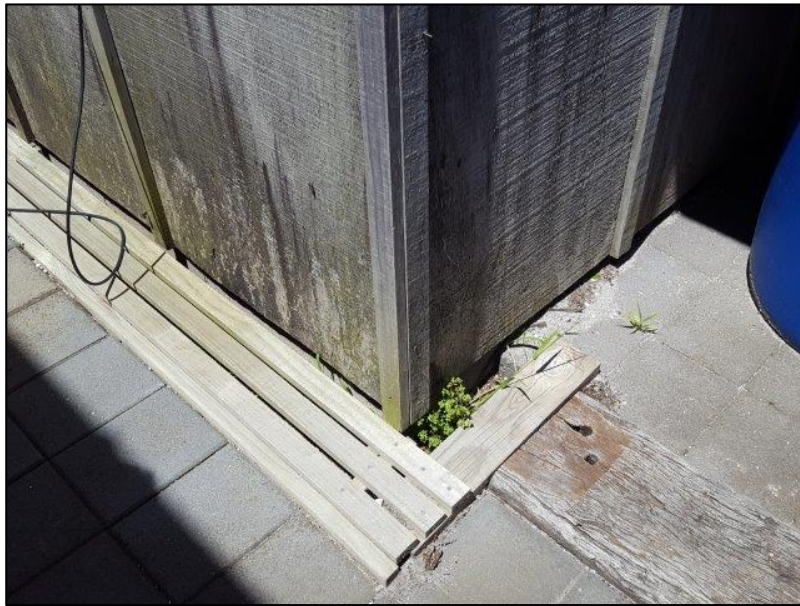
Photo 34: Minimal ground clearance at north corner of garage. Refer Dodd drawings for planned remediation (Minor Alterations 2).

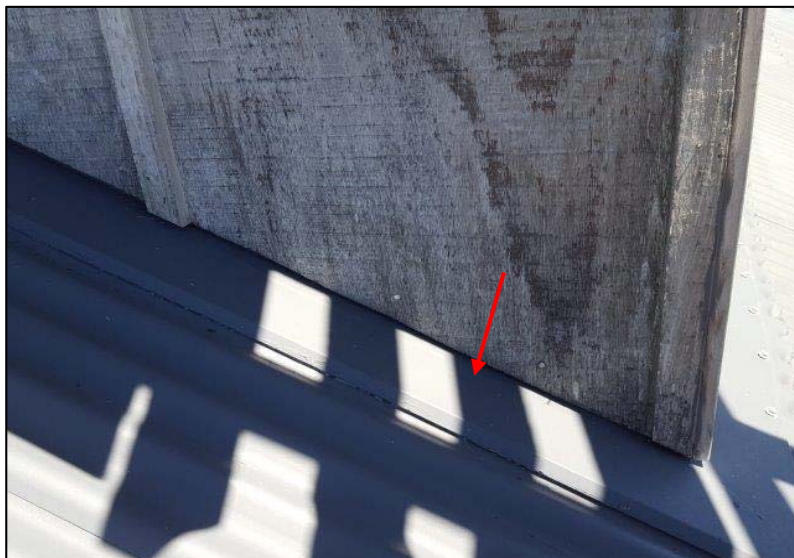
Photo 39: Minimal cladding clearance to apron flashing at upper east corner of house. Difficult to maintain bottom edge of cladding but unlikely to result in weathertightness failure within prescribed 15 year durability period

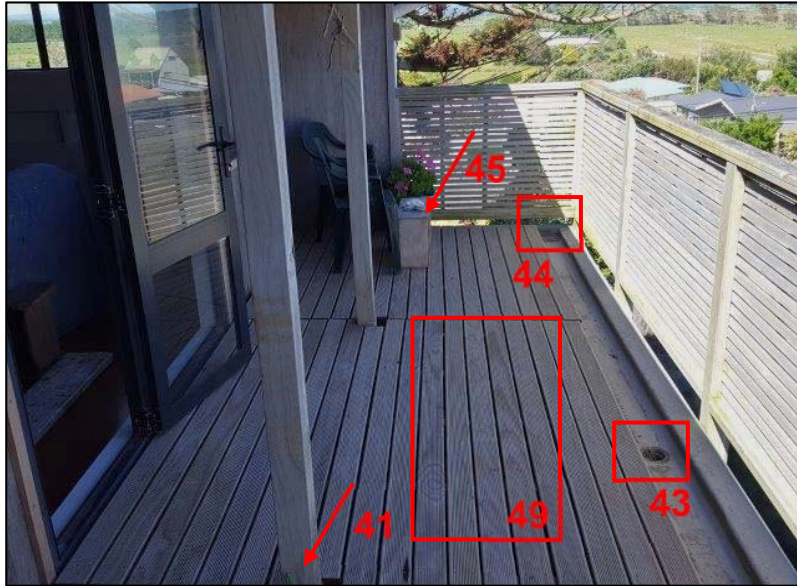
Photo 40: Deck on NW elevation of sleepout, west end. The open timber slatted balustrades are side fixed to the deck structure. Refer indicated photos below. Also refer upper wall photos 86-89

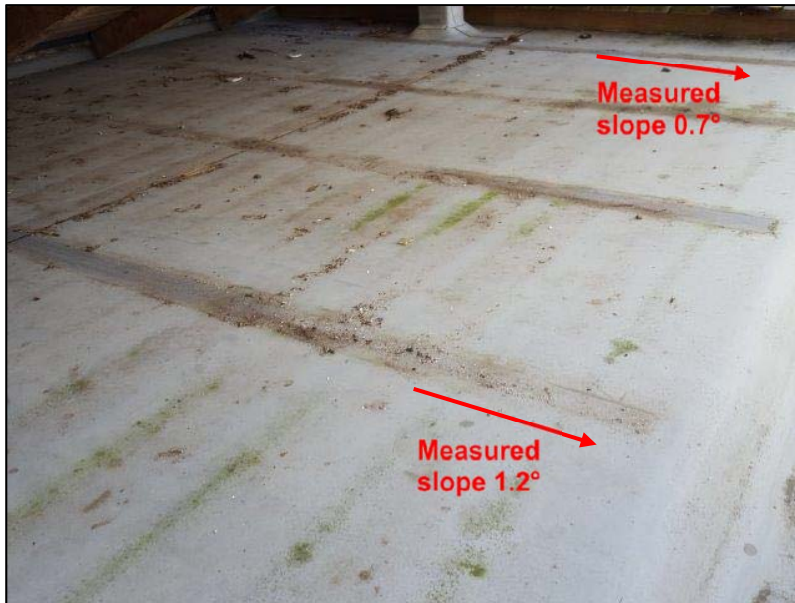
Photo 49: Butyl rubber deck cladding appears to be reasonably well detailed below central section of floating decking. Deck slope was minimal, measured at 1.2° and 0.7° in two locations. No evidence of failure was noted in the garage below and the butyl rubber membrane is protected by the decking

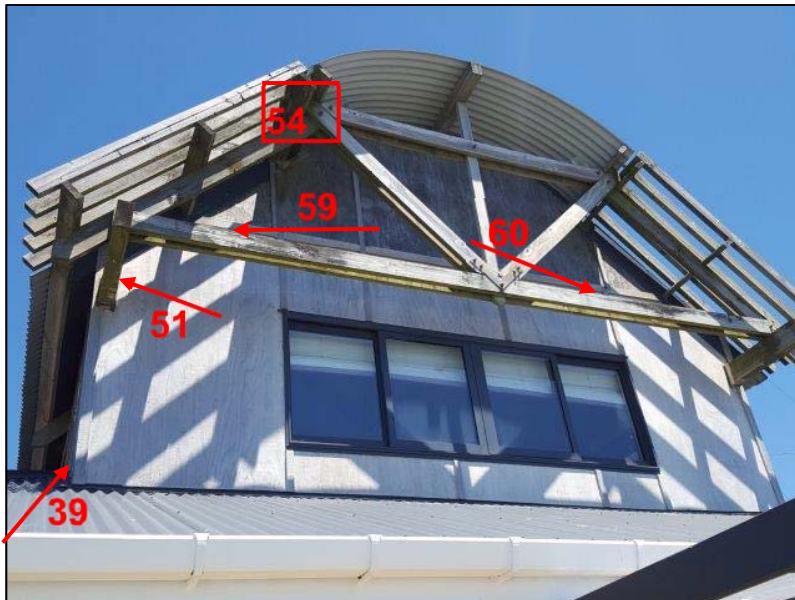
Photo 50: NE upper elevation facing the ocean. Refer indicated photos below

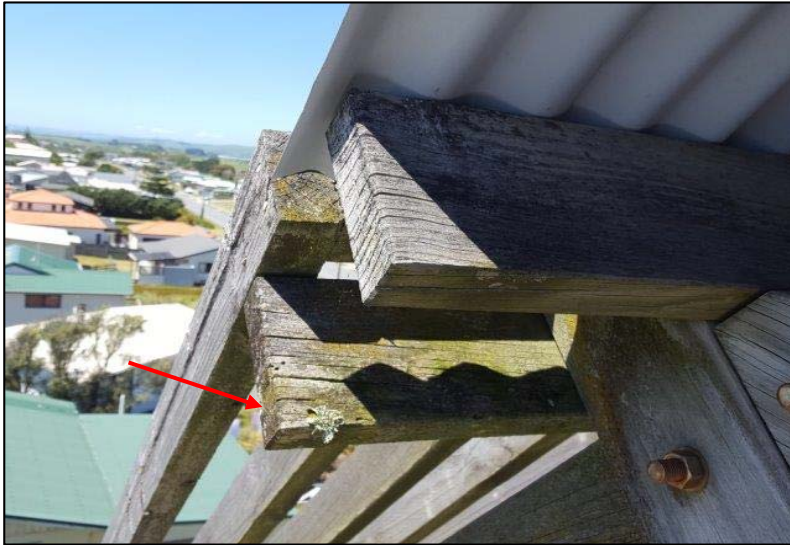
Photo 55: Exposed ends of beams are weathered and appear to have not been maintained. Builder mentioned that the pergola type beams may be replaced with roofing, which would provide improved weather protection to the cladding. Stainless steel bolts are in good condition (with minor staining only visible in photo)

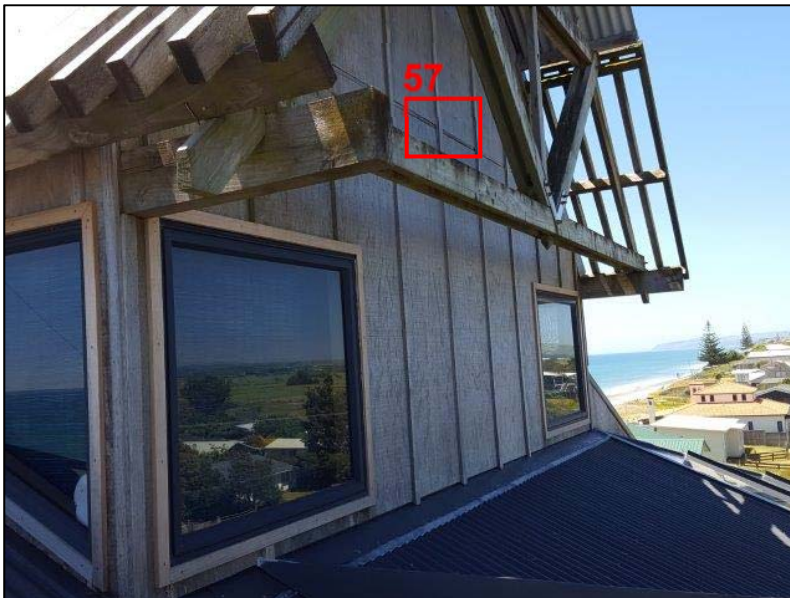
Photo 56: SW elevation at rear of house. Refer closeup photo below

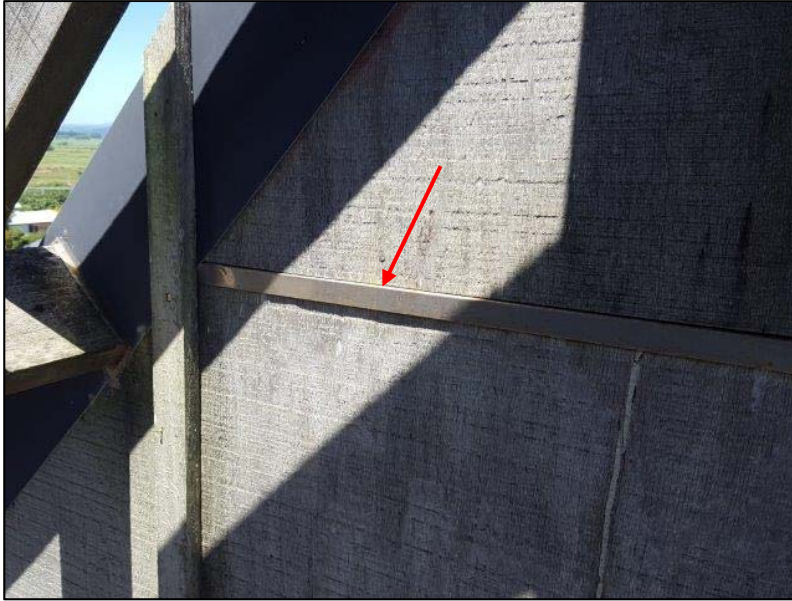
Photo 58: Plywood finished hard down on horizontal flashing. It is difficult to maintain the bottom edge of the cladding but unlikely to result in weathertightness failure (noting that the cladding has already performed for the prescribed 15 year durability period). There will however be an opportunity to correct the cladding detailing when plywood sheets are removed to install saddle flashings (refer Dodd drawings, Minor Alterations 5).

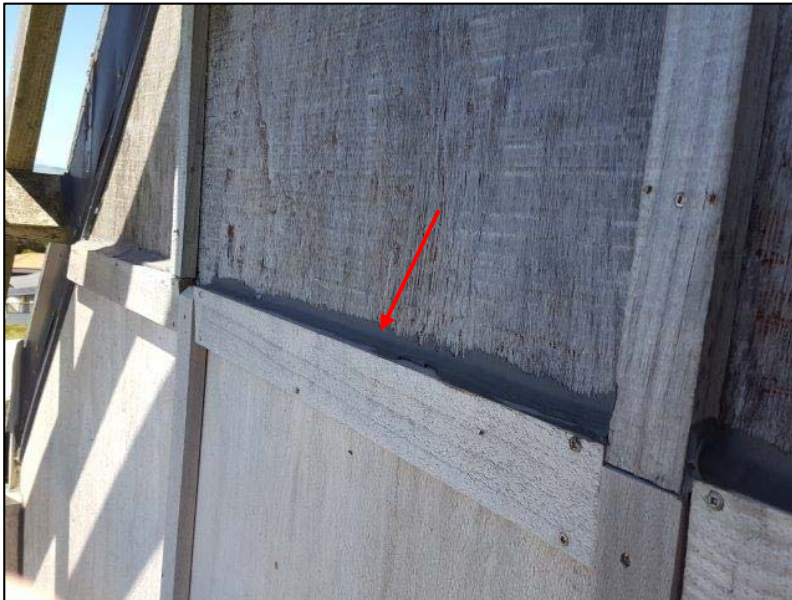
Photo 59: Horizontal flashing on NE beach elevation has been battened and partially sealed. It is unclear whether the sealant was added as a preventative measure or if the cladding was leaking. Also refer next photo and photo 50 for location

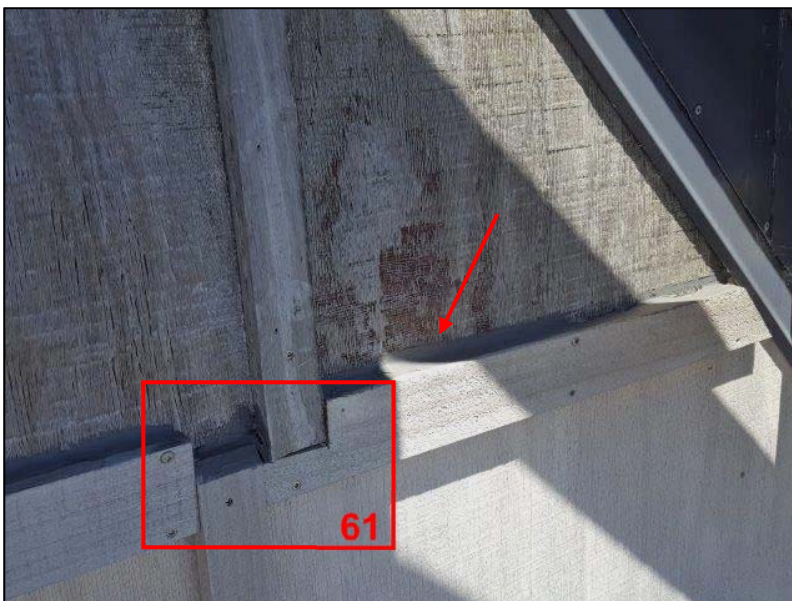
Photo 60: Horizontal flashing on NE beach elevation has been battened. Refer closeup in next photo and photo 50 for location

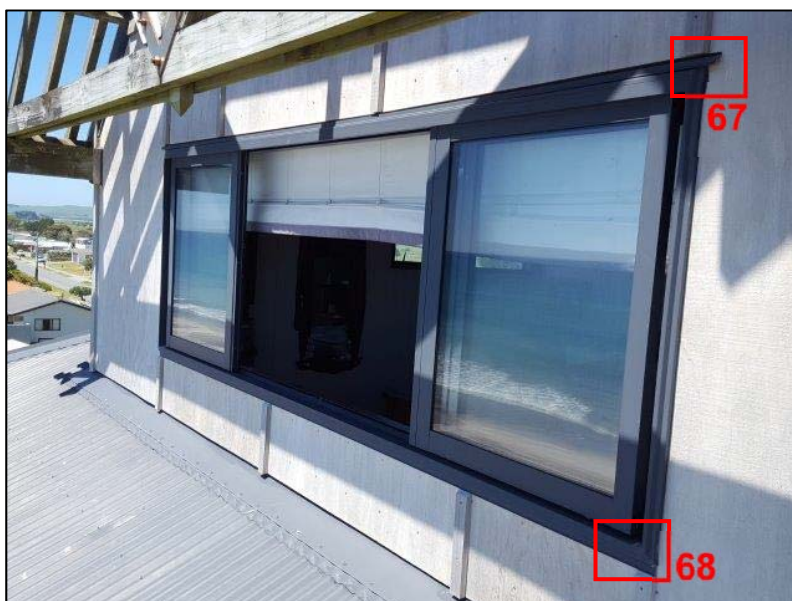
Photo 66: New window installed to master bedroom (not part of recent repairs). Refer indicated photos below

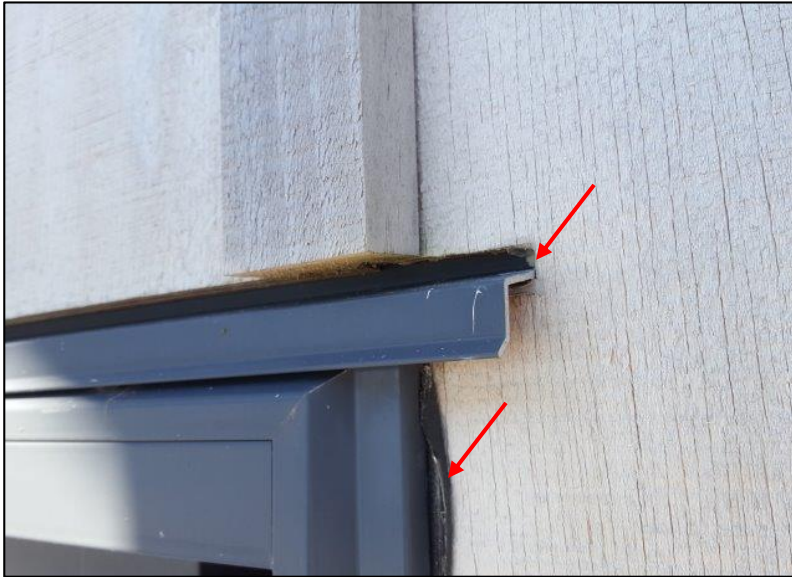
Photo 67: Cladding junction at end of master bedroom head flashing appears to be reasonably well installed (other end similar). Inseal strip is visible behind the jamb flange

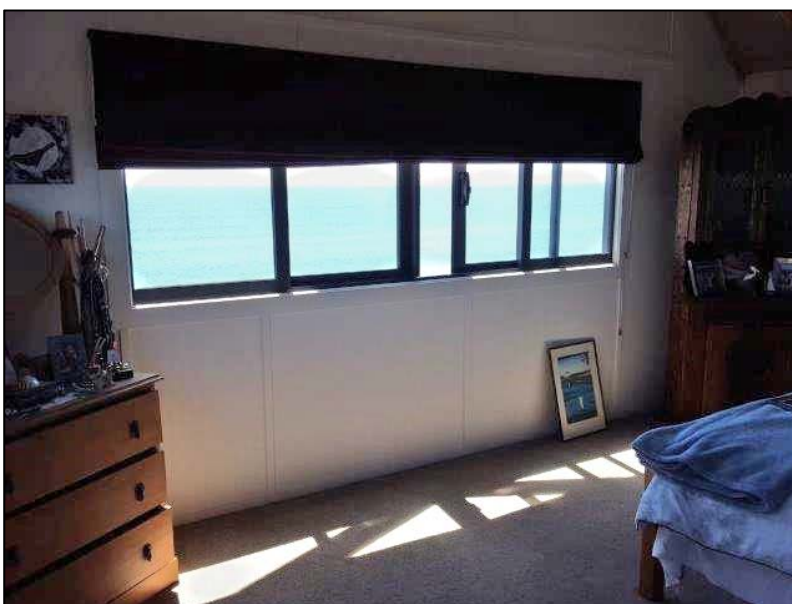
Photo 69: Master bedroom window interior view. No indication of any moisture entry was found

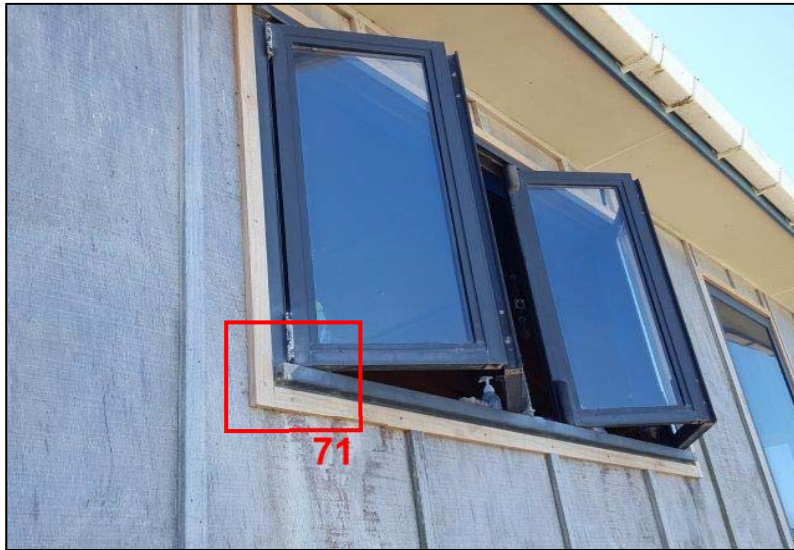
Photo 70: Bifold windows on SE elevation. Battens have recently been installed to all sides of some joinery. A photograph on page 90 of the Dodd cladding weathertightness report dated 17/12/15 indicated that sealant applied to a window jamb junction was in poor condition and the repair proposal recommended that all joinery should have cover battens installed to their perimeters. Refer to comments and photos below

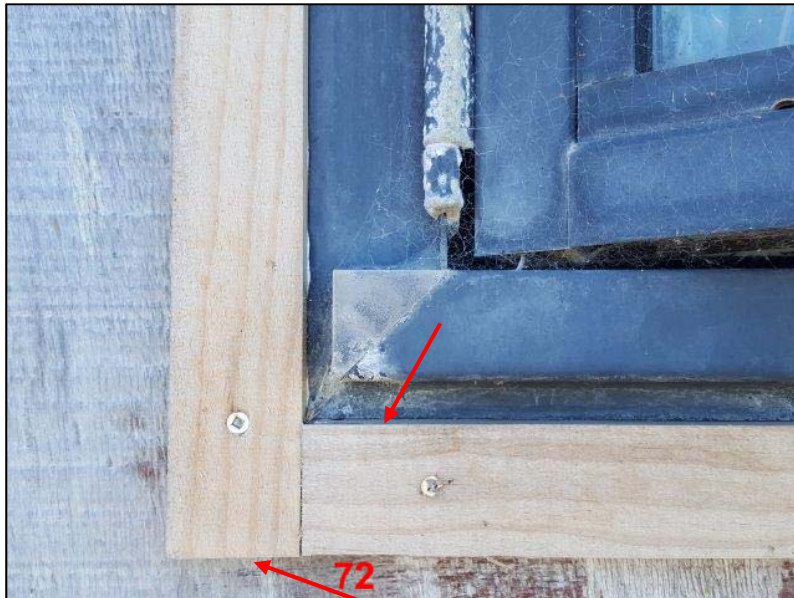
Photo 71: New jamb and sill timber trims installed to bifold window. Flat top surface allows water to pond on sill trim, potentially trapping water against the cladding and restricting drainage from behind the window flange. The Dodd drawings (Minor Alterations No. 6) dated 3.08.16 called for jamb sealant to be renewed and covered with new battens to sides of all joinery. It appears the sill trims may have been installed prior to these drawings being issued. Refer next photo from below trim.
