433 PUKEHINA PARADE EASTERN

Land Information Memorandum

Repair No. 1 – Laundry bulkhead

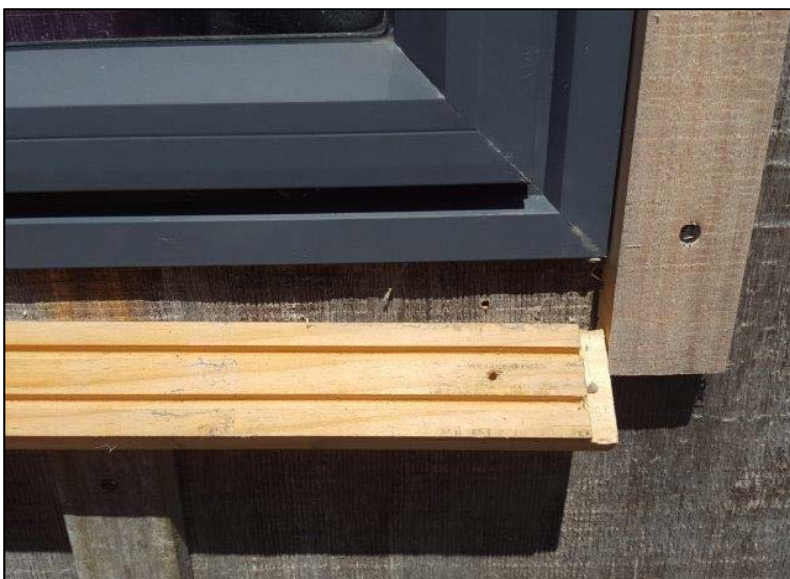
Photo 75: Grooved rear face of sill trim with ends rebated to allow drainage from grooves. Flat top surface allows water to pond on sill trim, potentially trapping water against the cladding and restricting drainage from behind the window flange. If sill trim is retained, the top 5mm of the trim needs to be removed to allow drainage from behind the window flange. The top surface of the trim also needs to be sloped 15° to prevent accumulation of water. Refer next photo for moisture test

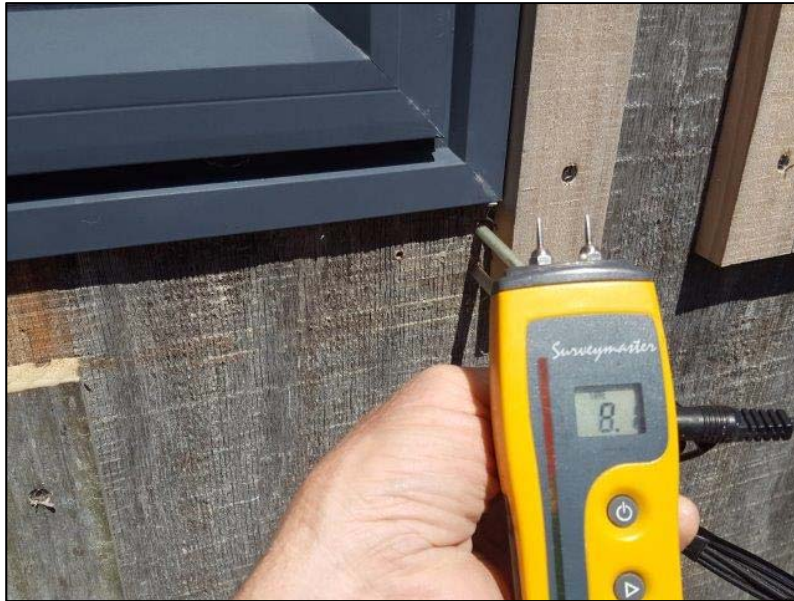
Photo 76: MC 8% normal moisture reading below sill flange

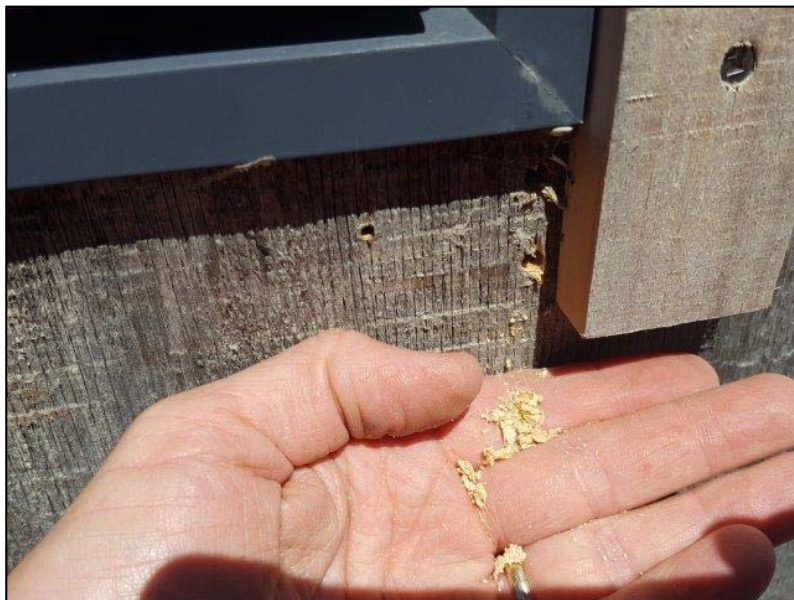
Photo 77: Drill shavings looked in good condition

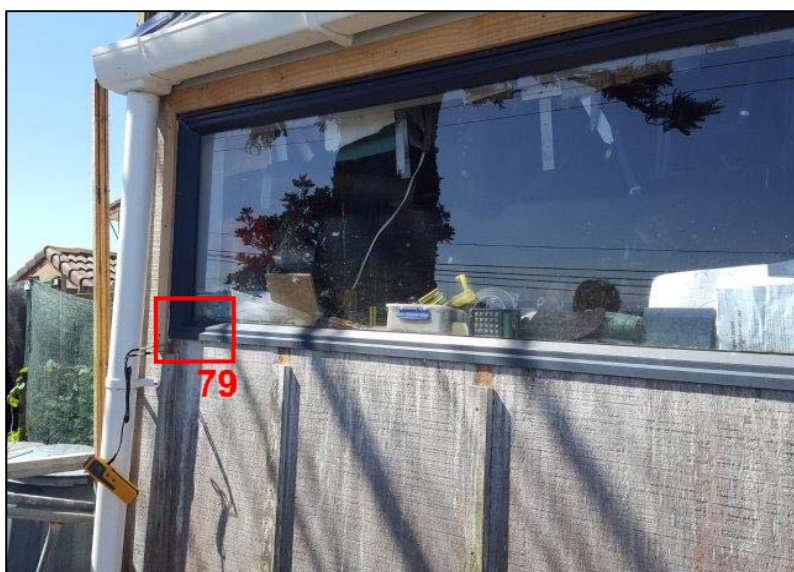
Photo 78: Workshop window with sill trim removed. Refer moisture testing in next photo

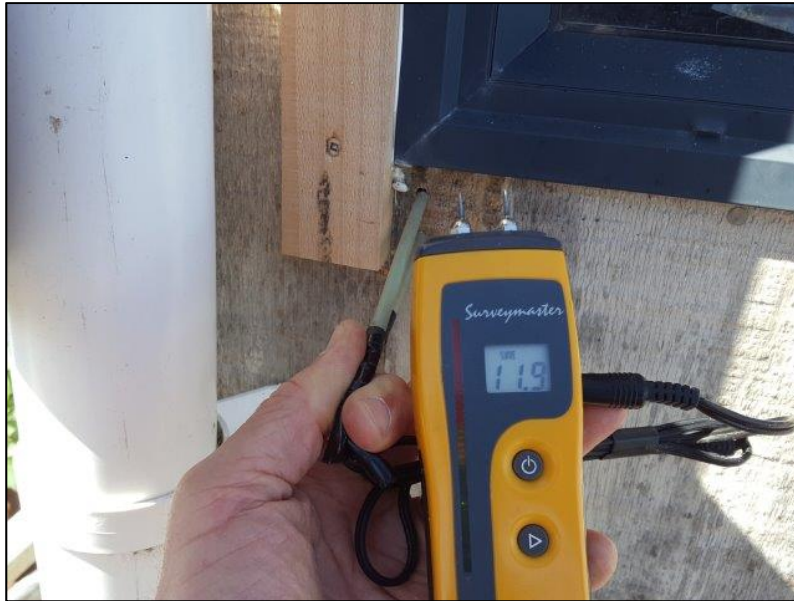
Photo 79: MC 11% normal moisture reading below sill flange. Drill shavings looked in good condition. MC 12% normal moisture reading was taken below sill flange at other end of window. Drill shavings also looked in good condition

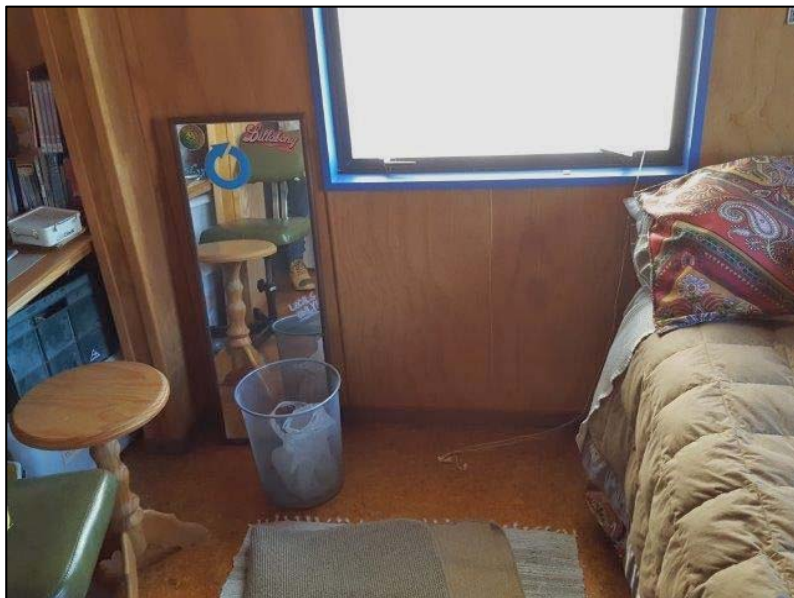
Photo 80: Interior view of bedroom window on NW elevation. Varnished strand board flooring is in excellent condition. No evidence of any moisture entry was found to the interior of the house other than noted in this report (photo 11)

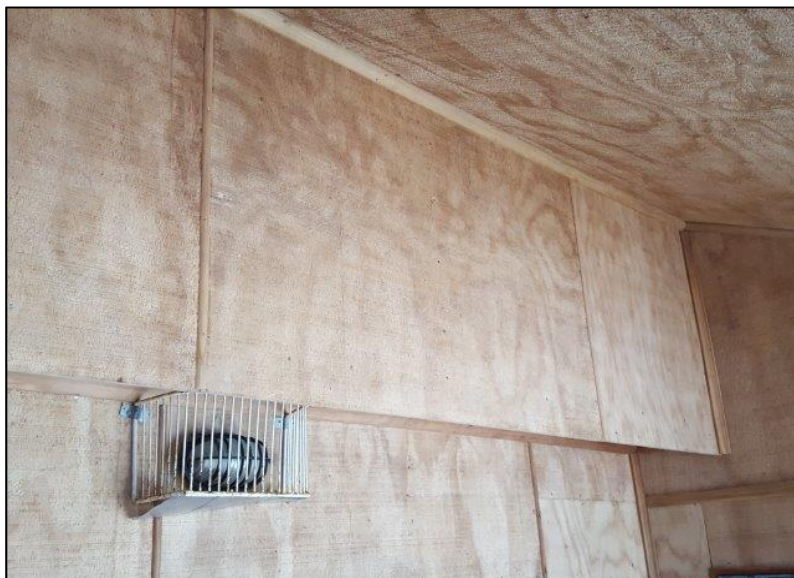
Photo 81: Plywood cladding in house entry area on SW elevation. Cladding has been neatly finished, with trims installed at plywood junctions

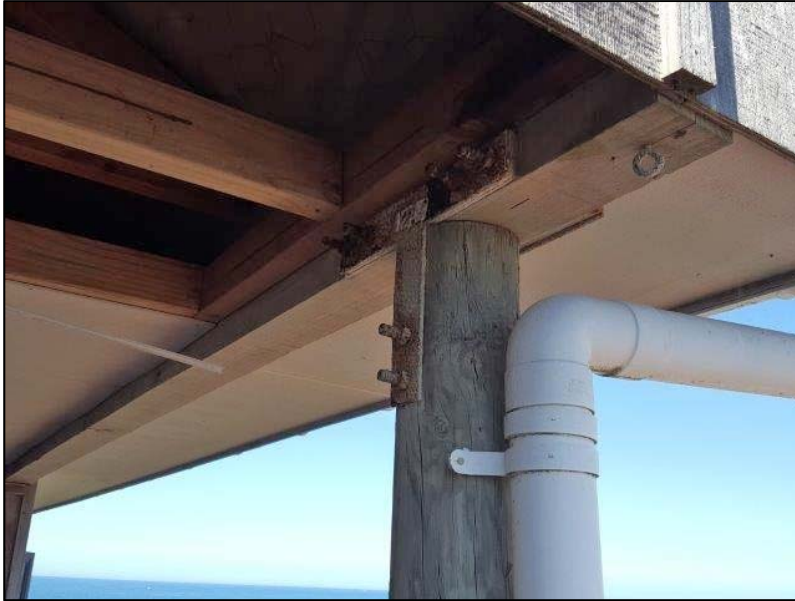
Photo 94: Corrosion to structural connection in laundry soffit area on SE elevation needs attending to. There is some inconsistency with a mix of stainless steel and galvanised connections/bolts installed. Refer photo 1 for general location

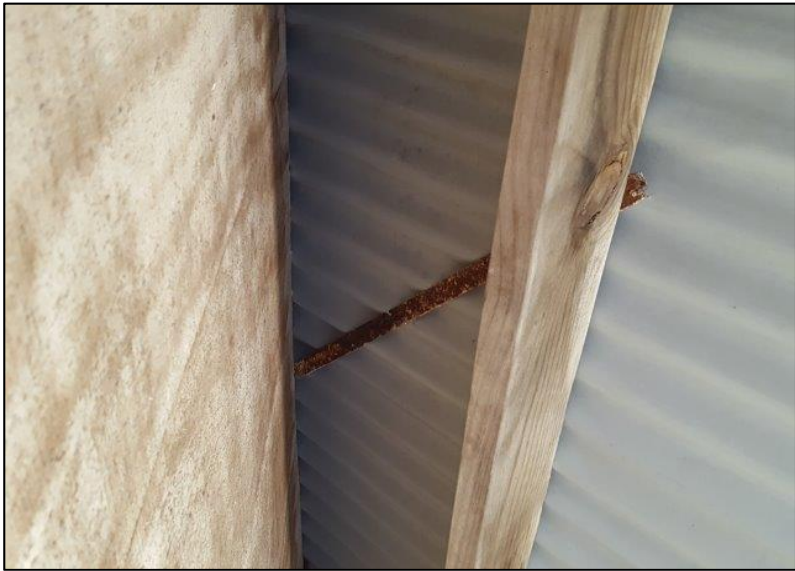
Photo 95: Corrosion on sleepout roof strap bracing above deck needs attending to

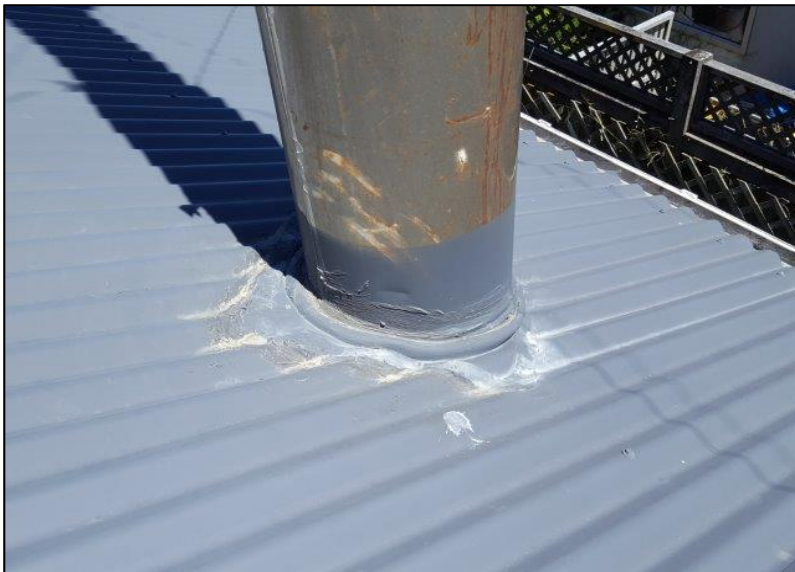
Photo 96: No issues were noted with the roof structure. The curved long run profiled steel roofing appears to be well installed, including the pictured chimney junction

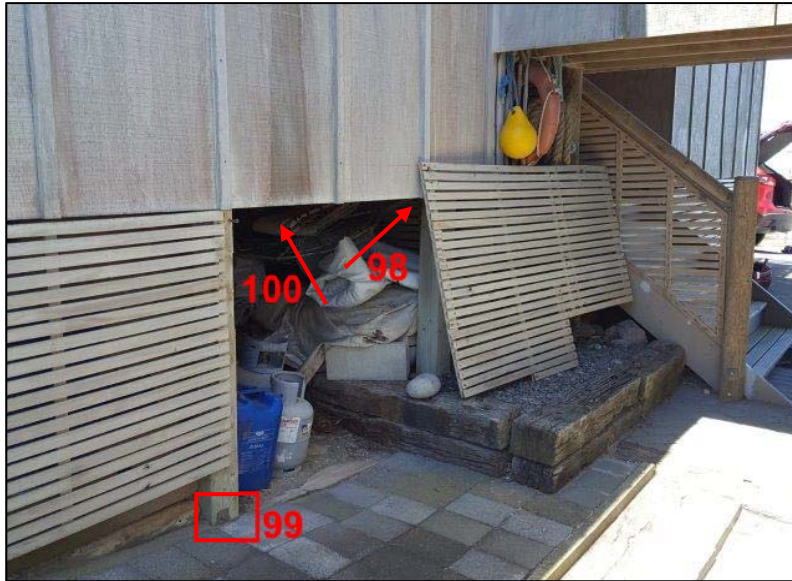
Photo 97: Subfloor access panel removed on house SW elevation. Refer indicated photos for views below house

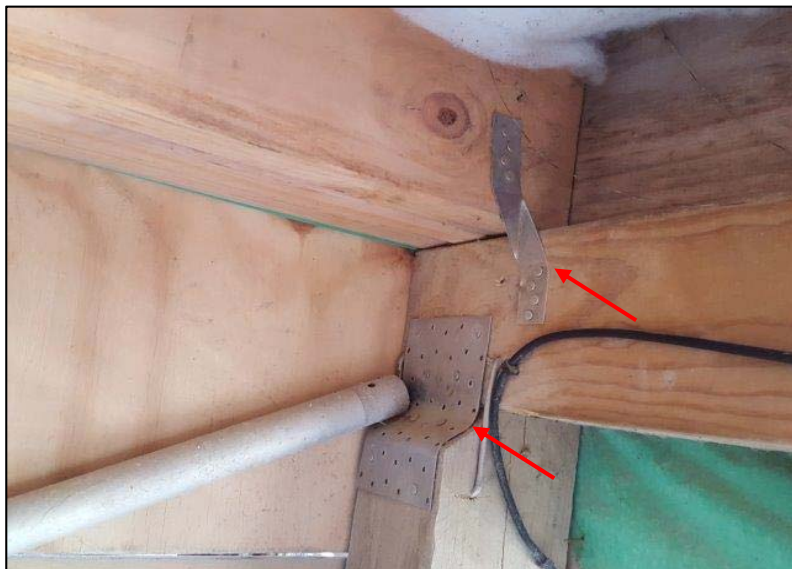
Photo 98: Stainless steel subfloor connections appear to be well installed

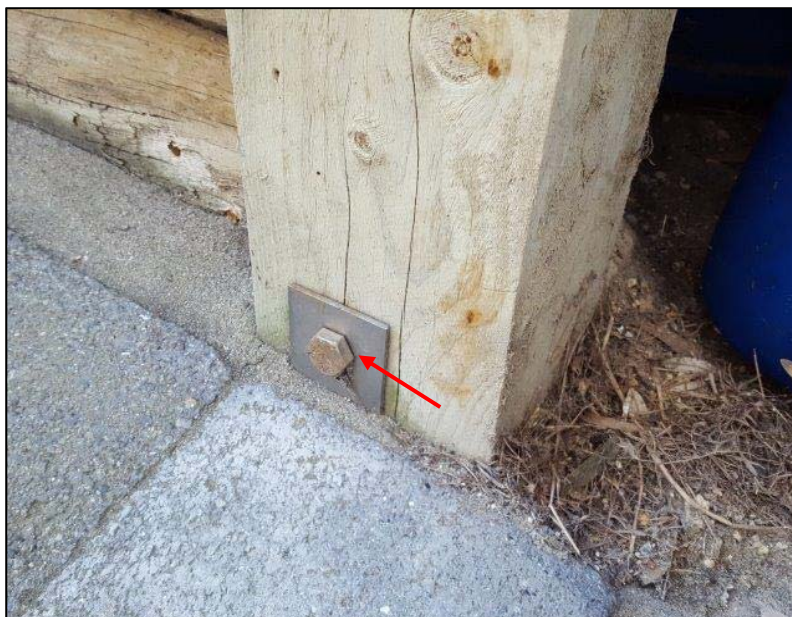
Photo 99: Stainless steel bolted connection

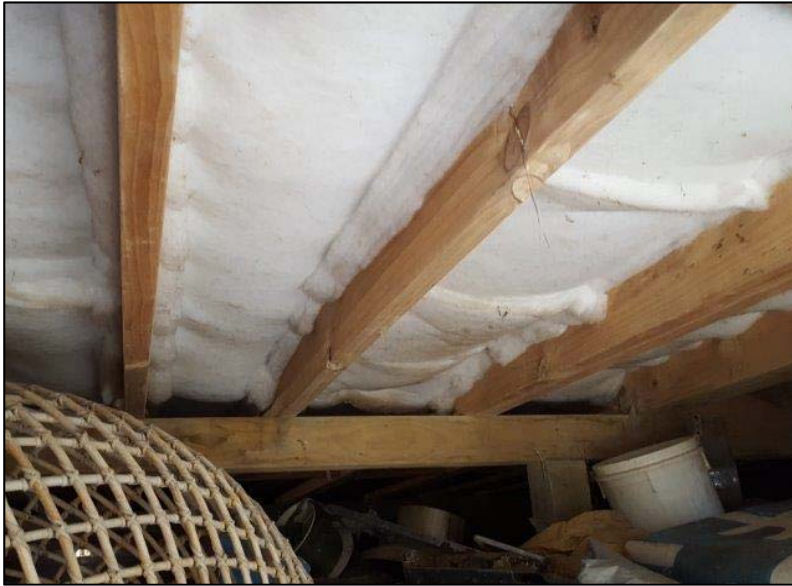
Photo 100: Polyester type insulation appears to be well installed between floor joists with no visible gaps

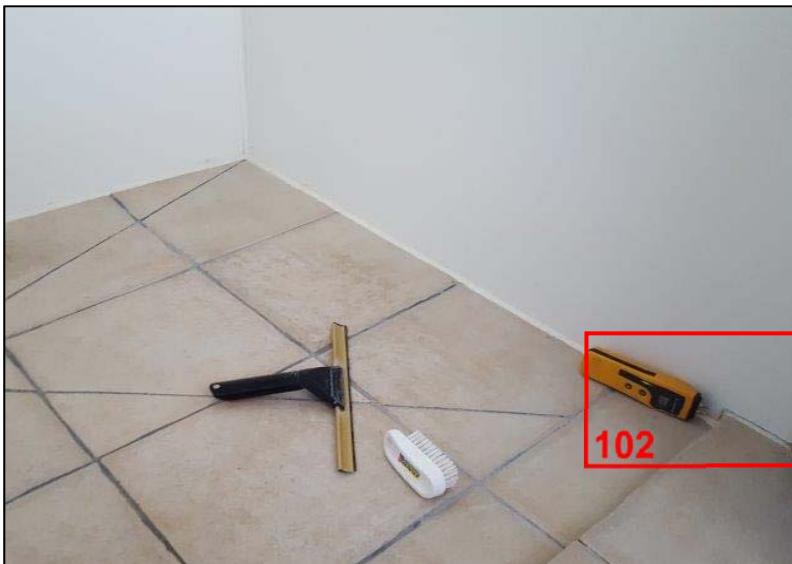
Photo 101: Seratone or similar wet wall linings in master bedroom ensuite shower are reliant on a sealant bead for waterproofing. The current manufacturer's instructions for tiled installations indicate a fully sealed junction between the two materials above a tiled upstand, which allows for drainage off the wall linings. Refer indicated closeup in following photo

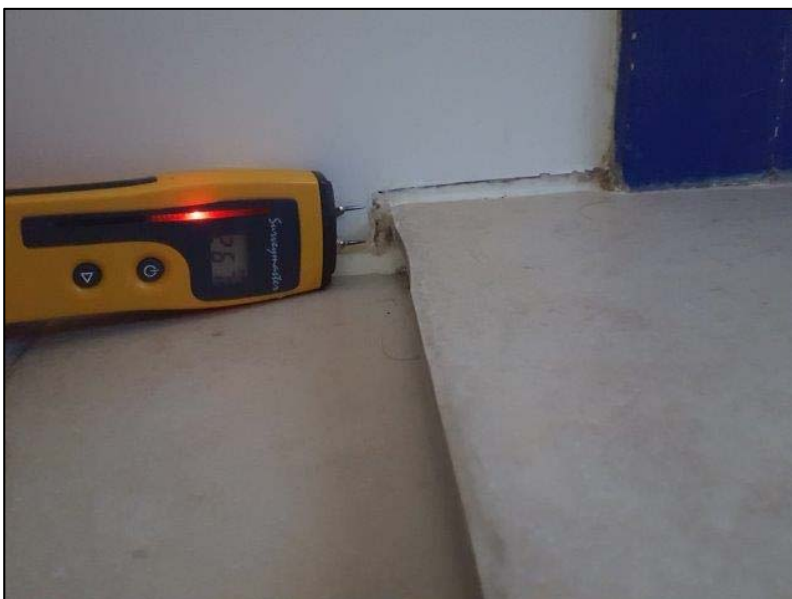
Photo 102: Moisture meter indicates elevated moisture levels on rear face of wall linings. It is assumed that undertile waterproofing will have been carried 150mm up behind the wall linings. There was no indication of any failure of the wall linings such as delamination. Refer following photos of flooring in adjacent space

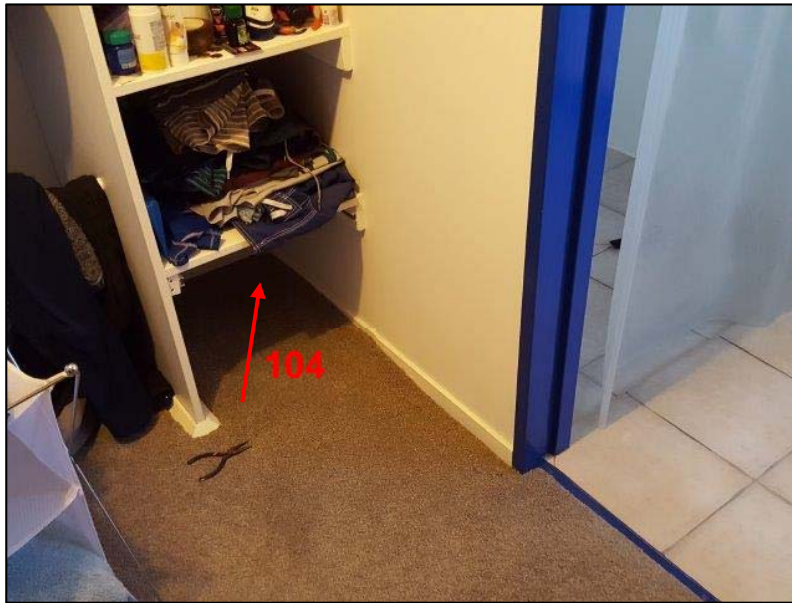
Photo 103: Robe space adjacent to master bedroom ensuite shower.
Refer following photo

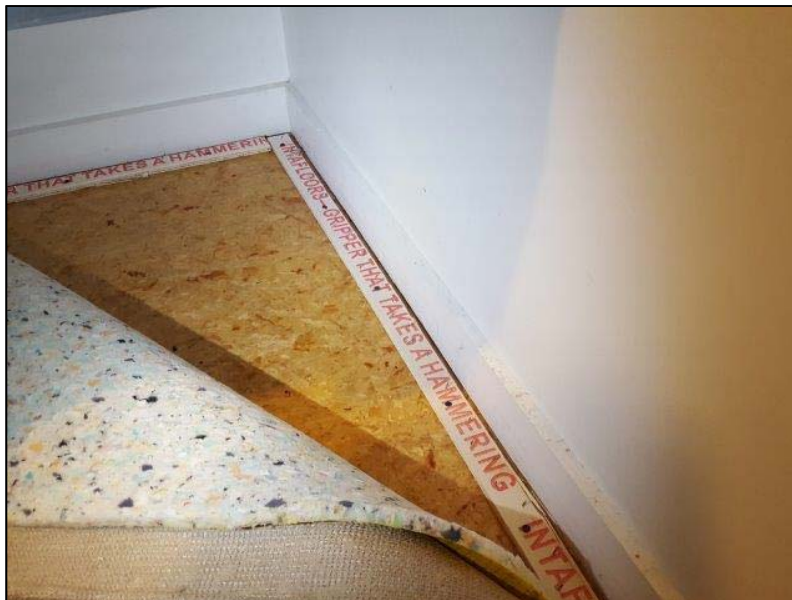
Photo 104: Strand flooring adjacent to shower in immaculate condition. Any leakage from the shower would rapidly indicate as staining on the flooring. The flooring adjacent to the shower in the master bedroom was also immaculate, indicating that the shower waterproofing is performing adequately

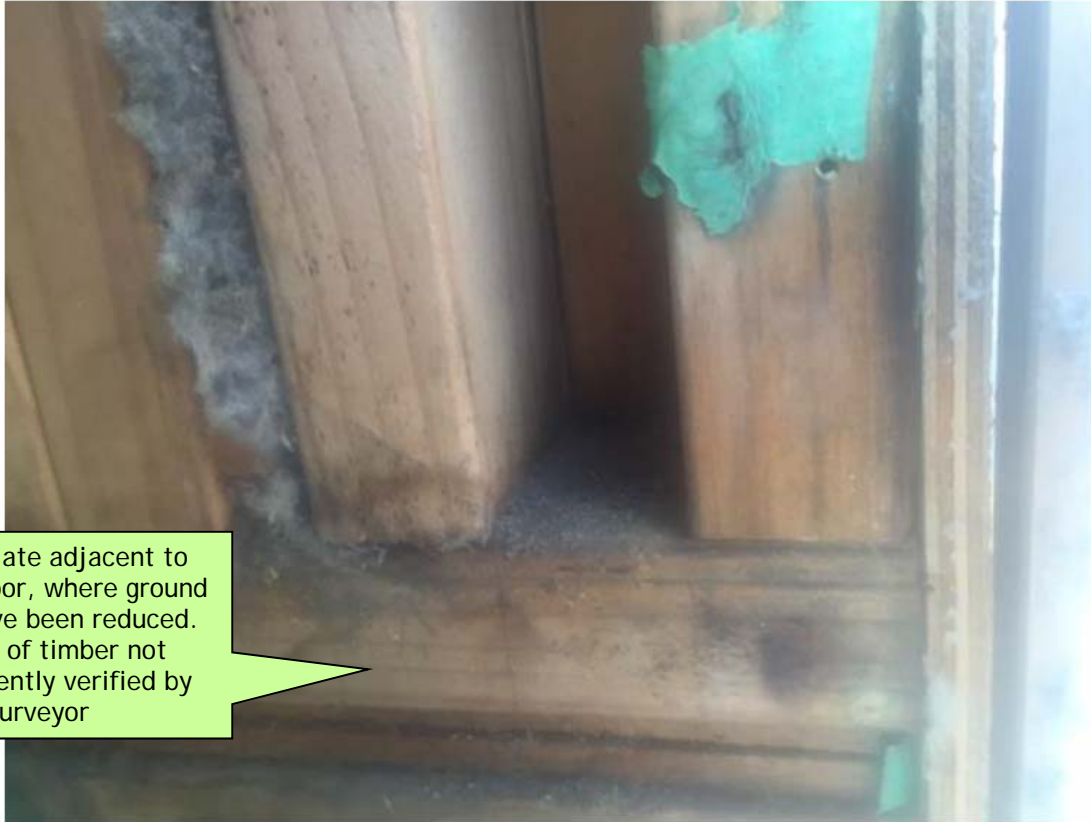
Bottom plate adjacent to garage door, where ground levels have been reduced. Condition of timber not independently verified by building surveyor
