Detailed Seismic Assessment

Aldan Lodge, 86 Wellington Street, Picton

Reference: 3587-9593

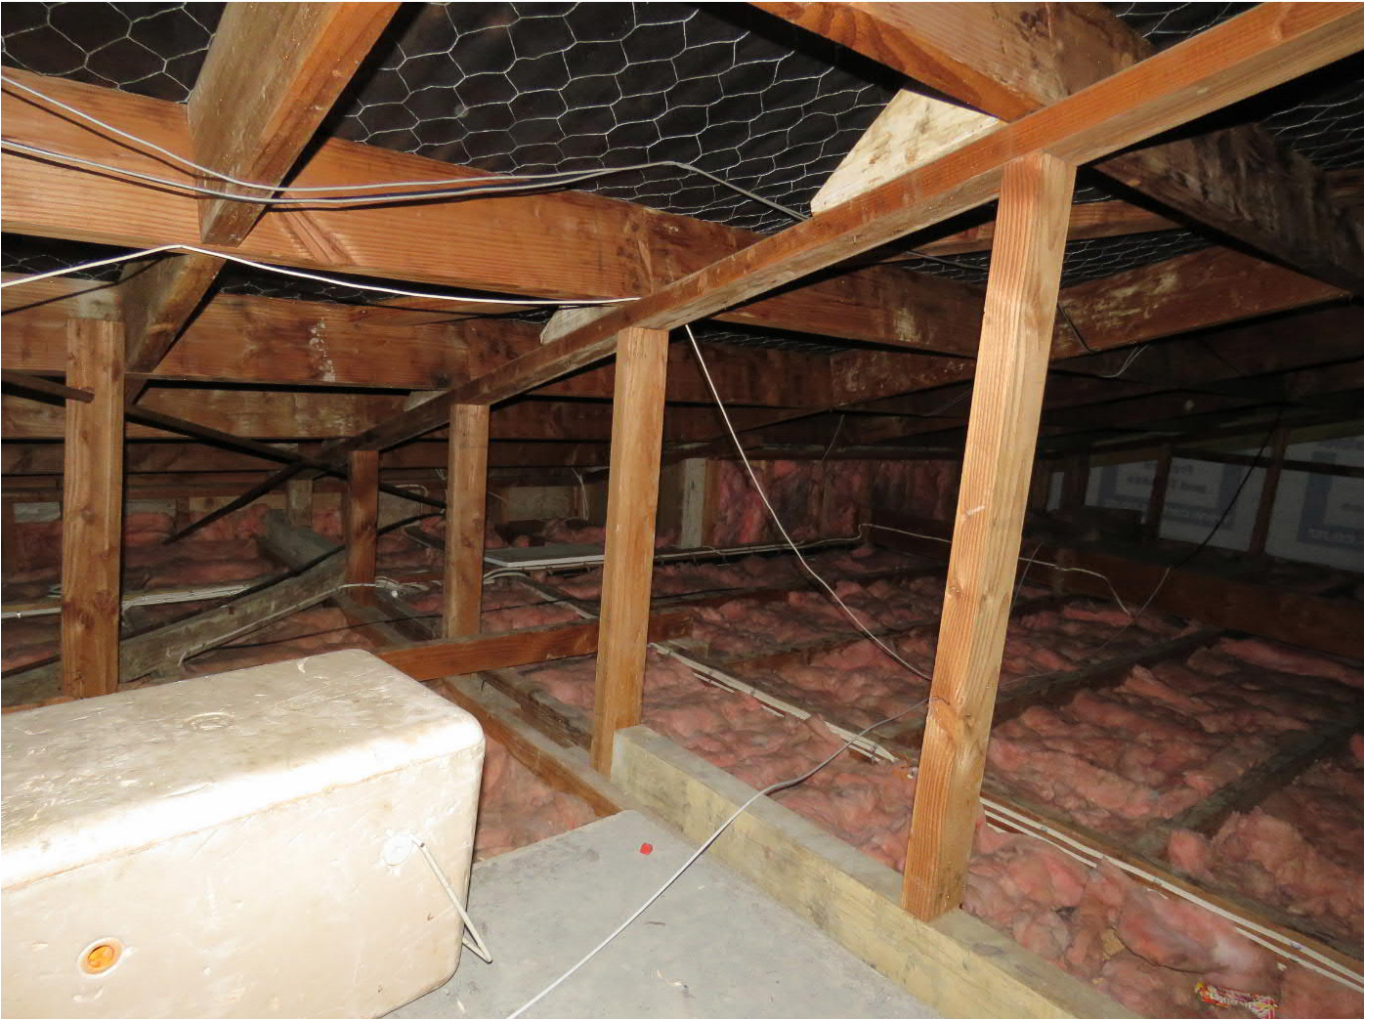
Roof structure

The roof cladding is corrugated steel longrun. The roof structure are purlins supported by the jack studs.

10.3 Strengthening can be achieved by upgrading the internal bracing elements of the upper floor/roof space.
