# Land Information Memorandum

Property address:  
80 Byron Street

LIM number: 70247257  
Page 1

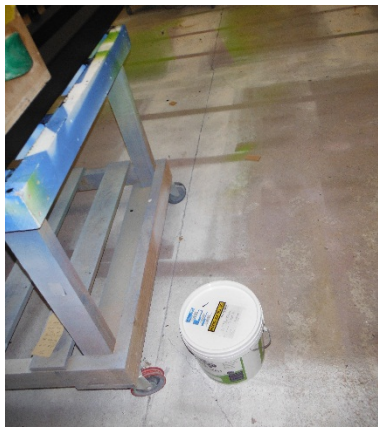
| Damaged Item | Location | Example | Recommended Repair |
|---|---|---|---|
| 1.1. Cracking and spreading at slab construction joints | <p>South section of eastern structure</p> <p>See damage map photo 1.</p> | | Chase channels each side of crack and install dowels across crack to prevent future lateral spreading of slab. |

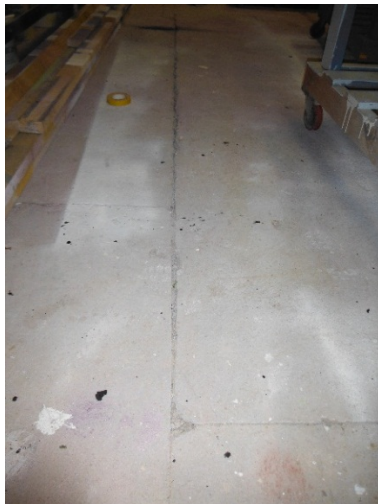
| Damaged Item | Location | Example | Recommended Repair |
|---|---|---|---|
| 1.2. Differential settlement of slab | <p>South section of eastern structure</p> <p>See damage map photo 2.</p> | | Remove section of slab that has lifted. Re-level ground. Install new slab with epoxy dowels into adjacent slab sections. |

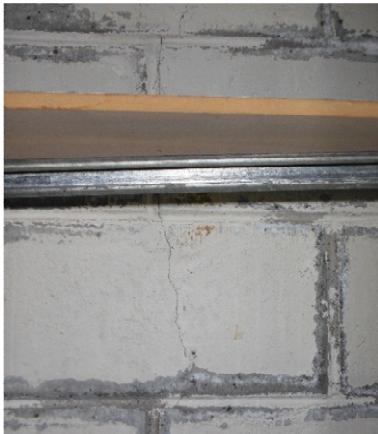
| Damaged Item | Location | Example | Recommended Repair |
|---|---|---|---|
| 2.2. Vertical cracking in concrete block work wall | Occurs in north section of west wall<br><br>See damage map photo 5. | | Remove and replace cracked concrete blocks. Repair and repoint cracked mortar joints. |
