## Elmdale Lane

### Unit 3

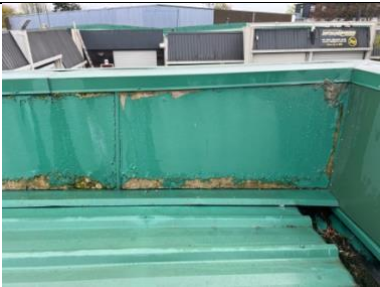
| | <p>Hardie sheet is well overdue to be replaced. This can be removed and a new flashing installed to replace it. Note this may need to be tested for asbestos prior to being changed</p> | <p>Repair Cost:<br/>\$ 766 + GST</p> <p>(no allowance for asbestos testing)</p> |

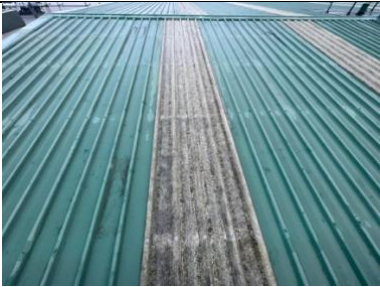
| | <p>Skylights are well past their used by date and require replacements.</p> | <p>Replacement Cost:<br/>\$4243.85 + GST</p> |

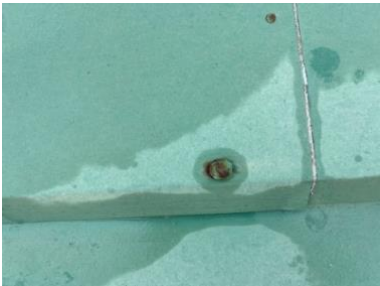
| | <p>Fixings are starting to corrode on flashings and require replacement with a Bra Embossed Washer to ensure water tightness</p> | <p>Replacement cost:<br/>\$ 260 + GST</p> |

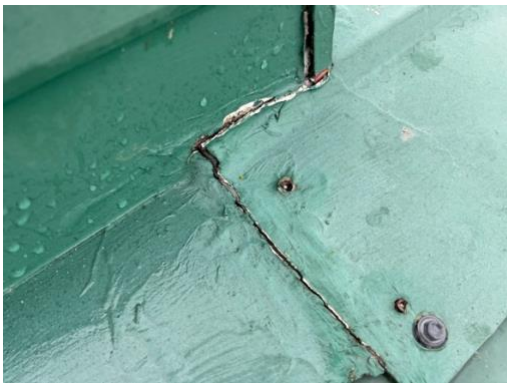
| | <p>All Flashing Joints need re-sealing and re-fixing</p> | <p>Cost for Repair:<br/>\$292.50 + GST</p> |

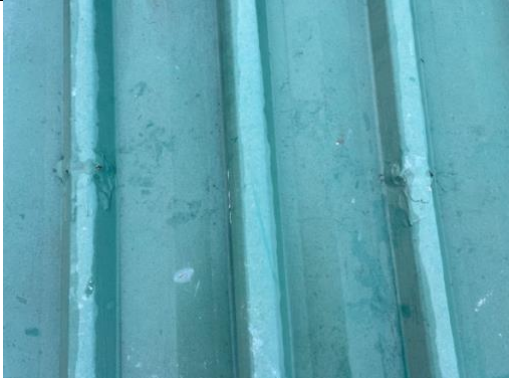
| | There is severe dents in roofing caused by foot traffic that have split and can cause water ingress. These can be fixed by using dent covers | Repair cost:<br>\$195 + GST |

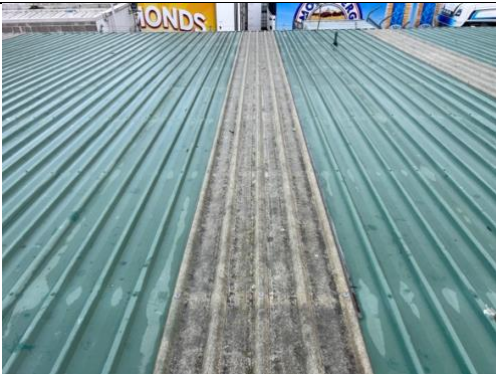
| | Skylights are well past their used by date and require replacement | Replacement Cost:<br>\$3012.07 + GST |

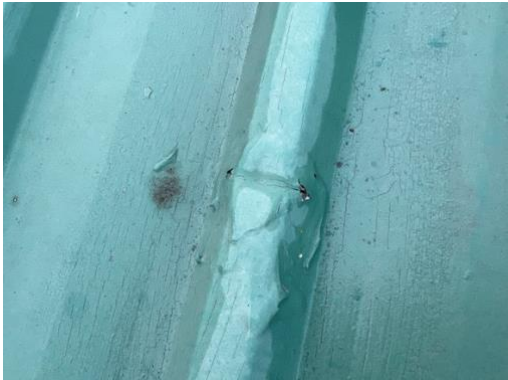
| | There is severe dents in roofing caused by foot traffic that have split and can cause water ingress. These can be fixed by using dent covers | Repair Cost:<br>\$195 + GST |

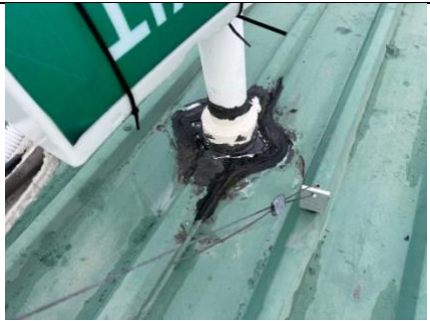
| | <p>The penetration looks like it has signs of previous leaking due to the amount of sealant used around the pipe. A drypan flashing and new aquaseal installed would bring this up to a correct standard</p> | <p>Cost of Repair:<br/>\$ 487 + GST</p> |

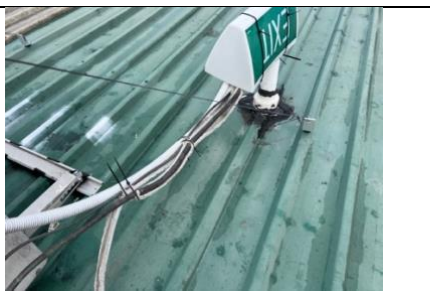
| | <p>The Heat pump pipe work needs new lagging and the correct Gooseneck connection going into the roof. It currently has a "Exit Sign" as its water proofing.</p> | <p>Cost of Repair:<br/>A Heatpump Contractor would need to do this work</p> |

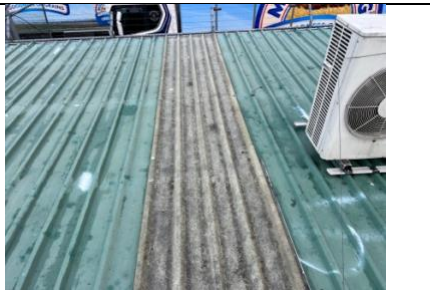
| | <p>Skylights are well past their used by date and require replacements. Please note these are not full length as they have recently been covered up with a Coloursteel roof sheet.</p> | <p>Cost of Replacement:<br/>\$ 1429.43<br/>+ GST</p> |

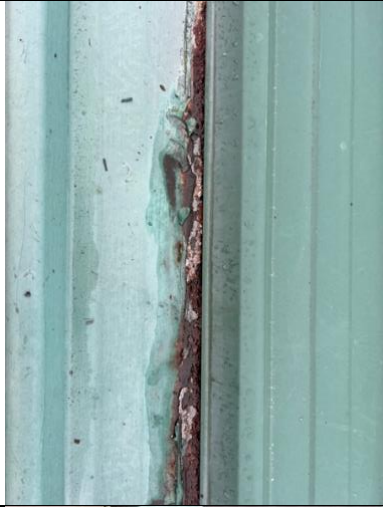
| | <p>Where the old skylight used to be it looks like they had tried sealing alongside the roof lap. This is not good practice as it traps moisture and causes corrosion. The best/cheapest option is to install a drypan flashing over the top all the way up to the ridge so if a hole is created it will be watertight.</p> | <p>Cost of repair:<br/>\$ 1093 + GST</p> |

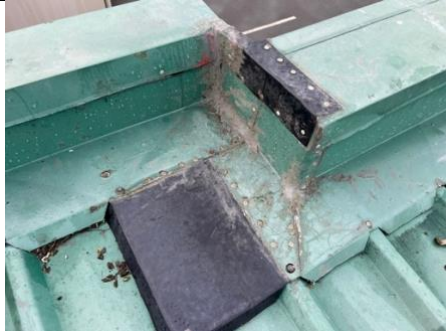
| | <p>Flashings at apron junction are not in a good state and need to be improved. A lot of Oversealing with silicon has been used however silicon breaks down when it is exposed to UV</p> | <p>Cost of Repair:<br/>\$ 283 + GST</p> |

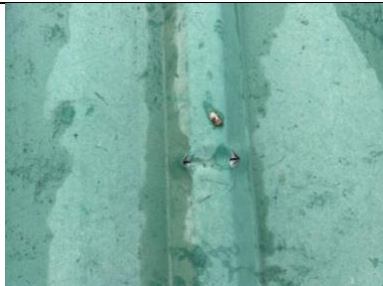
| | <p>There is severe dents in roofing caused by foot traffic that have split and can cause water ingress. These can be fixed by using dent covers</p> | <p>Cost of repair:<br/>195 + GST</p> |

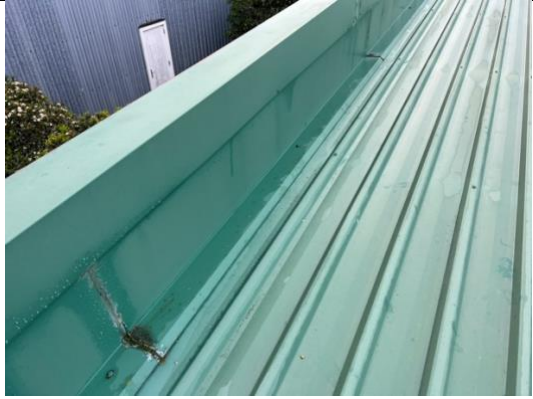
| | <p>Apron joins look like they have history of leaking. They also don't meet today's code and are only covering one roof rib where they should be covering two. Apron replacement is recommended</p> | <p>Cost of repair:<br/>\$1741 + GST</p> |

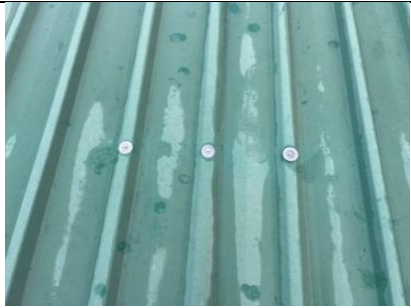
| | <p>Some of the fixings that have been used are not correct and could cause water ingress. These type of washers are only supposed to be used on Domestic Skylight sheeting</p> | <p>Cost of replacement:<br/>\$75 + GST</p> |

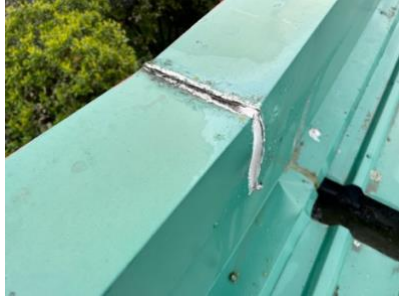
| | <p>Parapet joins are pulling apart and need to be re-fixed and sealed</p> | <p>Cost of repair:<br/>\$75 + GST</p> |

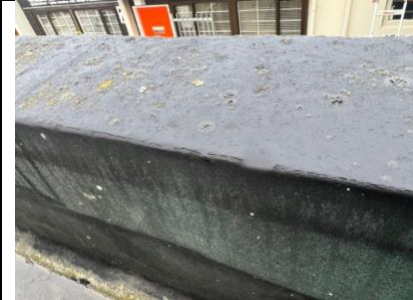
| | <p>Small internal gutter has membrane going up parapet and over to form its own capping. This is now splitting. A coloursteel Parapet needs to be installed</p> | <p>Cost of install:<br/>\$323 + GST</p> |

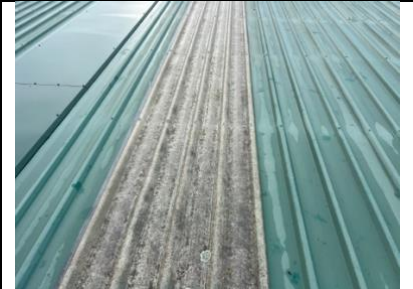
| | <p>Skylights are well past their used by date and require replacement.</p> | <p>Cost of repair:<br/>\$3335.62 + GST</p> |

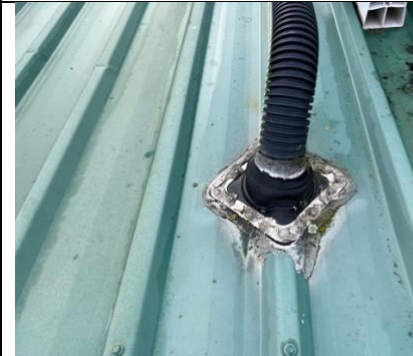
| | <p>The two Vents for the Heat pumps have signs of previous roof leaks. These should be replaced with new aquaseals installed along with drypan flashing</p> | <p>Cost of Repairs:<br/>\$ 943 + GST</p> |
