# Roof Maintenance Report & Management Plan

*Thompson Bros  
Limited*

*50 Gracefield Road,  
Lower Hutt*

08.09.2021

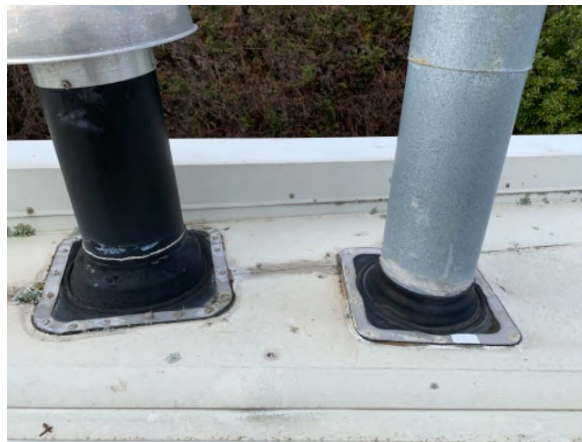
Moss build up on flashings

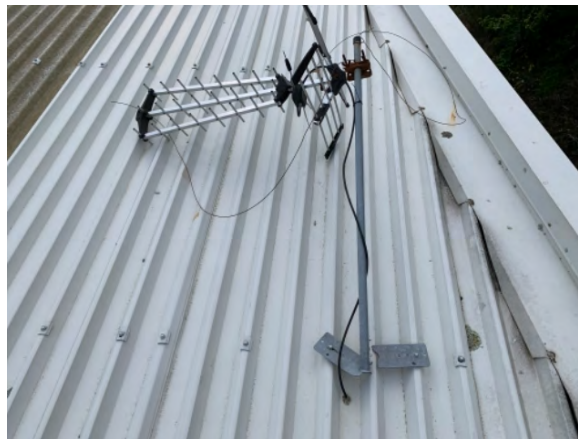
Broken aerial and mount  
Roof mounted aerial has broken off and is sitting on the roof. The mounting bracket has also broken.

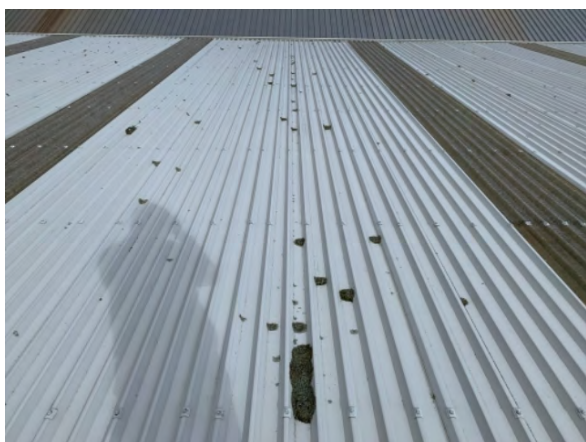
Moss on metalsheets  
Overview of moss present on sheets

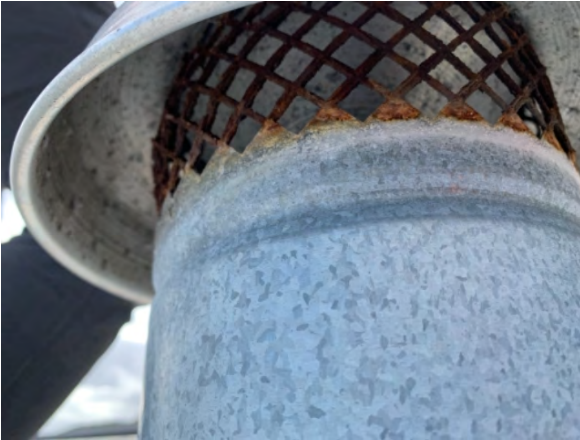
Corroded cowls

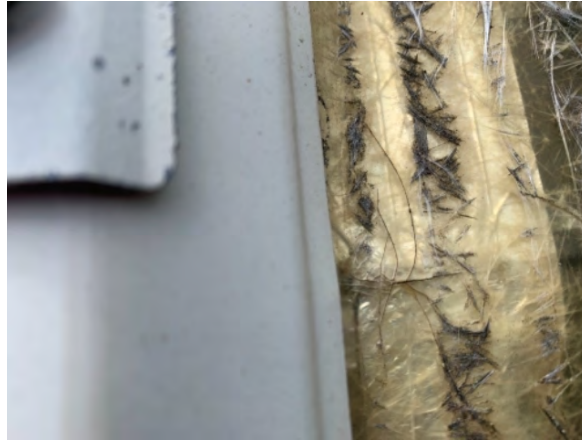
Fractures in skylight

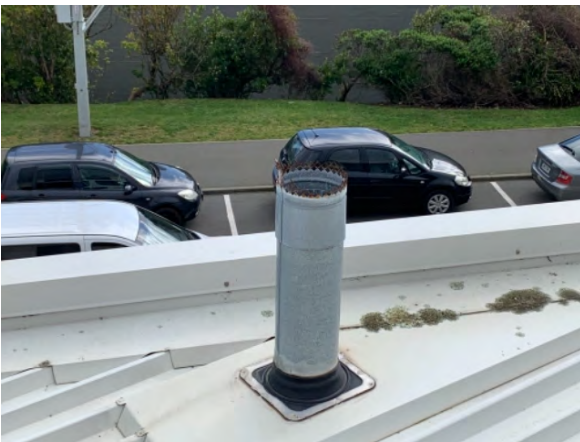
Missing roof cowl

There is a missing roof cowl that can allow water ingress into the building.

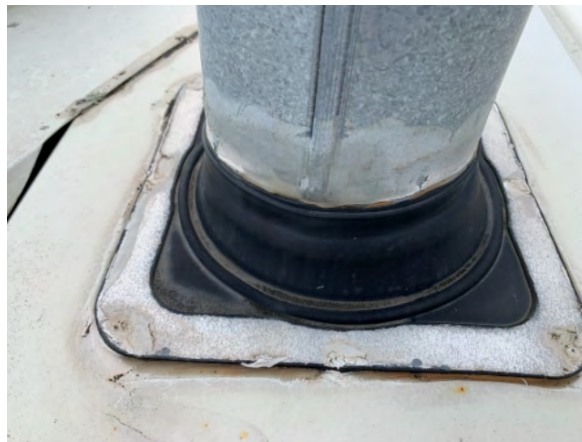
Faded sealant around Dektite

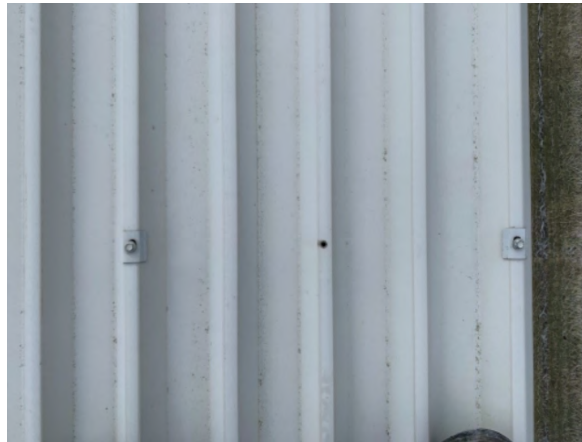
Missing fixing

Missing roofing screw in one of the metal sheets

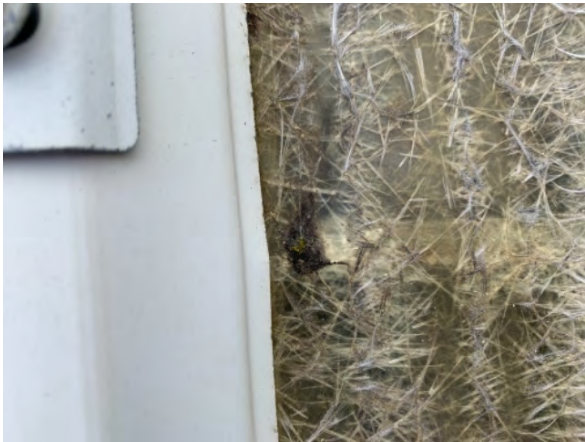
Hole in skylight

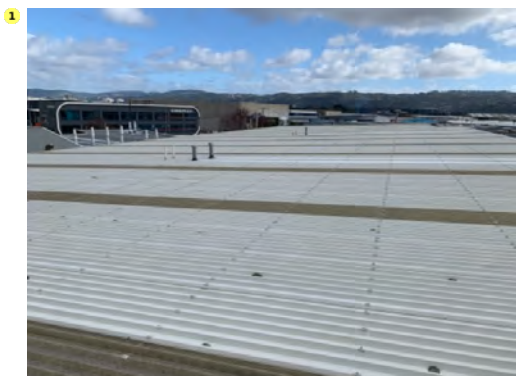
**Metal Roof - General Maintenance (Remedial)**

The metal roofing is required to be inspected at least once a year. Generally, the accumulation of organic material and debris can create blockage on the outlets, water ponding, open laps that can lead into potential leaks. It is imperative to inspect the metal roof, clean it and repair any defects found in order to avoid costly repairs in the future.

We will carefully and methodologically inspect the metal roof and assess its current condition. Any debris or organic material found will be removed.

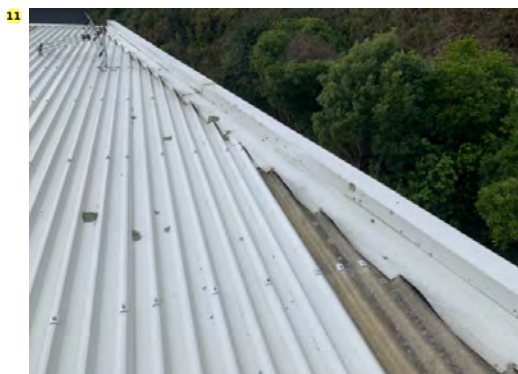
**Metal Roof - Open Flashing (Remedial)**

The flashing has gaps or holes in it, these gaps are allowing water ingress. This can be caused by insufficient counterflashing, movement in the building, poor insulation or a fixing coming loose.

Depending on the severity of the deterioration of the flashing, it will need to be removed completely and reinstalled with the existing flashing re-sealed and re-fixed in place. Install profile foam strip where necessary to ensure water ingress is prevented.

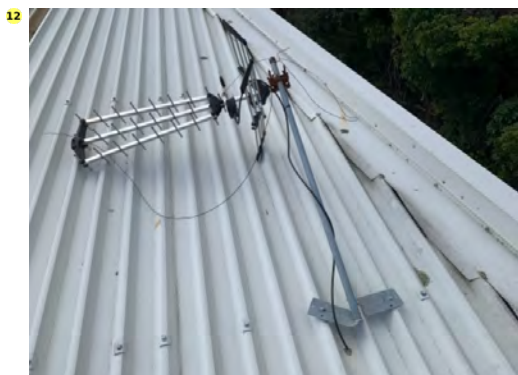
**Metal Roof - Rooftop Aerial damage (Remedial)**

The tenants roof mounted aerial is broken. The bracket has snapped and it is loose laid on the roof. This can cause potential damage to both the roof and aerial.

Works by others: Replace damaged aerial bracket.

Carry out any isolated repairs to the affected areas by either removing the aerial and flashing over the area. We can provide a quote for this if you choose.

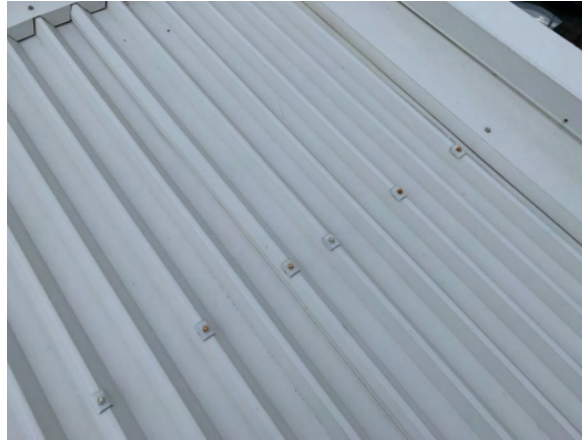
Rusty screws

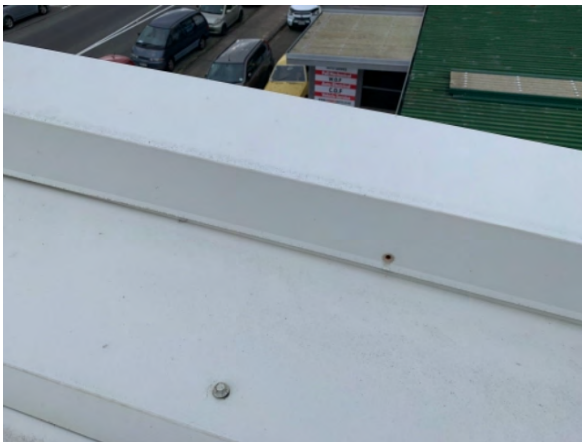
Missing fixing on cap flashing

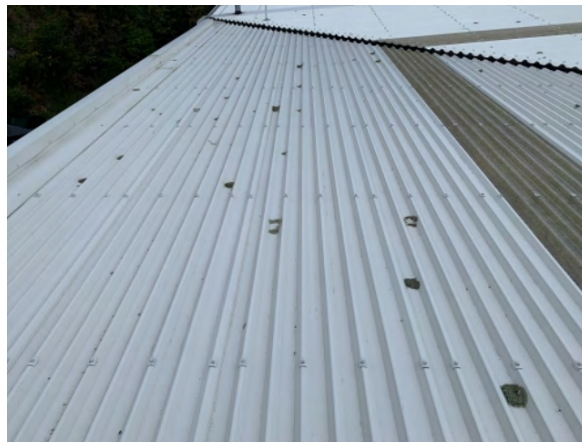
Moss on sheets

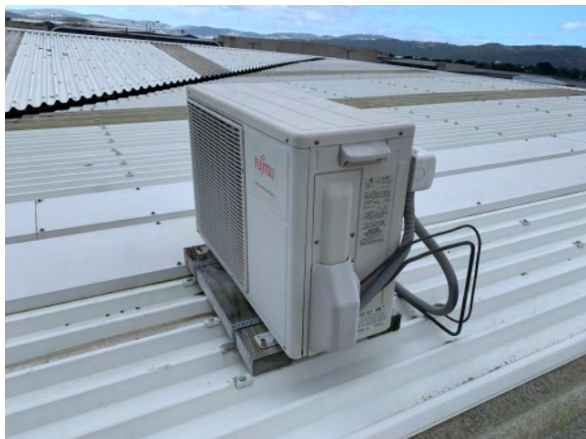
HVAC unit has been mounted on timber without a separation barrier which can lead to corrosion occurring on the sheets.

HVAC unit has been mounted on timber directly onto the roof without a separation barrier which can lead to corrosion occurring on the sheets.

Work by others: Contact HVAC installer to replace existing timber plinths for new monkeytoe style HVAC mount.

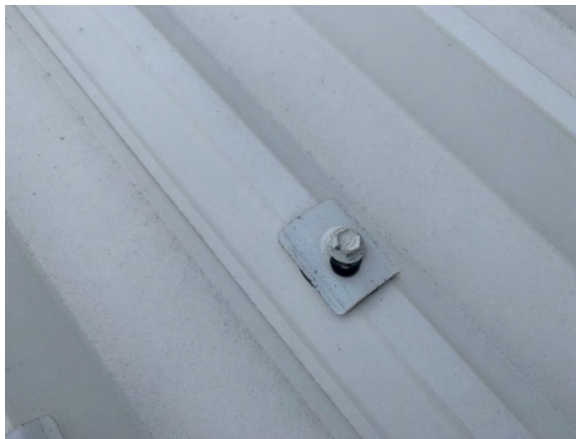
Split neo washer

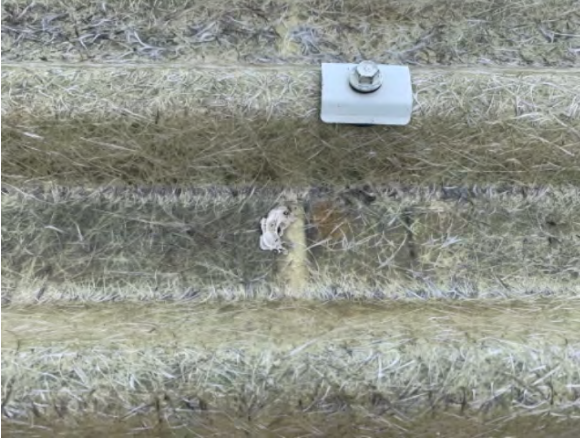
Sealant repair done to skylight

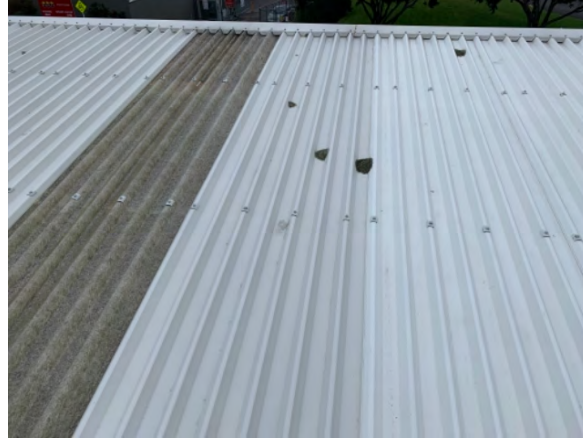
Two different sheet colors have been used on the roof. Possibly previous sheet replacement done.

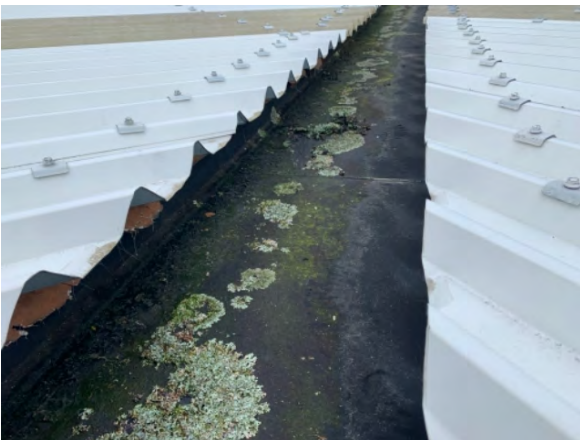
Moss and mold in gutter

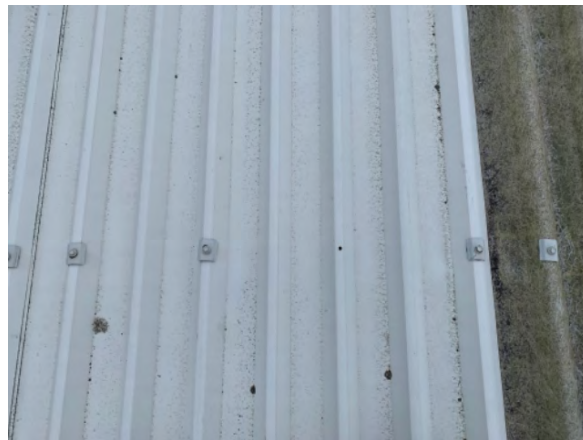
Missing screw and washer  
Example of an area where there are missing roof fixings and profile washers.

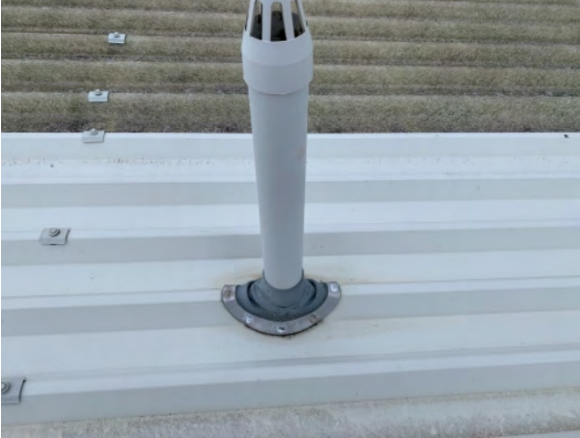
Dektite and vent penetration

The Dektite is fading and starting to form crack which can allow water ingress into the building. The sealant is also faded and needs replacing.

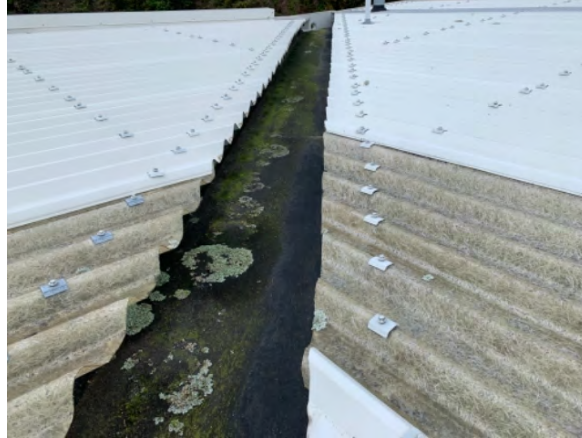
Moss and mould in gutter

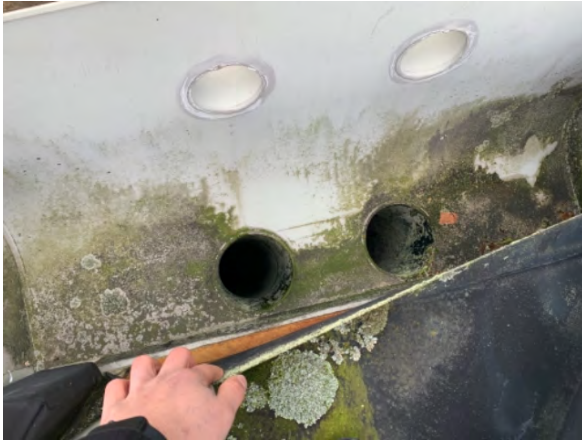
Loose butynol lap going into rainwater outlet  
There is a loose Butynol lap going into the rain water outlet that needs to be re-glued to reduce the risk of further damage occurring.

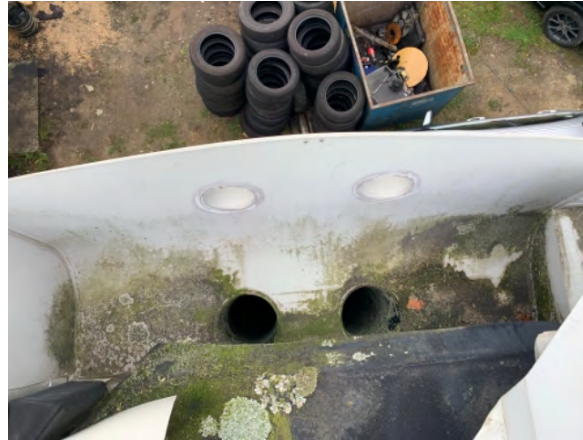
Moss and mould in outlet. Missing outlet covers  
Outlet strainers need to be installed into the outlets to reduce the risks of blockages.

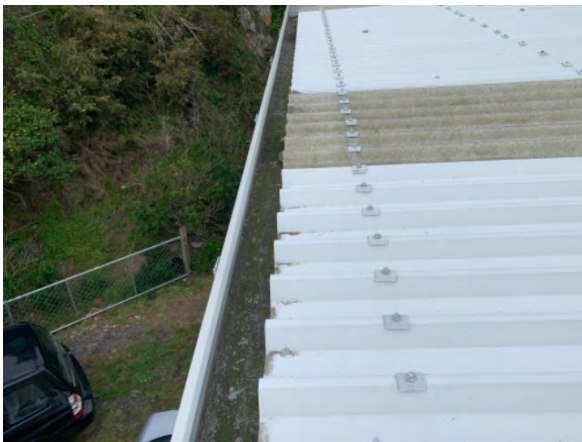
Box gutter  
Box gutter with moss and mold

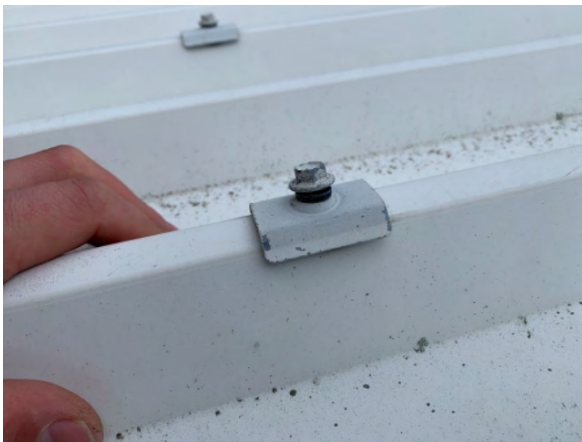
Loose screw

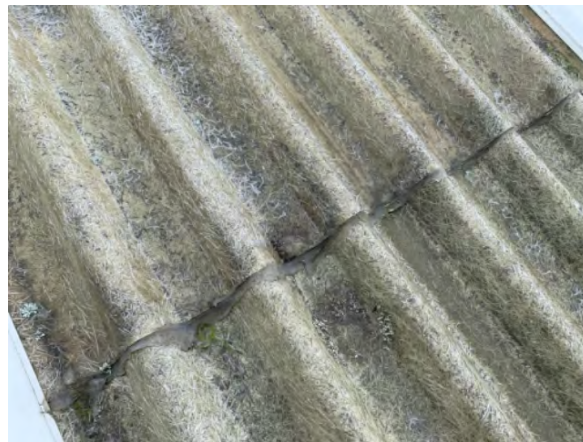
Sealant on skylight starting to fade  
The sealant in the junction where the two skylight sheets lap is starting to fade which can lead to water ingress by wind driven rain.

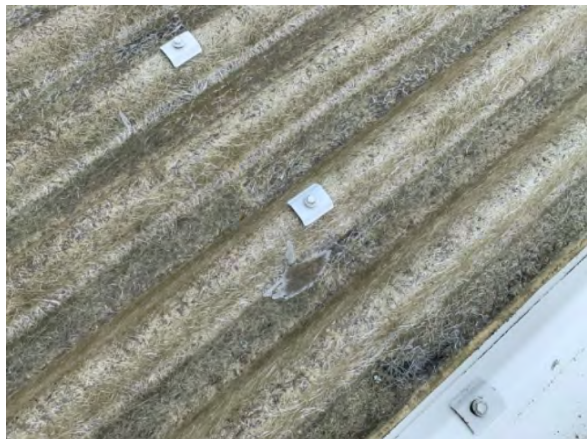
Previous skylight repair

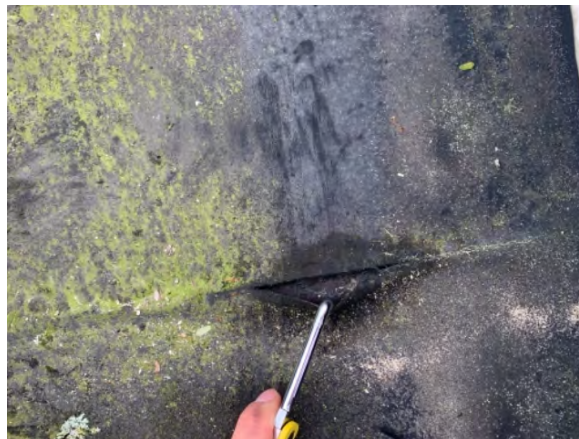
Tear in butynol gutter

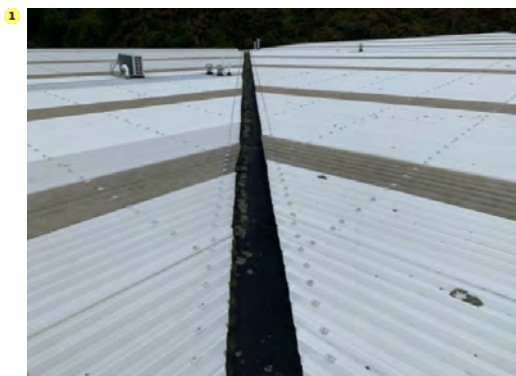
**Metal Roof - General Maintenance of metal roof (Remedial)**

The metal roofing is required to be inspected at least once a year. Generally, the accumulation of organic material and debris can create blockage on the outlets, water ponding, openings that can lead into potential leaks. It is imperative to inspect the metal roof, clean it and repair any openings found in order to avoid costly repairs in the future.

We will carefully and methodologically inspect the metal roof and assess its current condition. Any debris or organic material found will be removed.

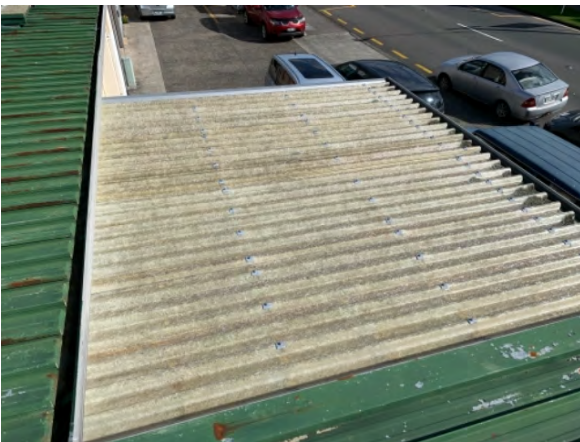
Skylight canopy above entrance to building  
These skylights are at the end of their serviceable life with cracks present and loose fibers starting to flake off.

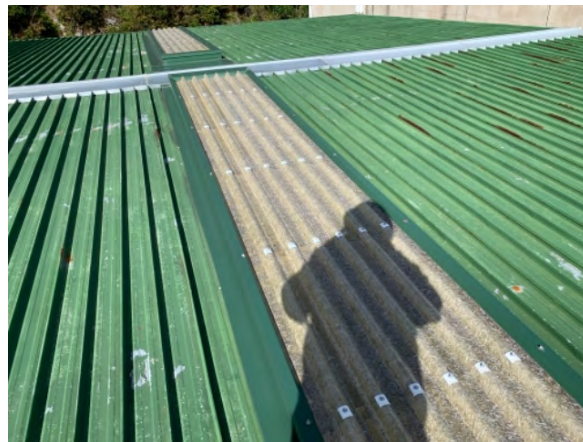
Skylight overview

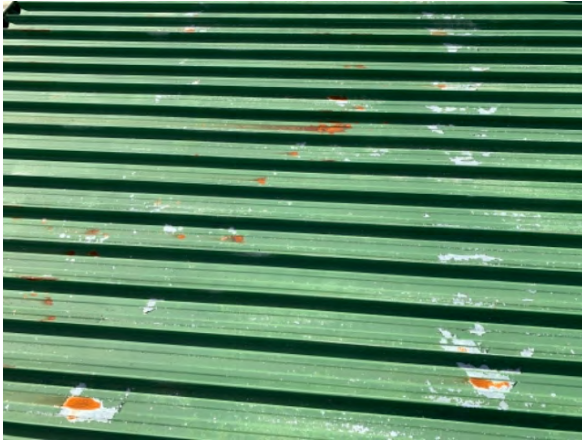
Corrosion spots on roof

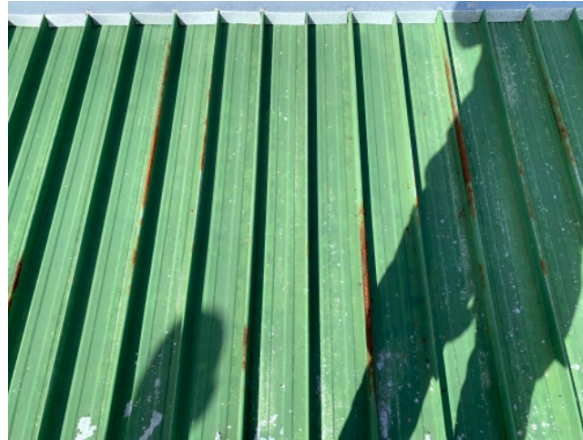
Corrosion on ribs

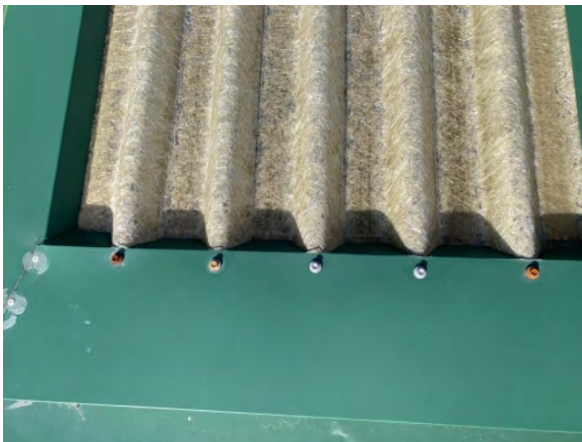
Rusty fixings

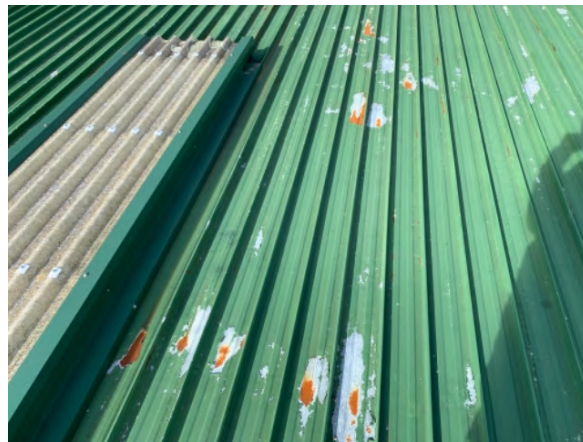
Rust patches

This is an example of some of the rust which is present on the whole of the roof. This surface rust can lead to advanced corrosion causing holes in the metal sheets, allowing water ingress into the building.

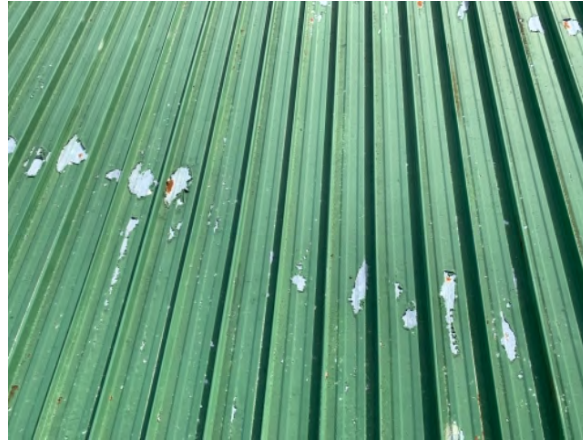
**Flakey paint**  
The roof has been repainted and the paint is starting to flake off in places. This can lead to corrosion on the metal sheets as they have to protective coating to protect them from the elements.

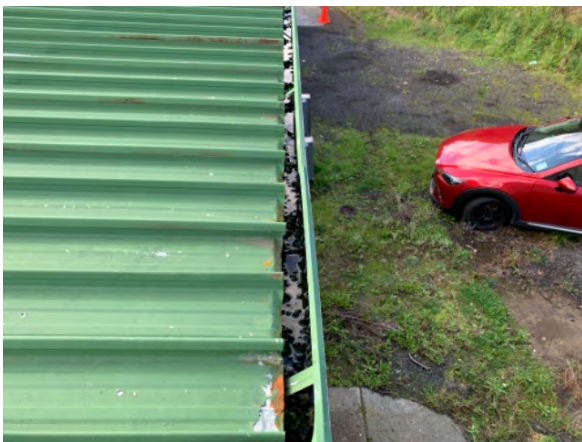
**Ponding water and organic materials in gutter**

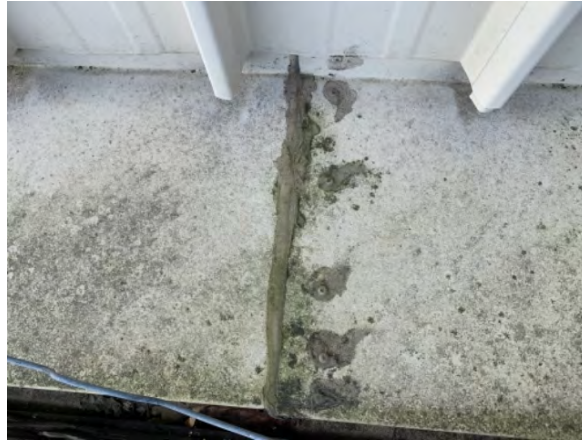
Faded sealant on flashings

Example of the cracked and faded sealant that is present in the junctions of the flashings. This needs to be replaced for new sealant to reduce the risk of water ingress into the system.

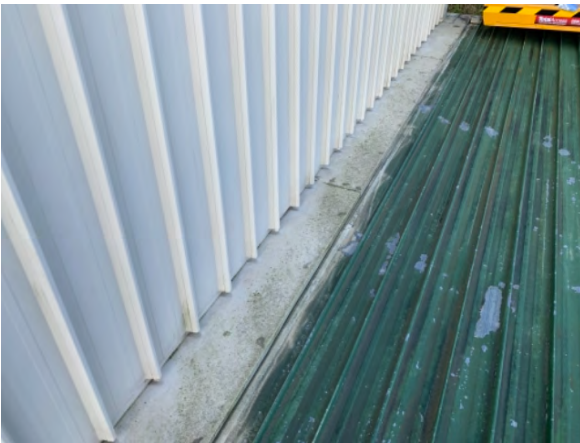
Moss and mould on flashing

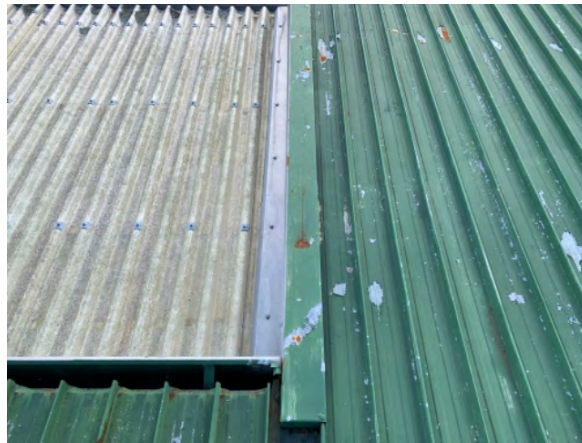
Surface rust spots on flashing

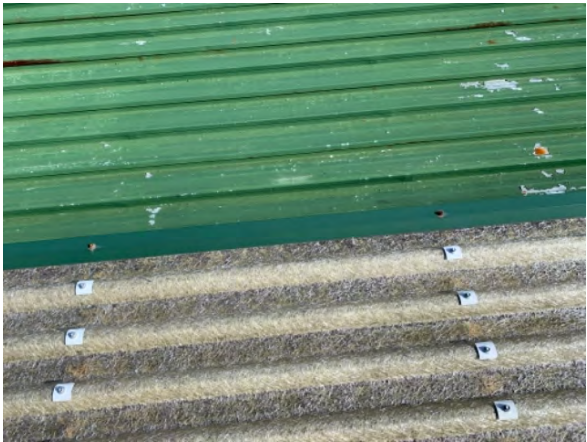
Rusty fixings

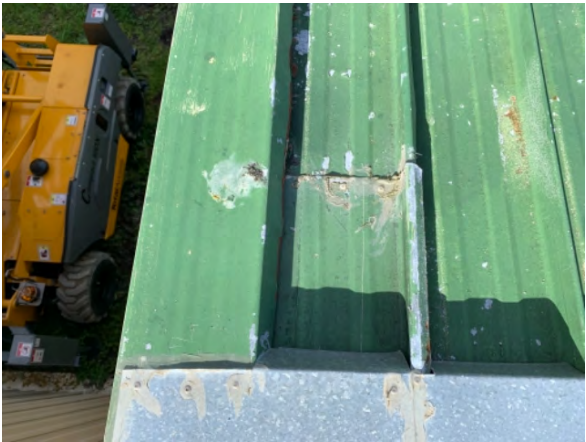
Faded sealant on short sheet

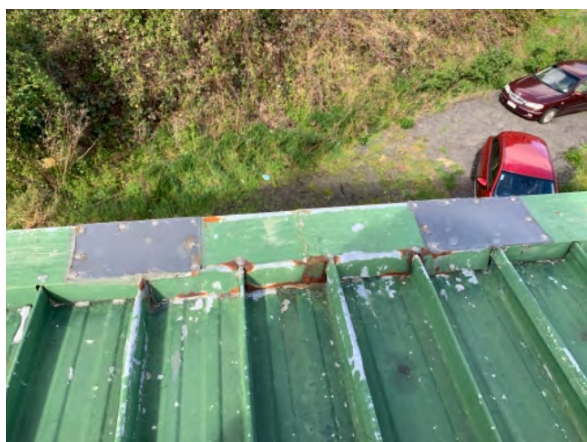
Corroded flashing with repairs

Example of areas where rust has eaten through the flashing and a new patch has been installed to cover this area. these areas need to be checked and the sealant replaced.

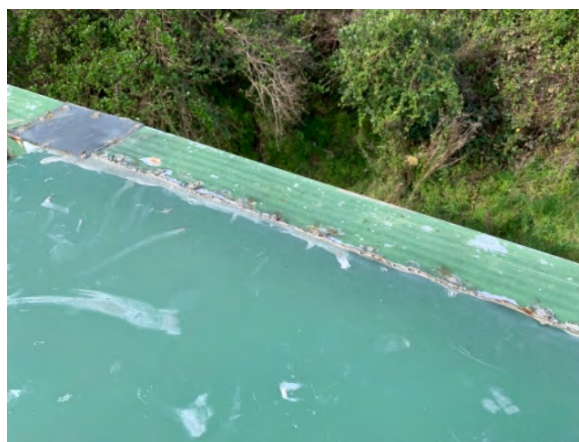
Faded sealant

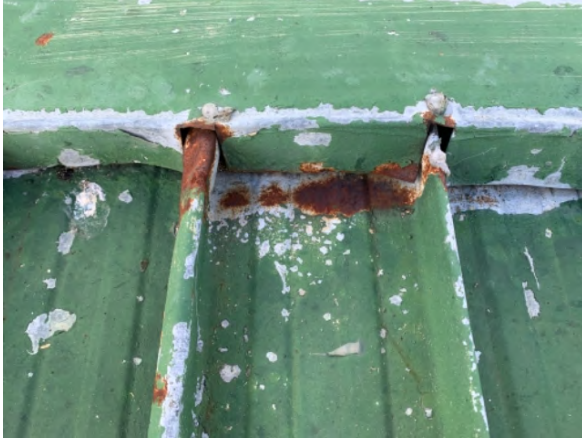
Rust on roof sheets

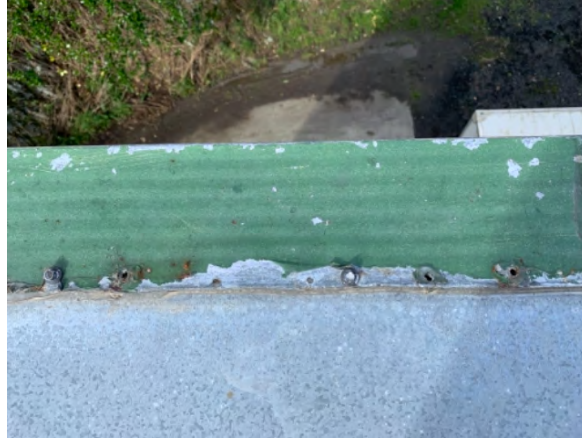
Missing fixings

The flashing has missing fixings which need to be installed to hold the flashing in place.

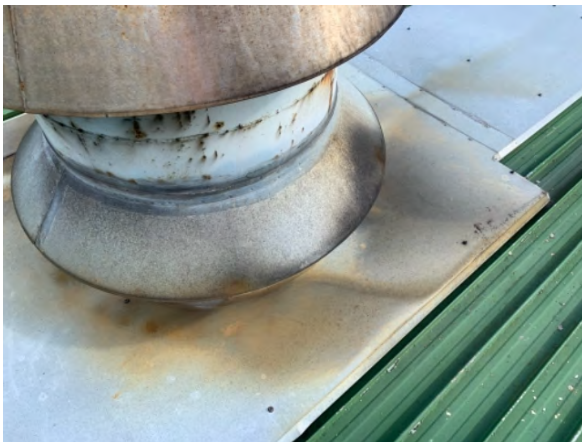
Stains on flashings

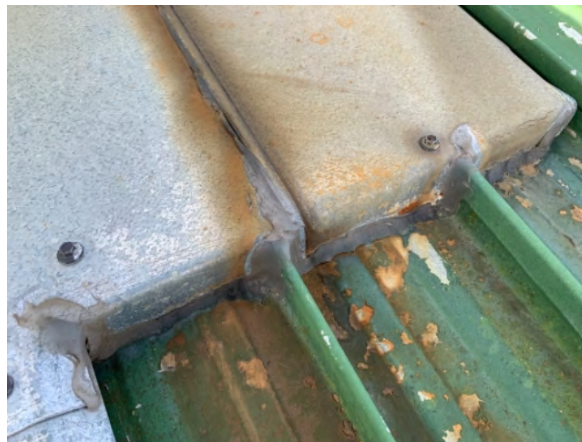
Previous sealant repairs

Previous sealant repairs done to the flashing are now cracked and faded.

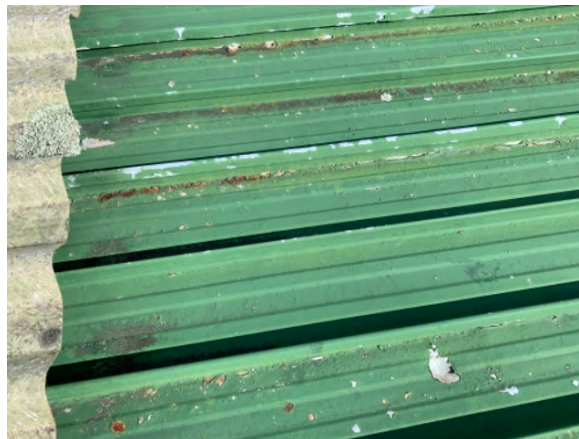
Surface rust on roofing iron

There are many areas where surface rust is present on the roof. This can lead to holes in the metal sheets and water ingress into the building.

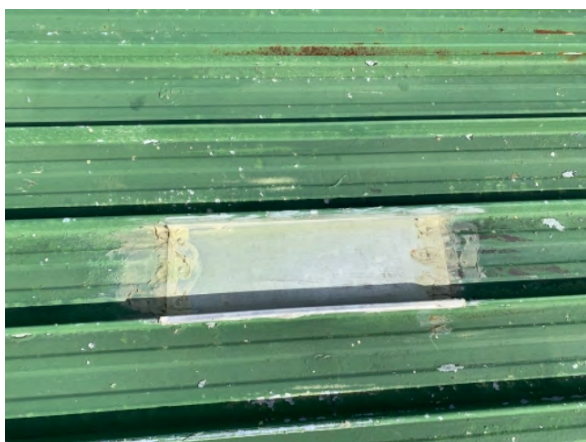
Previous repair

Previous repair to the metal sheets. Sealant around this repair is starting to fade which can lead to water ingress.

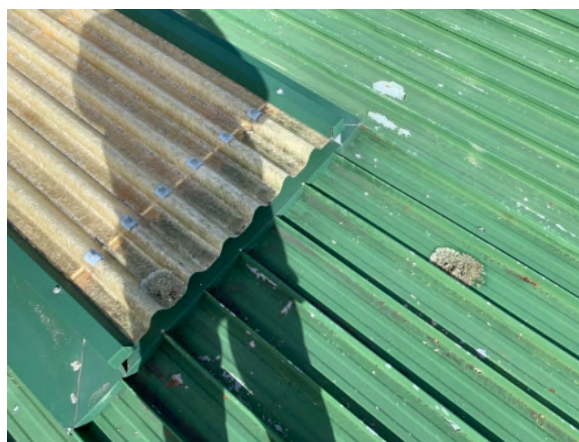
Moss on roof

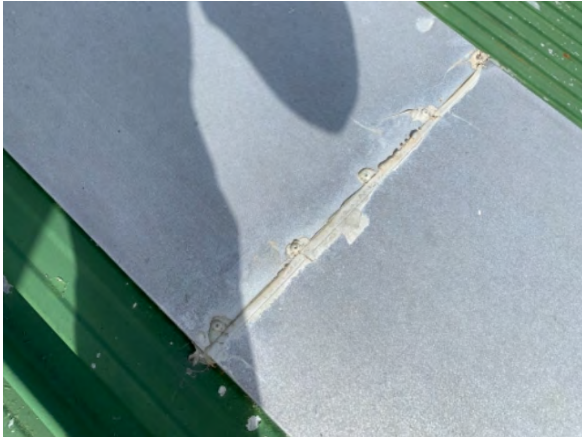
**Sealant fading**

The sealant in the joints of the flashings is cracked and faded which can allow water ingress into the roofing system.

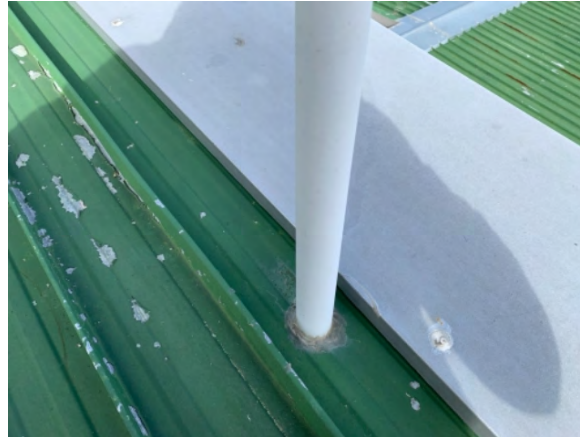
**Incorrectly flashed penetration. Fading sealant**

This pipe penetration is missing the correct tray flashing and Dektite to properly seal the area. The sealant that has been used to seal the penetration is now cracked and faded which can allow water ingress into the system.

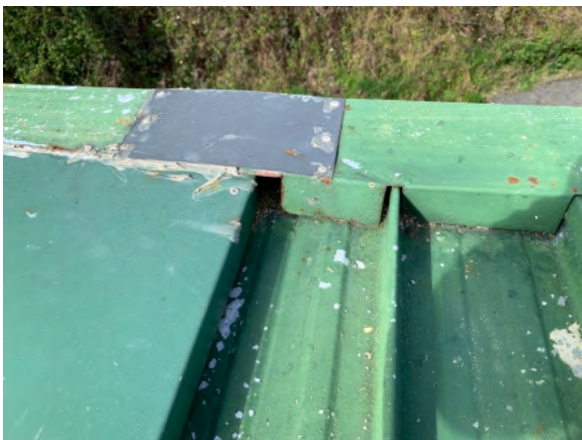
**Gaps in flashing**

There are gaps in the notching done to the flashing which can allow wind driven rain into the system.

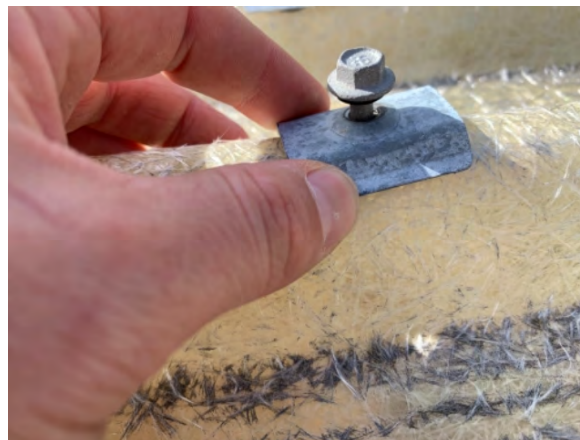
**Loose screws skylight**

There are many loose screws on the skylights. The skylights are at risk of damage in high winds.

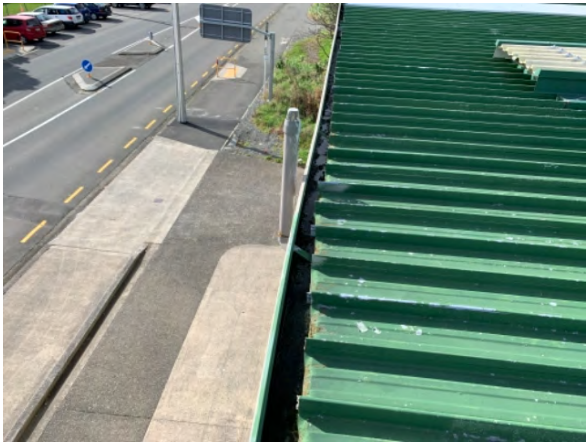
Metal box gutter  
Debris and organic materials in the metal box gutter which can cause blockages.

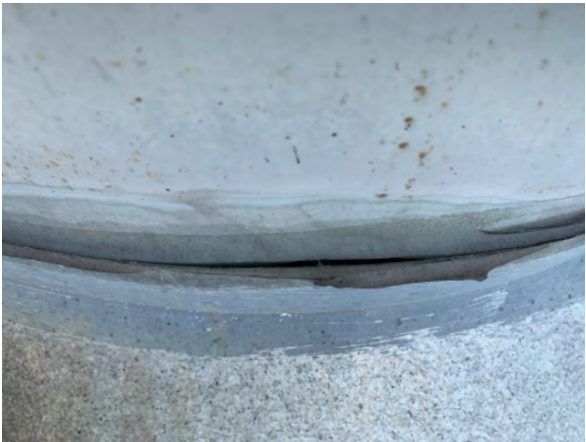
Gaps in sealant and sealant fading  
There are gaps in the sealant around the chimney penetrating through the roof.
