# **Detailed Seismic Assessment of the Waterloo Apartments Building – 28 Waterloo Quay - Wellington**

Report ref:  
PJCE 1062

10 March 2014  
Revision 05

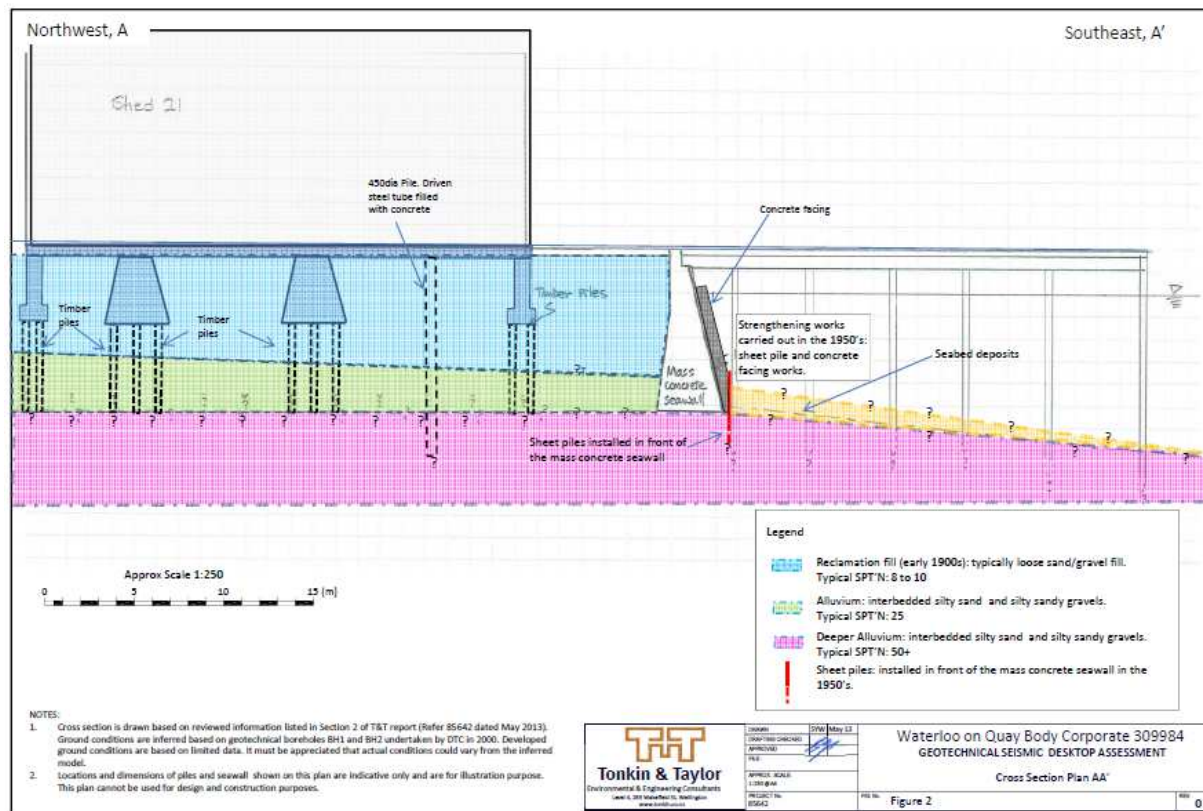
Figure 1 - Cross section through the foundations and sea wall

Refer to Figure 1 - Cross section through the foundations and sea wall. This is an extract from the Tonkin and Taylor report.

This slumping of the sea wall could cause the ground between Waterloo Quay and the sea wall to progressively migrate (or stretch) towards the seaward side. Current analysis by geotechnical engineers, Tonkin and Taylor, estimate that some movement could occur at PGA levels equivalent to 50% NBS and increase in magnitude to a degree that could cause damage to the building at 75% NBS levels of ground shaking.

If work is done to strengthen the resistance of the block of land moving seawards then the capacity of the subsoil and the foundation system can be increased up to the same 69% NBS that the building has been assessed at.

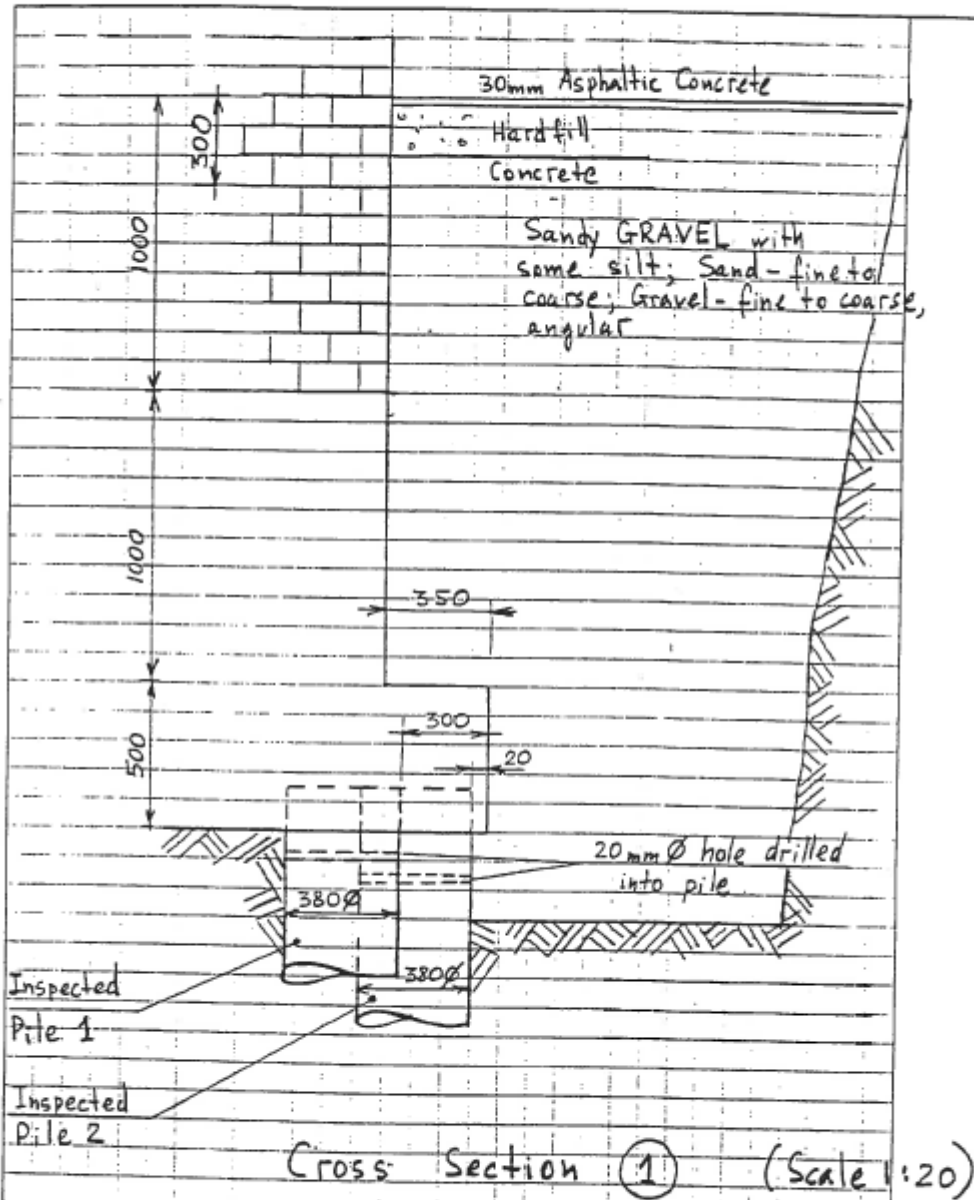
Our observations and conclusions from the inspection are reported below. Figure 2 attached shows in cross section the profile observed in the test pit.

The dimensions of the concrete ground beam and pile cap recorded in the test pit are shown on Figures 2 and 3. There was no evidence of cracking or degradation of the concrete.

The exposed sections of two piles were visually inspected, probed and each had a hole drilled through it by a Tranz Rail NZ bridge inspector (refer cross section 1 on Figure 2). From his inspection, the bridge inspector reports the piles comprised sound ironbark hardwood of 380 mm in diameter. The boring indicated no trace of discolouring or decay. Therefore, the two piles are considered to be in sound condition.
