Christchurch Property Inspections Report

419 Kainga Road,
Brooklands

30/05/2025

Pre-Sale Visual Non-Invasive Property Inspection

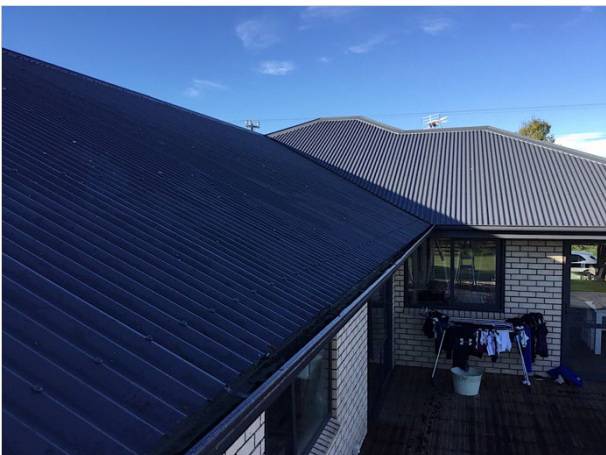
5. Typical roof

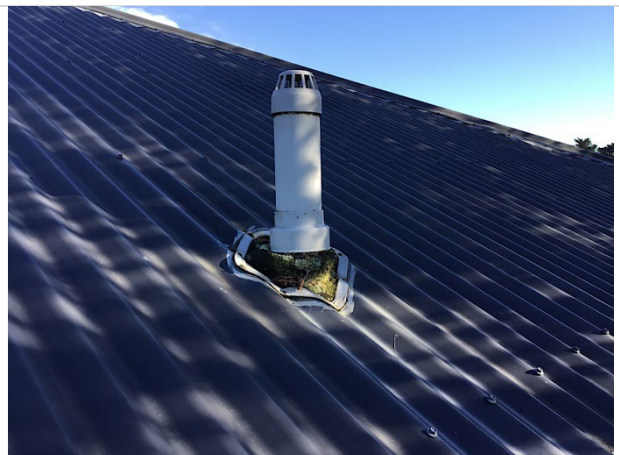
6. Roof penetration

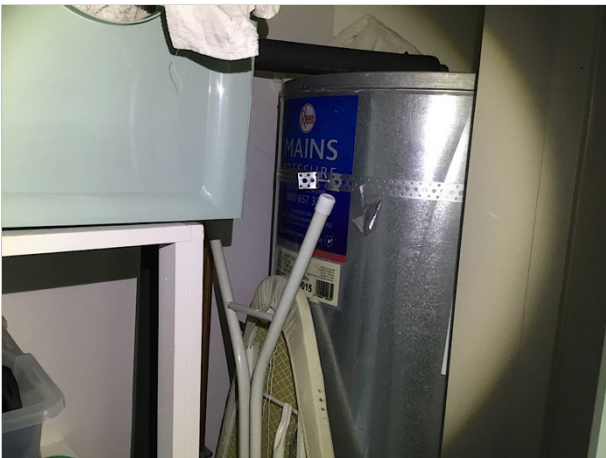
9. 250L mains pressure HWC manufactured 2009

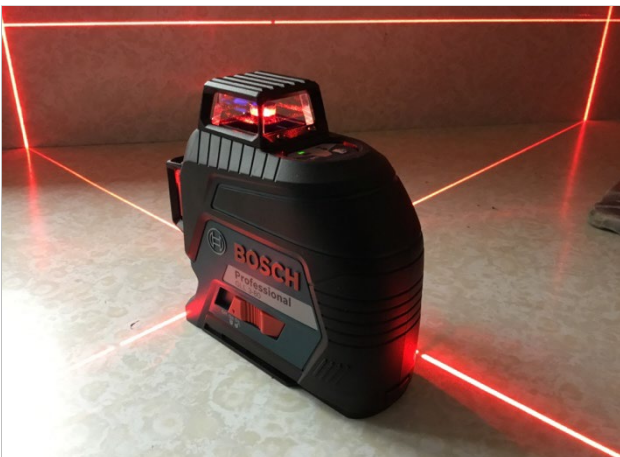
Floor Levels	<p>Spot checked throughout using a Bosch GLL 3-80 mini laser. Findings below.</p> <p>6mm variation over 10m well within guidelines below.</p> <p>MBIE GUIDELINES: 1. The floor slope between two points greater than 2m apart is less than 0.5% (1:200)</p> <p>Floor levels are spot checked using a Bosch GLL 3-80 mini laser. This is not a comprehensive floor level survey and is not designed to replace an engineer's assessment. These measurements are to be treated as indicative readings only. Floors are spot checked at different areas of the house. If a more in depth survey is required, a zip level survey should be commissioned to capture the exact floor level condition.</p>	Photo 11
Insulation Ceiling	Fibreglass batts 100mm thick. Generally sound, typical for age.	8
Insulation Floors	Concrete floor. Check plans for in slab insulation.	
Roof Structure	<p>Colorsteel roofing over building paper, timber purlins and timber trusses. Generally sound, typical for age. No significant rot or borer visible.</p> <p>NB: Due to current NZ legislation (Health & Safety at Work Act 2015) – in regard to working alone and in confined spaces; we will only provide a very limited visual inspection of the roof cavity which can be seen from a ladder at the manhole location (within a 2m radius) and/or any safe attic access space available. If you have any concerns about the quality of the structure, insulation or pest infestation we recommend further investigation by a qualified roofing/insulation/pest contractor to provide you with a specialist report.</p>	7

11. Floor levels checked with laser level

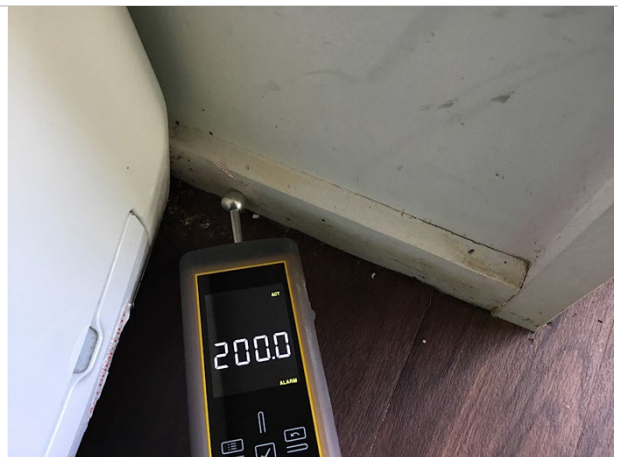
Moisture Levels	Tested high left of side door, maybe related to washing machine, further investigation required.	18

18. Beside washing machine

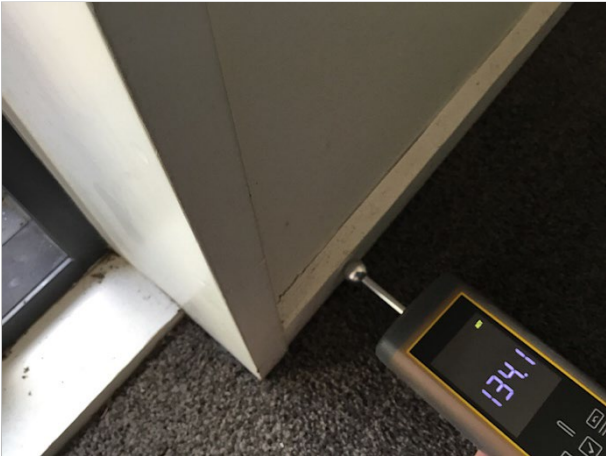
Windows/ Slider	Aluminium double glazed. Operational. Generally sound, typical for age.	Photo
Doors	Paint finish. Operational. Generally sound, typical for age.	
Flooring	Carpet. Appears in good condition, typical for age.	
Walls	Painted plasterboard. Generally sound, typical for age.	
Ceilings	Painted plasterboard. Generally sound, typical for age.	
Lighting	Downlights. Operational. Generally sound, typical for age. 1 not working.	
Architrave/ Skirting	Paint finish. Generally sound, typical for age.	
Heating	N/A.	
Moisture Levels	Tested high right side of slider, peel carpet back to see point of water entry.	19

19. Beside living slider

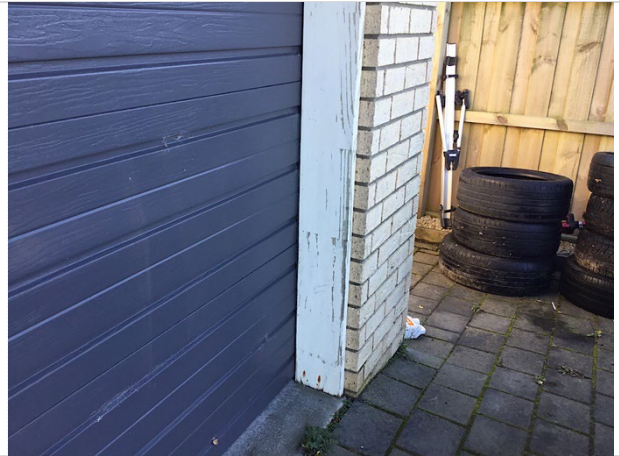
20. Garage door jamb needs painting

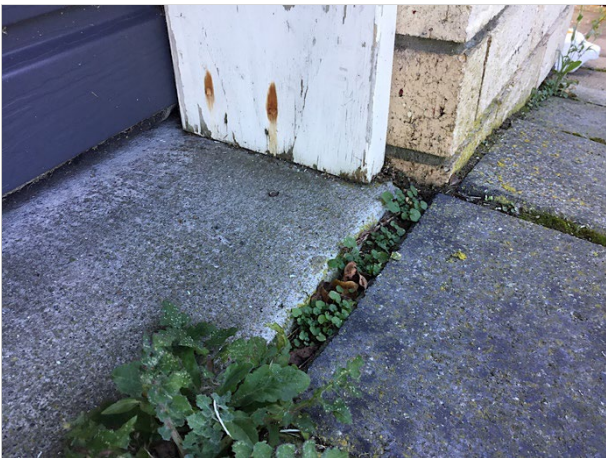
21. I recommend 12mm gap between garage door jamb and concrete to prevent moisture transfer

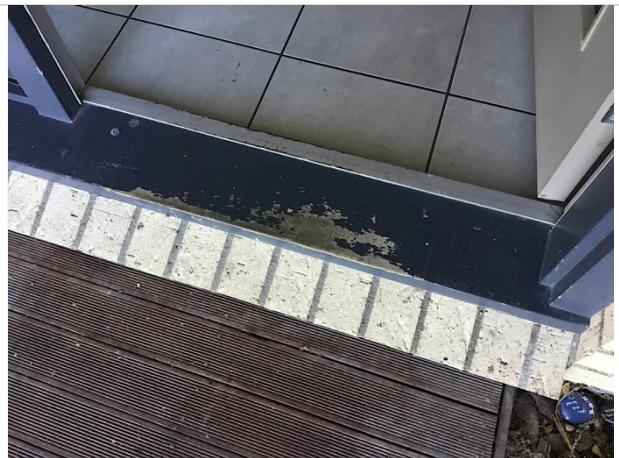
22. Front door sill needs painting

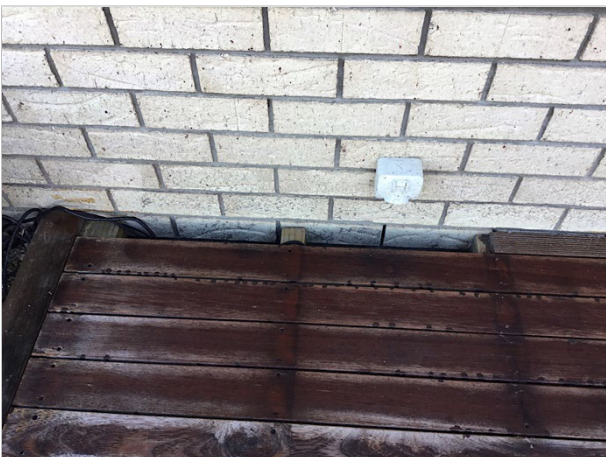
23. Install missing decking

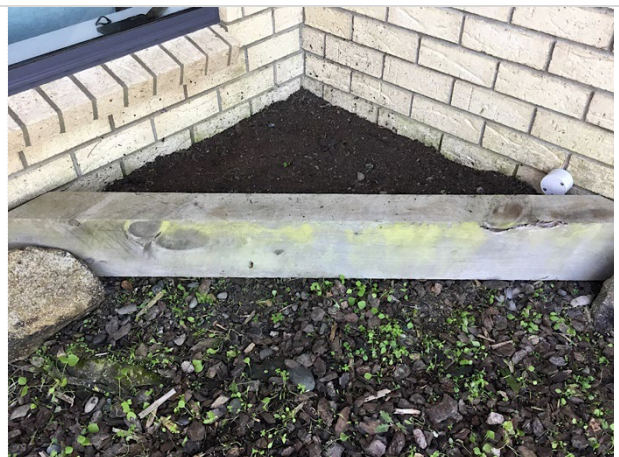
24. Remove soil from bottom brick course vents

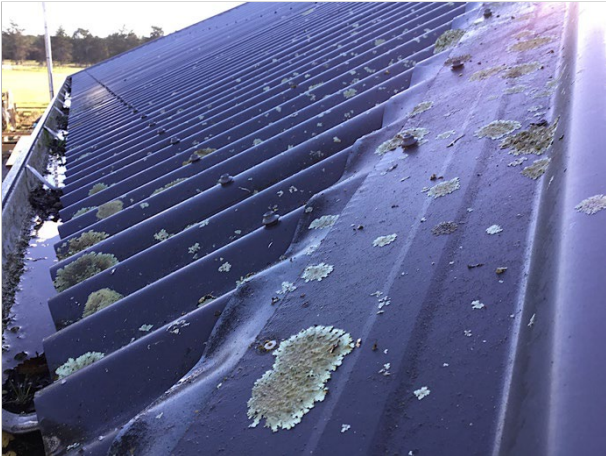
Roofing	<p>Coloured steel roofing with tek screw fixings. Generally sound, typical for age.</p> <p>This type of roofing will need to be checked occasionally as part of routine maintenance.</p> <p>Requires lichen treatment</p> <p>Restrictions: Due to current NZ Health & Safety at Work Act 2015 in regard to working alone and at height: We will provide only a very limited visual inspection of the exterior roofing which can be seen from a ladder (3.6m) at several locations around the building. If you have concerns about the quality of the roof cladding or roof structure, we recommend further investigation by a qualified roofing professional.</p> <p>(No watertightness or weathertightness tests are carried out during visual, non-invasive inspections of this kind so all comments regarding these issues are on the basis of observation only. Furthermore for health and safety reasons (as specified above) the inspector does not walk on the roof and all comments are based on the limitations of line-of-sight observations made from laddertop positions or in the case of two or more storey buildings from scaffolding, if present, or from vantage points either on the ground or inside the building).</p>	5, 6, 25

25. Roof needs lichen treatment

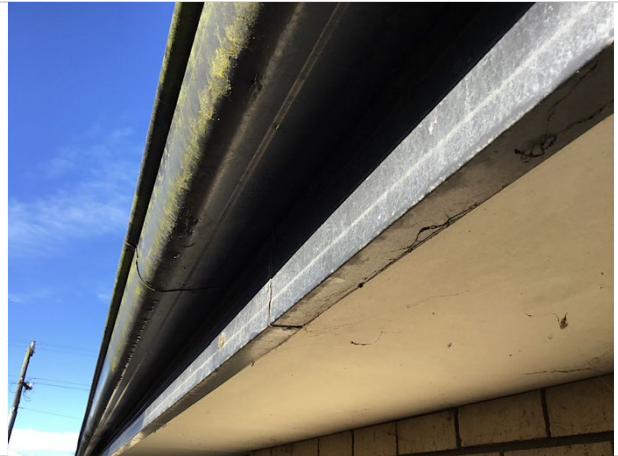
Downpipes, G/T & Stormwater	<p>PVC downpipes fall to PVC storm water risers, appear sound usable condition. Gully traps clear.</p> <p>No guarantees can be given as to the state of the underground piping due in part to the ongoing nature of seismic activity in the Canterbury region. No pipework tests were undertaken during this inspection.</p>	
Guttering	<p>Coloured steel. Generally sound, typical for age.</p> <p>Needs cleaning inside and out.</p> <p>Note: It is important to maintain clean guttering to eliminate blockages that may cause moisture ingress into the wall framing.</p>	26

26. Gutter needs cleaning inside and out

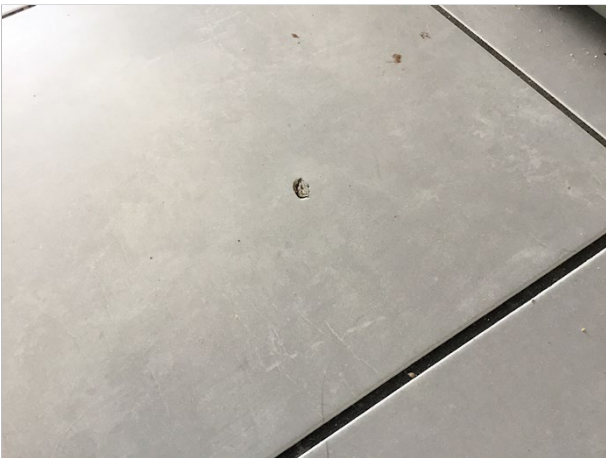
Benchtop	Formica. Generally sound, typical for age.	Photo
Cabinets	Laminate. Generally sound, typical for age.	
Sink & Waste	Stainless steel. Generally sound, typical for age.	
Plumbing Fittings	PVC waste water pipe and water pipes have no visible leaking. Good pressure. Good condition.	
Oven	Under bench 600mm Fisher and Paykel. Generally sound, typical for age. Untested. Check with vendors immediately prior to property settlement that all oven and hob functions are fully operational.	
Hob	4 zone ceramic. Generally sound, typical for age. Untested.	
Range Hood	900mm extractor. Operational. Externally ducted. Generally sound, typical for age.	
Fridge Space	900mm x 1750mm.	
Windows	Aluminium double glazed. Operational. Generally sound, typical for age.	
Flooring	Tiles. Appears in good condition, typical for age. A couple of chipped tiles.	27
Walls	Painted plasterboard. Generally sound, typical for age.

27. Chipped kitchen tile

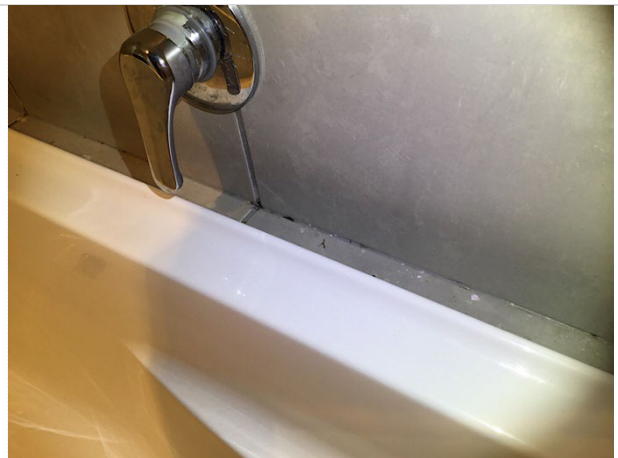
28. Spots of mould in bath cradle silicone

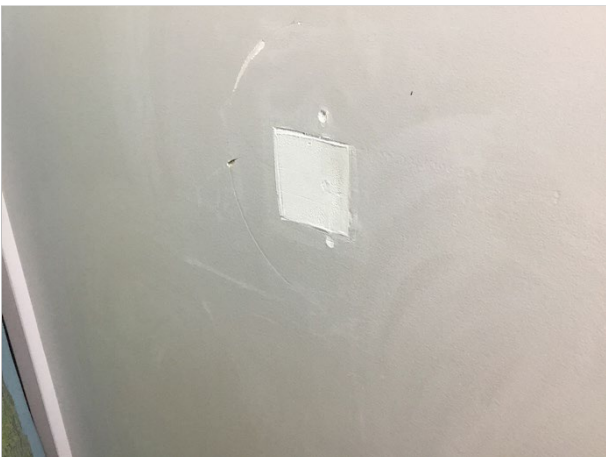
Pan & Cistern	Porcelain. Dual flush. Operational. Generally sound, typical for age.	Photo
Flooring/ Skirting	Tiles. Appears in good condition, typical for age.	
Walls	Painted plasterboard. Generally sound, typical for age. Repair incomplete.	29
Ceilings	Painted plasterboard. Generally sound, typical for age.	
Door	Paint finish. Operational. Generally sound, typical for age. Door stop rubber missing.	
Windows	Aluminium double glazed. Operational. Generally sound, typical for age.	
Lighting	Downlights. Operational. Generally sound, typical for age.	
Architrave	Paint finish. Generally sound, typical for age.	
Moisture Levels	Tested low at time of inspection.

29. Unfinished toilet wall repair

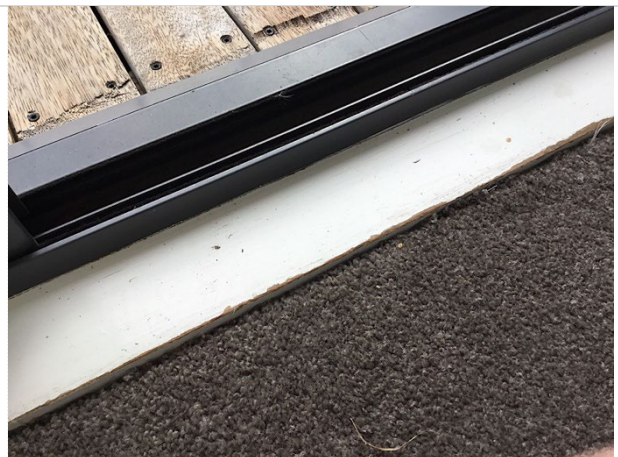
Windows/ Slider	Aluminium double glazed. Operational. Generally sound, typical for age. Dining living slider reveal needs painting	30
Doors	Paint finish. Operational. Generally sound, typical for age.	
Flooring	Carpet. Appears in good condition, typical for age.	
Walls	Painted plasterboard. Generally sound, typical for age.	
Ceilings	Painted plasterboard. Generally sound, typical for age.	
Lighting	Downlights. Operational. Generally sound, typical for age. 1 not working.	
Architrave/ Skirting	Paint finish. Generally sound, typical for age.	
Heating	Mitsubishi high wall heat pump. Generally sound, typical for age. Untested.	
Moisture Levels	Tested low at time of inspection.

30. Dining living slider reveal needs painting
