## PRODUCER STATEMENT – PS4 – CONSTRUCTION REVIEW

IN RESPECT OF: Seismic Strengthening  
(Description of Building Work)

AT: 34 Upland Road, Kelburn  
(Address)

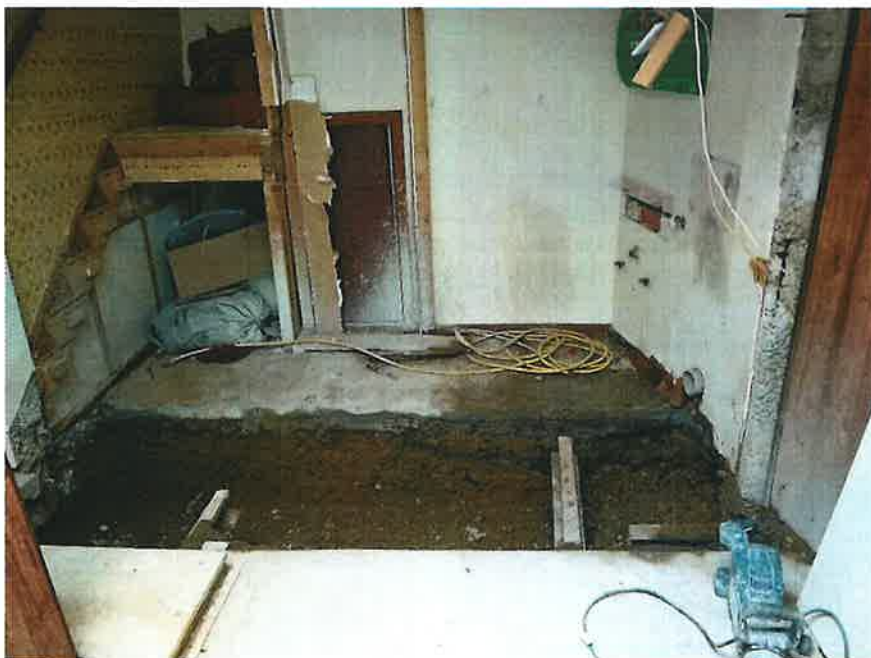
**Figure 1**

First-floor ground beam location.

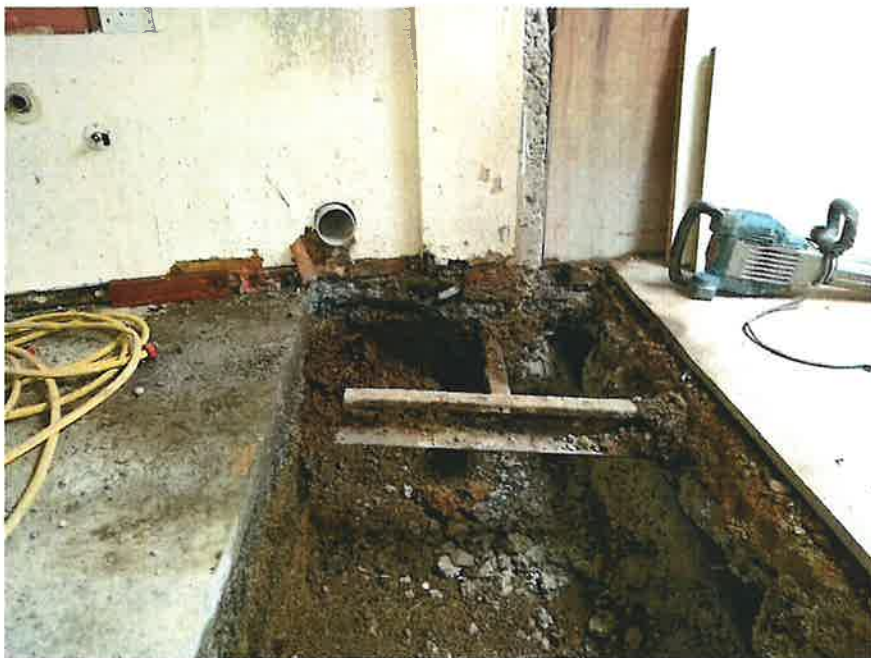
**Figure 2.**

Looking towards the existing column  
at GL3/GLD intersection.

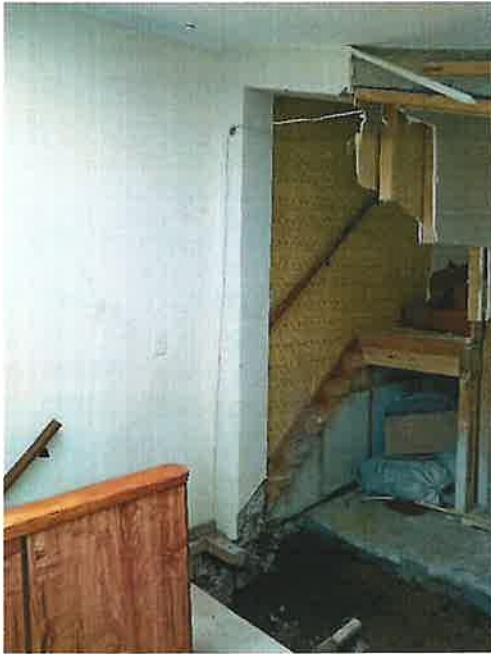
**Figure 3.**

Looking towards the existing column  
at GL1/GLD intersection.

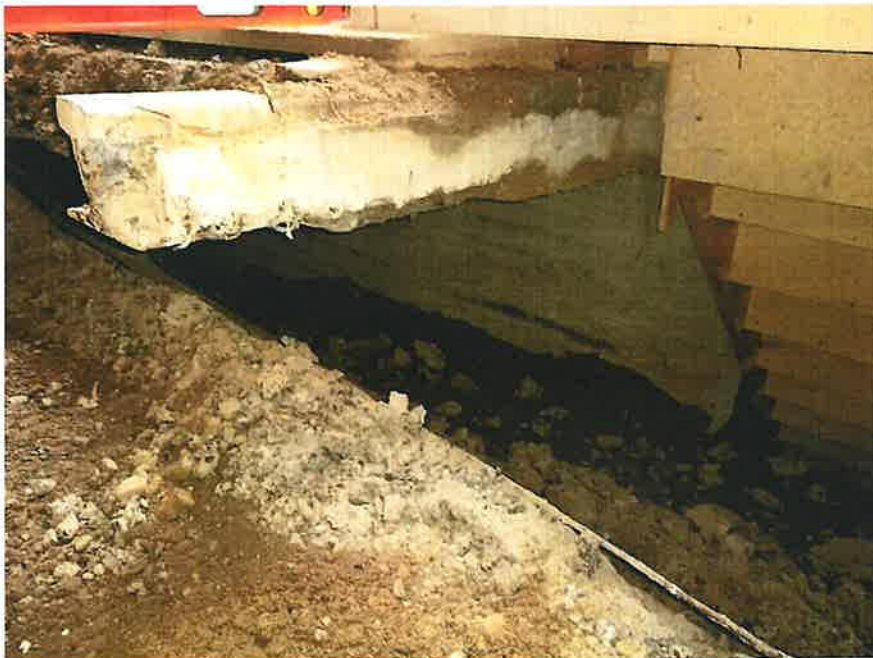
**Figure 4.**

Railway iron spanning from the  
concrete retaining wall to the next  
concrete retaining wall that has  
been partially demolished.

- As the concrete that was supporting the perpendicular railway irons has been removed, new support for this slab is needed. To avoid any clashes, we recommend that the railway irons are cut back to the edge of the existing slab, and starter bars (as per our detail) are installed.
- The design intention was for the ends of the ground beam to be tied into the foundations of the side walls. These existing foundations are shallow and there is insufficient concrete to tie into to transfer the beam loads into the side walls.
  - To resolve this issue, a Micropile will need to be installed at both ends of the ground beam, with 2-HD16 bars that hook into the core of the ground beam. An augured concrete pile at each end can also be installed.

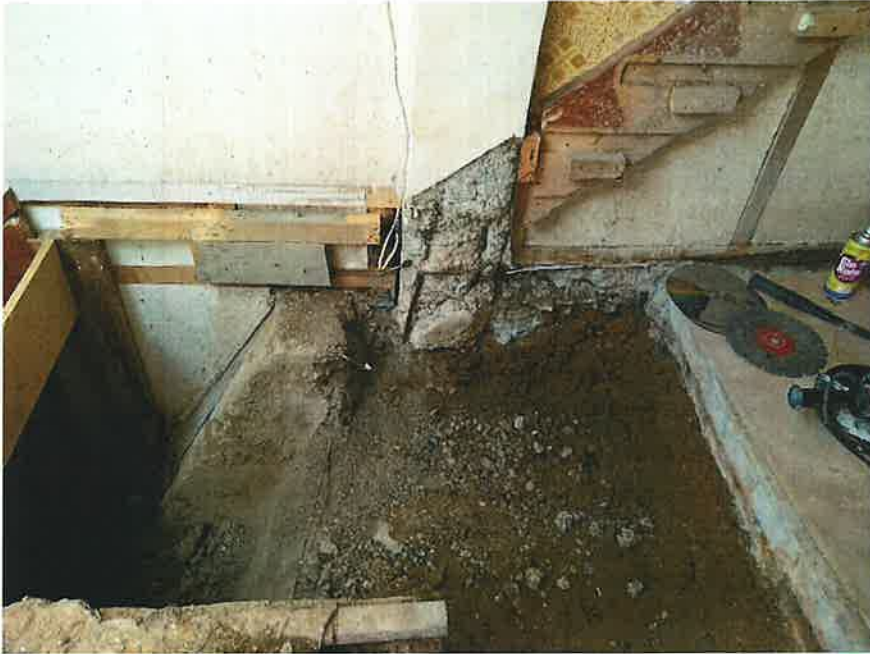
**Figure 1**

Ground beam at GL1/GLD.

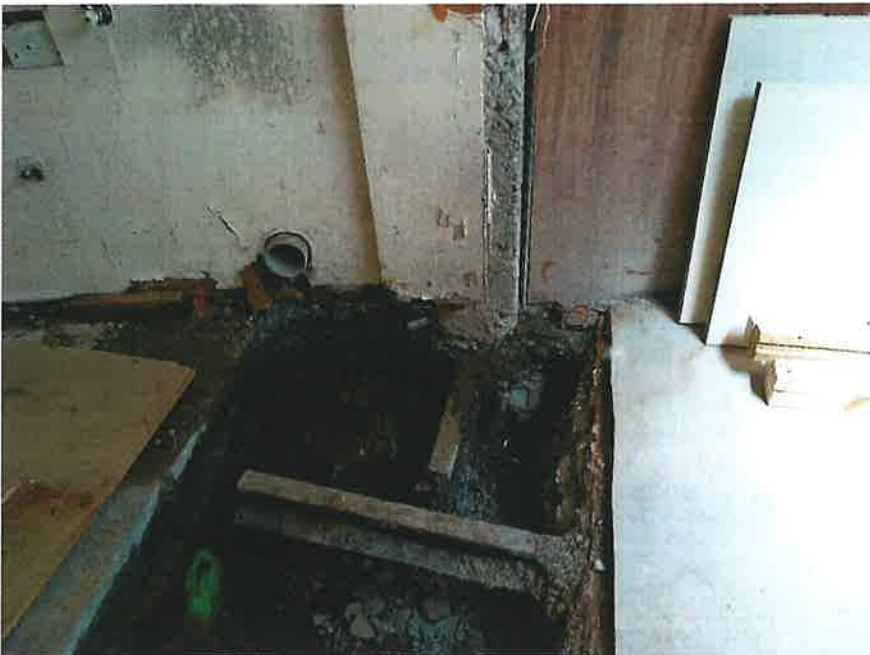
**Figure 2.**

Ground beam at GL2/GLD.

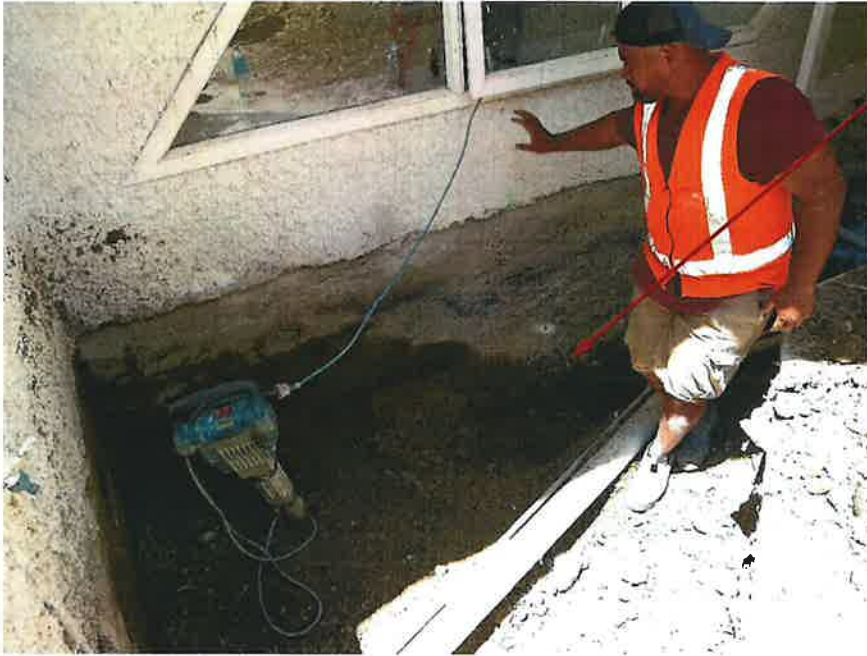
**Figure 3.**

The proposed location of the ground floor titan anchor is intended as shown on DR-501. The existing foundation wall of the building extends deeper than shown in Detail 2a/501, meaning the concrete wall will need to be core drilled at the angle of the anchor to enable drilling.

Anchor location.

Approximately 600mm below the  
internal floor level.

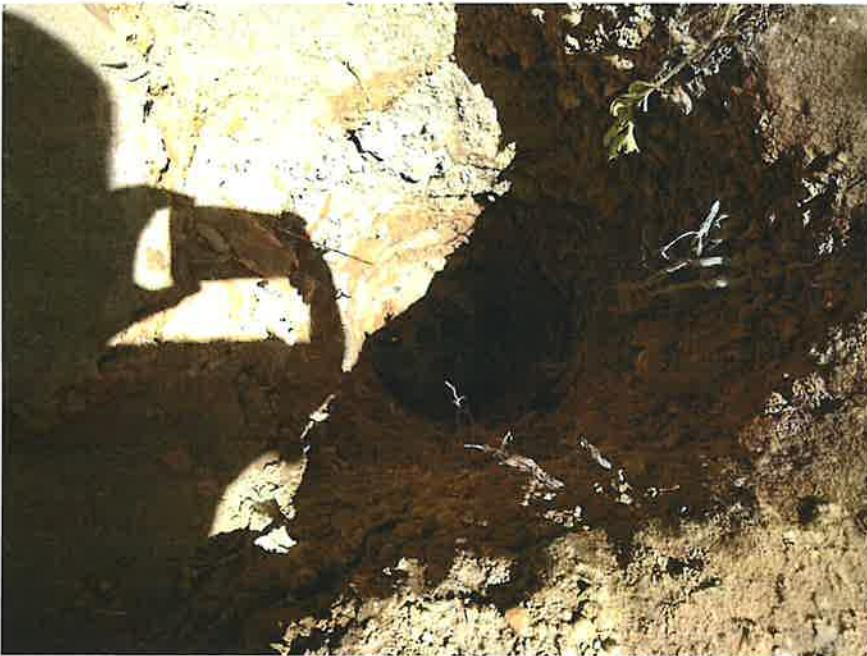
**Figure 4.**

We prodded the foundation hole for the SHS post and confirmed firm bearing has been achieved.

SHS post foundation hole.

The loose soil will be removed before installing the reinforcing cage.

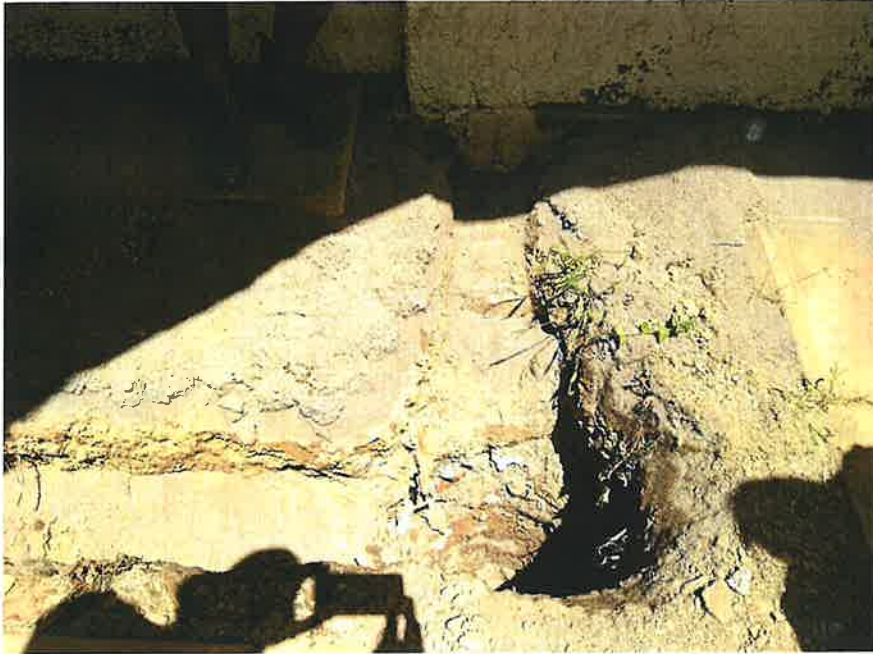
**Figure 5.**

SHS post tie beam excavation.

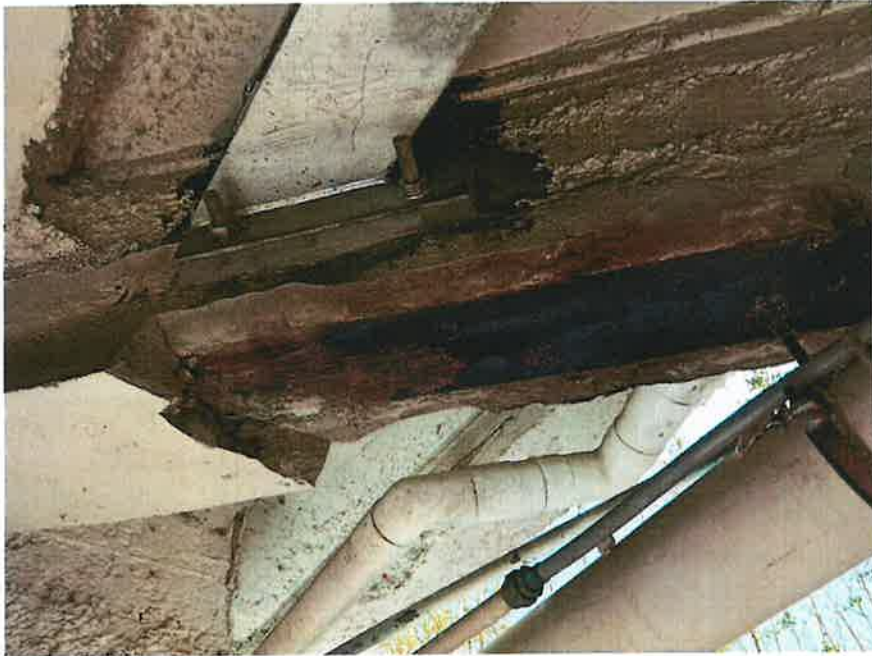
**Figure 5.**

Corrosion has been wire brushed and treated (darker colour).

Towards the left-hand side, there was no corrosion.

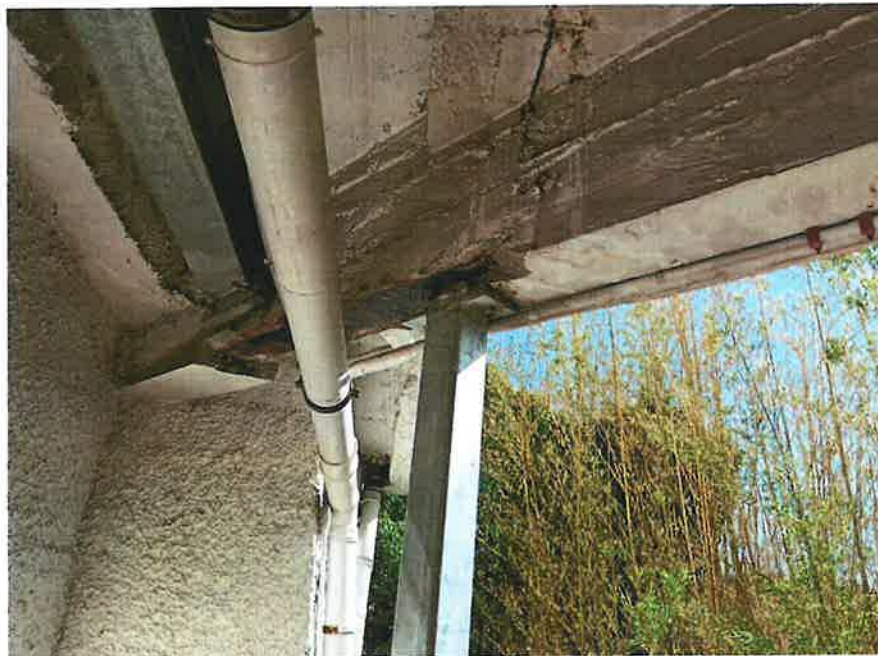
**Figure 6.**

Ground level SHS post and location of cast in I-Beam corrosion repair.

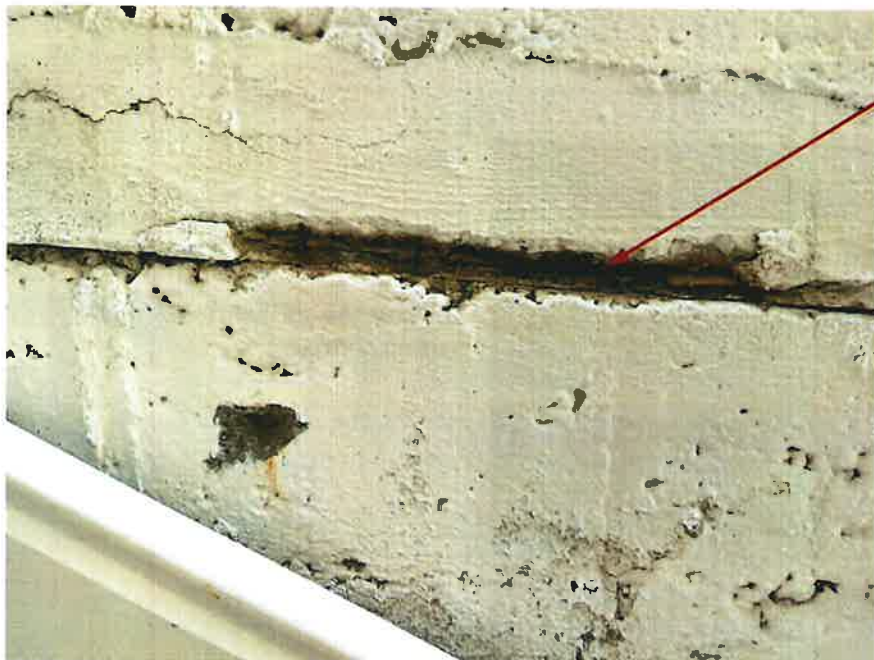
**Figure 3.**

Example of reinforcing that has been treated.

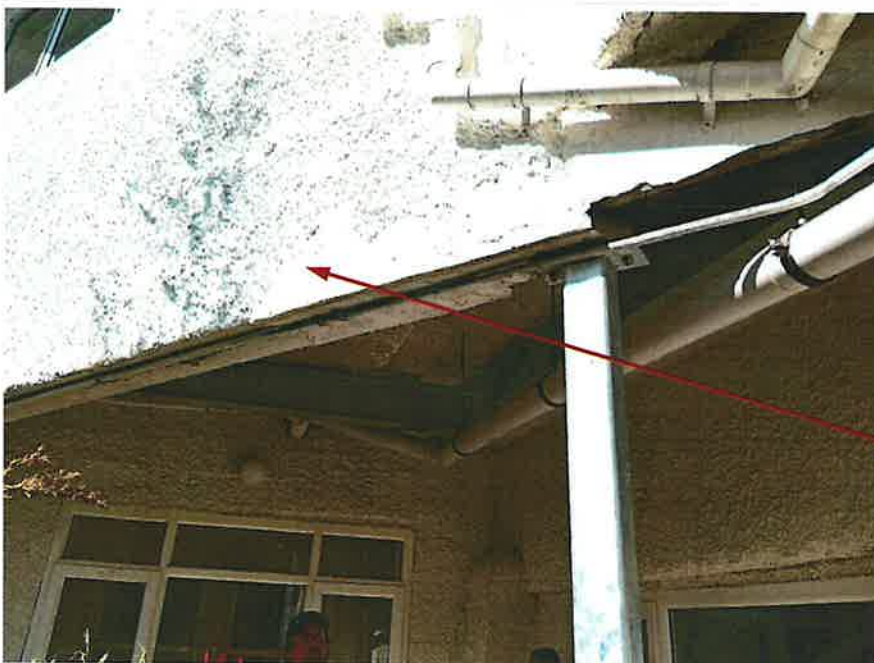
**Figure 4.**

Ground level SHS post and location of cast in I-Beam corrosion repair.

Further exposing to be done.

Extent of historical repair.

**Description:** The cracked concrete has been broken out and the underside of the cast in I-beam partially exposed. The corrosion to one side of the SHS has been treated however that other side has not been exposed as the concrete was not cracked.

**Recommendation:** We have instructed the contractor to break out more of the concrete above the SHS post as there is still visible corrosion. The concrete will be broken out until the corrosion stops, or once the historic repair has been fully removed – we want to avoid breaking out undamaged original concrete. If corrosion is still observed at the end of the historical repair, contact DTCE for further instruction.

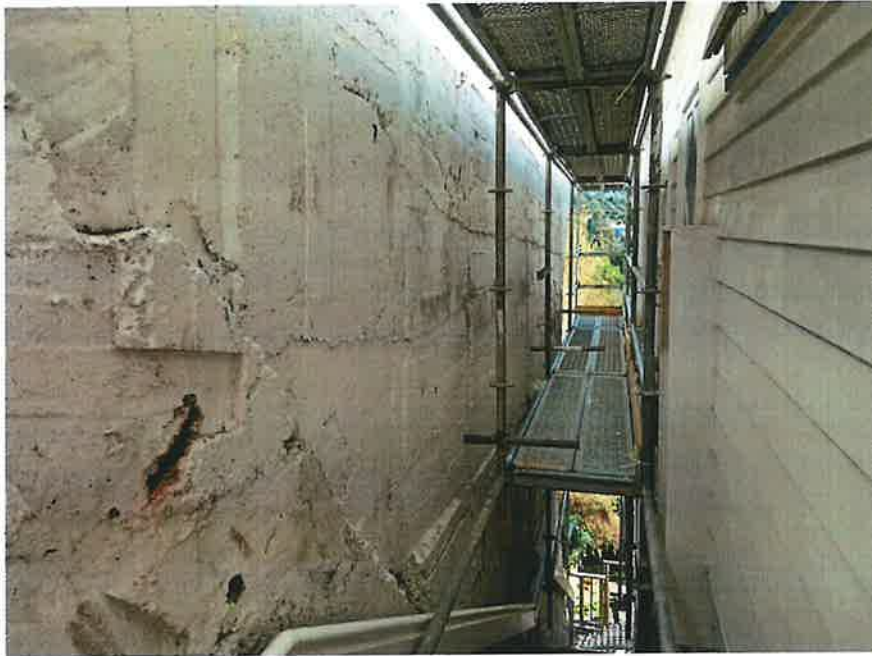
**Figure 1**

Overview of the northern elevation corrosion repair work.

**Description:** The bulk of the corrosion remedial work on the northern elevation has been completed.

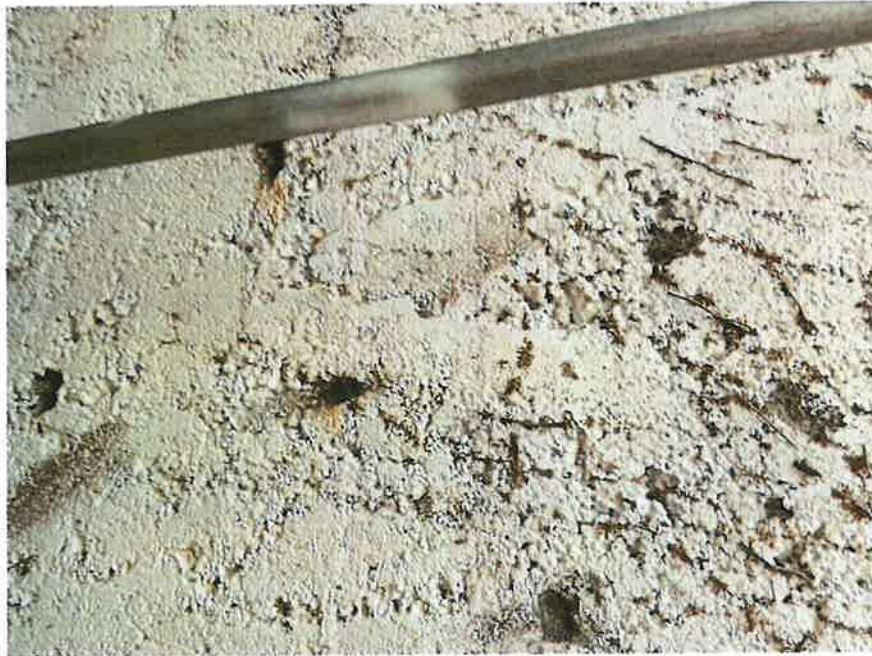
**Figure 2.**

Examples of where corroded wire has been cut back and treated – ready for mortar to be placed.

- The corroded wires have been cut back and treated as specified. These areas are ready for the repair mortar to be installed.
- The majority of the exposed reinforcing has been wire brushed and treated. There are some locations that have not yet been addressed.
  - Photos to be sent of the remaining areas for approval.
  - Corrosion that has been addressed is ready for the structural mortar repair.

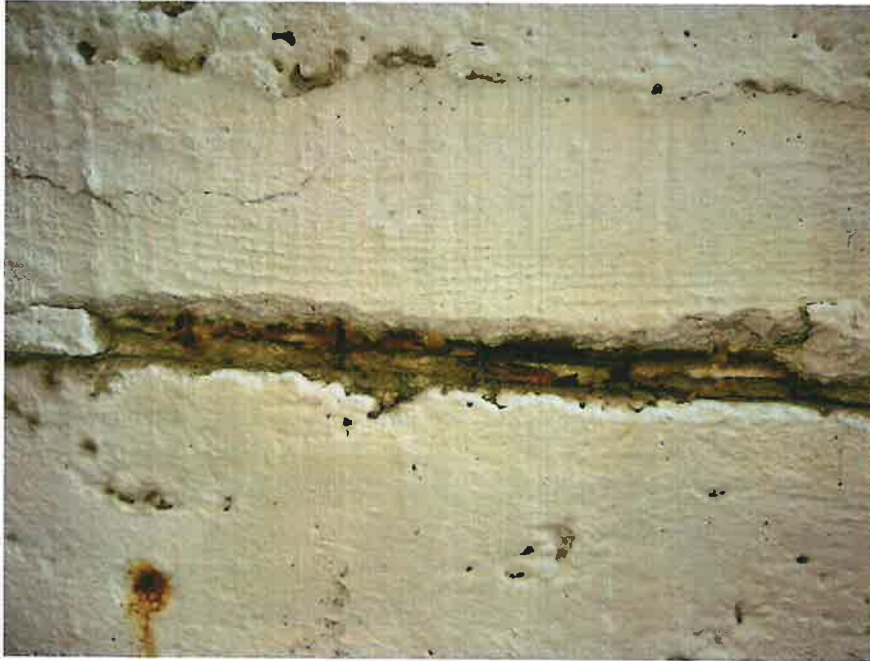
**Figure 5.**

Example of exposed reinforcing on the northern elevation that requires repair.

**Description:** There are two types of corroded steel on the northern elevation; reinforcing steel and small diameter wire. As the wire is not serving a structural purpose, we recommend that these pieces of wire are cut back, rust treated and plastered. The repair efforts on the northern elevation should be focused on the main reinforcing bars that are exposed and the spalling sections of concrete.

- i. Address the corroded reinforcing/spalled concrete (Structural repairs) as previously discussed. Alternate products to the Sika Monotop product previously suggested can be used, including Ardex BR 345 and Ardex BR 340. If there are other suitable products found, discuss with DTCE before proceeding.  
*Note: A curing compound such as Sika Antisol A Curing Compound can be used to protect the fresh mortar, in place of covering the concrete with polythene etc.*
- ii. At locations where voids in the concrete are being filled (due to poor placement of the original concrete), a mortar such as Cemix Quick Patch or Gorilla Powercrete 7min Cure Mortar Repair can be used.
- iii. As an alternate option to sand blasting, all exposed corroded reinforcing can be wire brushed and treated with a rust convertor. The concrete repair methodology previously discussed can then be implemented.

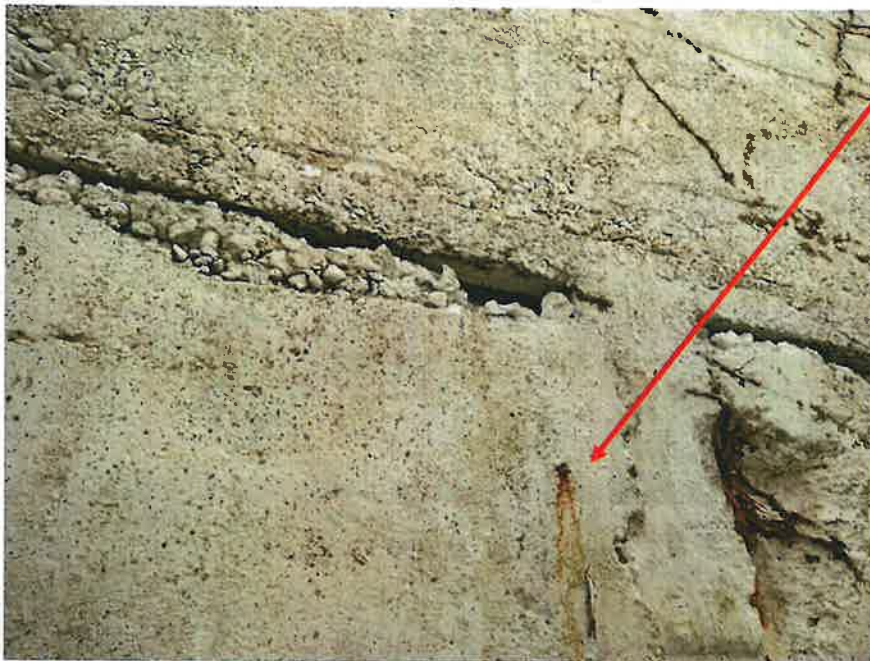
**Figure 6.**

Example of exposed wire that doesn't require a full structure repair.

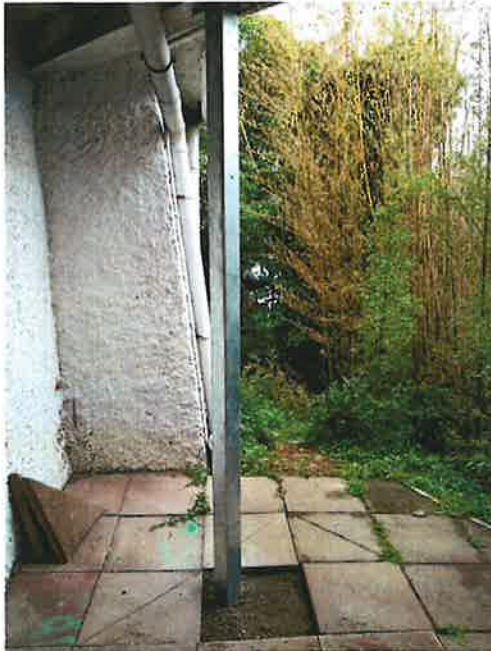
**Figure 3.**

Ground floor SHS post.

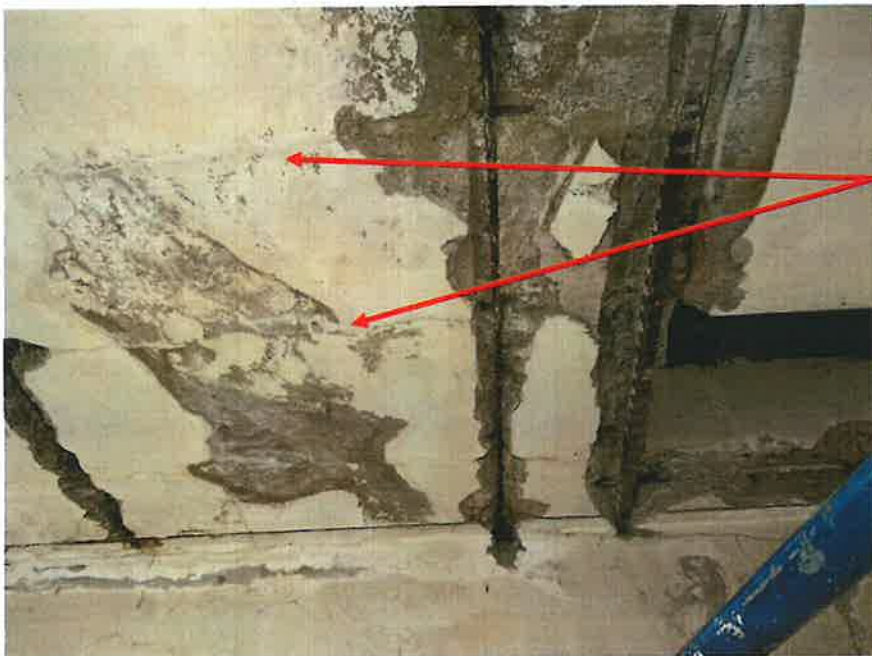
**Figure 4.**

Typical exposed garage ceiling  
reinforcing.

Cracks along the line of the  
reinforcing bar.

**Description:** The worst cracks in the ceiling of the garage have been broken out. Heavily corroded reinforcing has been found. The cracks left untouched line up with the location of the steelwork, suggesting that the entire slab is corroded.

**Option 2:** Install a steel gravity support and bracing structure below the existing slab. This will provide gravity support to the slab should it fail and will provide a sufficient diaphragm to support the external walls. This option reduces the risk of the concrete slab being a life- safety risk however it will continue to deteriorate.

**Option 1:** Remove the entire bottom layer of plaster, treat/replace reinforcing and reinstate a minimum 35mm thick layer of concrete. This will address the observable damage to this slab, however given the condition of the internal face of the slab, it is probable that the top layer of

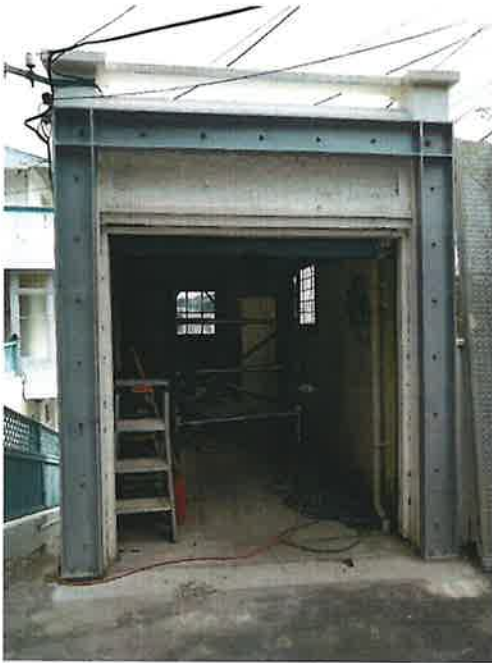
**Figure 1**

Garage Portal Frame.

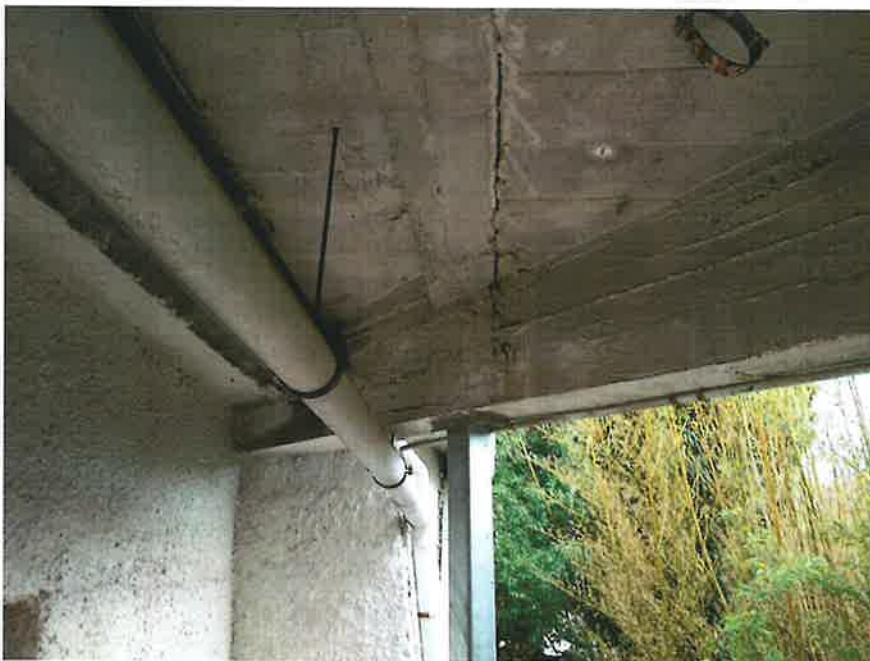
**Figure 2.**

Ground floor SHS post.

**Recommendation:** The crack repair in this area still needs to be carried out. We understand that there is a structural steel member within the concrete. The concrete should be broken out/the crack chased within this area, and the steelwork treated as needed. If severe corrosion of this beam is found, contact DTCE.

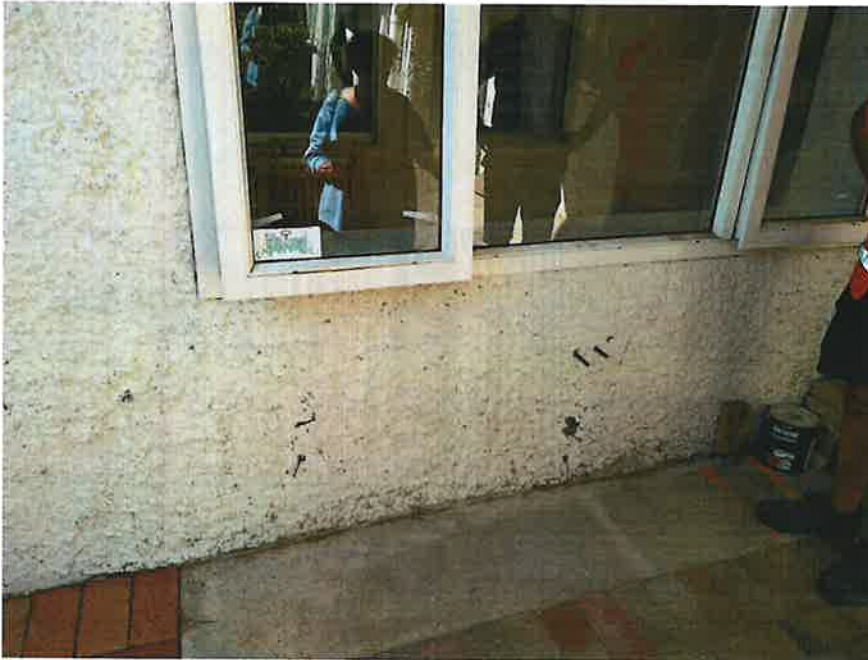
**Figure 5.**

Penetrations in the concrete wall that are not of structural concern.

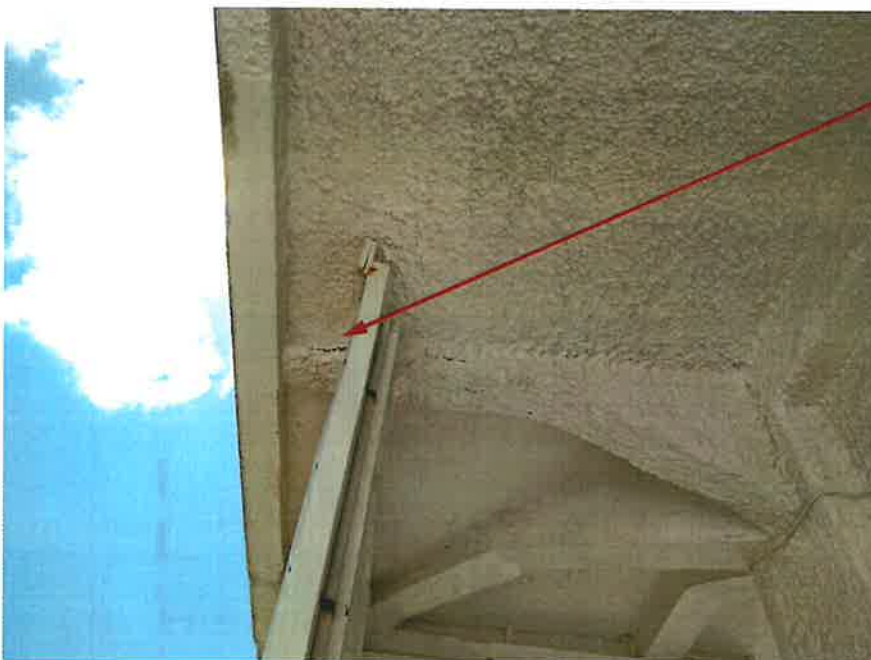
**Figure 6.**

Cracking in a concrete beam of the main building.

**Description:** Following an earthquake in late 2024, Marilyn noticed some new cracks in the previously strengthened building. These cracks were primarily internal and have since been repaired. We also noted cracking to one of the beams that supports the balcony above. This crack couldn't be measured due to the height of the beam but appears to be significant and should be further investigated.

Further investigation of the external beam crack should be carried out and repairs should be made. Likely exposing and treating the reinforcing, then epoxy injecting the crack.

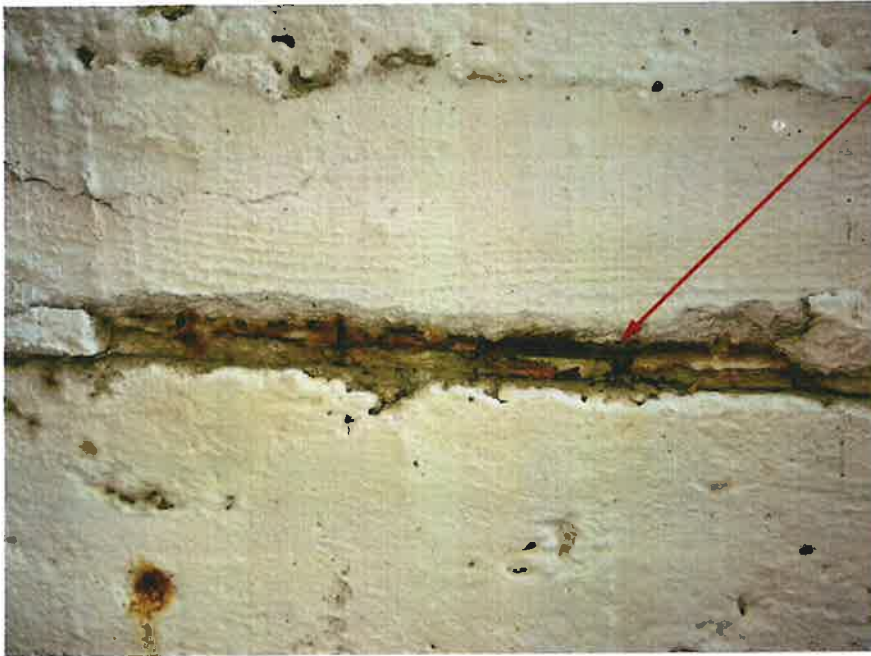
**Figure 3.**

Example crack with corroded reinforcing where the reinforcing needs to be exposed, treated/replaced and the concrete repaired.

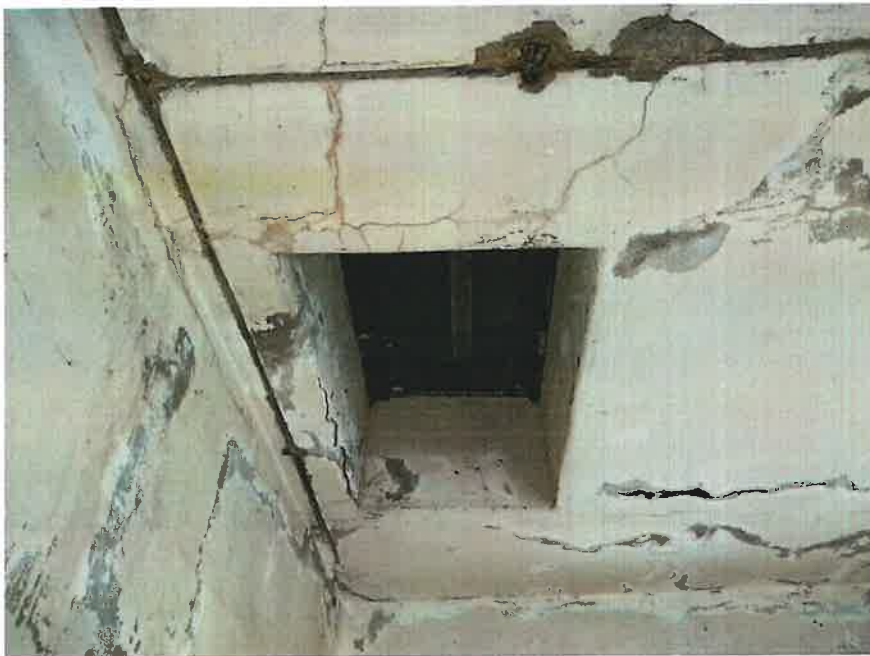
**Figure 4.**

Significant cracking (internally) throughout the garage, with reinforcing already exposed in some locations.

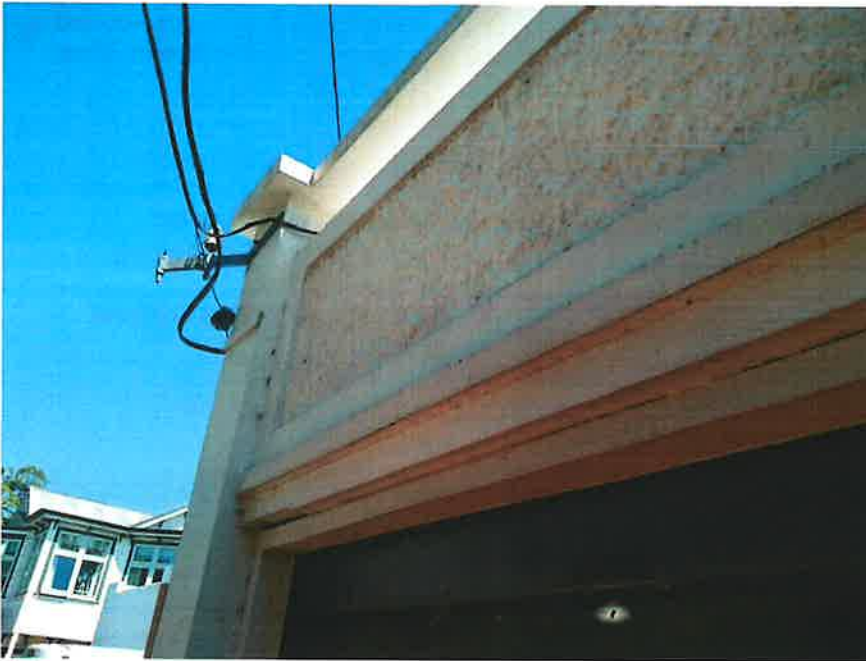
**Figure 1**

Garage lintel is ~60mm recessed from the front face of the columns.

**Recommendation:** As the primary purpose of the portal beam is to connect the legs (not support the concrete lintel) this connection is not critical to achieve the required strengthening.

We recommend that the beam bolts are increased from M12 to M16 to account for the additional length and the beam packed out to close the gap between the face of the concrete and the backside of the PFC. The gap can be packed out with a RHS (200x50 (or larger)) welded to the PFC and dry packed or the entire gap can be filled with mortar.

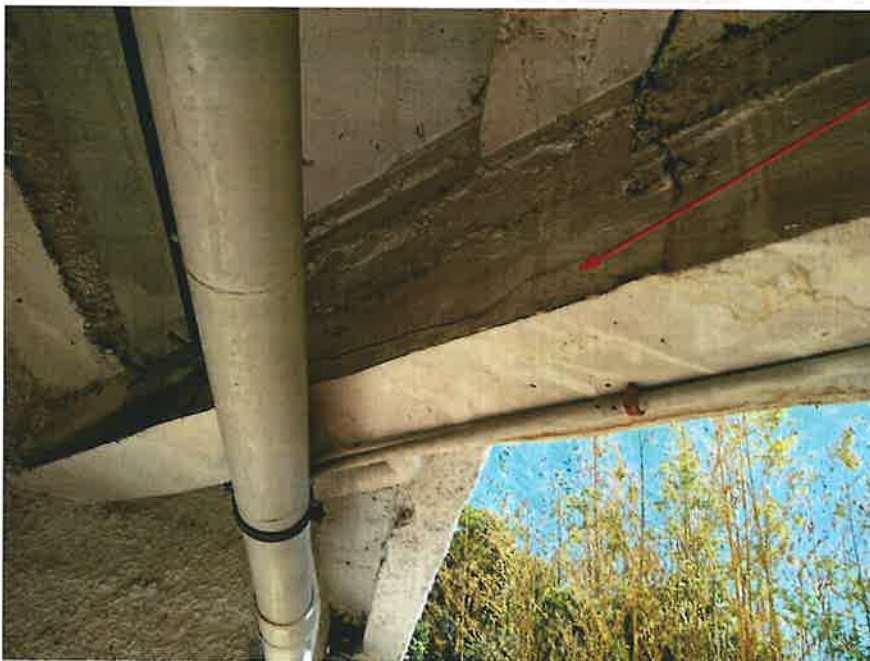
**Figure 2.**

Example crack where the reinforcing needs to be exposed, treated and the concrete repaired.

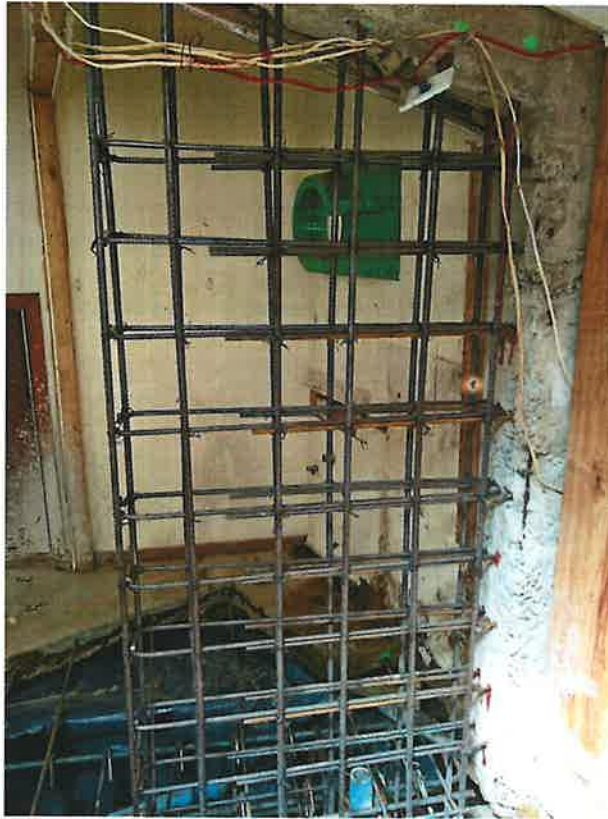
**Figure 5.**

Shear wall reinforcing and connections to the existing structure.

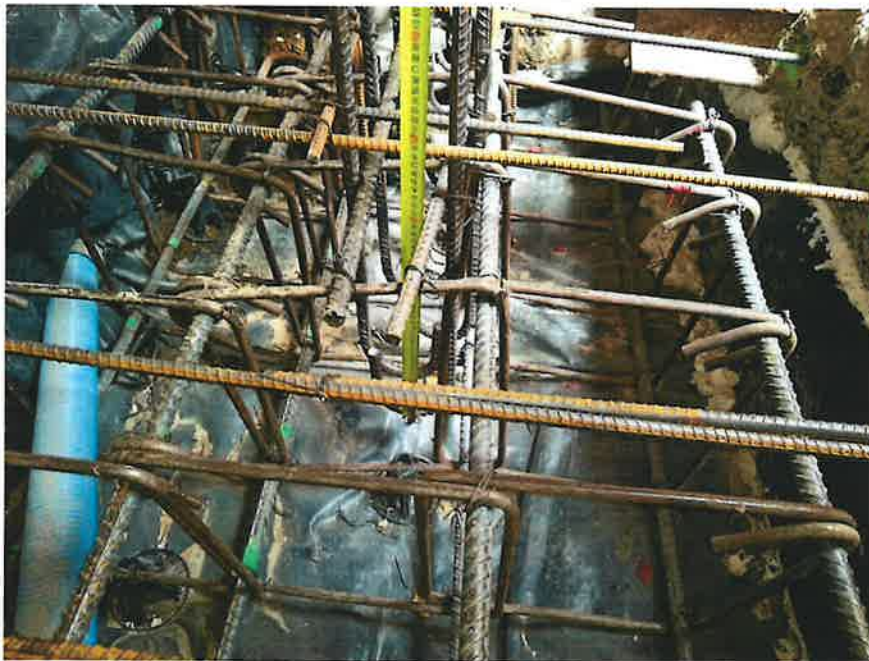
**Figure 6.**

Shear wall vertical bars hooked into ground beam.

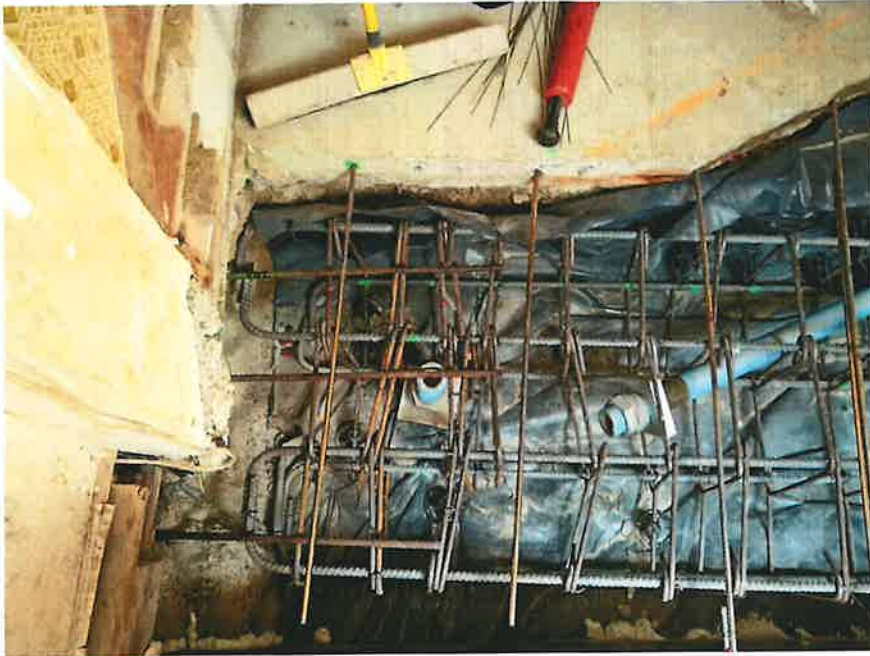
**Figure 3.**

GL-D ground beam – Starters and additional stirrups installed.

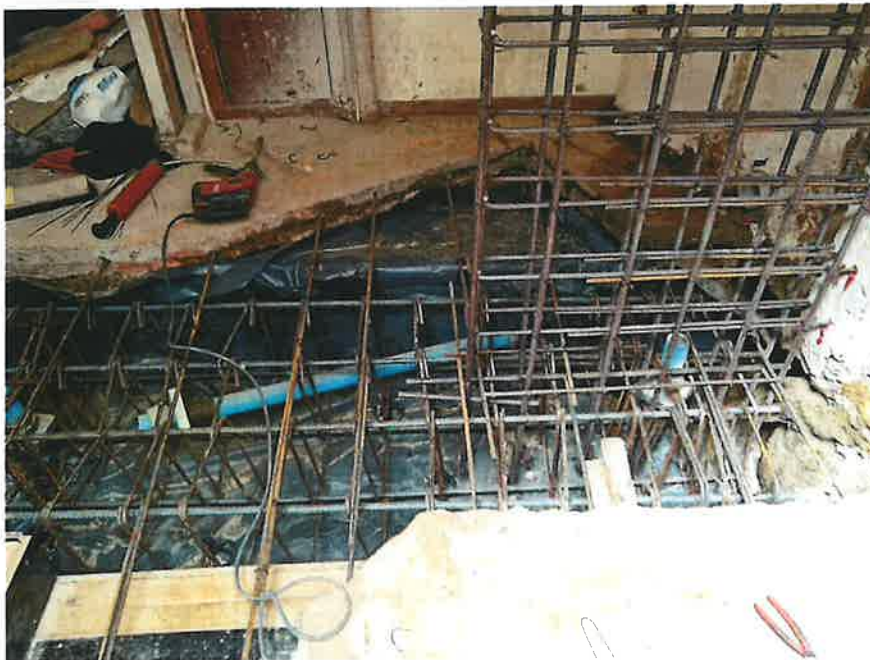
**Figure 4.**

GL-D ground beam – vertical bars for the shear wall and additional stirrups installed.

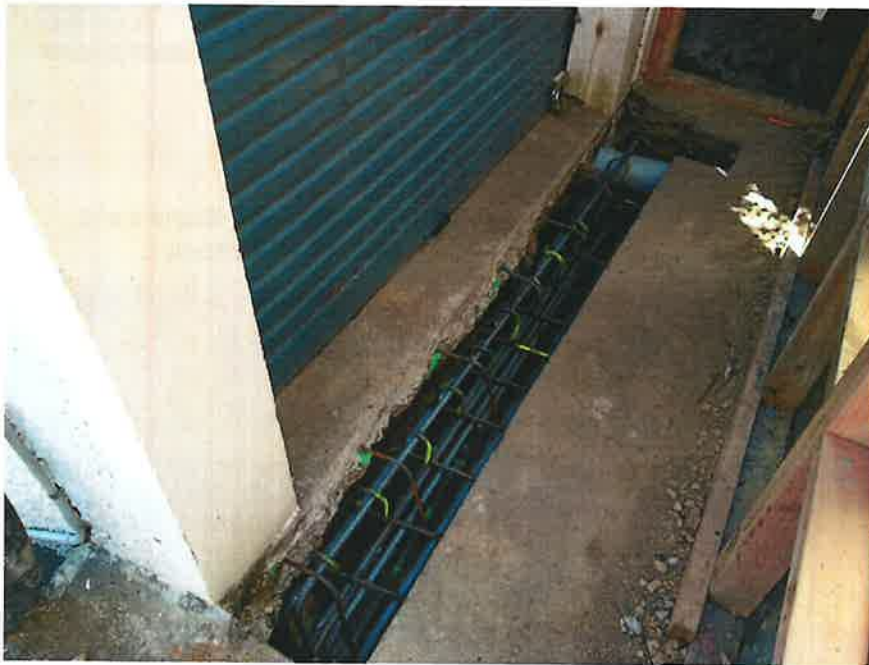
**Figure 1**

Garage beam reinforcing.

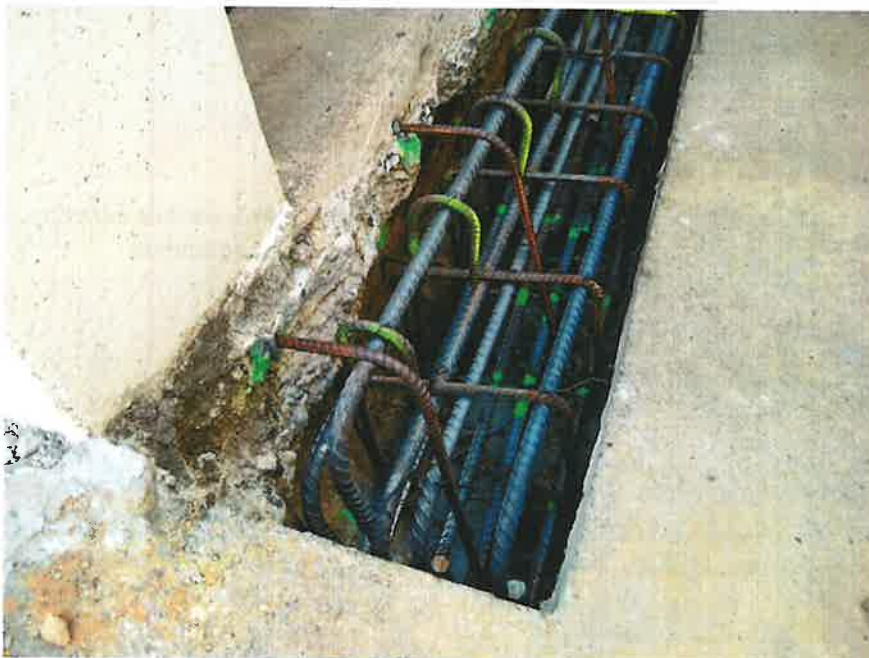
**Figure 2.**

Garage beam upstand and  
connection to existing concrete.

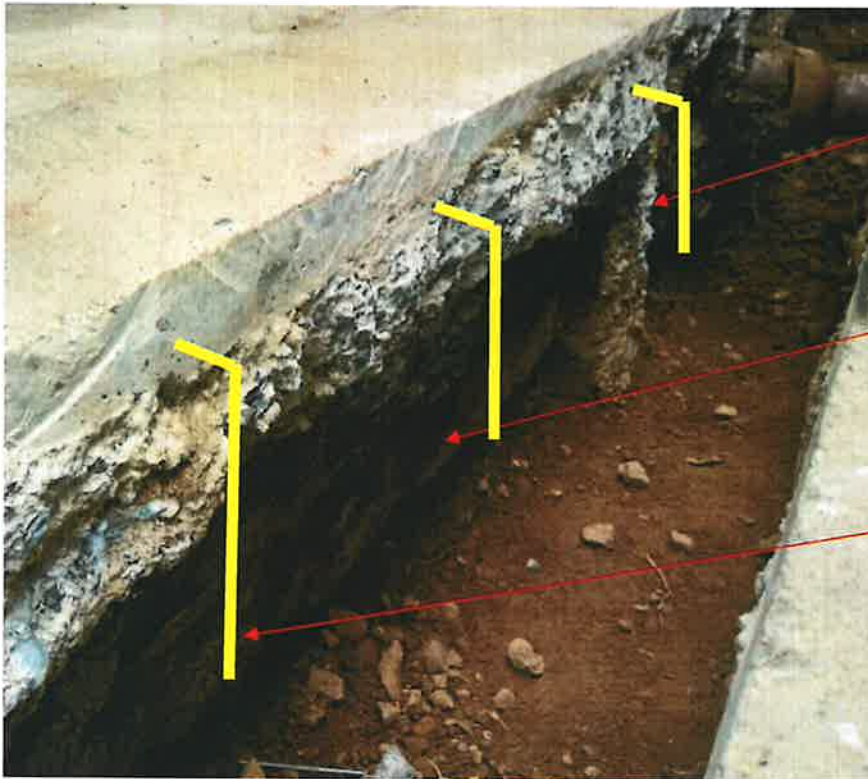
**Figure 7. Garage foundation at grid A**

Buttress found after excavation

Existing retaining wall found after excavation

Install HD12 starter L-bars, 400 centres, epoxy 200mm into existing slab and retaining wall/buttress at ends.

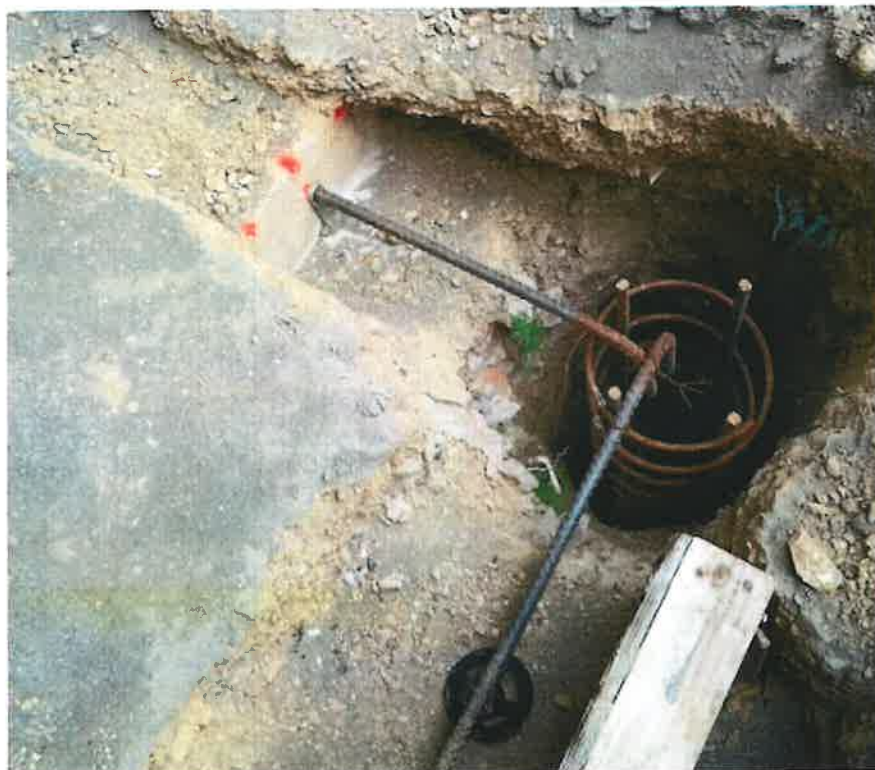
**Figure 6. Concrete beam at grid G**

Pile reinforcement and HD12 bars epoxied into the existing concrete,

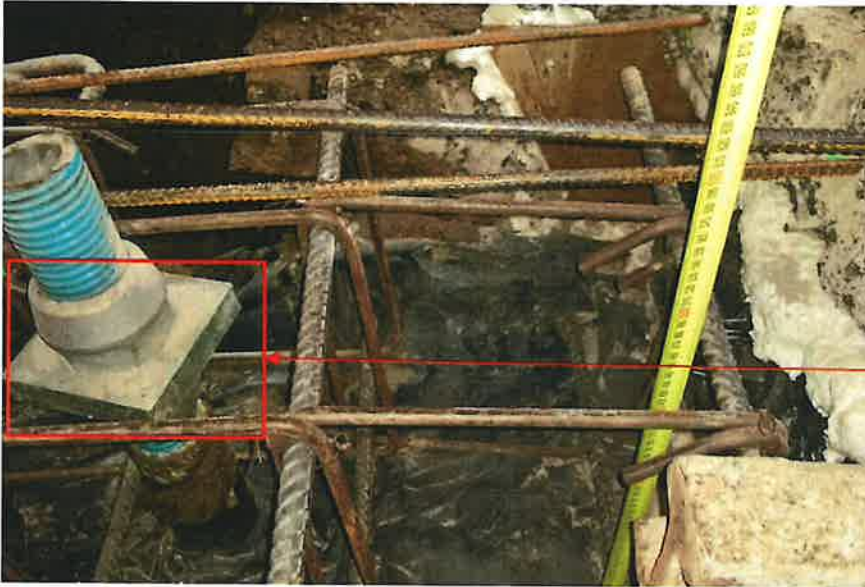
**Figure 4. Concrete beam at grid D**

Showing around 600mm beam depth.

Shift the anchor plate to be vertically centred in the cage.

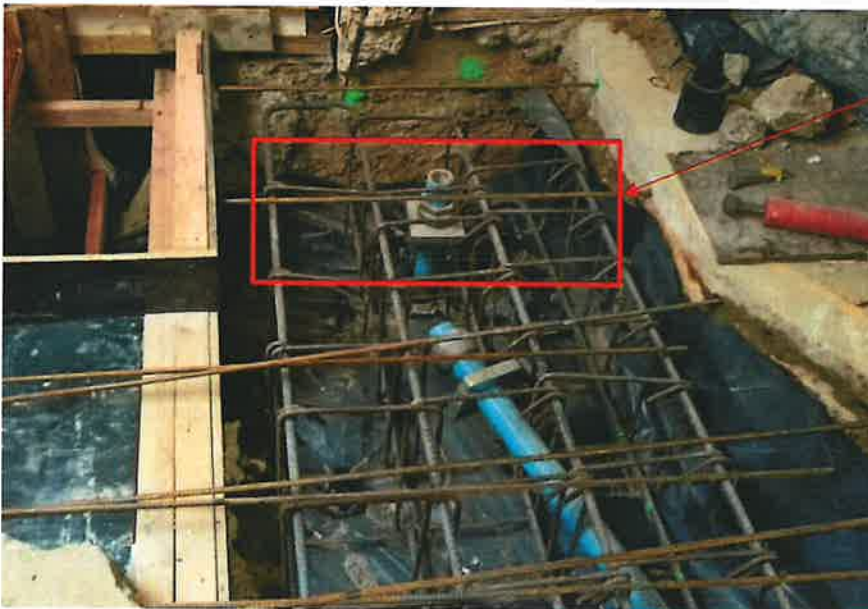
**Figure 5. Concrete beam at grid D**

Only ten (10) legs of R12 stirrups are present. The required number of legs is sixteen (16).

Install additional three (3) sets of R12 near the anchor
