## PRODUCER STATEMENT – PS4 – CONSTRUCTION REVIEW

IN RESPECT OF: Seismic Strengthening  
(Description of Building Work)

AT: 34 Upland Road, Kelburn  
(Address)

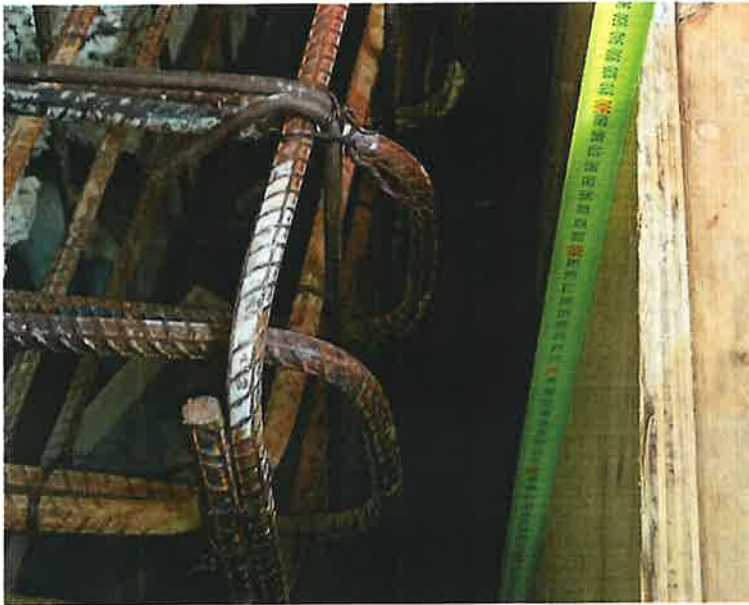
**Figure 2. Concrete beam at grid H**

Around 900mm beam depth

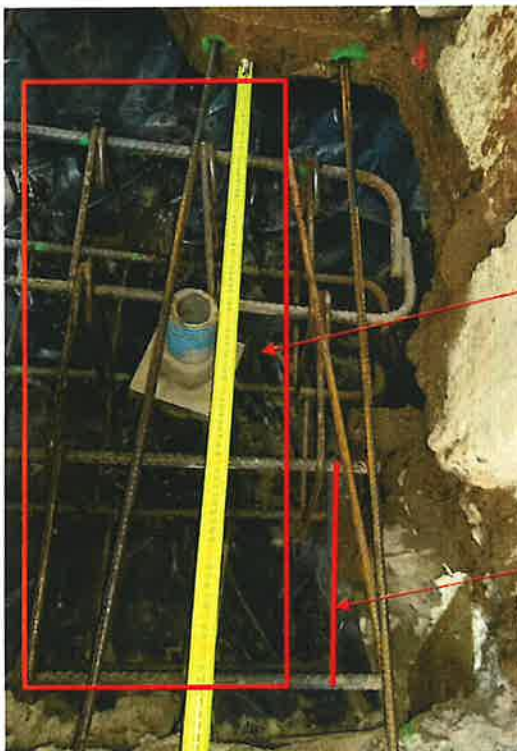
**Figure 3. Concrete beam at grid D**

Showing around 1000mm beam width.

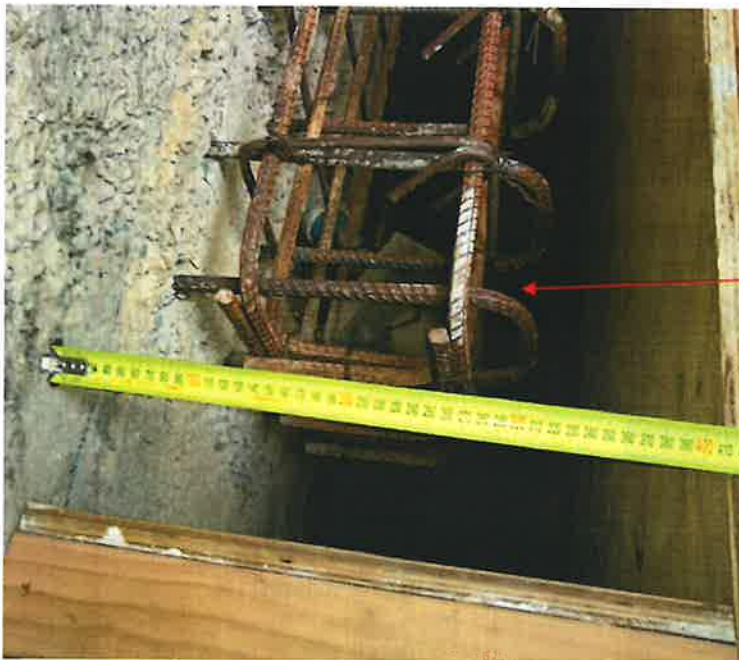
**Figure 1. Concrete beam at grid H**

Approximately 400mm beam width

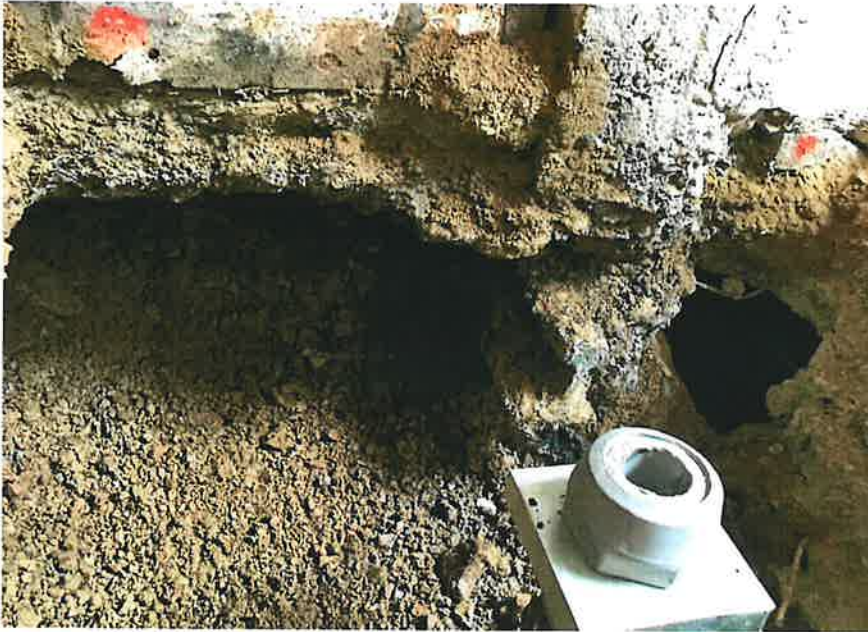
**Figure 3.**

Ground beam with vertical Titan  
Anchor

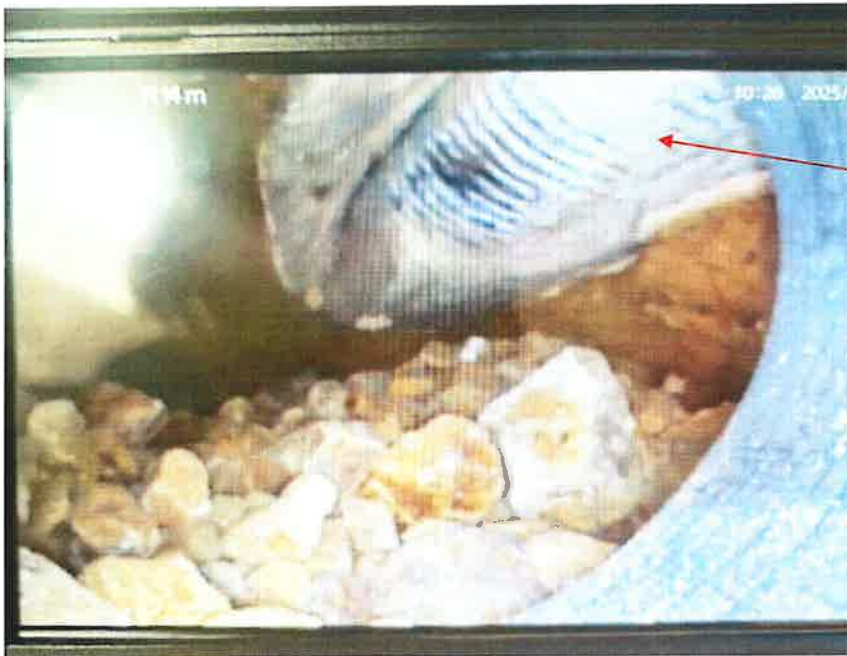
**Figure 1**

Excavation photo encountering an existing soil anchor.

Existing soil anchor

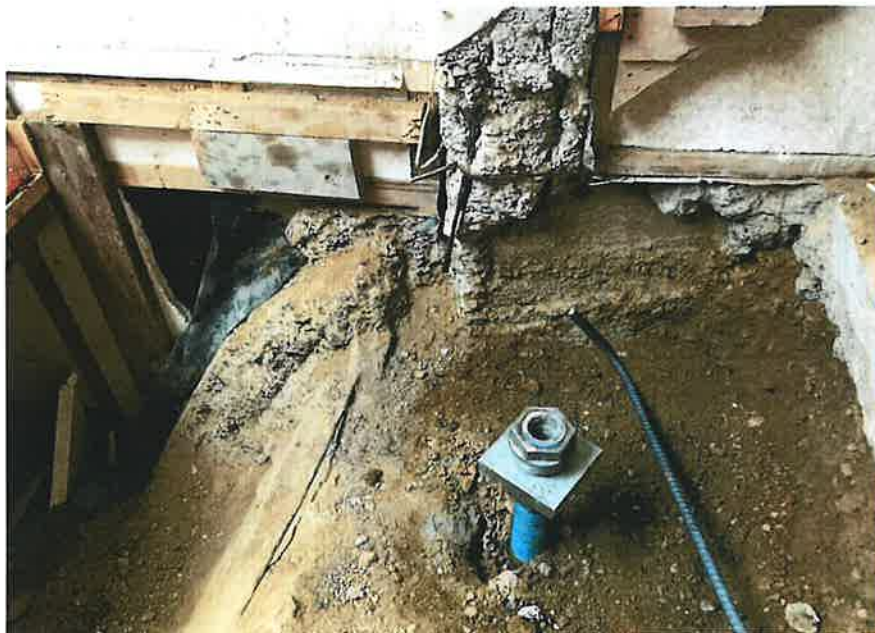
**Figure 2.**

Ground beam with vertical Titan Anchor
