## **1D Quadrant Drive, Lower Hutt**

### **Presumptive Management Survey**

**Report Type:** Presumptive Management Asbestos Survey  
**Report issue:** Final  
**File reference:** 6271C-1  
**Report date:** 02/07/18  
**Survey date:** 23/06/18  
**Address:** 1D Quadrant Drive, Lower Hutt  
**Prepared for:** Graham Pudney  
**Contact number:** 021 587 010  
**E-Mail contact:** graham@pudney.co.nz

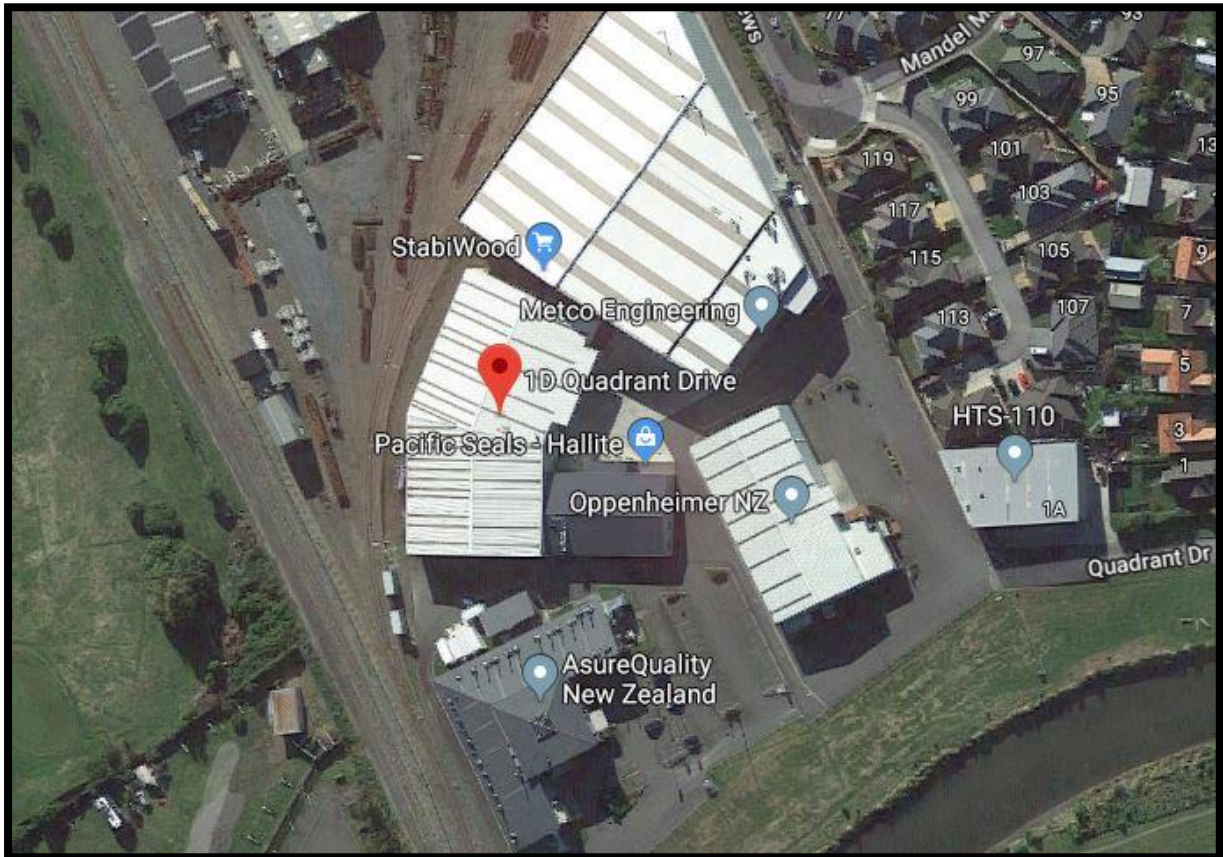
1D Quadrant Drive is an office building and warehouse.

The warehouse part of the structure was constructed in 2004, the office building was constructed in 2013-2014.

All materials used were new and modern at the time of construction.

*Due to the age of the building (constructed post 2000), correspondence with Graham Pudney and inspection of all materials accessible during normal occupancy of the premises, no asbestos products have been identified on site.*
