## GoGet Inspection Outcome Report

Consent No: **20172013**  
 Applicant: **Spaghetti Junction Limited**  
 Site Address: **80 Byron Street Sydenham**  
 Legal Description: **Lot 1 DP 449853**  
 Work Type: **Addition to Factory - New Offices, Meeting and Store Room**  
 Workgroup: **Area 4 - Residential**

Inspection Type: **210 - Commercial - Final**  
 Inspection Outcome: **Fail**  
 Inspected By: **Brian Abrahams**  
 Inspection Date: **7 February 2020 9:02 a.m.**  
 Duration: **45 minutes**

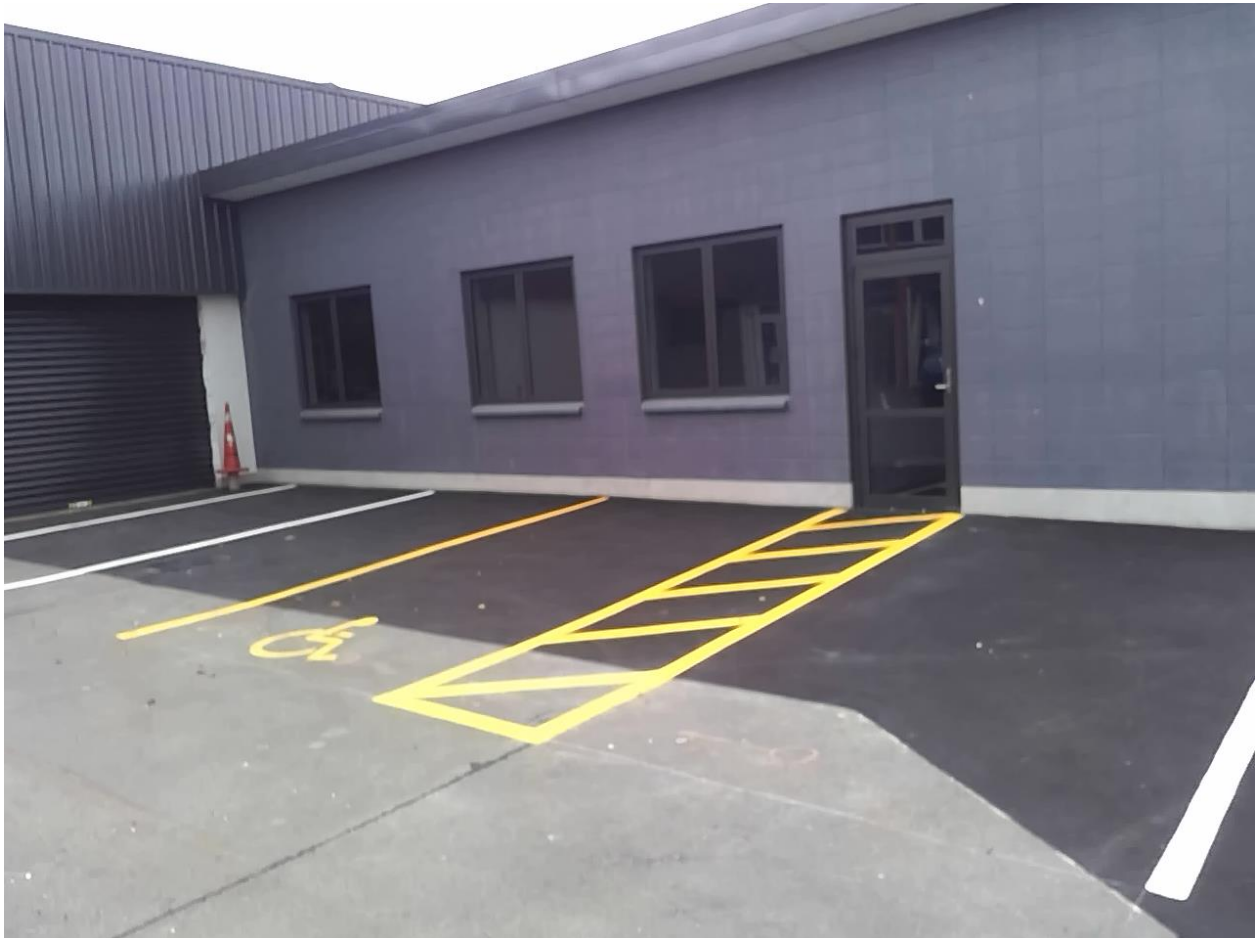
| <b>ISA symbols have not been installed as per F8/AS1</b> | |
| <b>Accessible routes and facilities for persons with disabilities - (ISA) has not been installed</b> | |

**ISA sign required**  
Taken at 8:35 AM on Friday 7/02/2020

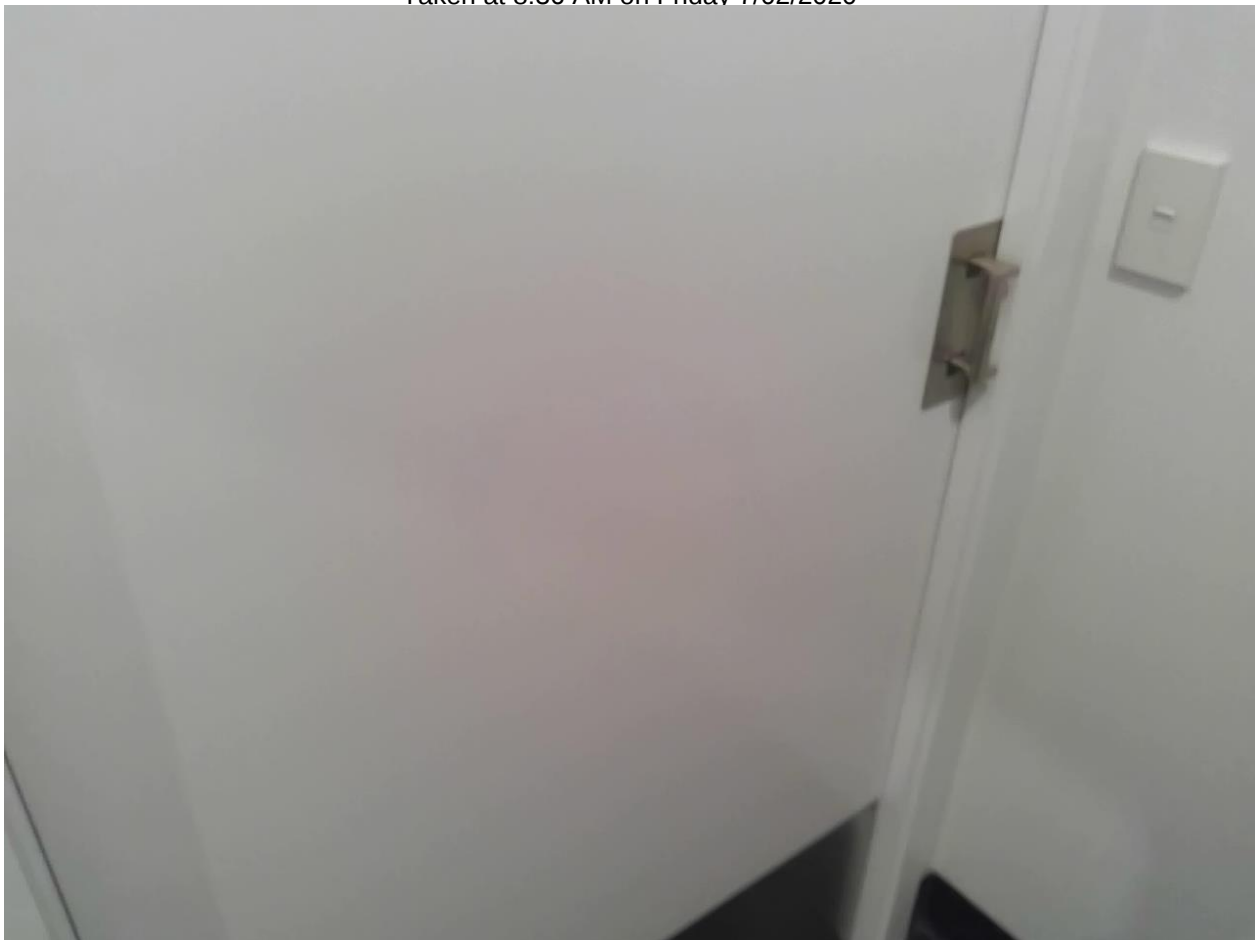
**Accessible wc door---handle moves up & down for lock/unlock**  
Taken at 8:37 AM on Friday 7/02/2020

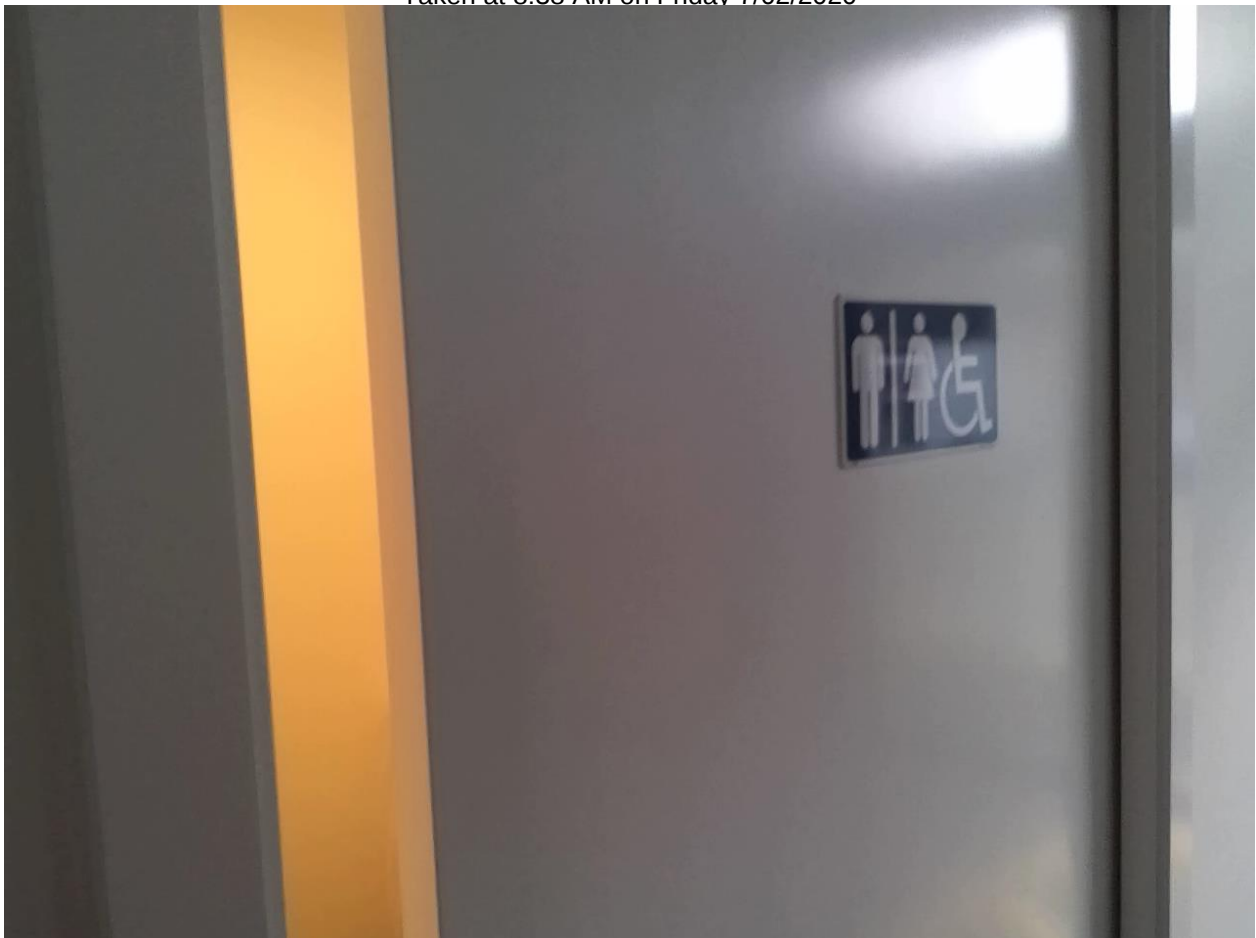
**Accessible wc door**

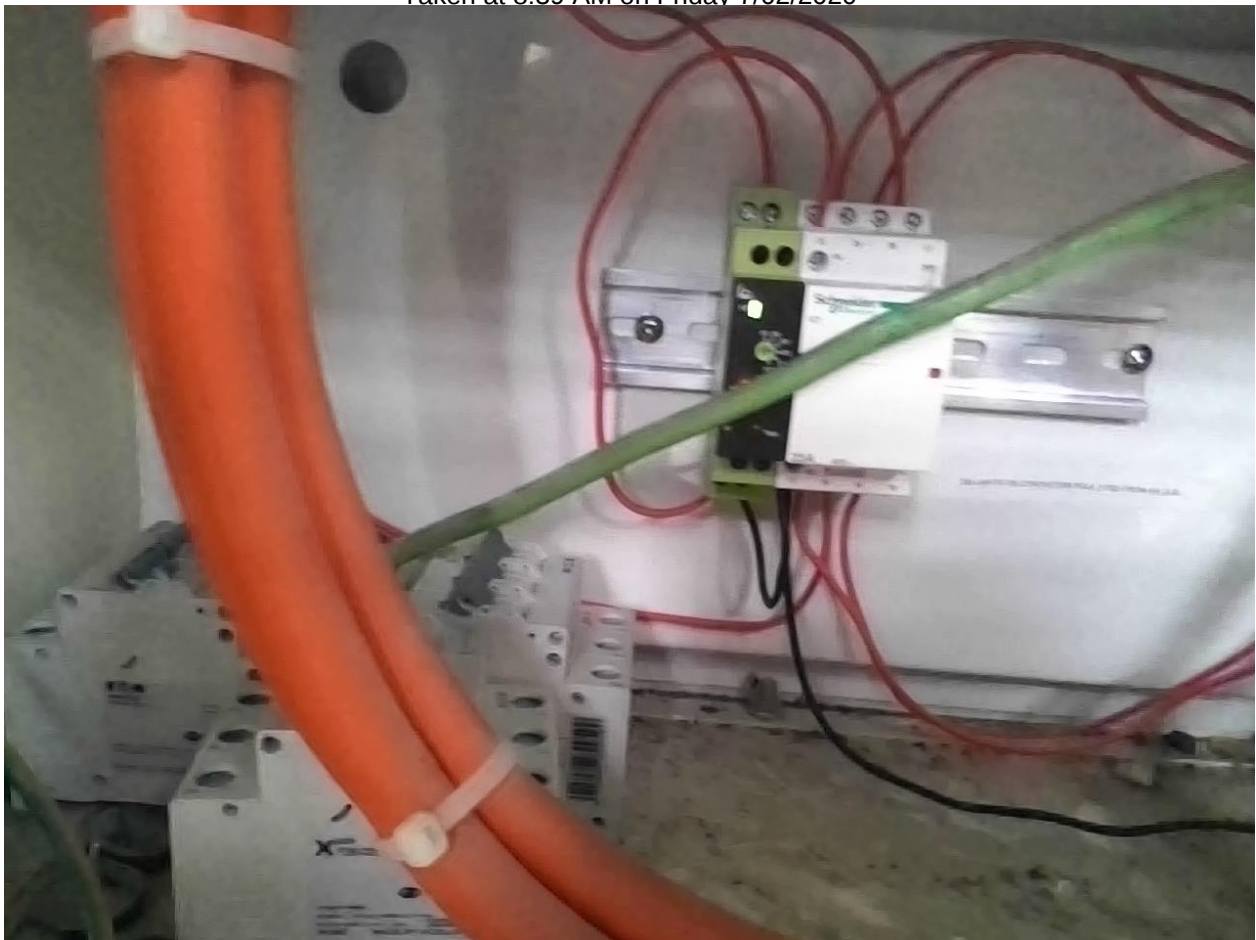
**Emergency lighting test facility**  
Taken at 8:40 AM on Friday 7/02/2020

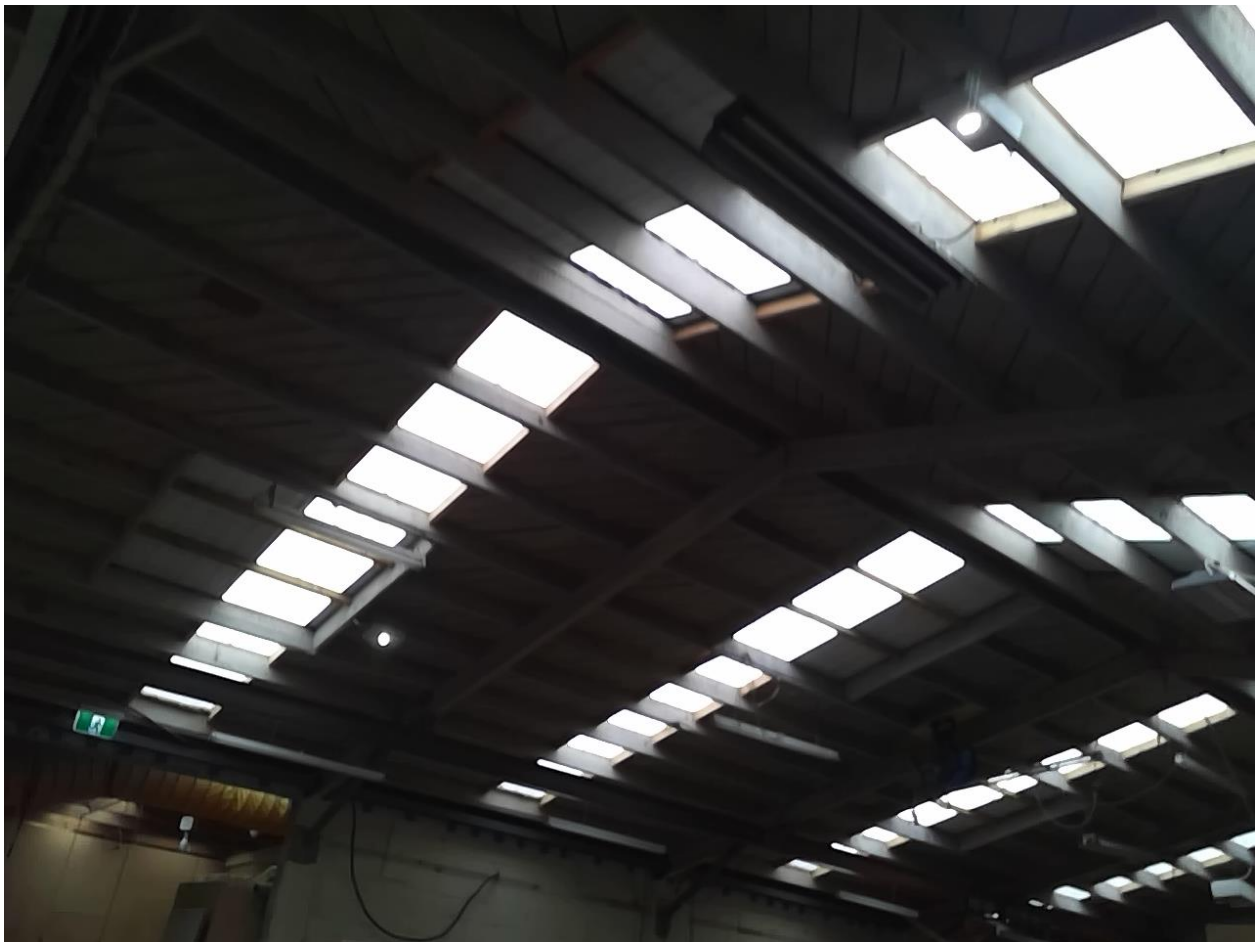
**Exit sign + emergency lighting**  
Taken at 8:41 AM on Friday 7/02/2020

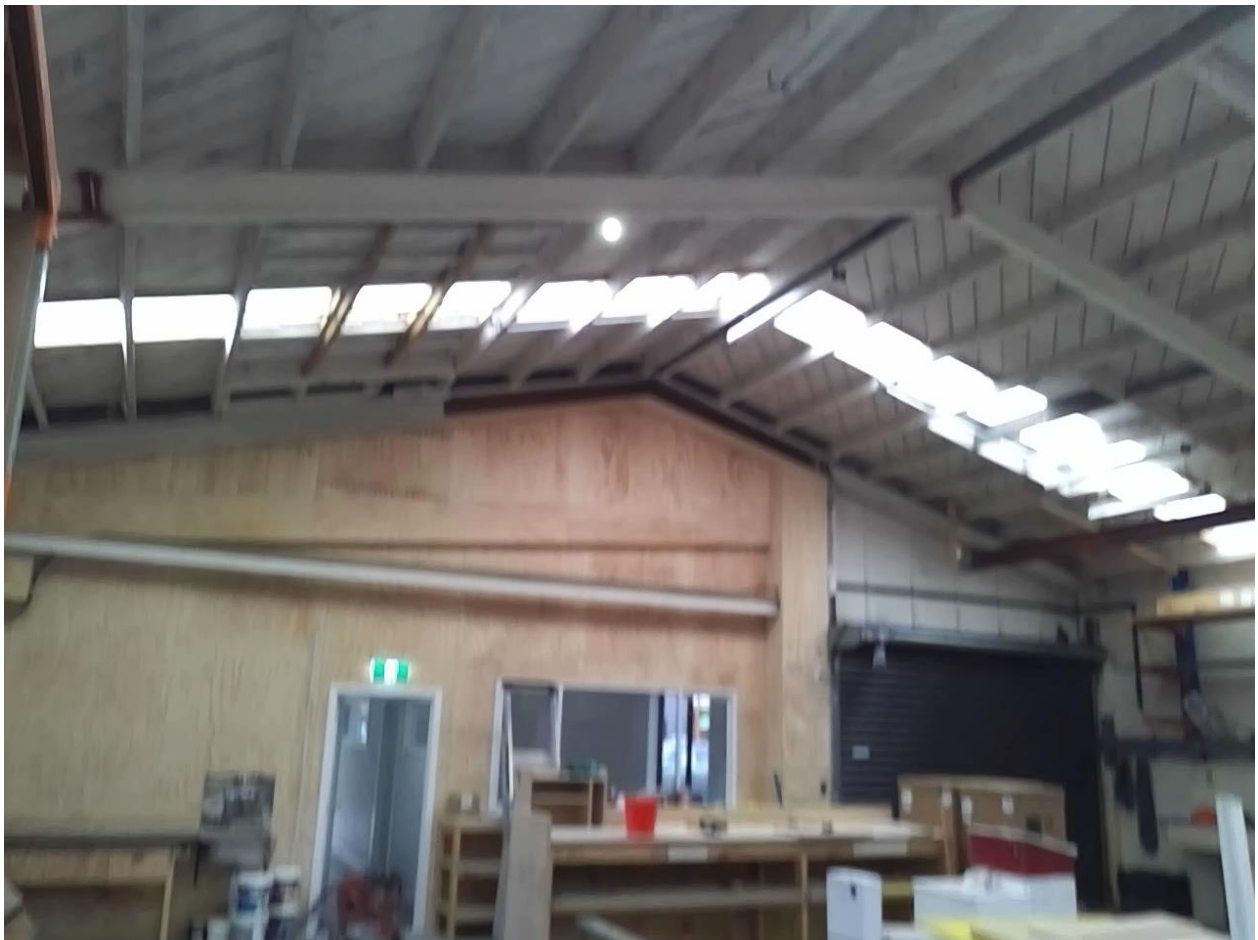
**Emergency lighting + illuminated exit sign in warehouse**  
Taken at 8:41 AM on Friday 7/02/2020

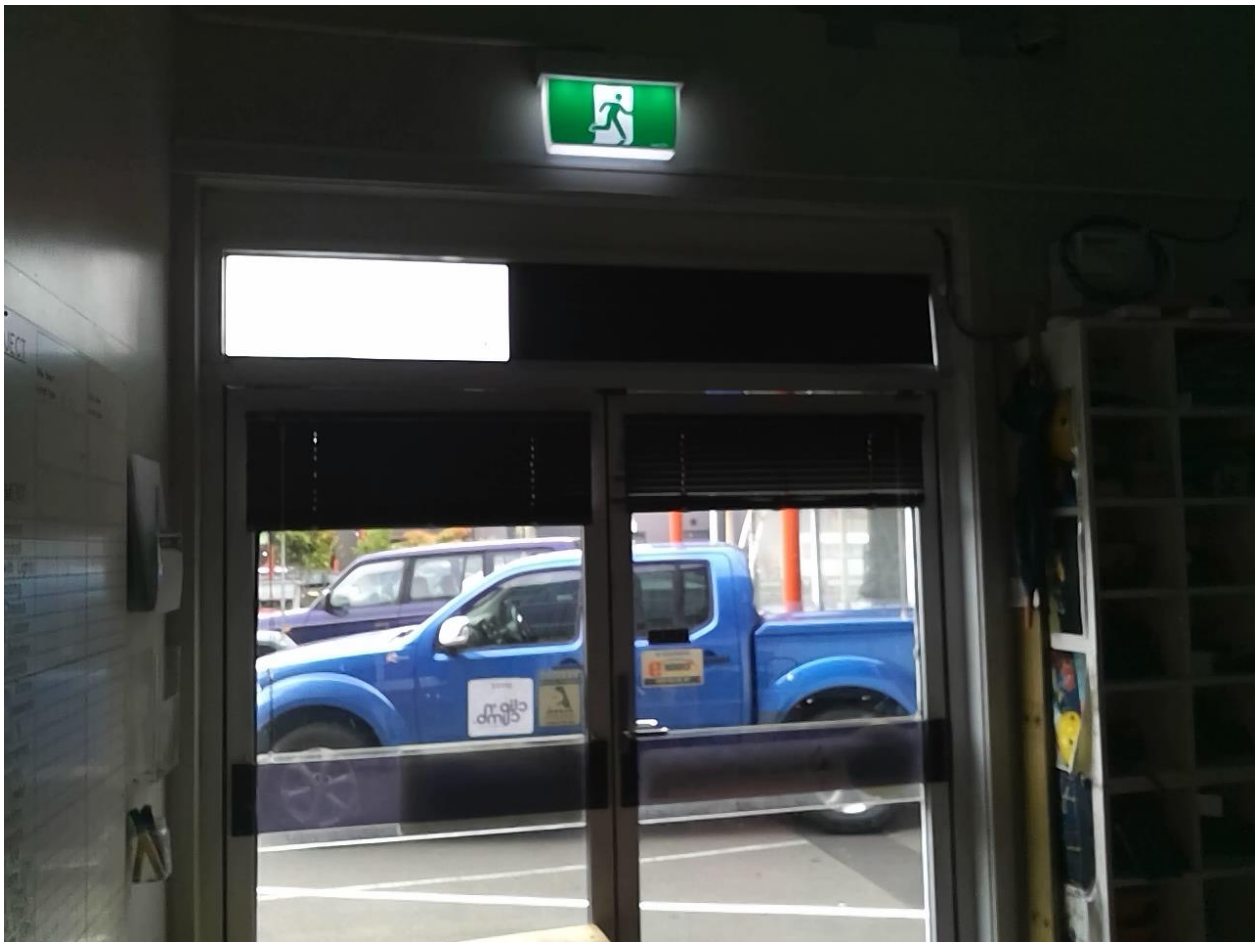
**Illuminated exit sign + keyless lock installed @ existing office**  
Taken at 8:42 AM on Friday 7/02/2020

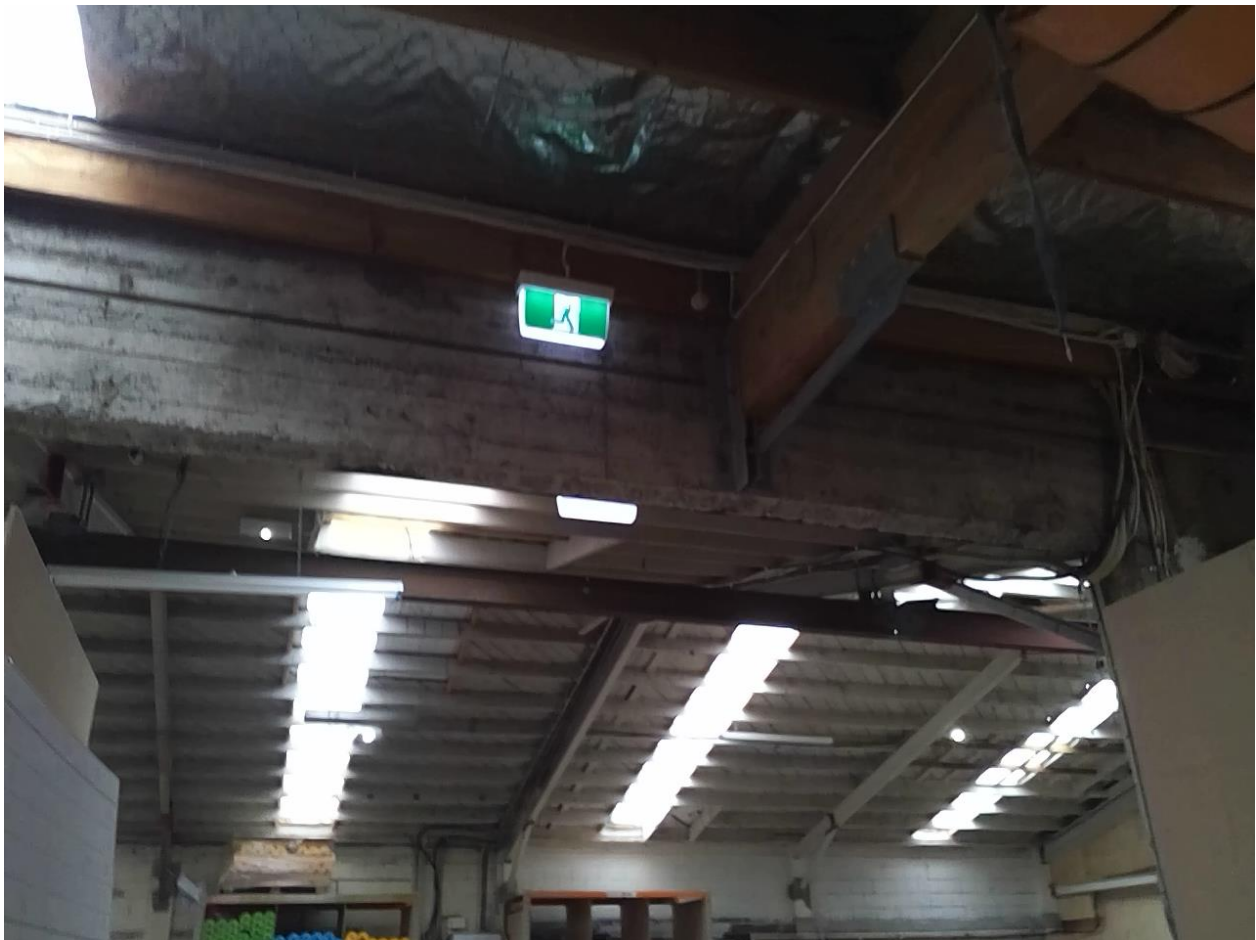
**Illuminated exit sign in warehouse**  
Taken at 8:52 AM on Friday 7/02/2020

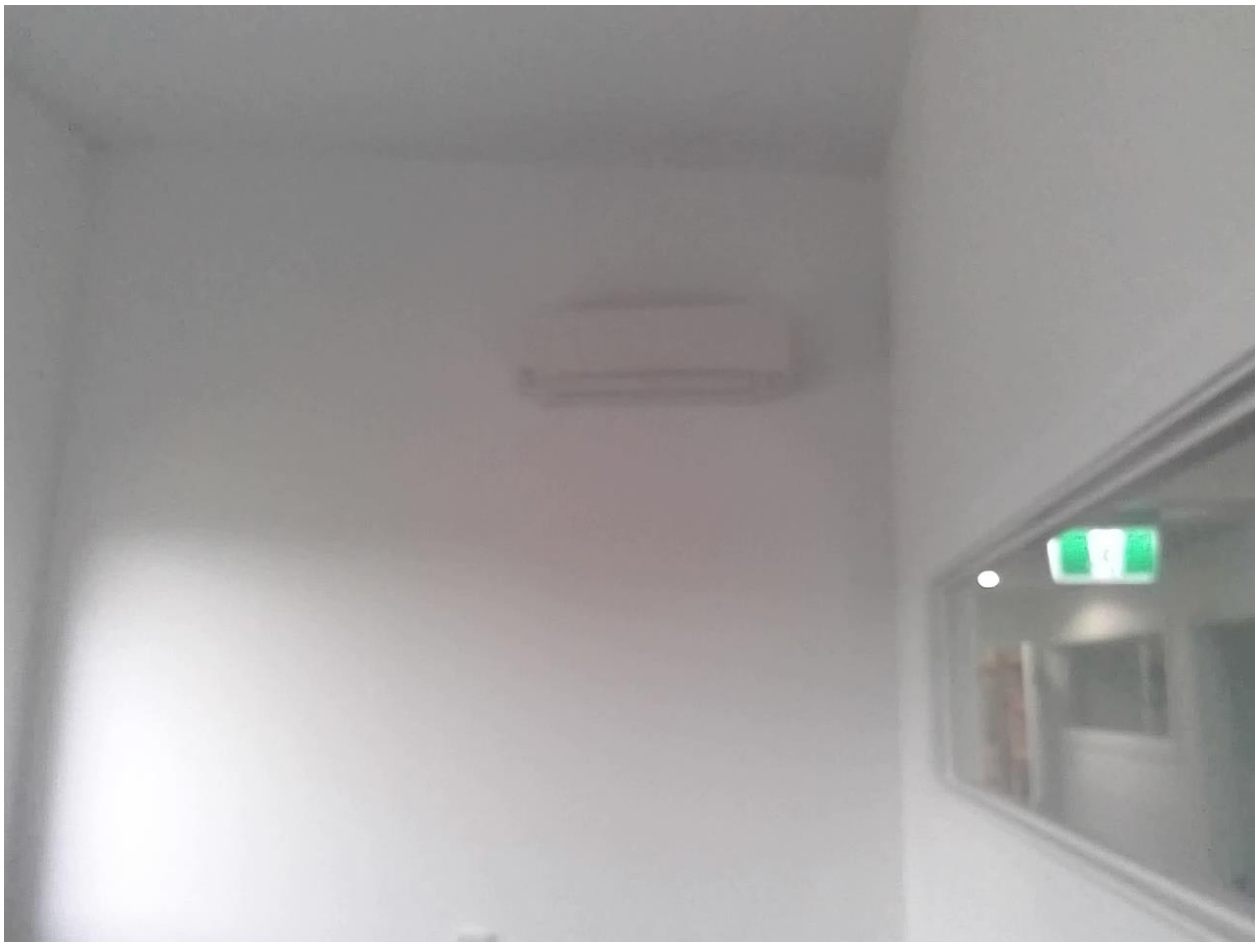
**Heatpumps installed**  
Taken at 8:54 AM on Friday 7/02/2020

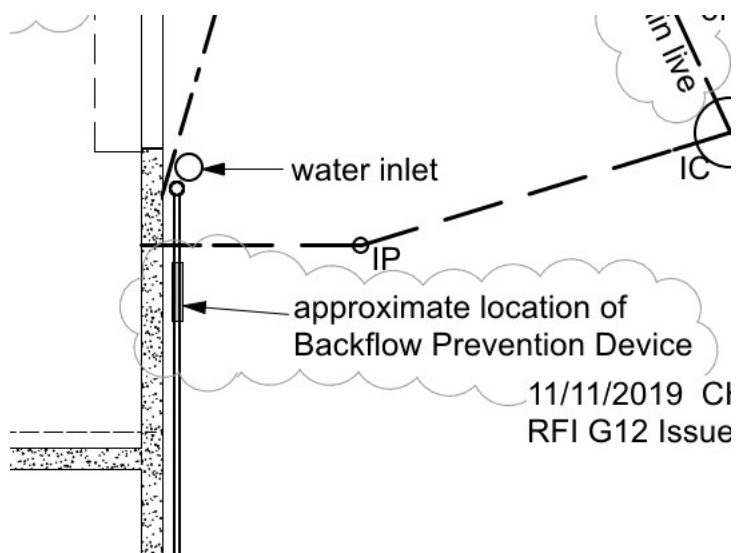
**Backflow prevention device**  
Taken at 11:14 AM on Friday 7/02/2020

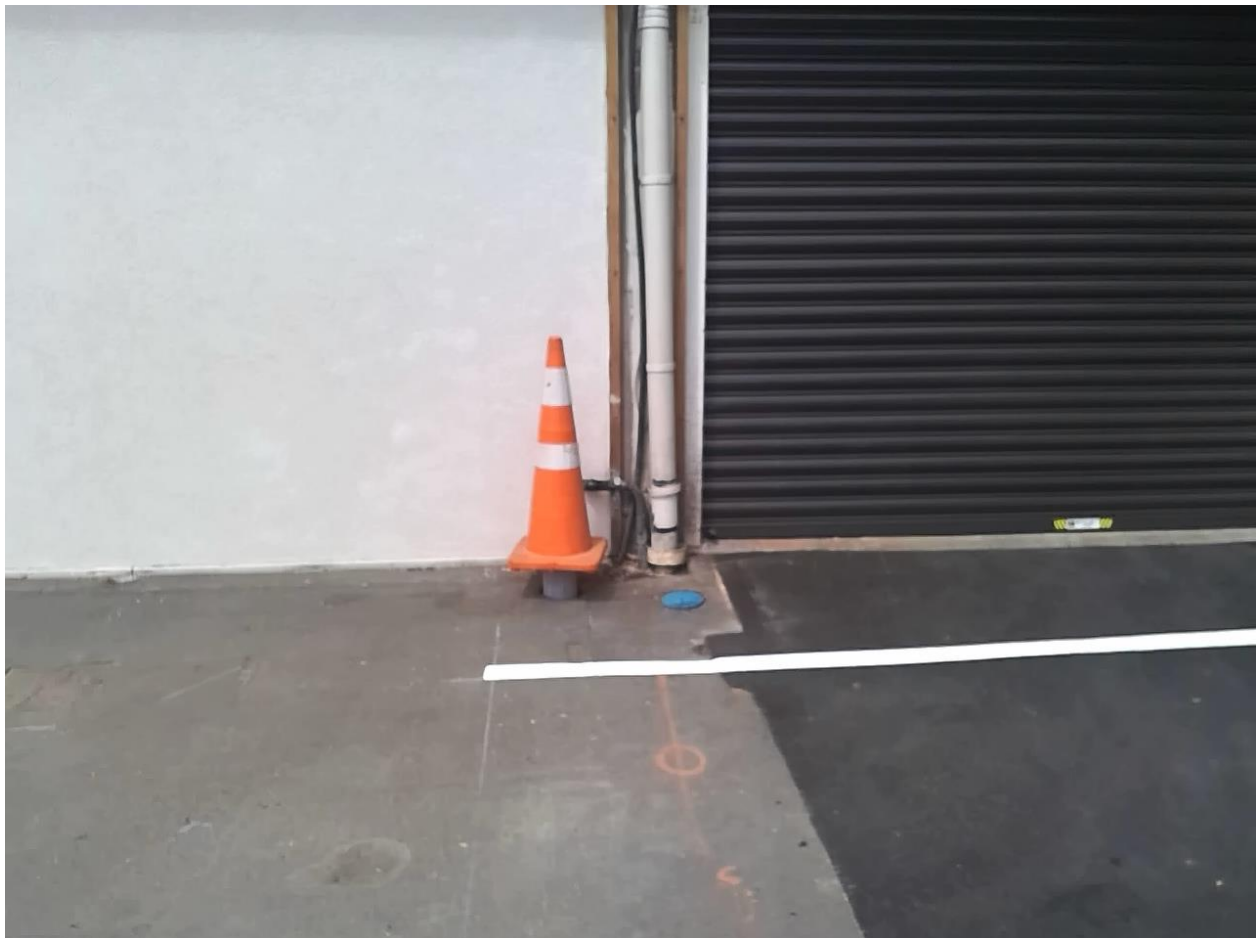
| Inspection Element | Status |
|---|---|
| <b>Observation:</b><br><b>1. Kerb &amp; channel to be completed.</b><br><b>2. ISA signage required.</b><br><b>3. UV protection required @ lagging @ gas mixer.</b><br><b>4. Soffit to be sealed/painted.</b><br><b>5. Owner's written approval required for change in building paper as requested in 253 inspection.</b><br><b>6. Backflowprevention device required..see attached photos.</b> | |

**Proposed position of new backflow preventing device not installed yet**  
Taken at 12:33 PM on Friday 7/02/2020
