**Re: Body Corporate 582203  
Property at Lyall Bay Junction, 68-72 Kingsford Smith Street, Rongotai, Wellington  
Annual General Meeting**

## BODY CORPORATE NO 582203 (BODY CORPORATE)

### Property at Lyall Bay Junction, 68-72 Kingsford Smith Street, Rongotai, Wellington

Ref: 68 – 72 Kingsford Smith Street Lyall Bay Wellington / Defects Report

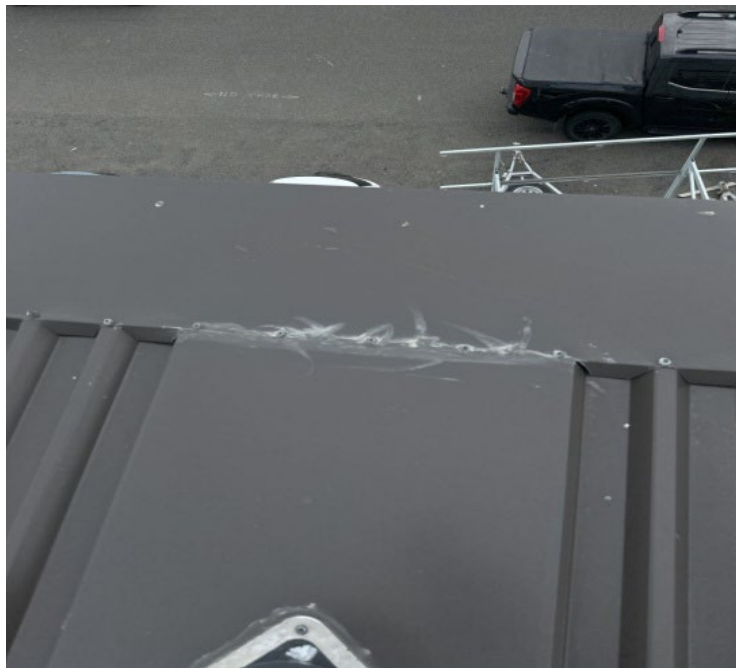
Evidence of poorly applied sealant

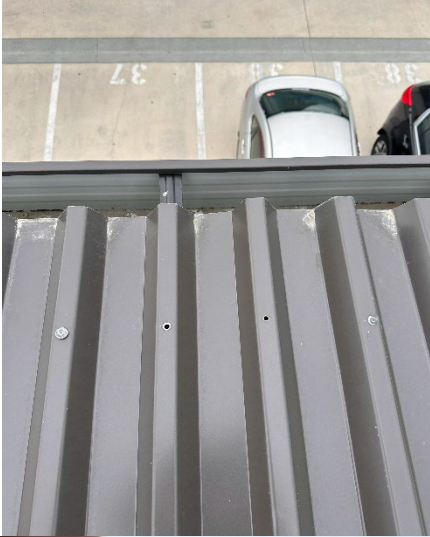
Missing screws

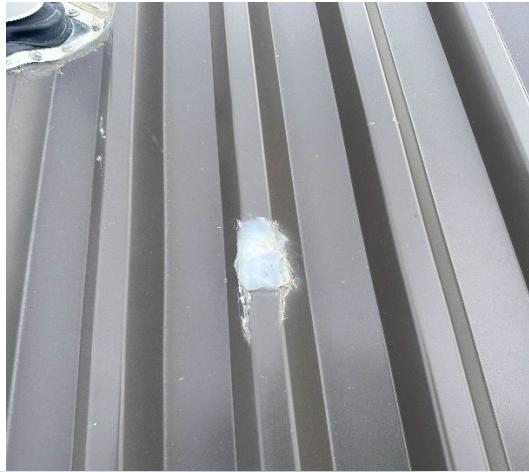
Poor use of sealant to fix damage to sheet

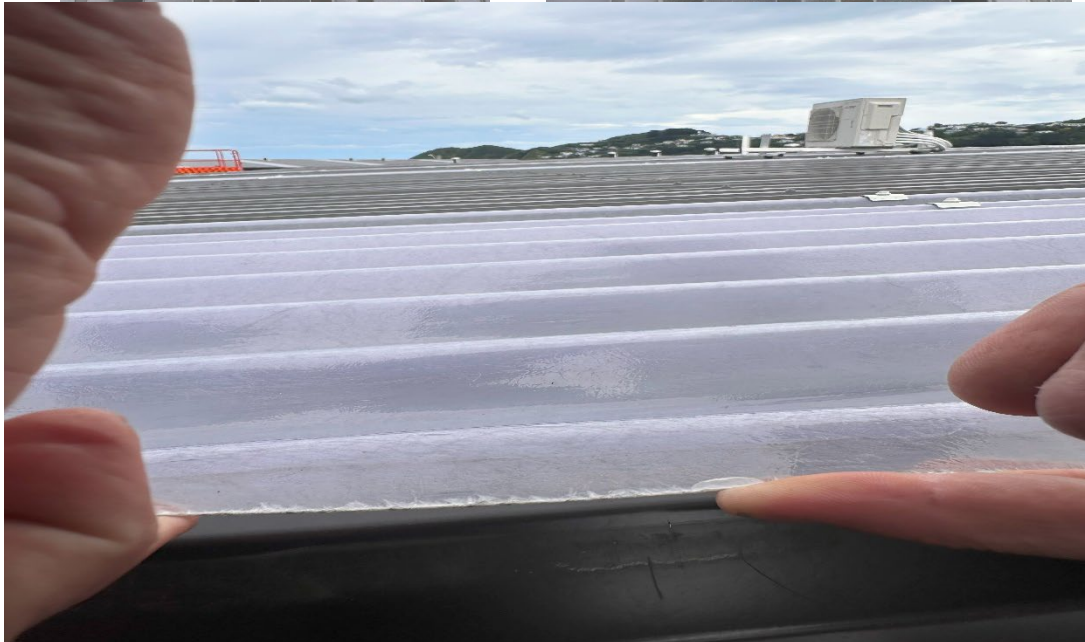
Missing foam seal as per manufacturers nstallation guide- evident on all sheets.

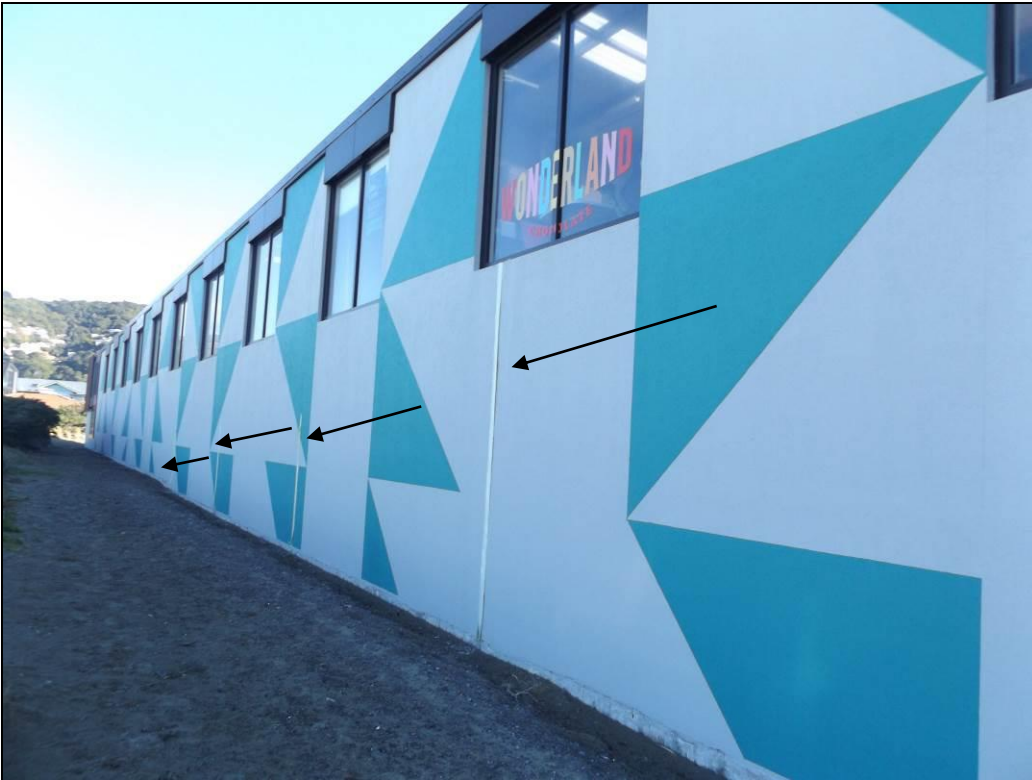
1

The southern boundary wall still complete with masking tape evidence of crack fixing repairs

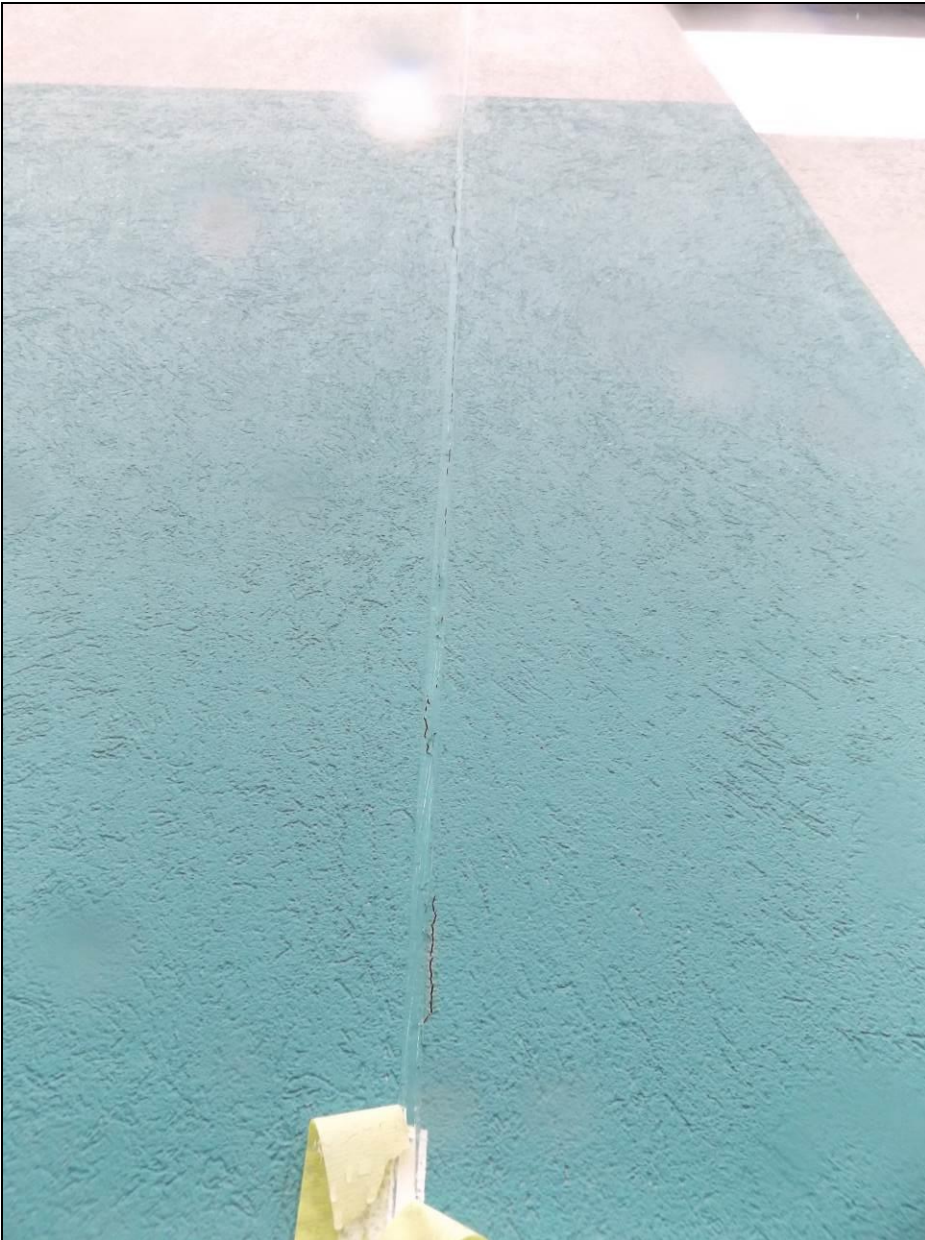
Showing the failure of sealant in a control joint that extends roof to floor – typically the result of moisture entry – There are two, both have failed in the same way – note only the lower portion was repaired (but unpainted) as evidenced by the masking tape !

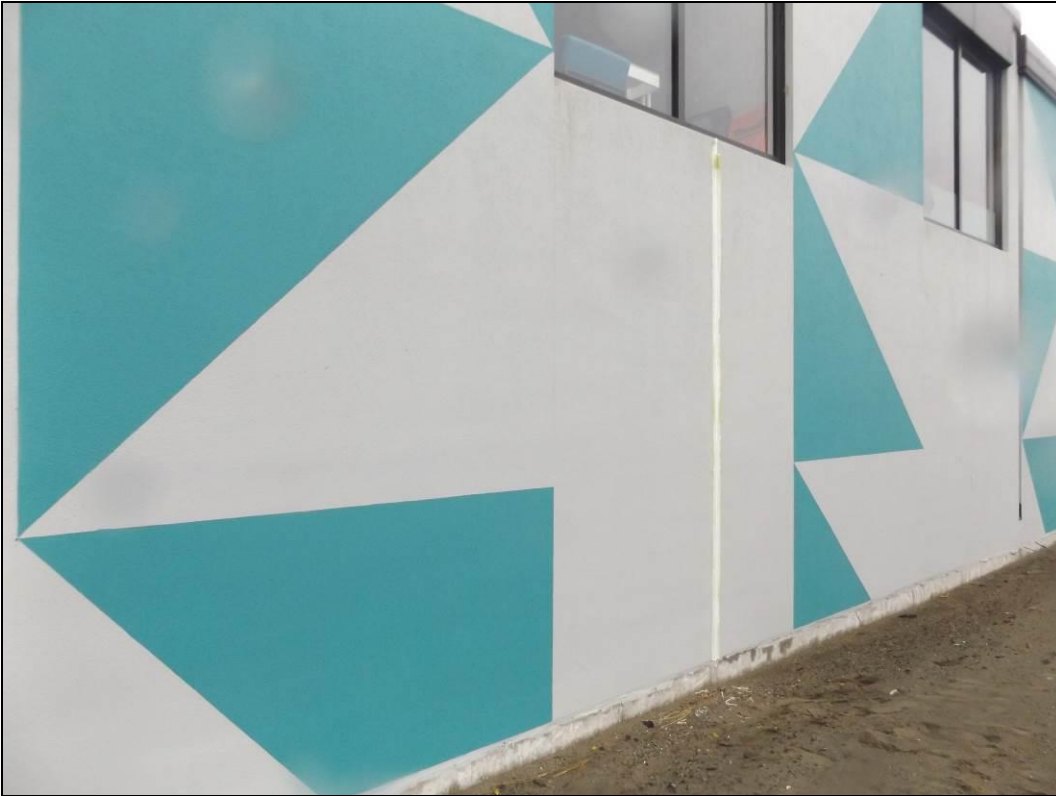
3

The remaining cracks extend from window sills

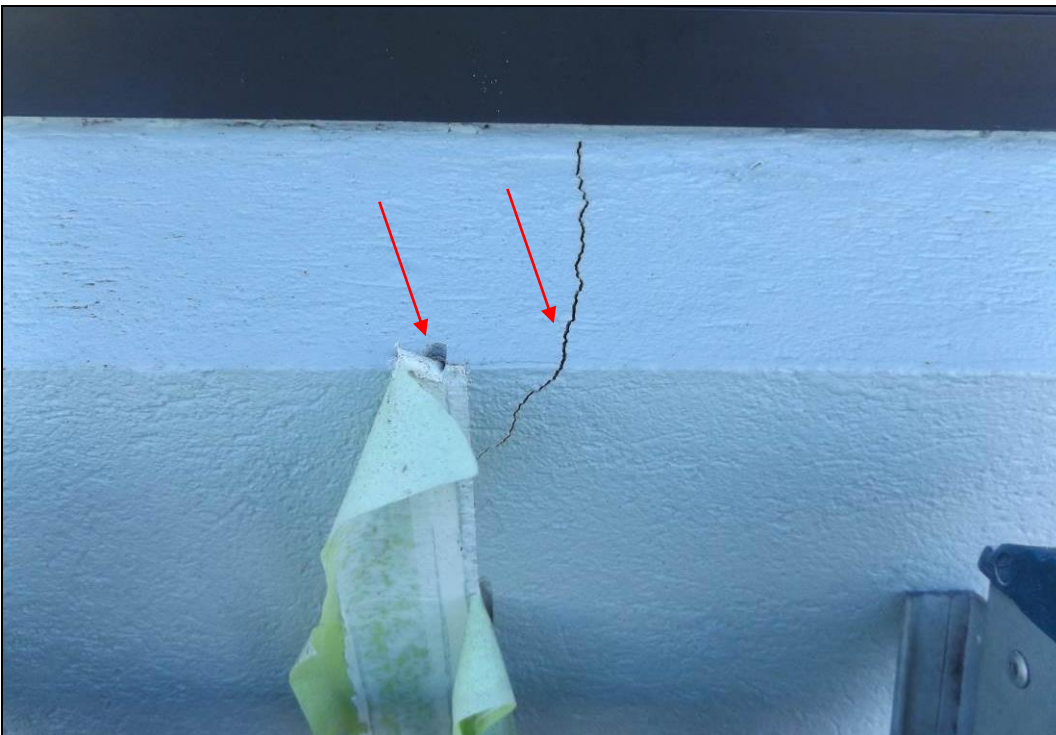
4

A typical finding showing the window sill – showing a ground out sealed crack repair – failing to seal the top of the cut and not repairing the crack in the sill that allows water down behind the sealant

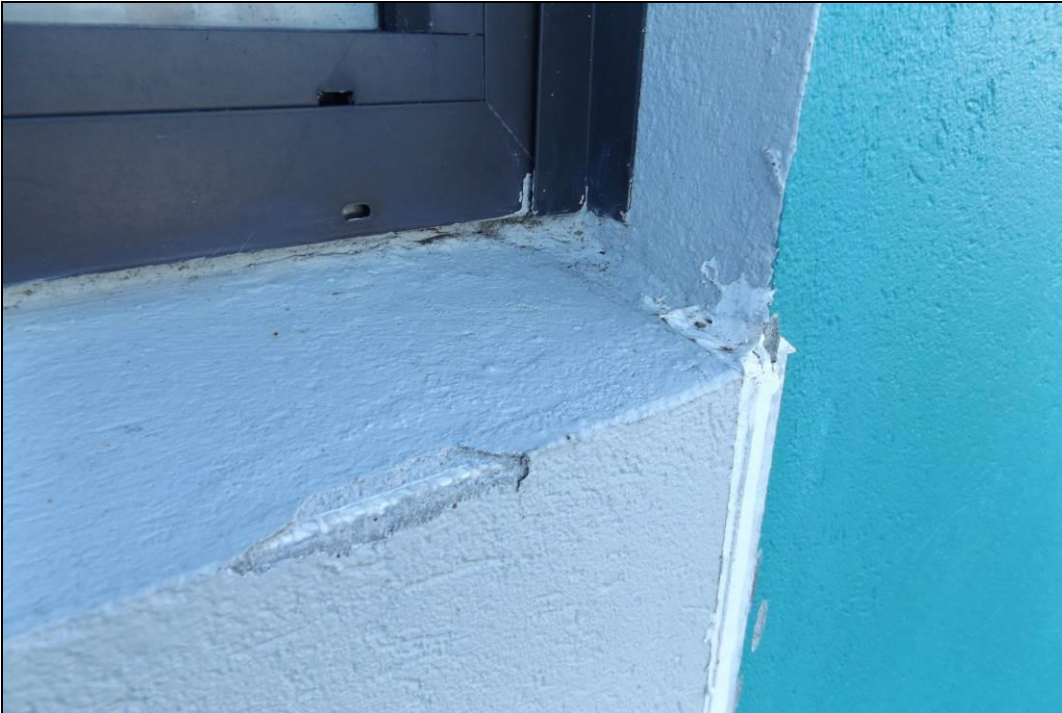
5

Showing damaged Rockcoat and a partially repaired crack on the outter edge of the sill

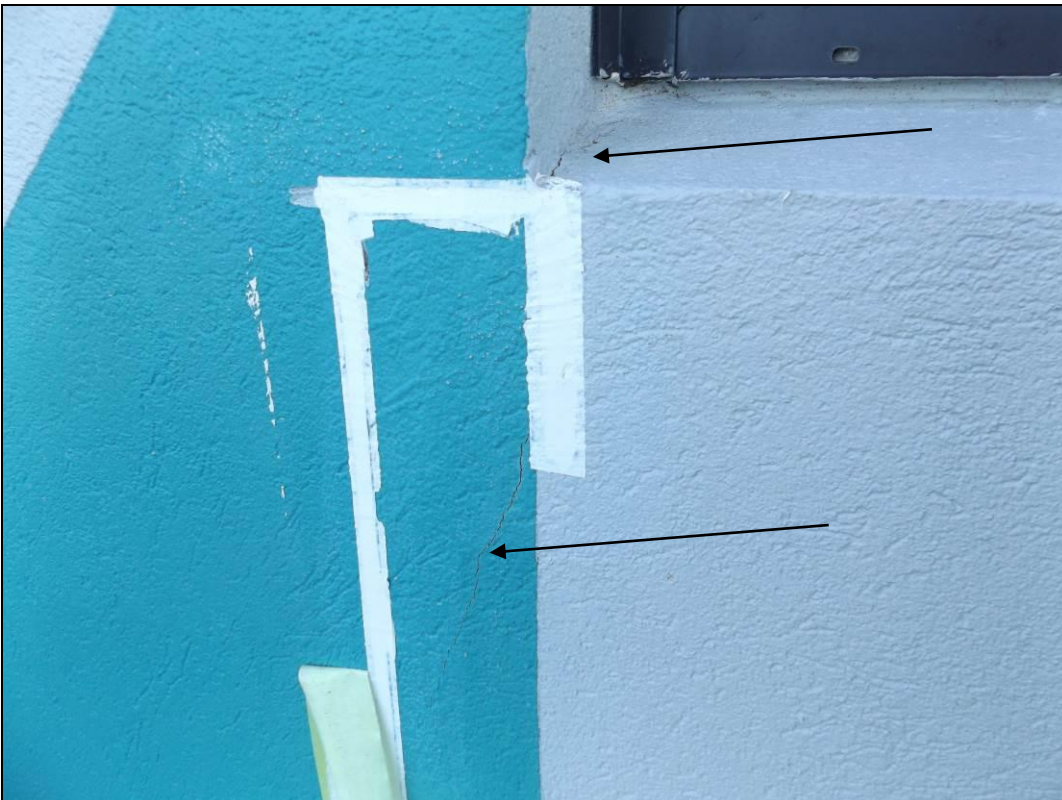
6

Another example of an unpainted repair – that hasn't addressed the top of the crack or the diagonal crack below

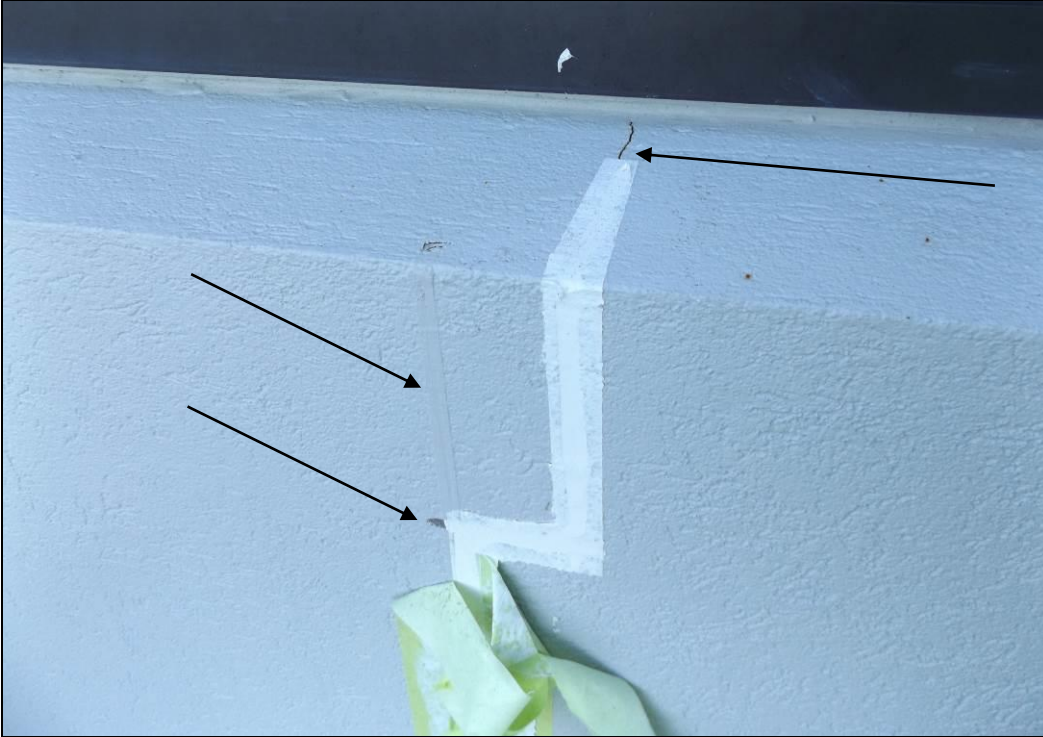
7

An example of an attempt to seal the sill crack but it has either cracked further since or it wasn't completed sufficiently – note the open end of a cut (it looks like an early repaired crack is also visible)

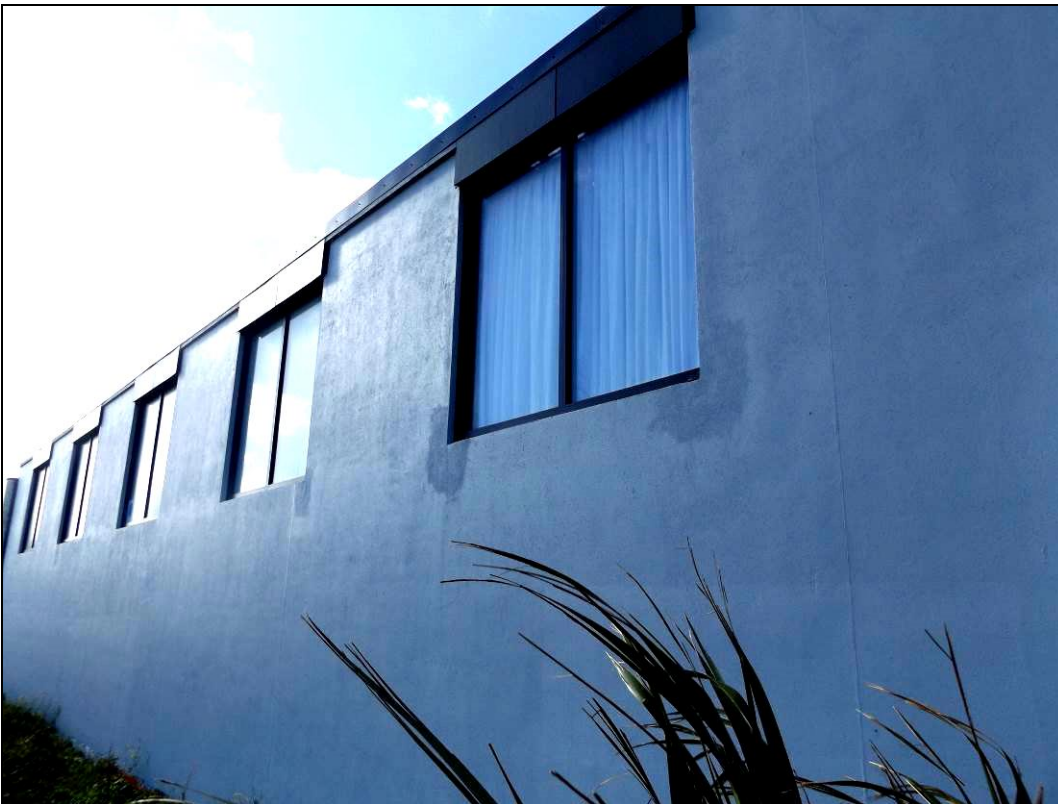
8

Western elevation boundary wall – showing evidence of earlier repair below window corners

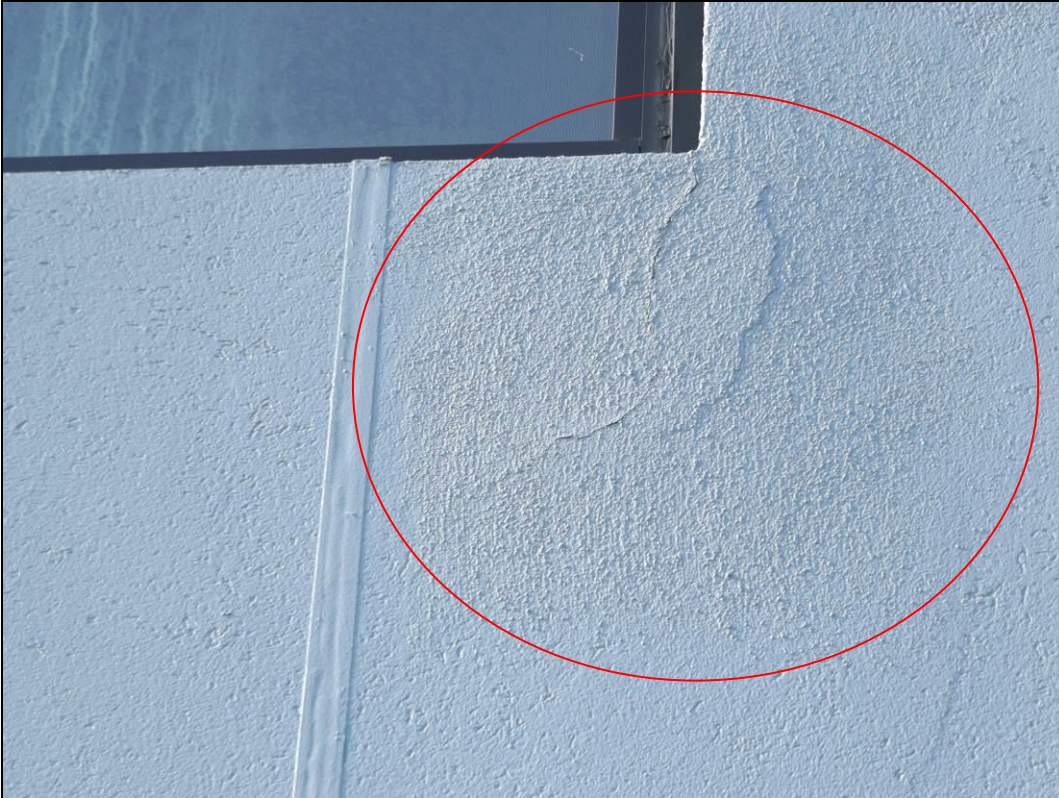
9

Showing an area that has re-cracked after repair (repair noted by the shadow)

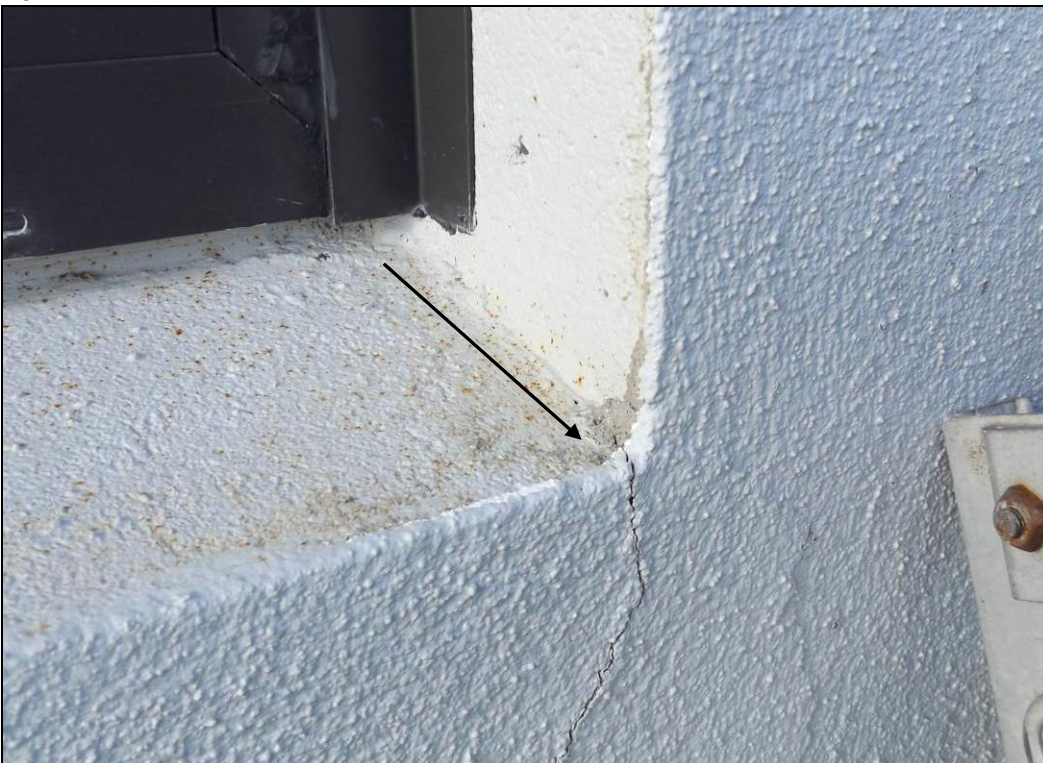
10

Showing the difference in materials and the ridge created by the repair and unsealed concrete allowing water to get down behind into the wall and behind the Rockcoat plaster delaminating it.

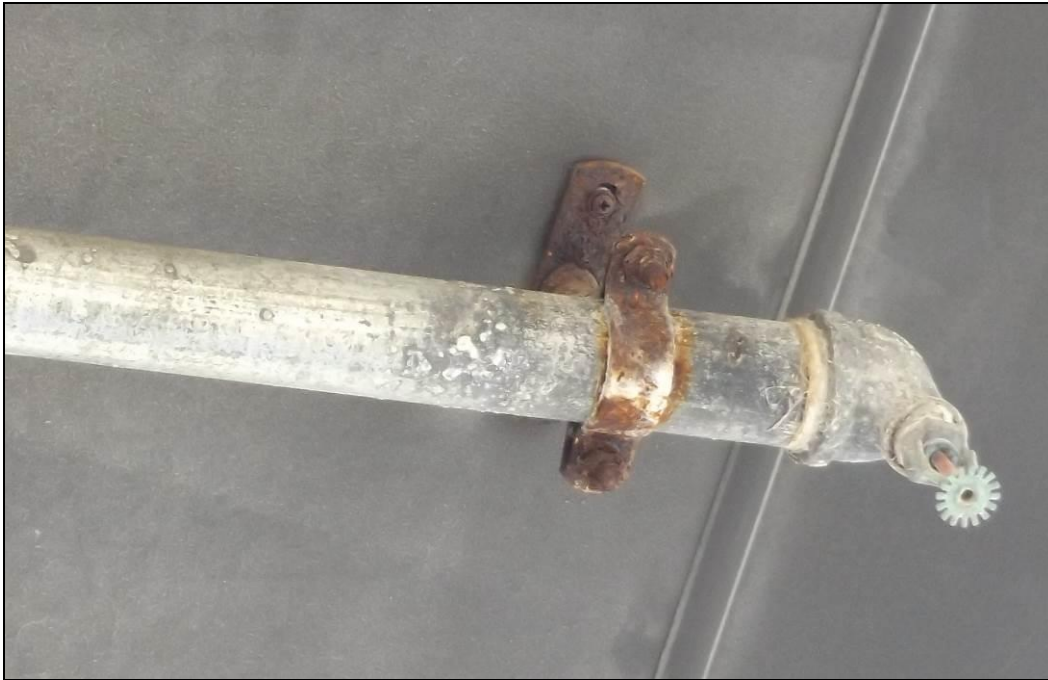
11

| Lyllall Bay Junction Defects List | | | | | | |
|---|---|---|---|---|---|---|
| <b>4 Corrosion</b><br>sprinkler pipe and brackets under south canopy of units 23 & 24 corroded<br>pipe moderately corroded, brackets severely corroded<br>appears brackets not suitable for external use in that environment, pipework not suitable for use in environment<br>isolate sprinkler system<br>remove brackets and pipework<br>replace pipework<br>replace brackets<br>scissor lift hire to access | | | | | | |

Showing a corroded sprinkler bracket and the white and red corrosion forming on the galvanised pipe - Units 23, 24

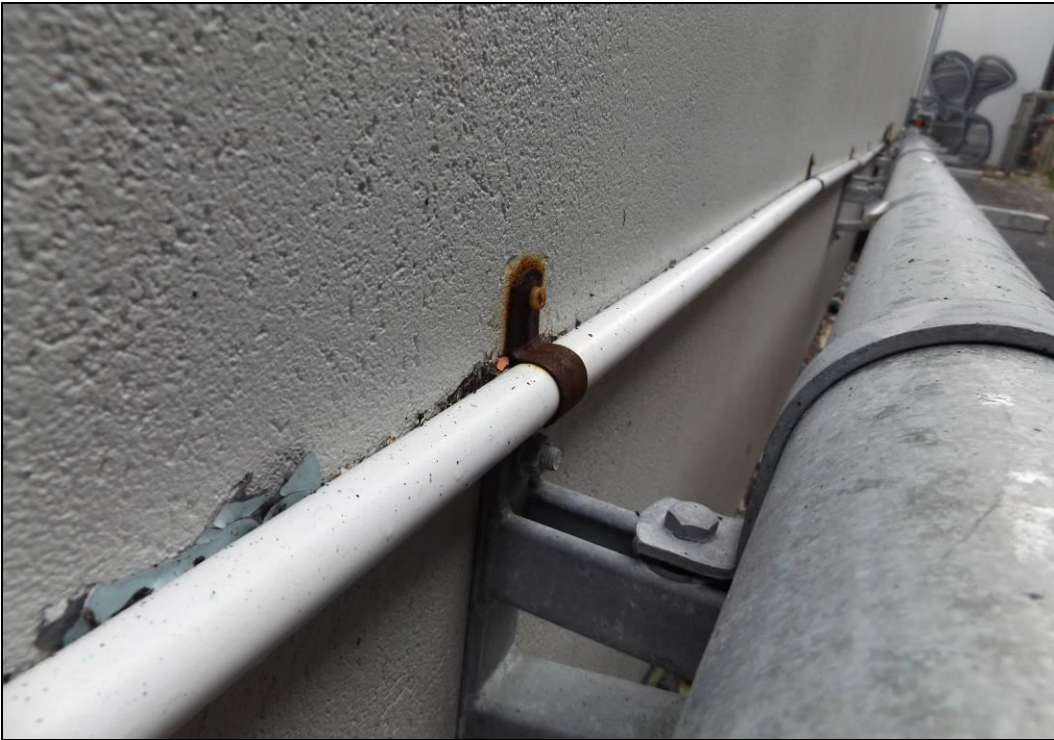
12

| Lyllall Bay Junction Defects List | | | | | | |
|---|---|---|---|---|---|---|
| <b>5 Corrosion</b><br>pipe clips to wall mounted PVC pipe corroded<br>clips installed do not appear to be suitable for external use<br>remove clips<br>replace clips<br>scissor lift hire to access high level to end of block A | | | | | | |

Showing some of the 20 corroding brackets that secure a water pipe connected to the sprinkler system – northern elevation

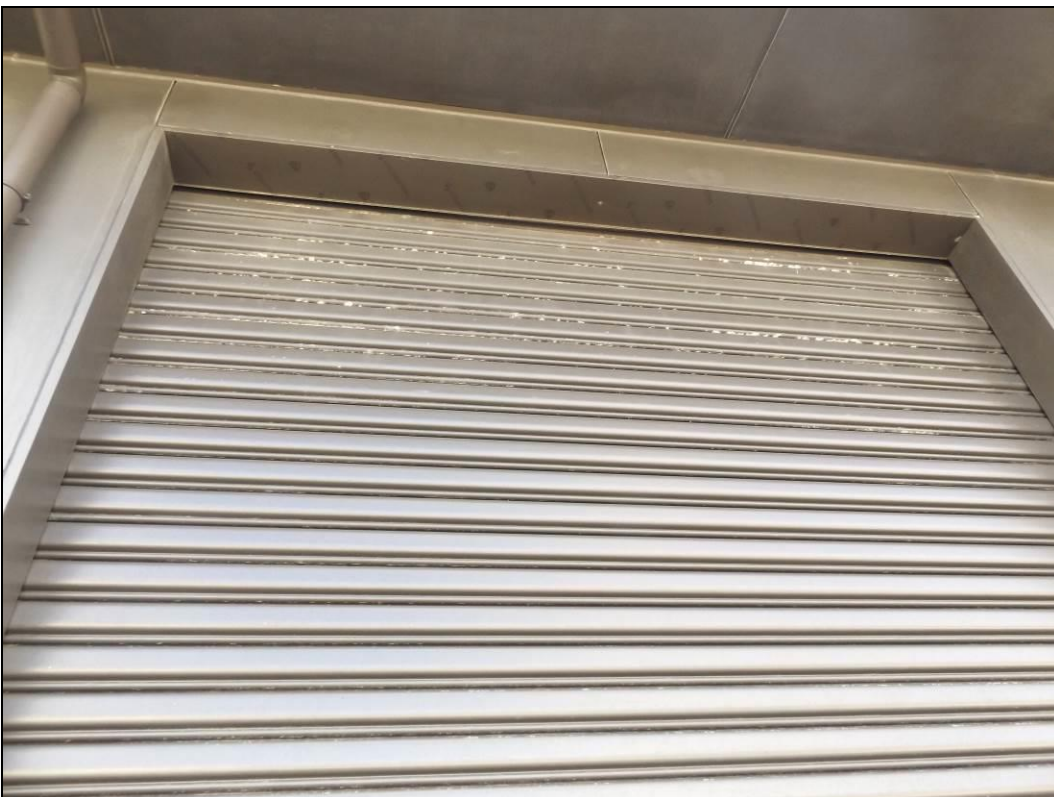
13

Showing what appears as the formation of deposited salts onto the paintwork of a roller door located in an non-rainwashed area which are typically the 1<sup>st</sup> places to corrode

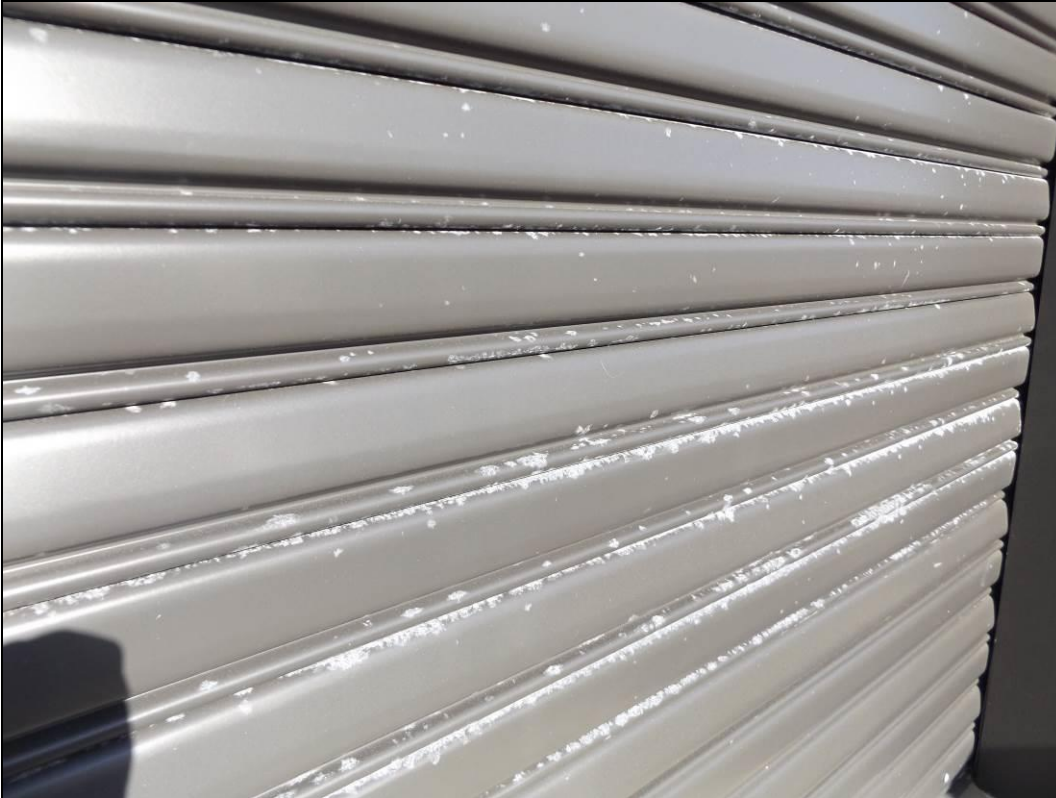
14

An example of an exposed door that has the formation of salt build ups and possibly early corrosion setting in through the paint – typically not fully removable because of the complex assembly including (as was visible) between the flexible segments and behind the door track

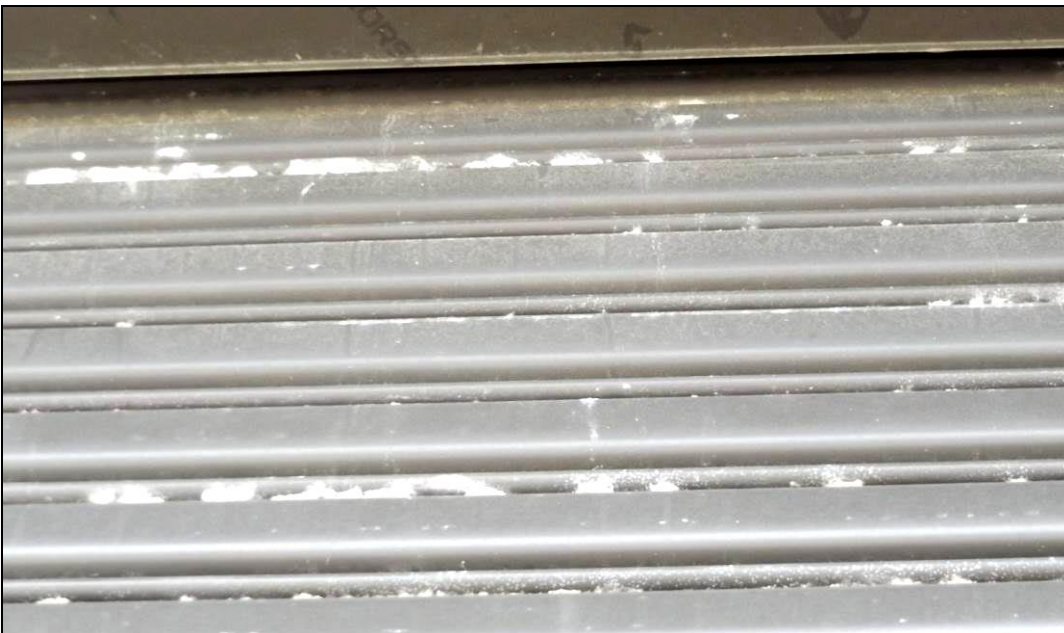
15

Showing the heavy salt build up observed on a south facing roller door – very difficult if not pragmatically impossible to fully remove

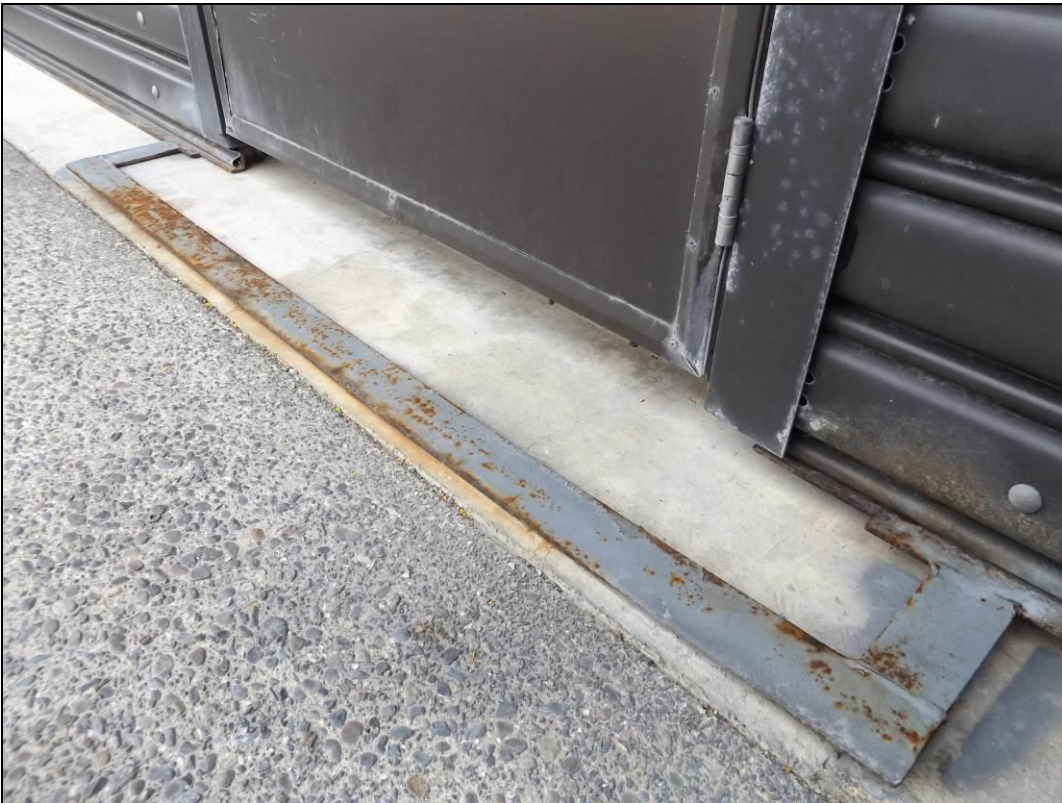
16

| Lyllall Bay Junction Defects List | | | | | | |
|---|---|---|---|---|---|---|
| <b>7 bottom steel rail of doors corroded</b><br>the bottom steel rail of the doors is already visibly corroded and needs to be treated to reduce the speed of corrosion<br><br>wire brush to remove rust, rust prime and repaint with suitable coating<br>paint manufacturer to provide specification to suit - likely to need an epoxy coating eg Uracryl or similar<br><br>steel flat bar to personal access doors within roller door (3no) | 4.5 | M | 120.00 | \$ 540.00 | \$ 540.00 | |

Showing the formation of corrosion into the bottom steel rail – demonstrating the corrosive nature of the location early into the life of the doors –but noting several others were similar- note the visible salt deposits

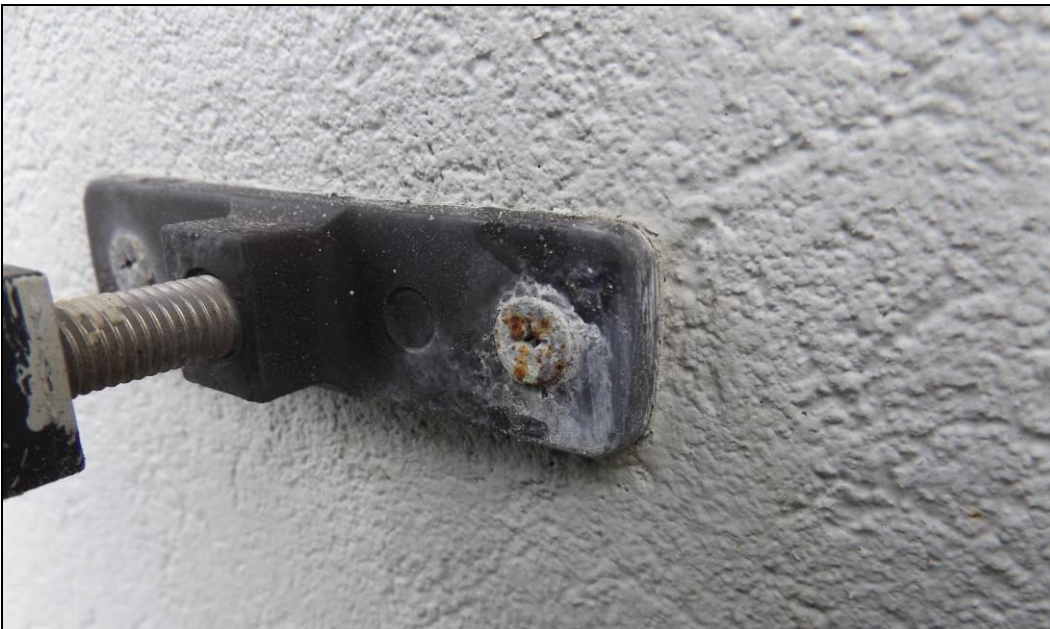
17

| Lyllall Bay Junction Defects List | | | | | | |
|---|---|---|---|---|---|---|
| <b>8 Screw fixing to downpipe brackets corroded</b><br>screws used to fix bracket not suitable for location<br><br>remove corroded screws<br>replace with suitable screws<br>scissor lift hire to access high level | 138.0 | No | 5.00 | \$ 690.00 | \$ 690.00 | |

Showing an example of corrosion forming on a downpipe securing screw of which different types of fixings are observed

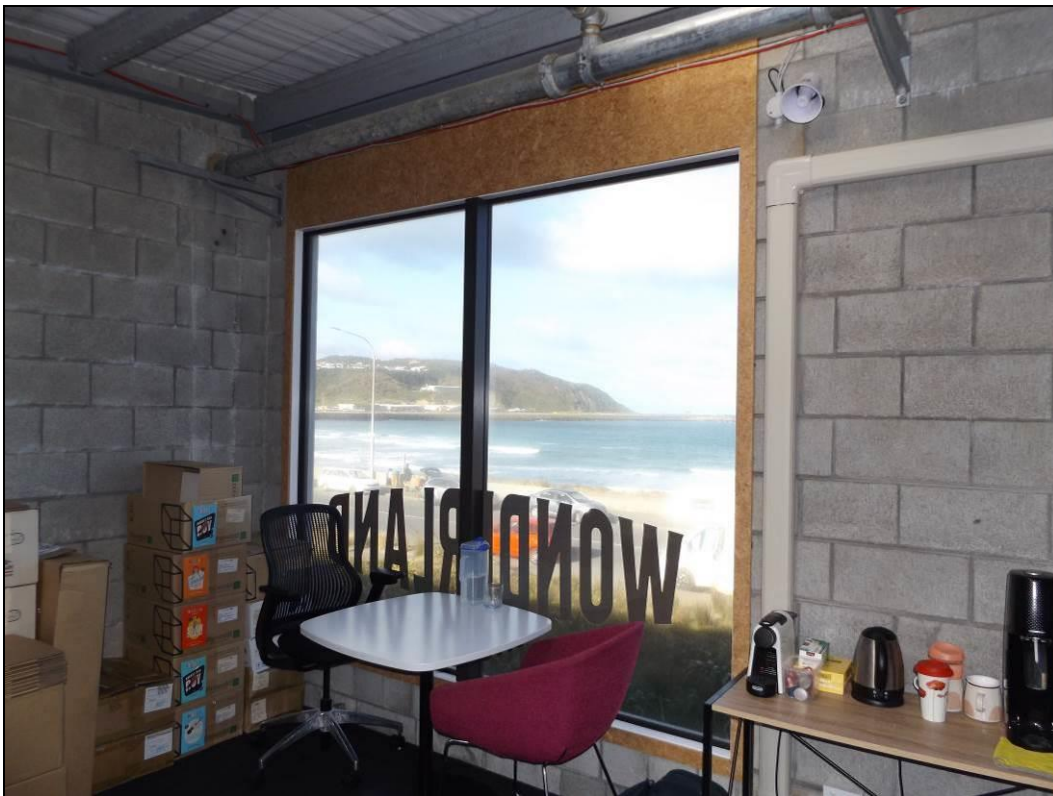
18

Showing typical upper level fixed window detail set behind particalboard lining into the block walls

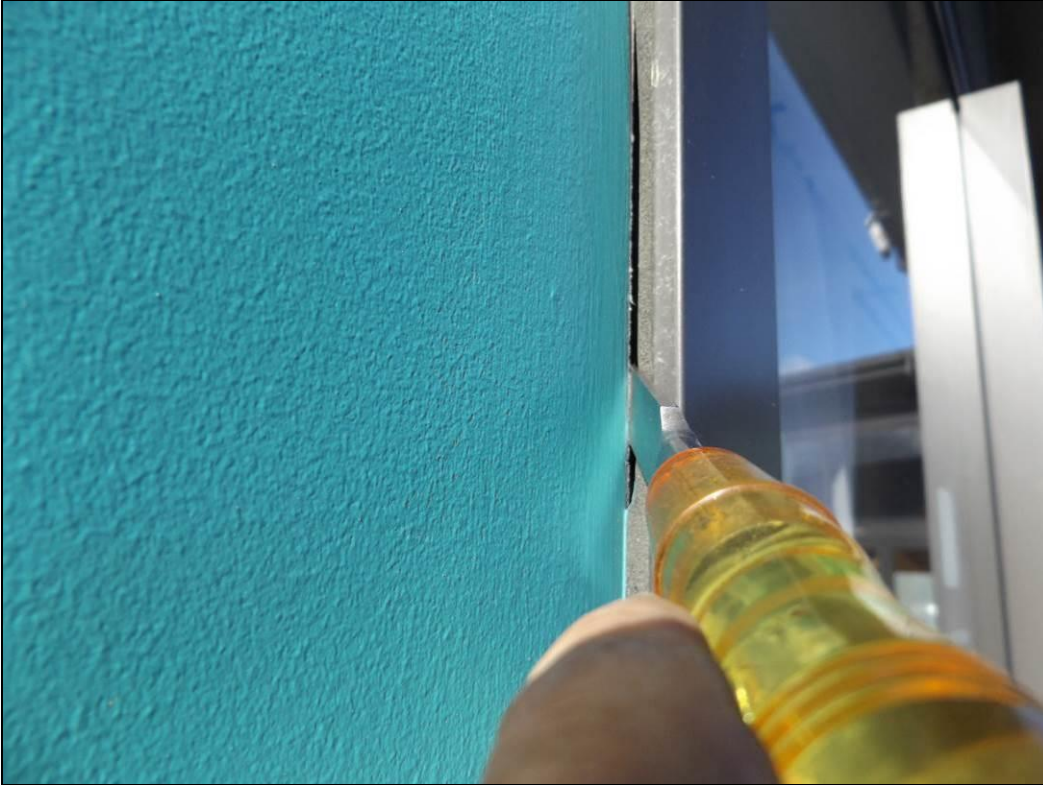
19

Showing a lower level joinery unit set against fibre-cement – showing the window set 5mm beyond the cladding with easy access behind the cladding if it were not for the reliance on the foam strip which is barely secure due to lack of joinery pressure – unit 53- 54

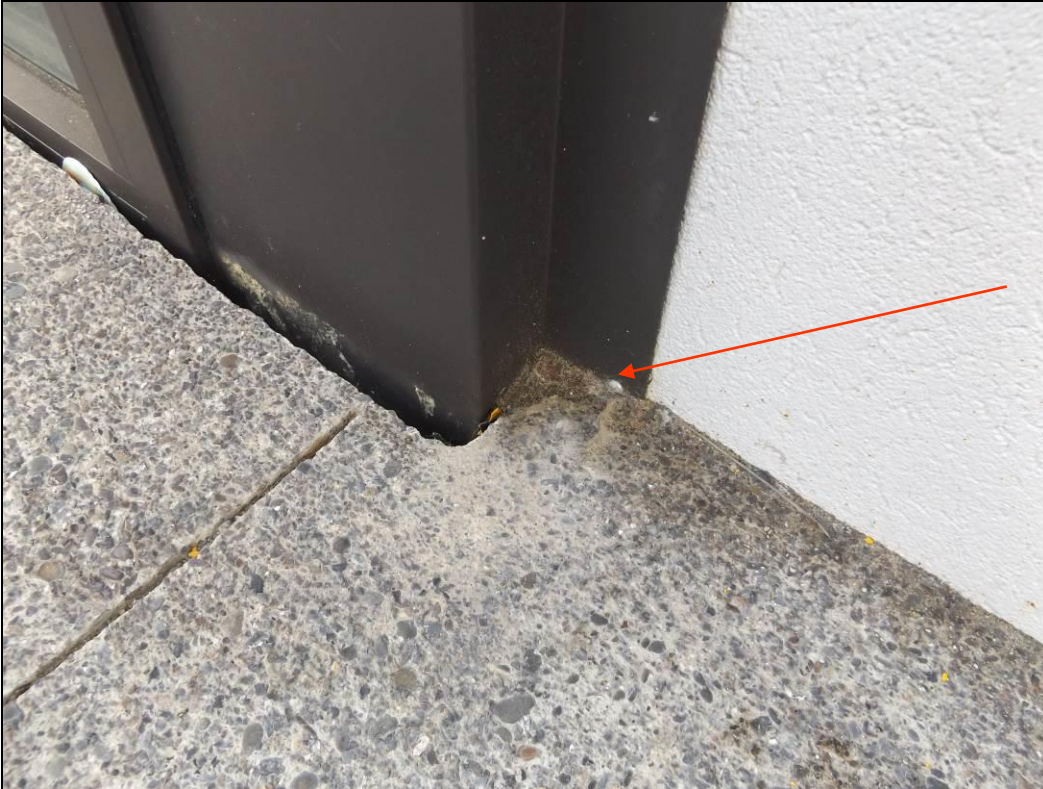
21

Showing a common example where concrete is placed against the steel joinery flashing assemblies  
Note the narrow separation gap which the joinery sits down into

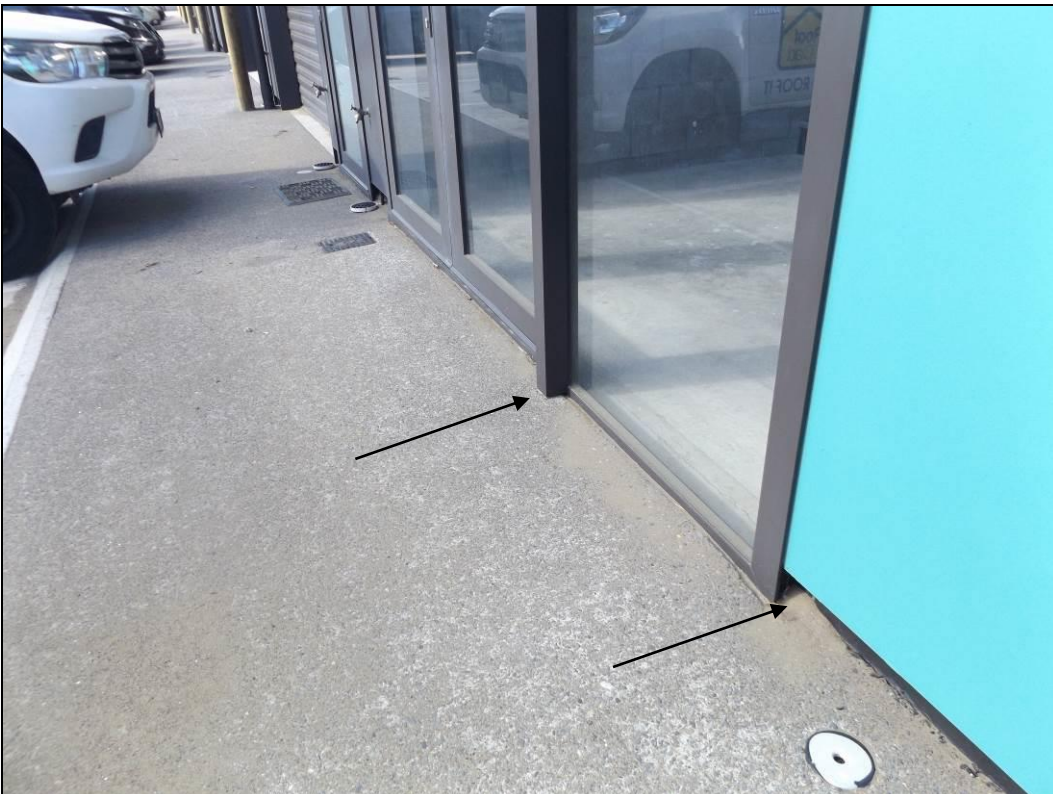
22

An example only - not only is the thin gap filled with accumulated sand but the concrete path is in direct contact with the joinery frames

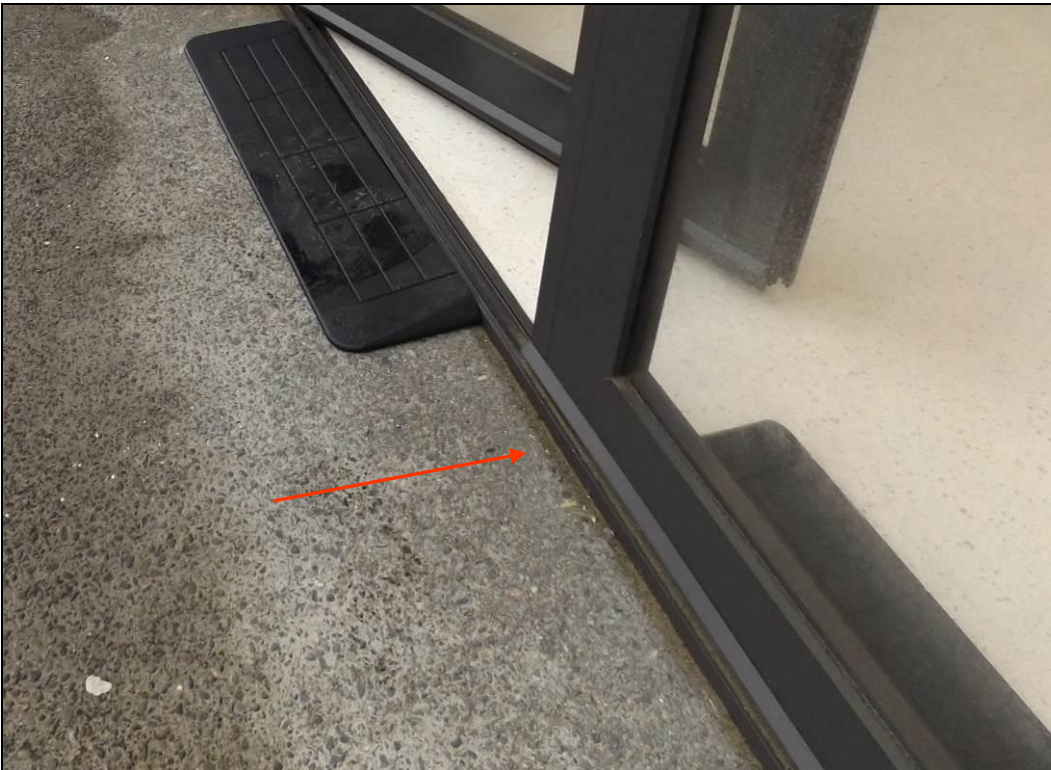
24

Showing a gap between joinery and concrete – filled with wet sand – note the optional owner supplied ramp demonstrating the threshold lip

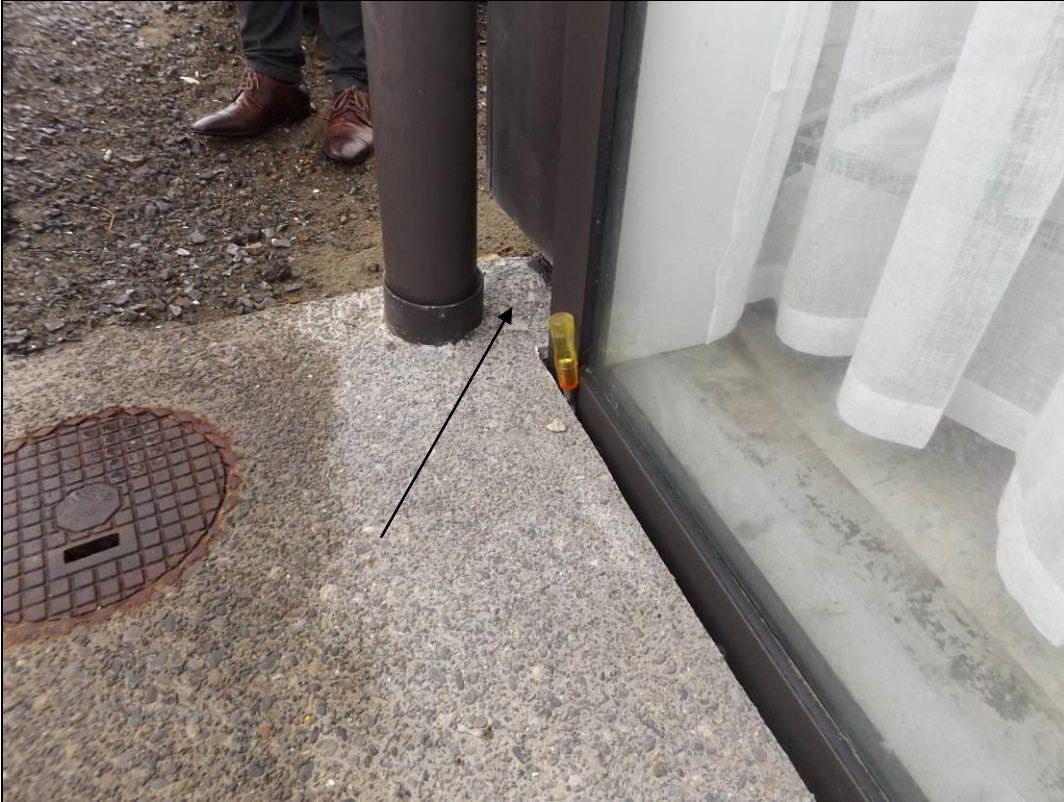
25

Showing a gap between joinery and path – which is blocked off preventing drainage of trapped water – or does it stop water entry ? because it looks like the finished floor levels in this location are set too low when compared to the surrounding land, road and paving – (southern corner)

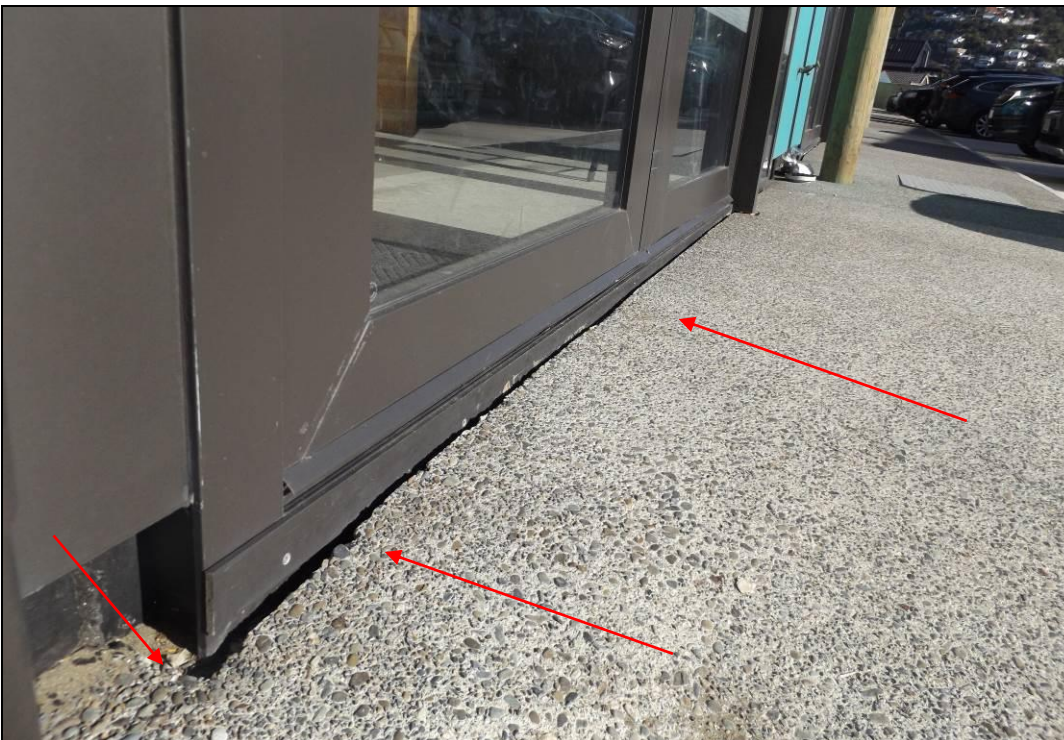
26

To stiffen and protect the shape of the raised threshold alluminium sill a stiffening bar has been added to the front of the sill – showing the blocked draiange on the end
