**Re: Body Corporate 582203  
Property at Lyall Bay Junction, 68-72 Kingsford Smith Street, Rongotai, Wellington  
Annual General Meeting**

## BODY CORPORATE NO 582203 (BODY CORPORATE)

### Property at Lyall Bay Junction, 68-72 Kingsford Smith Street, Rongotai, Wellington

Ref: 68 – 72 Kingsford Smith Street Lyall Bay Wellington / Defects Report

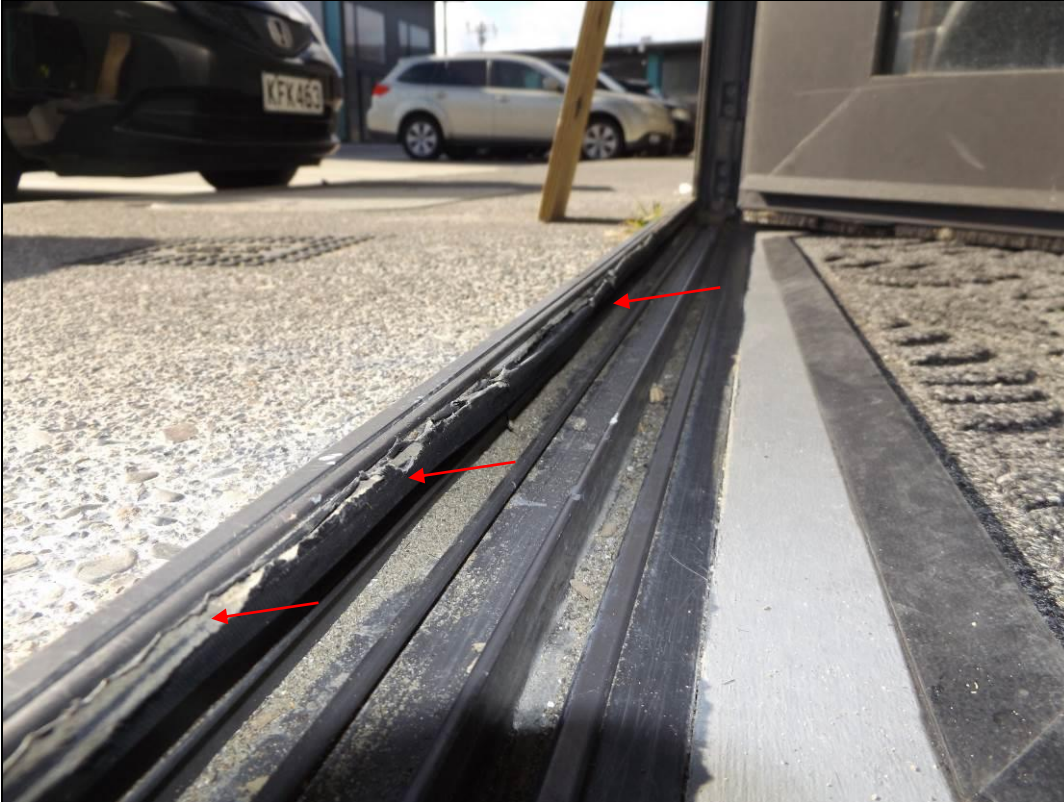
27

Showing “normal use” impact damaged door seal on the raised threshold sill, example only many others were found – note the sand building up in the channels

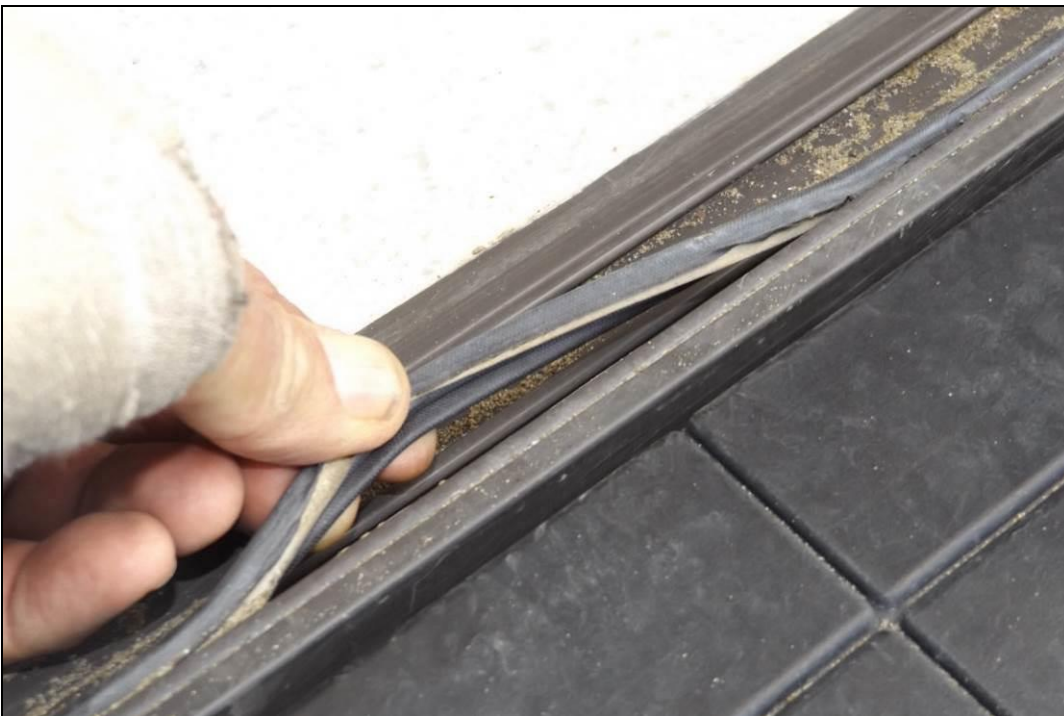
28

A torn rubber seal no longer able to stay in the track

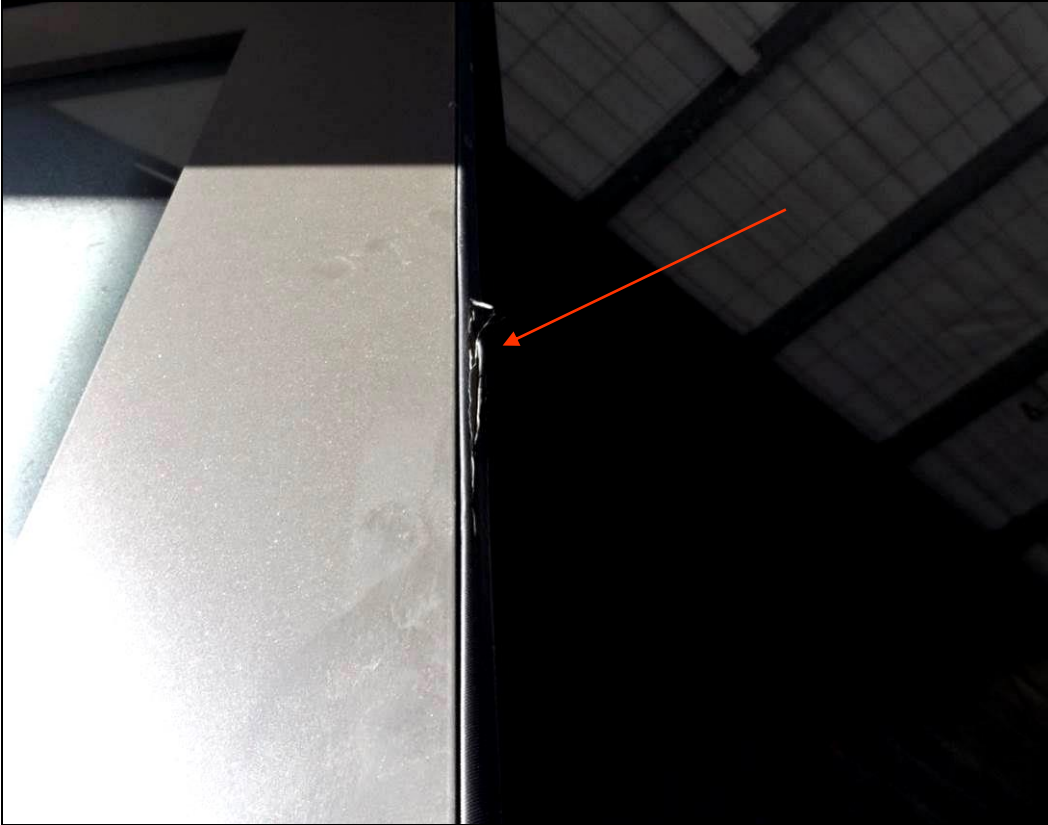
29

A torn rubber on a door jamb, cause unknown, perhaps after striking the double door locking clasp

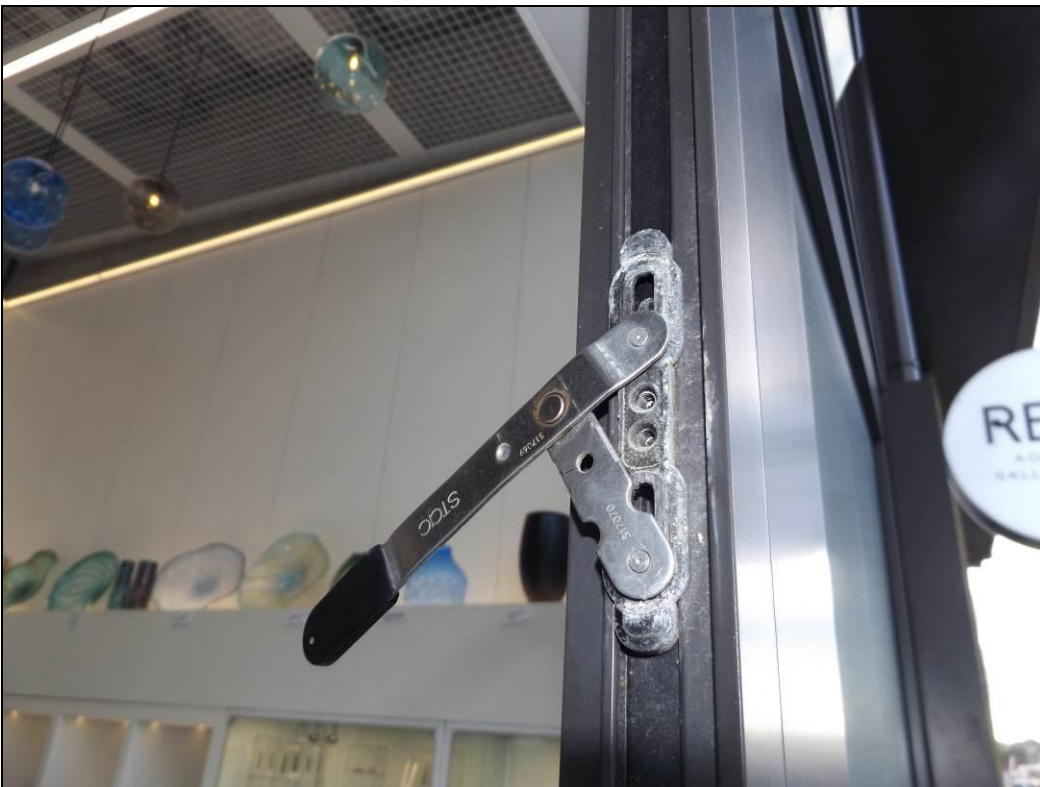
30

A double door fastening lever – In my opinion very flimsy engineered construction and noting the obvious formation of corrosion on the non-stainless part of the clasp

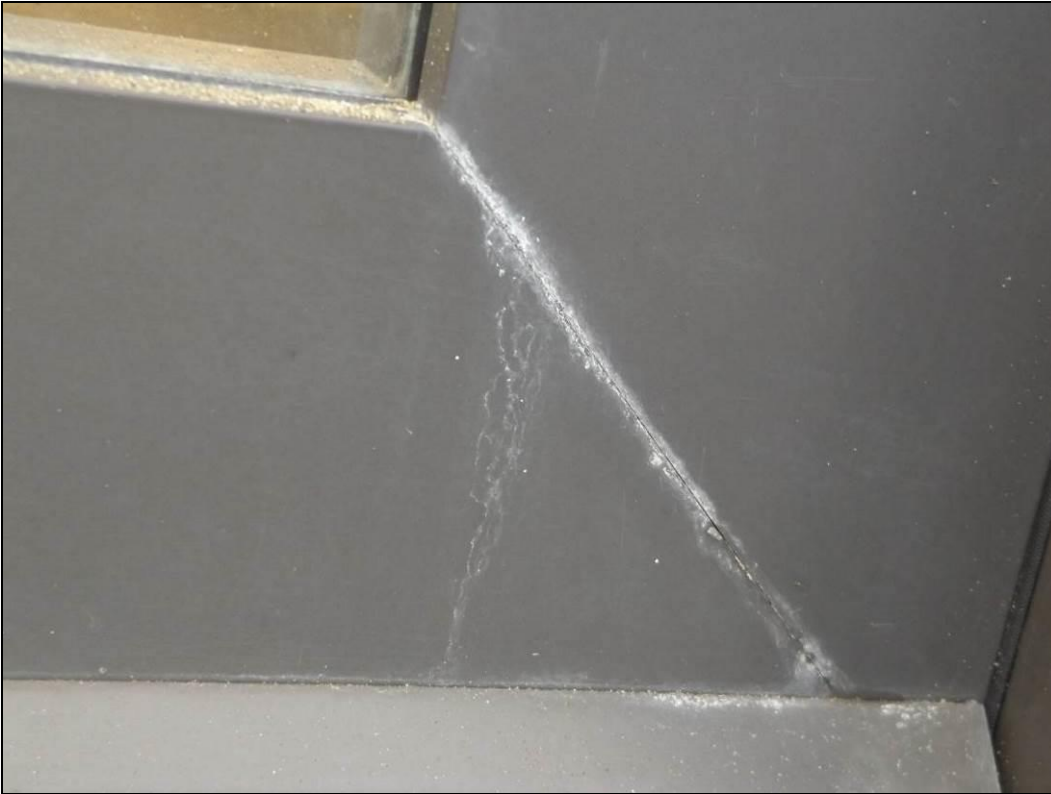
31

Noting salt deposits clinging to a mitred joinery junction – example only

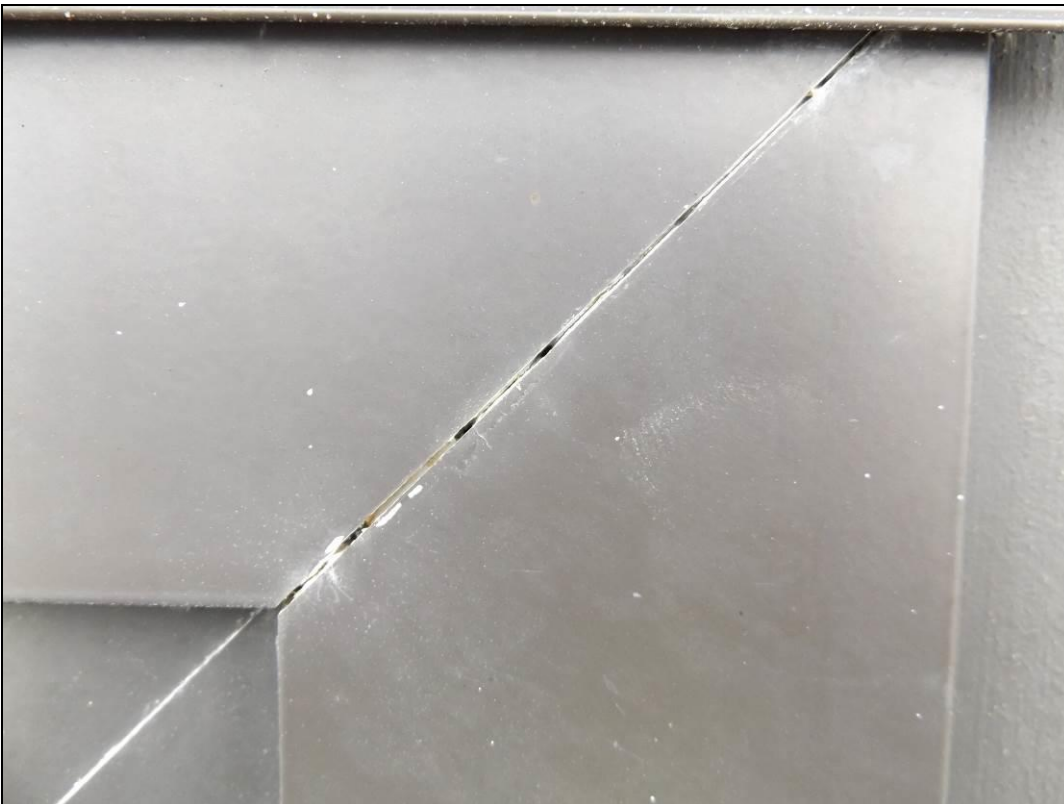
32

On the eastern elevation – showing a poorly jointed or racked joinery unit – salt ladden water and sand will enter the junction in every windy southerly rainstorm – indicates poor construction detail

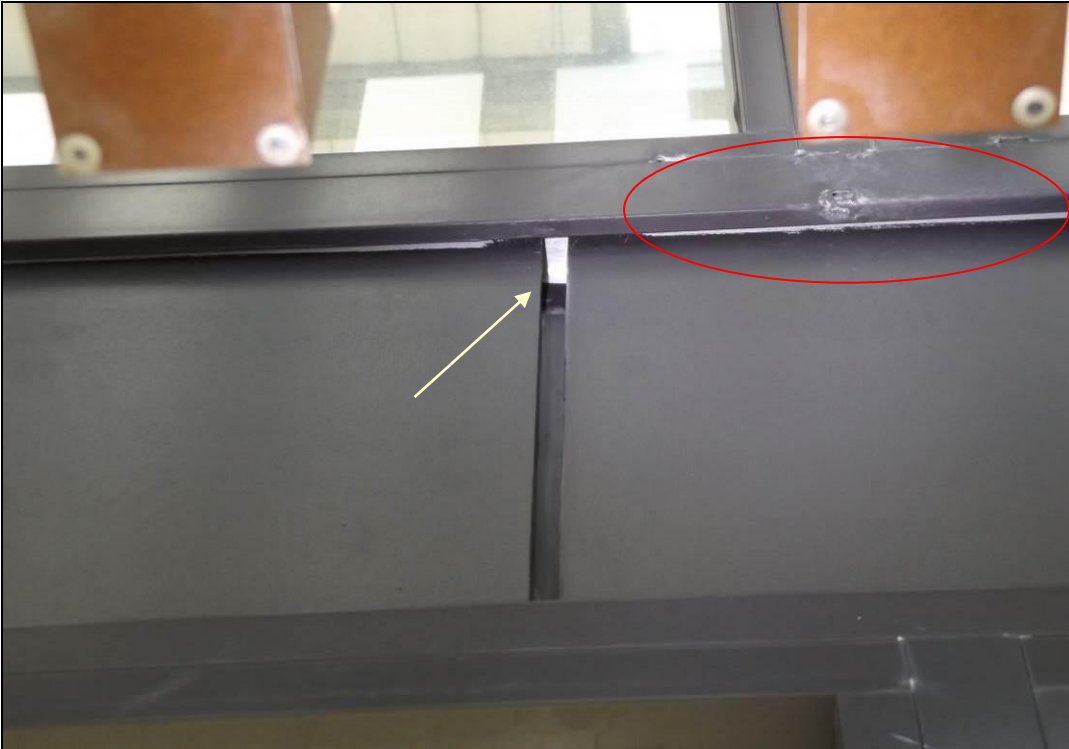
33

Showing how sealant installed between joinery panels doesn't extend to close the gap and salt deposits clinging to the joinery frame

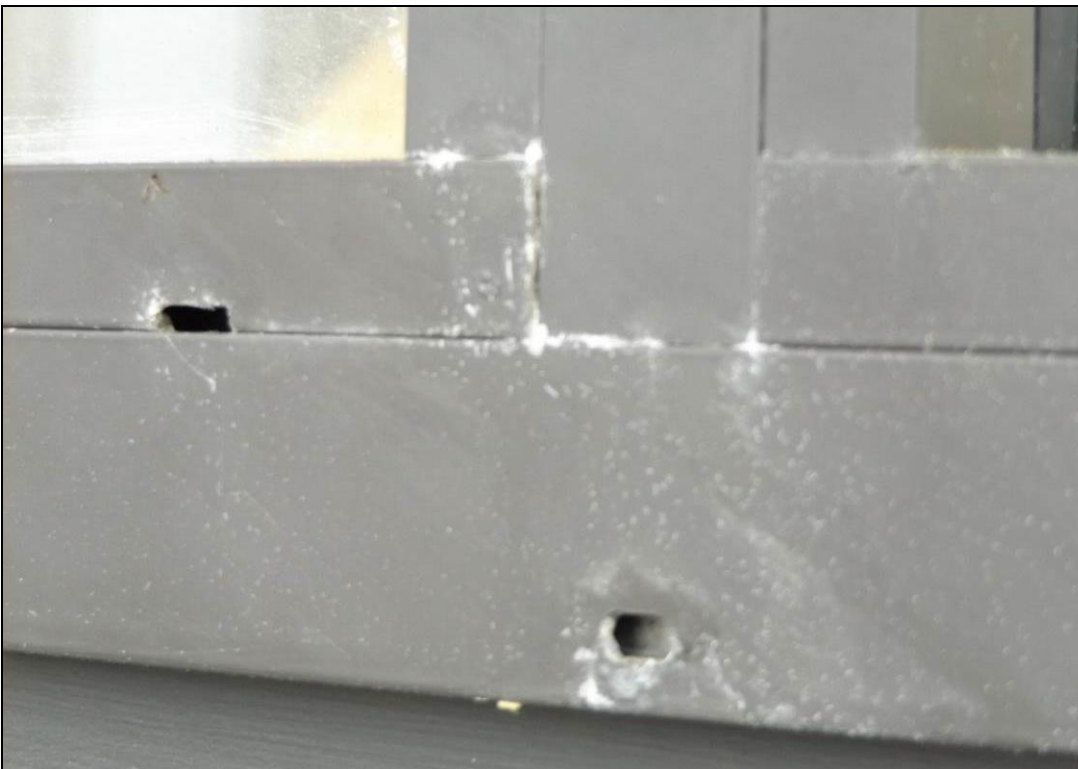
34

Showing corrosive salt deposits around drainage openings and joinery junctions – Manufacturer's recommend washing of the joinery "at least" every month in similar locations

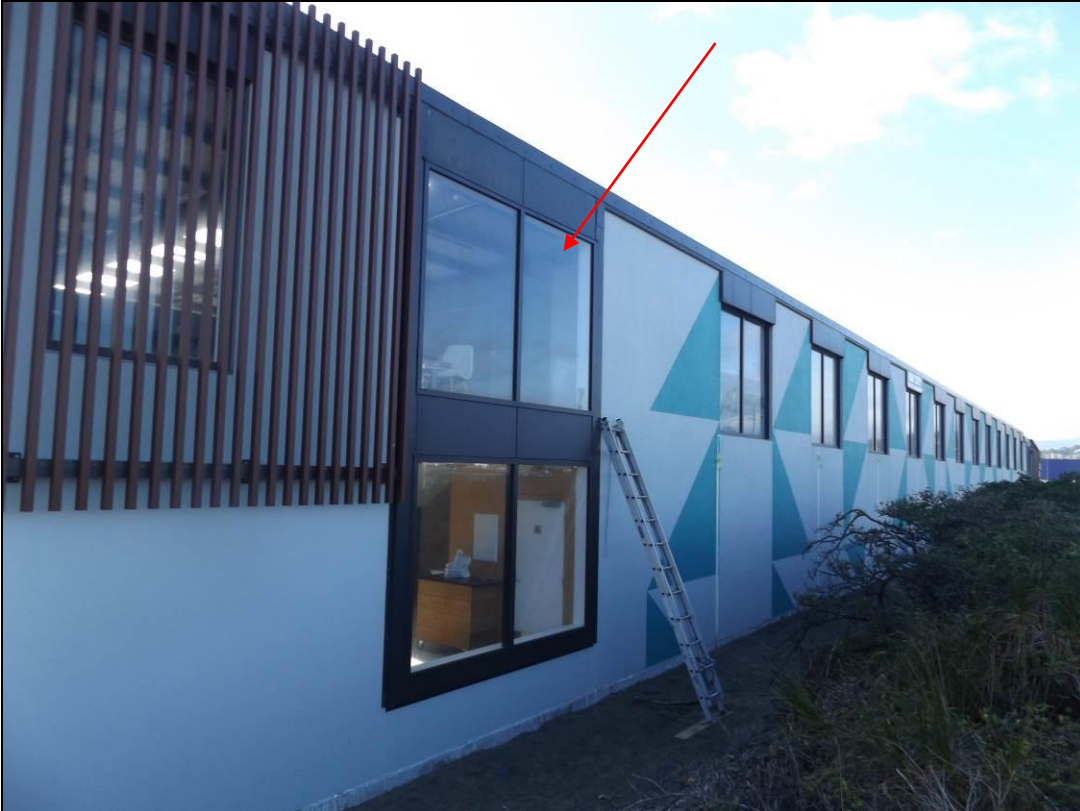
The large southern elevation western corner feature window assembly - Unit 35

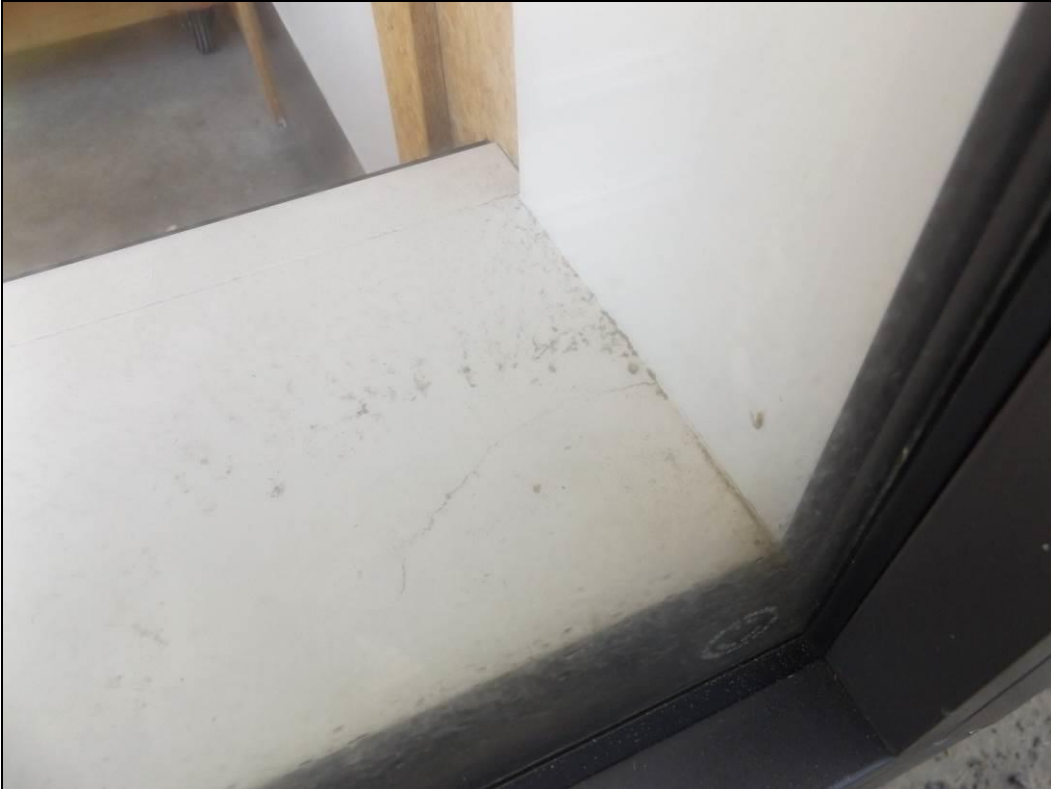
37

Showing sand on the southern elevation window sill – showing the non-opening window which when in that environment is not actually weathertight

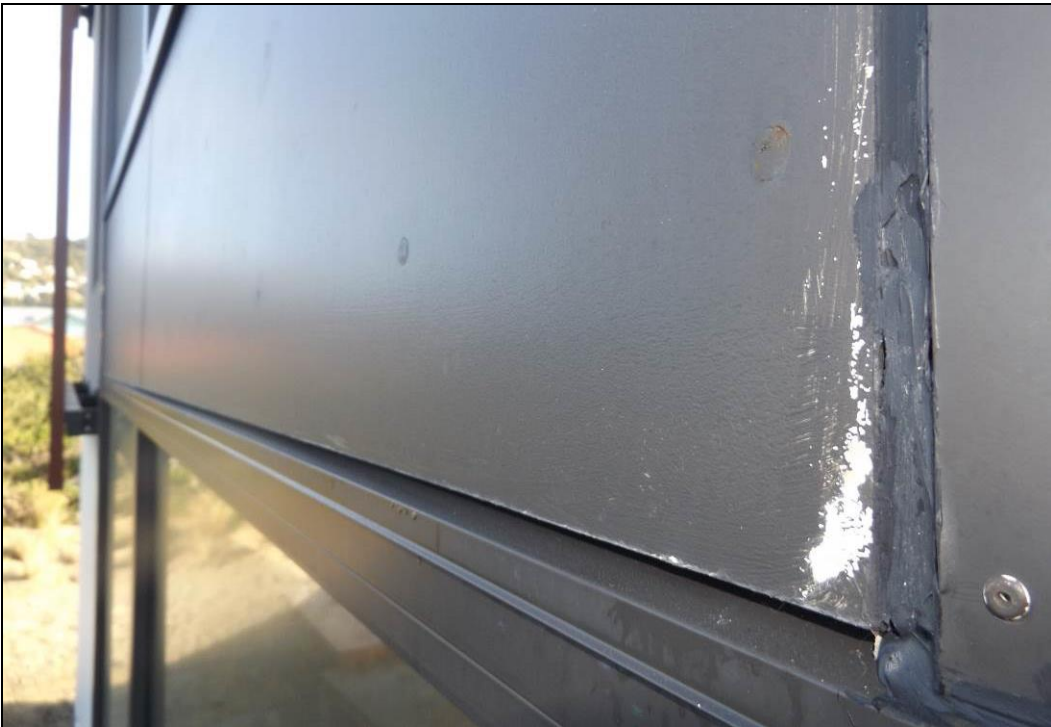
38

Midway up the southern window showing poorly painted fibre-cement cladding panel and messy application of sealant - The reason it is applied is not known – maybe to stop a leak ?

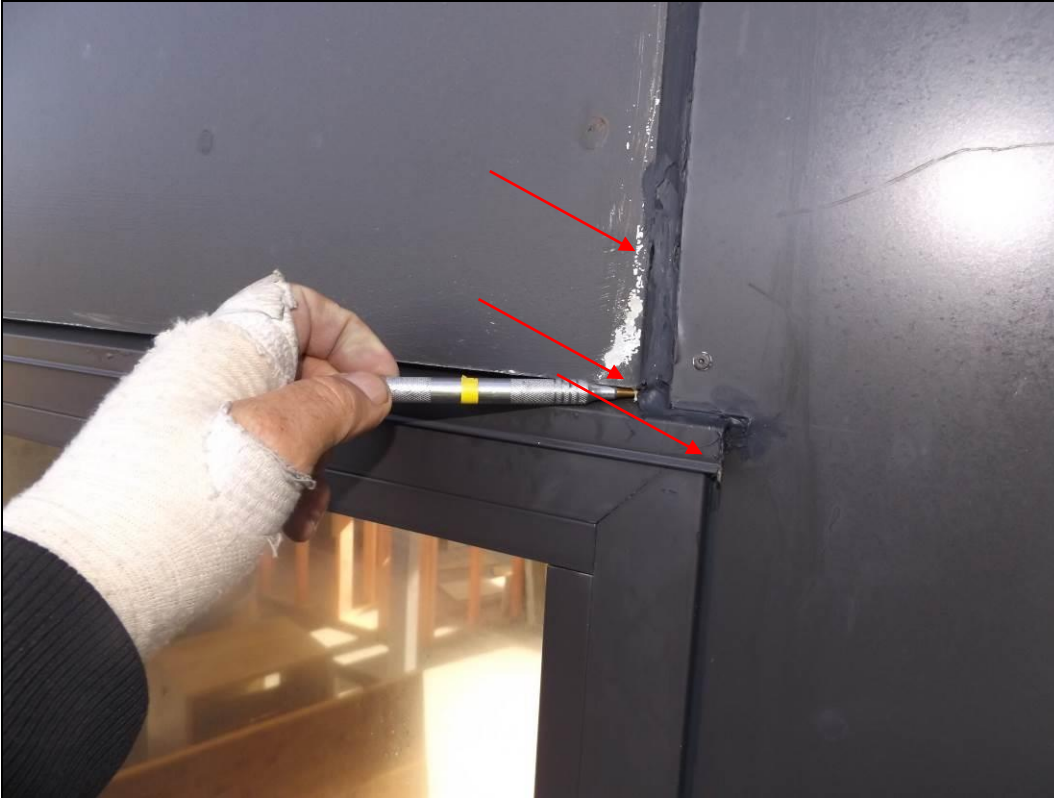
39

Showing gaps behind the sealant as well as a gap above – also note the very short head flashing overhang

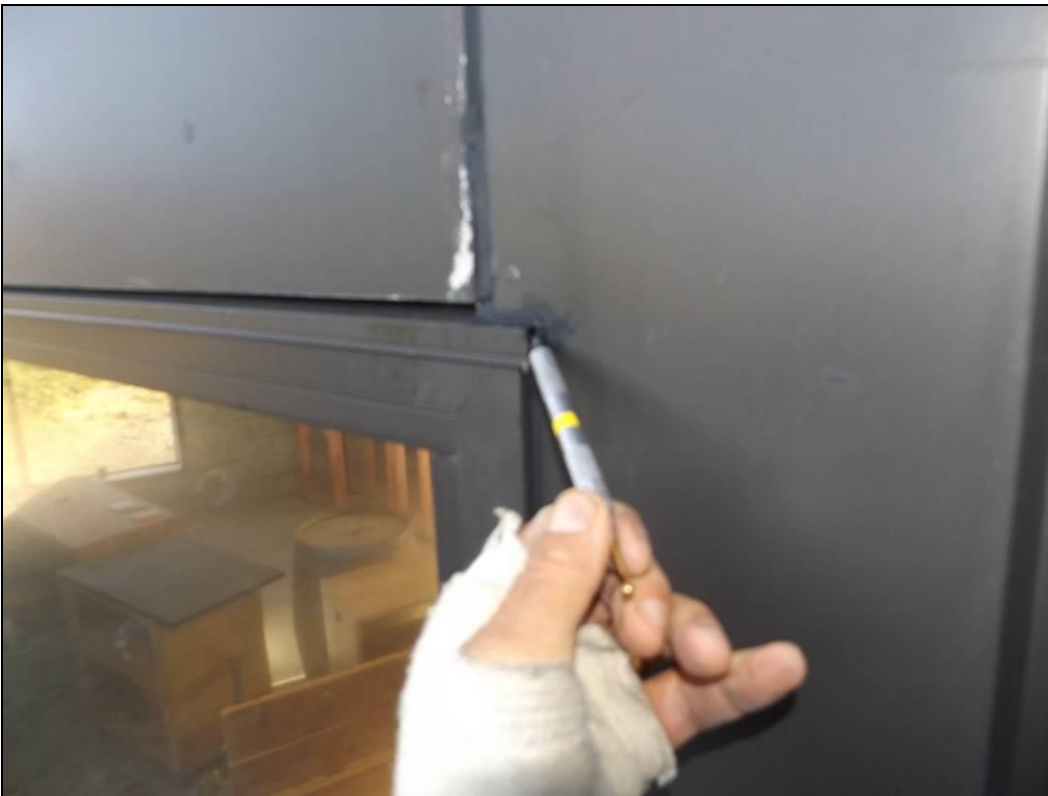
40

Showing a gap between the end of the short head flashing and the steel flashing panel beside

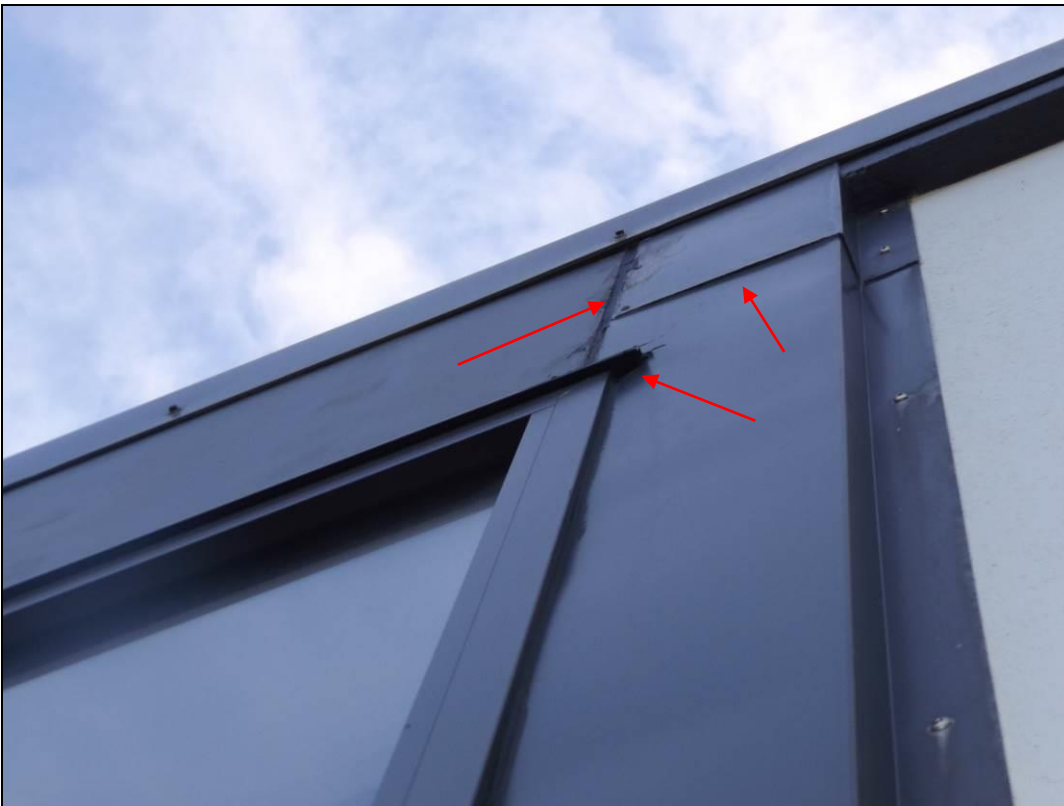
42

Showing a head flashing of “slightly” longer length with sealant roughly applied and a overlap jointed rather than one peice or a welded flashing assembly – southern window assembly

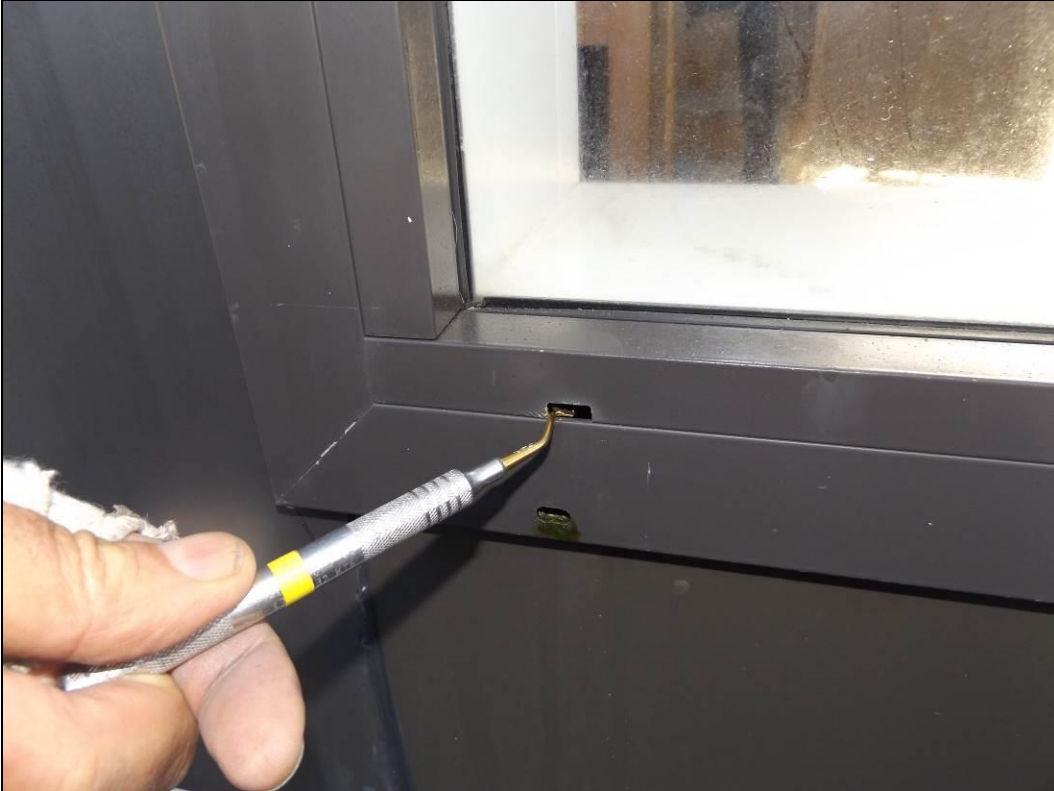
43

Showing an example of the unprotected exposed openings in the frame that are likely to contribute to wind blown sand entering the interior and frame

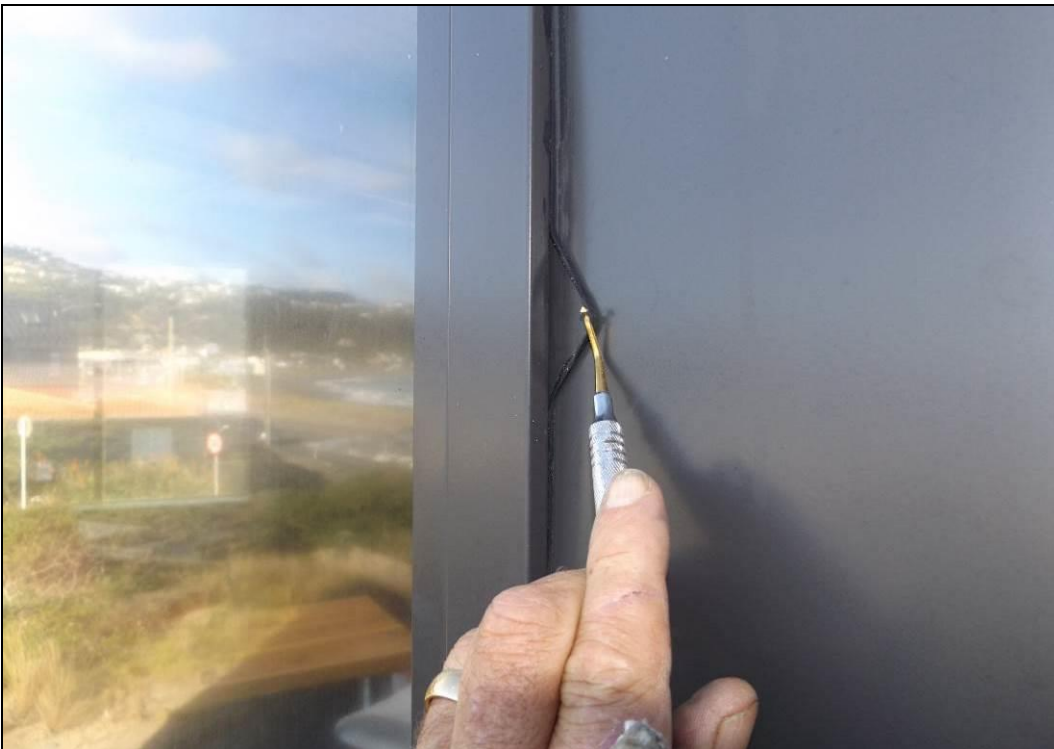
44

Demonstrating the likely lack of inseat behind the frame with reliance on only a thin bead of retrospectively applied external sealant – already failing to adhere to the materials

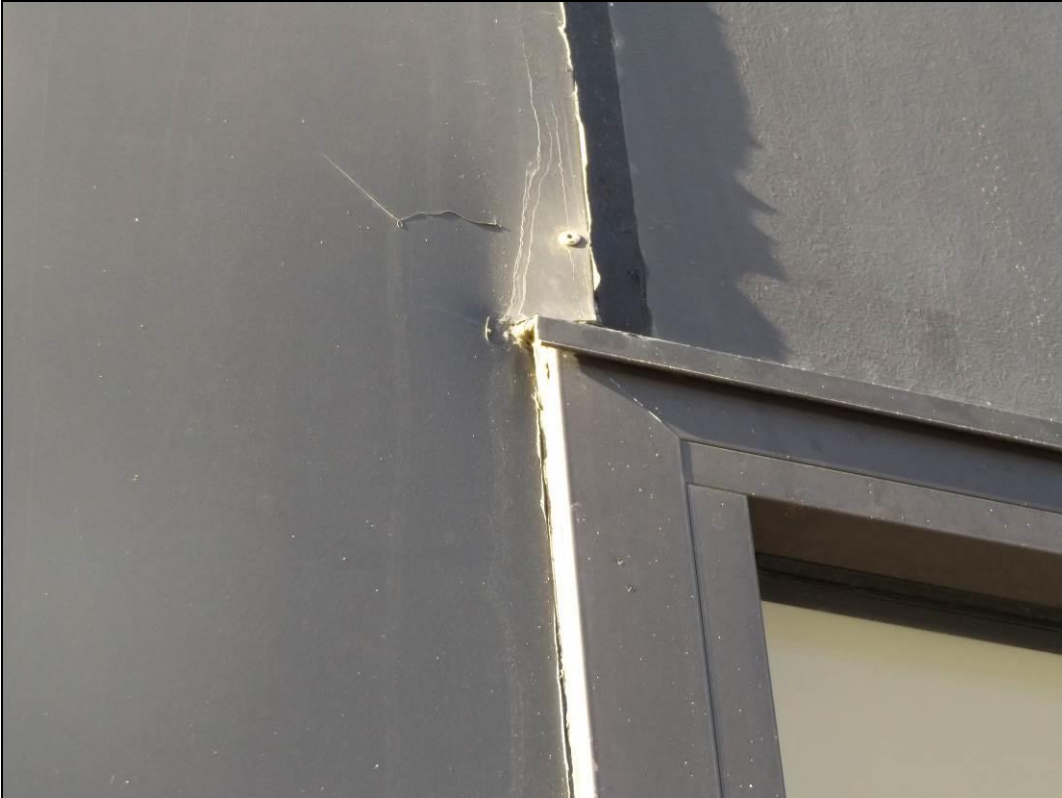
45

Western window – Bent flashing with reliance on sealant to provide protection to a bent joint – note the short head flashing detail and thin bead of sealant

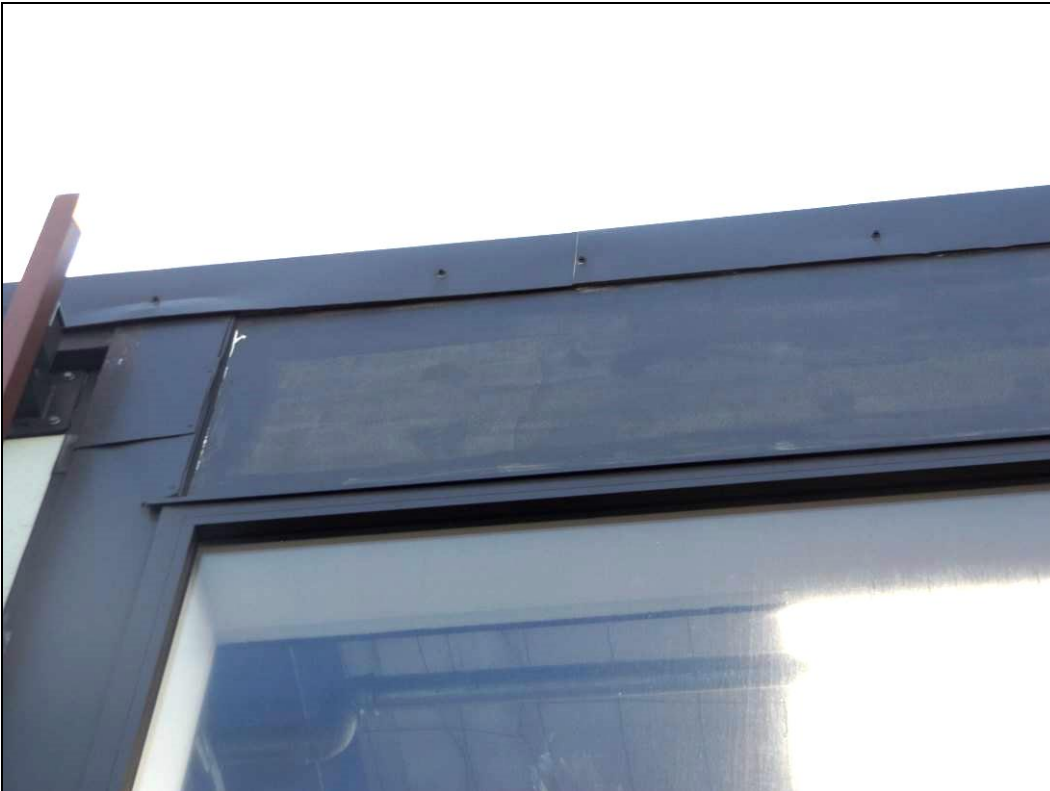
46

Western window showing poor application of paint

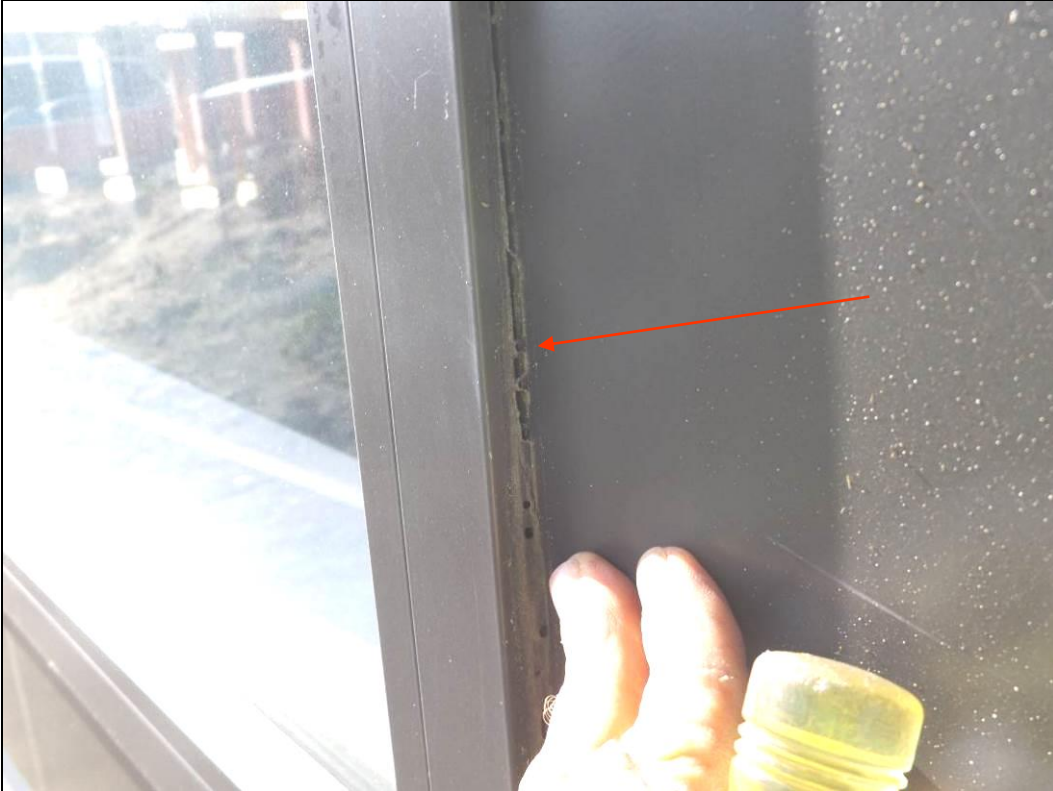
47

Showing how easy it is to depress some of the steel to create a gap between the window frame and the panel- expect similar in high winds and rain – note how the thin exterior sealant has failed

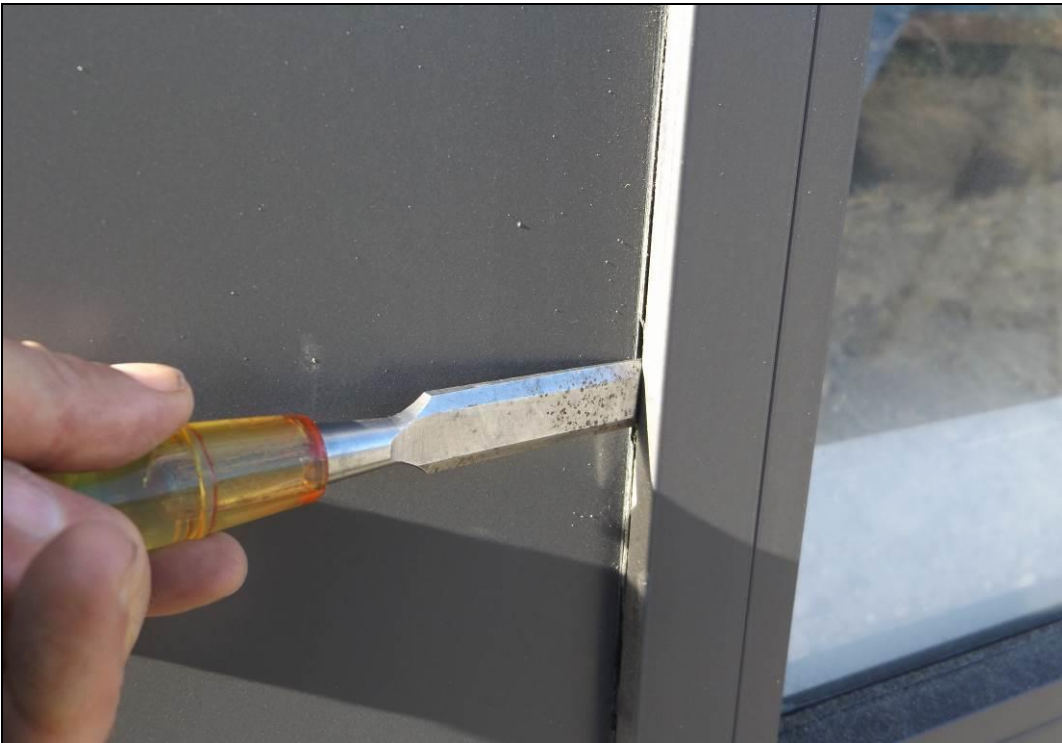
48

An example of the lack of inseat or sealant behind the window frame – certainly not adequate detail for this particular wind and coastal environment – if my chisel can easily enter so can water

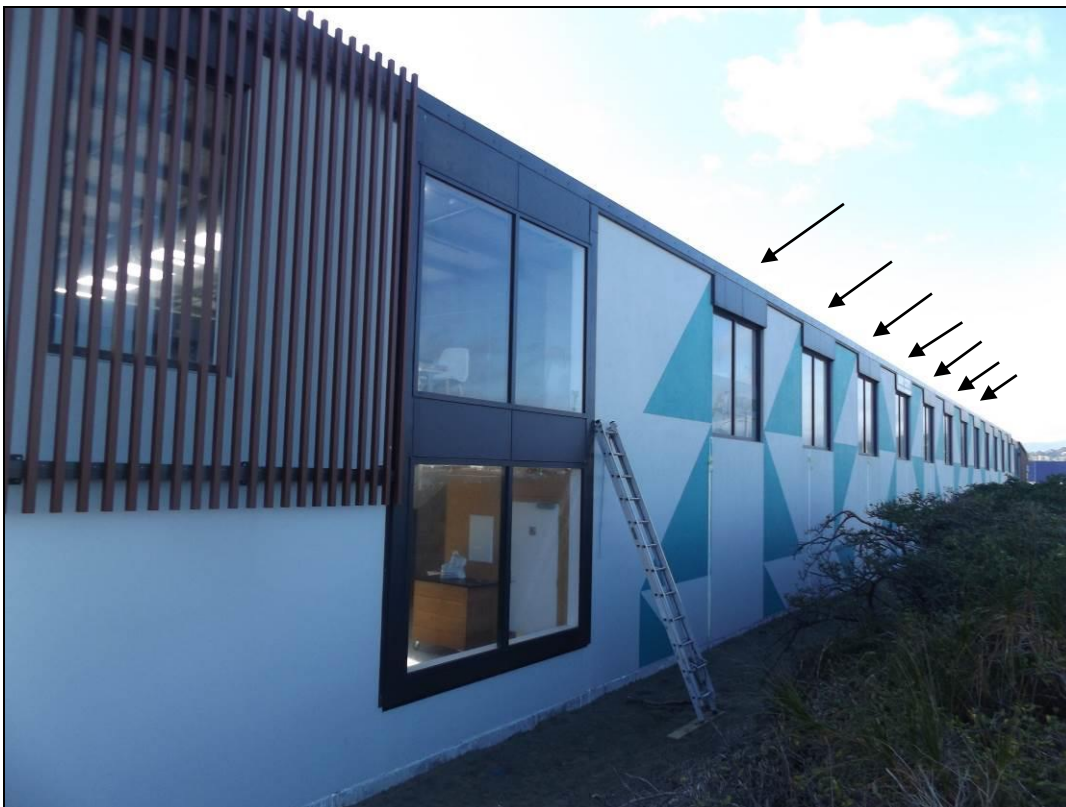
49

The southern elevation – showing the painted fibre-cement panels that act as the head covers for the windows below

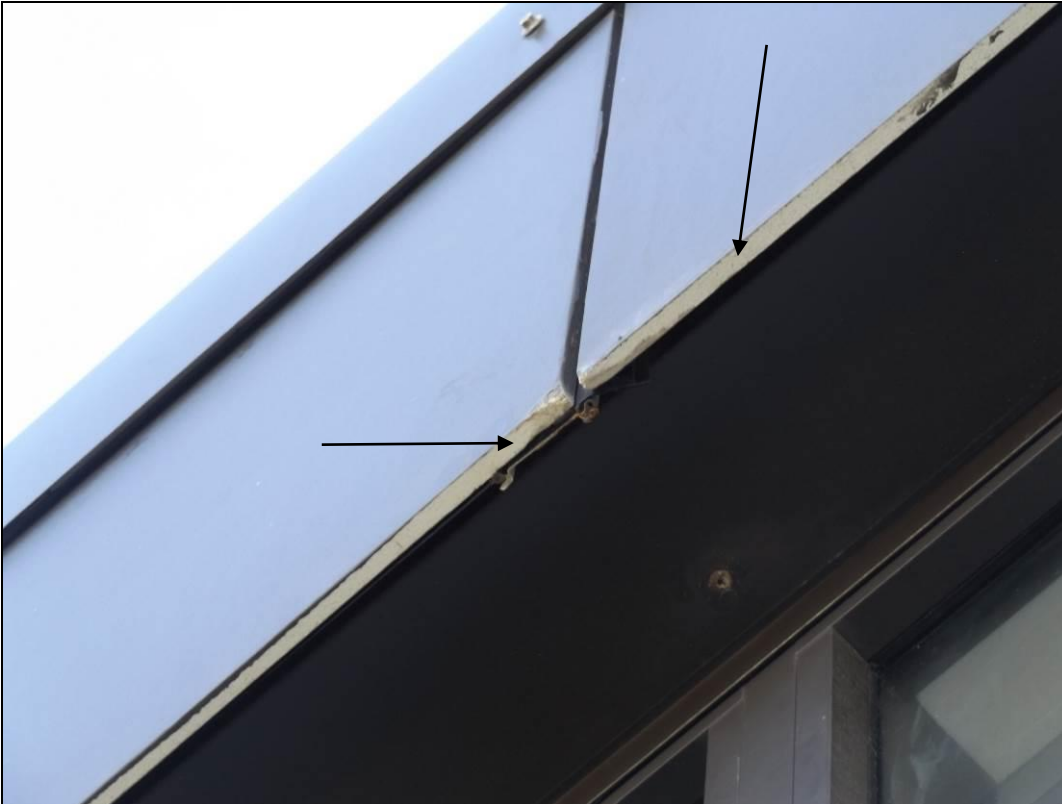
50

| Lyall Bay Junction Defects List | | | | | | |
|---|---|---|---|---|---|---|
| <b>13 &amp; 14 Fibre cement cladding at window heads</b><br><br>Fibre cement cladding panels install above windows on south and west elevation bottom edge not painted in most situations. This will allow moisture to be drawn into the sheets causing premature failure of the cladding panels<br>multiple sheets are bowed and do not sit flush or straight, indicating in adequate fixing and in cases obvious signs of structure behind protruding further than required to allow panels to be installed correctly<br><br>Manufacturer states cut edges should be primed immediately after cutting and exposed faces and edges should be primed and painted within 90 days of installation<br>as 90 days since install has already past the manufacturers warranty on the installed product is currently void. As such any panels that have not been sealed should be replaced to achieve the warrnaties required for the project<br><br>remove bowed, misaligned and unsealed panels<br>address structure behind to ensure panels can be fitted correctly<br>supply and install new panels<br>paint all exposed edges to ensure panels are fully sealed as required<br>scissor lift hire to access high level | | | | | | |

Showing the bottom and likely the sides of the panels are unpainted

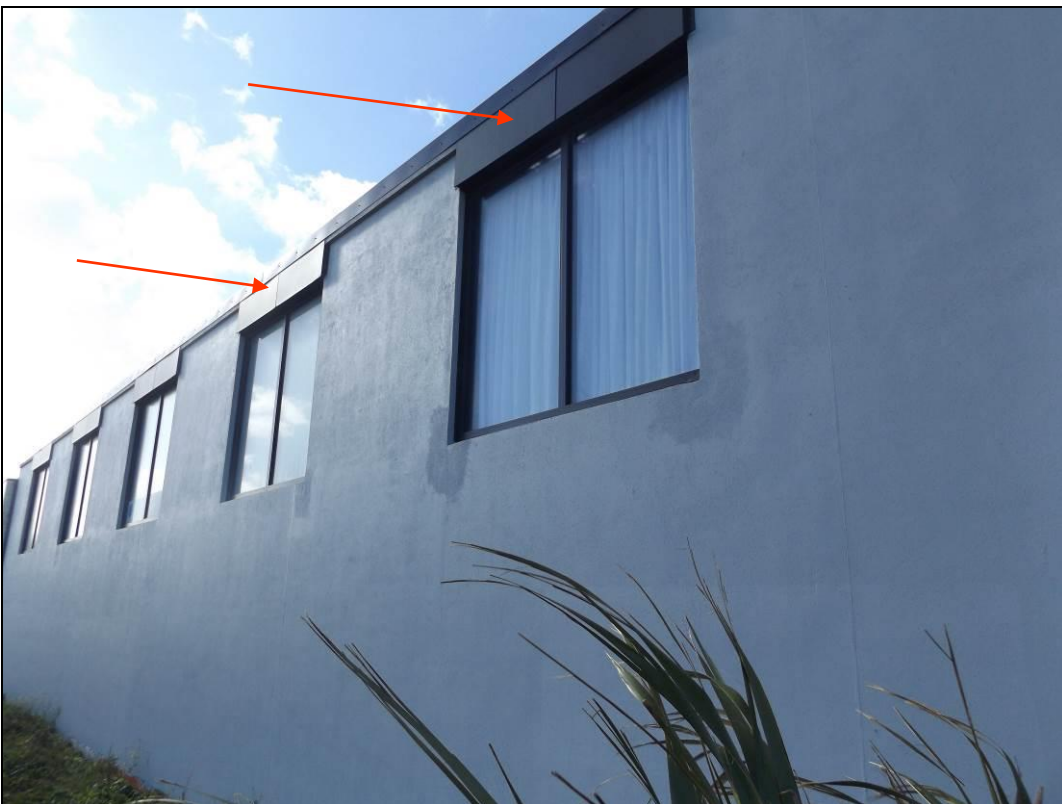
51

Showing the western elevation fibre-cement panels

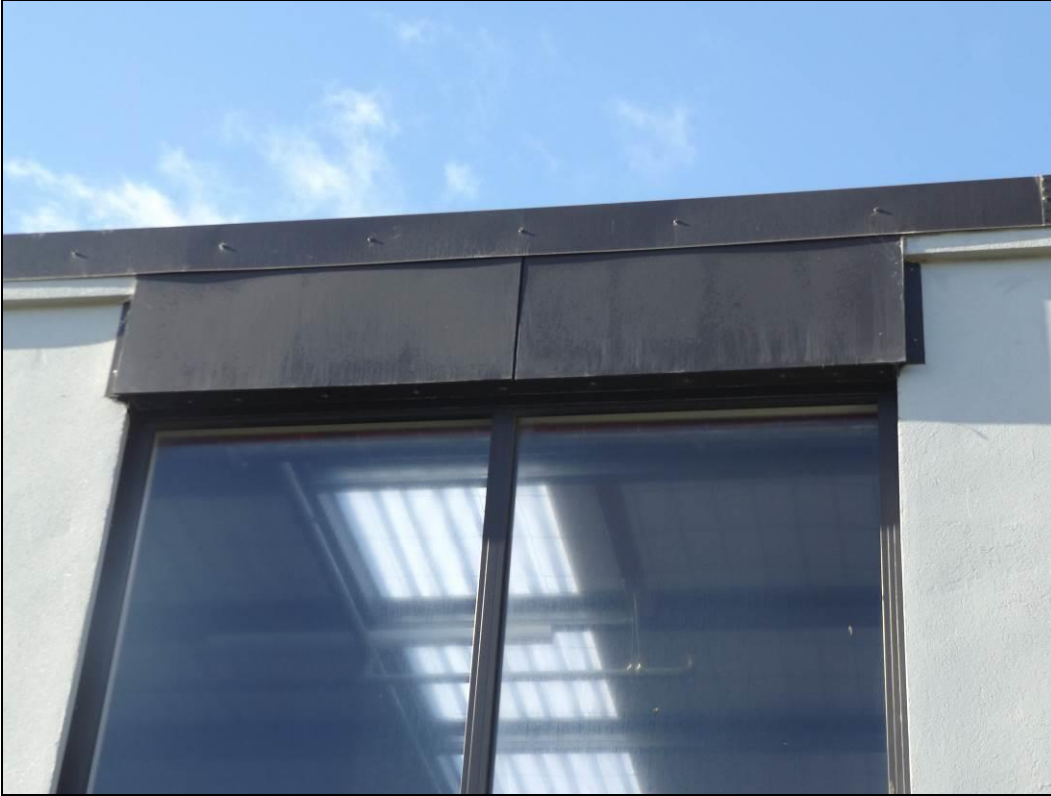
52

Showing an example of the poorly painted and uneven non aligned panels

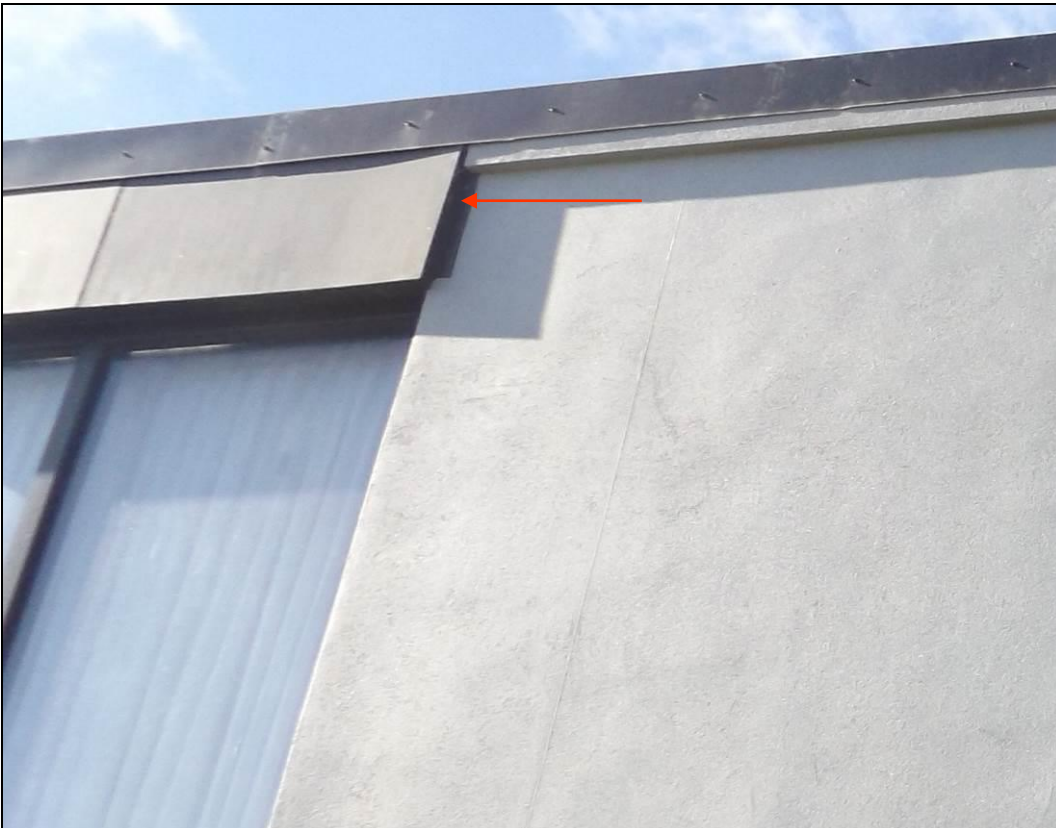
53

Showing an example of the proud brackets forcing the end of the panels out
