**Re: Body Corporate 582203  
Property at Lyall Bay Junction, 68-72 Kingsford Smith Street, Rongotai, Wellington  
Annual General Meeting**

## BODY CORPORATE NO 582203 (BODY CORPORATE)

### Property at Lyall Bay Junction, 68-72 Kingsford Smith Street, Rongotai, Wellington

Ref: 68 – 72 Kingsford Smith Street Lyall Bay Wellington / Defects Report

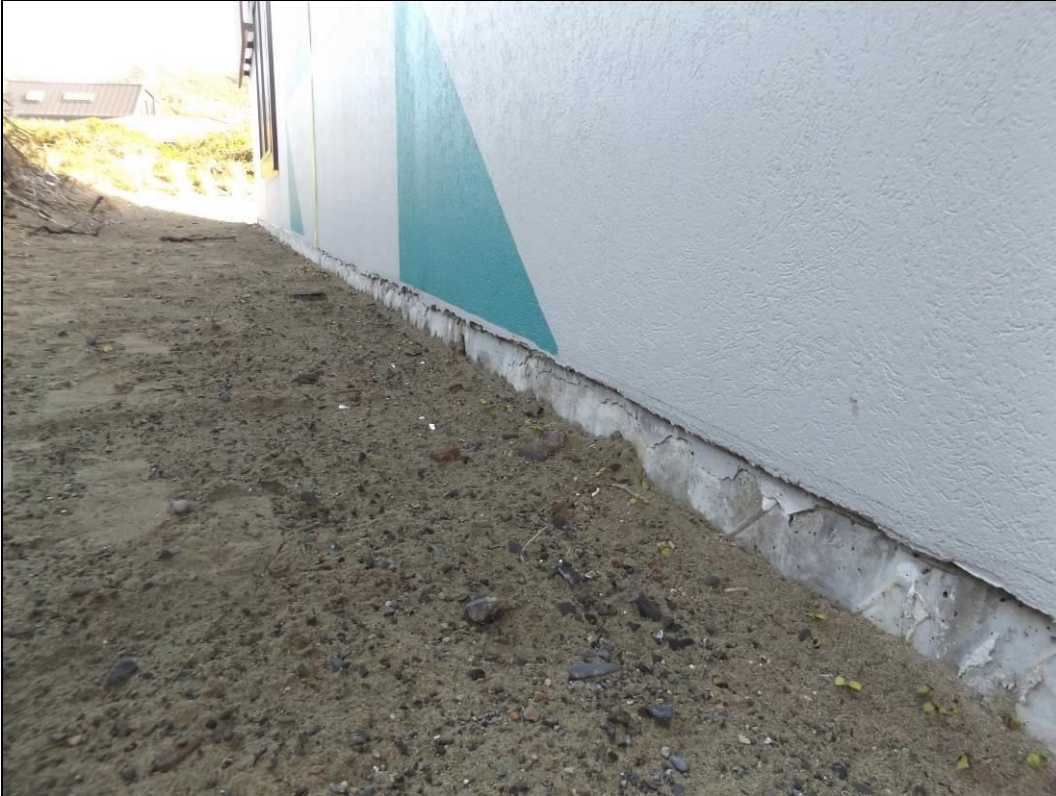
54

| Lyal Bay Junction Defects List | | | | | | |
|---|---|---|---|---|---|---|
| <b>15 &amp; 16 Damp proof membrane at slab edge</b><br><br>DPM at slab edge on south elevation has been cut back below ground level<br>Render finishes at bottom of block wall leaving exposed slab edge exposed<br>wet sand build up likley to cause water inigress through unseled edge of slab<br><br>Western elevation DPM is still in place but loose along slab edge allowing water to sit between DPM and unsealed slab edge<br><br>Rockcote detail shows starter strip for rockcote render sitting below the blockwork to slab junction. Blockwork should be in rebate at slab edge at least 50mm below internal floor level<br><br>consent drawing detail 1 sht A500 shows DPM just below finished ground level<br>Sto flexy lapping DPM by 50mm and extending 150mm above finished ground level with render system applied over Sto Flexyl to just below ground level<br><br>Confirm detail with Rockcote prior to undertaking repair to ensure compatability between intended products<br>remove sand built up against slab edge to below slab/block wall junction<br>trim back barier on west elevation<br>grind back lower edge of render to 150mm above ground level<br>apply mulseal or similar tanking to exposed slab edge<br>install rockcote starter strip to rockcote detail<br>apply rockcte render system and paint to match - ensure lap over tanking as required | | | | | | |

Southern elevation - Showing the unprotected foundation and junction with the Rockcoat – note the sand and sand dune located to left of photo

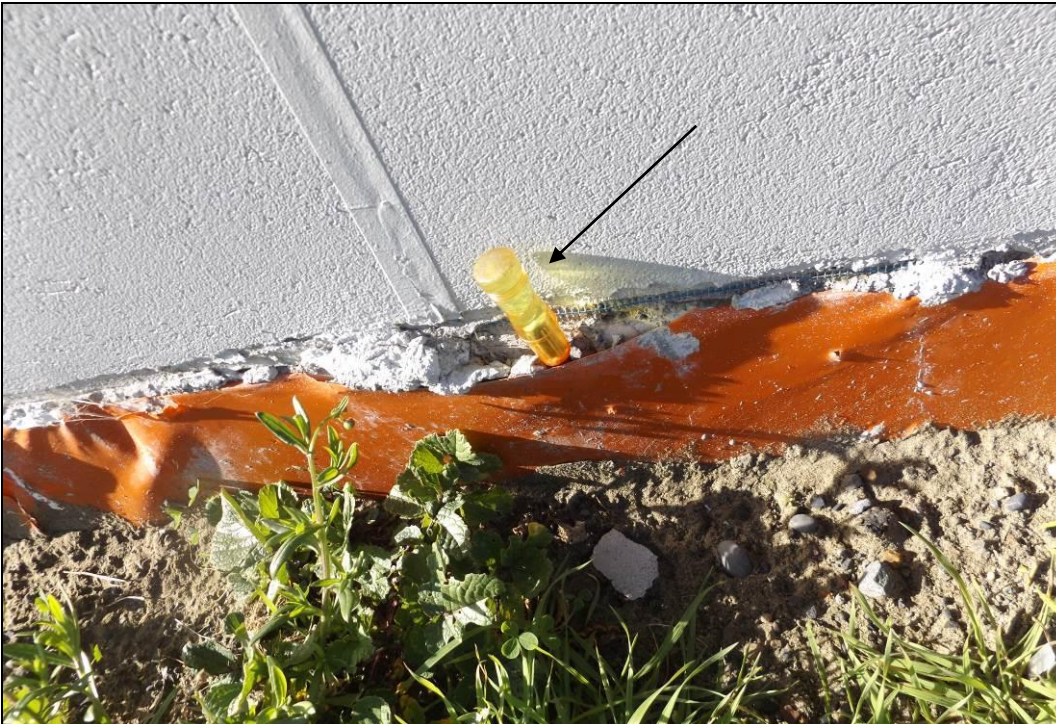
55

Western elevation showing the DPM which is turned up but not taken up under the rockcoat – note the chisel showing the access for water entry behind

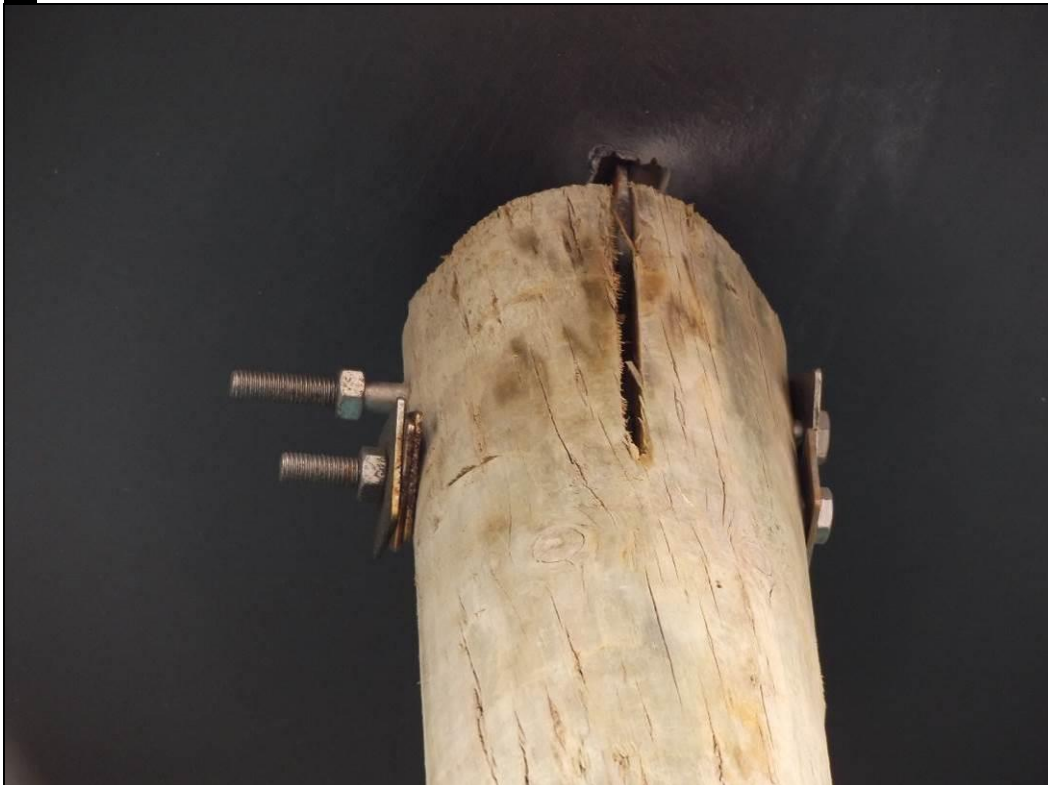
56

Showing the insecure pole fitting – noting the lack of thread length - Unit 55

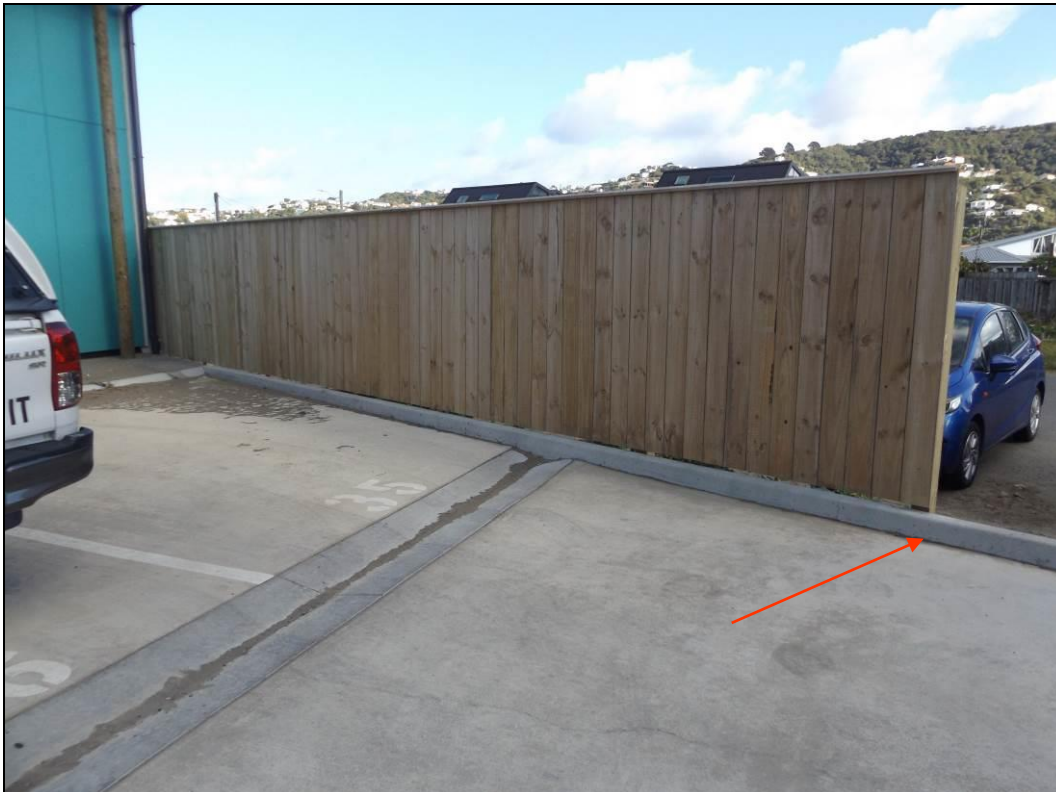
58

Showing the area that might be able to act as an overflow exit point.

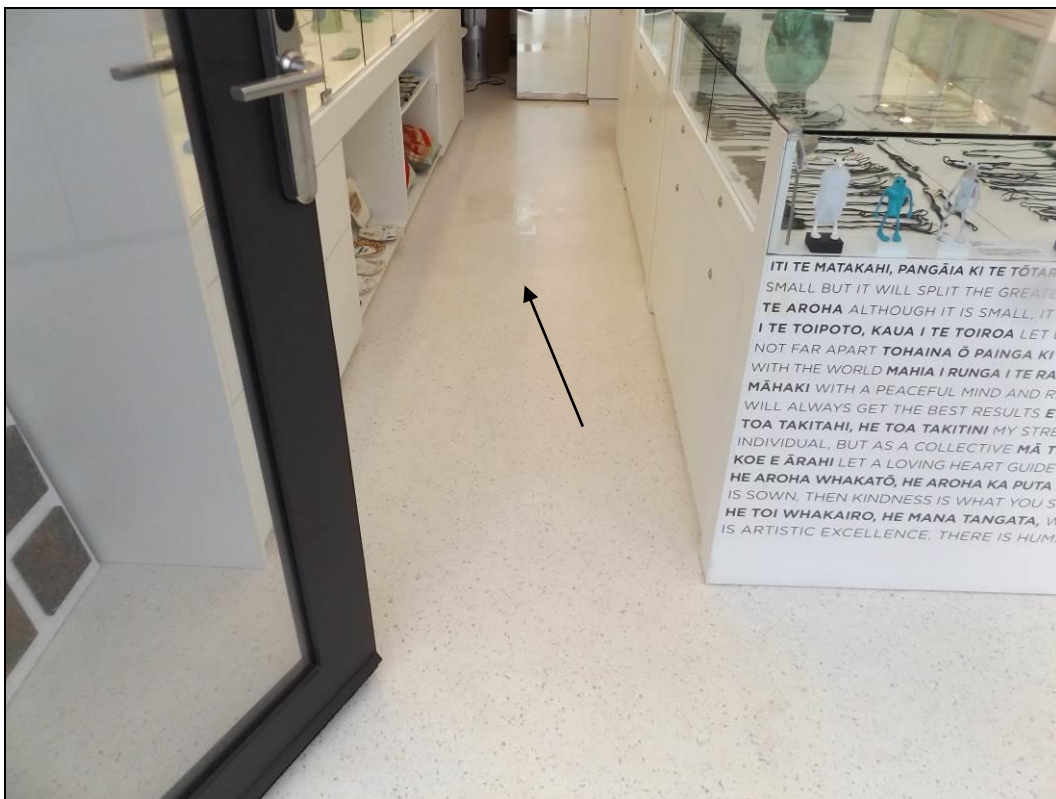
59

Unit 55 – showing the water on the floor from the leak

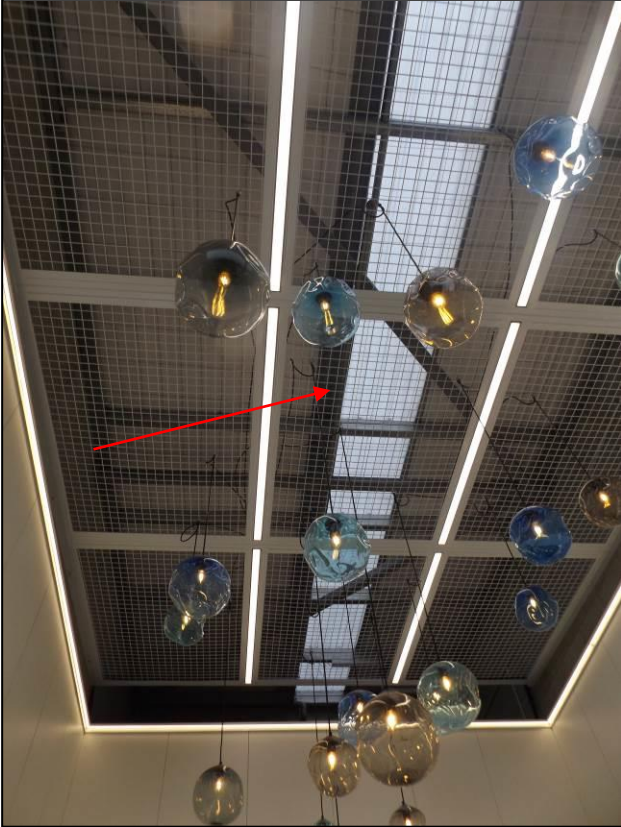
Showing the general location of the unit 55 leak via the clear light area
