## CALL REPORT

**CUSTOMER**  
WPC 2020 Ltd

**SITE ADDRESS**  
19 Nga Mahi Road  
Sockburn, Chch

Routine observation report to assist WPC 2020 Ltd with their repair options to the external precast concrete panel joints and fibre cement cladding joints to a set of commercial warehouse & office units built approx. 10 years ago. **This is a second report and for units 9 – 19.**

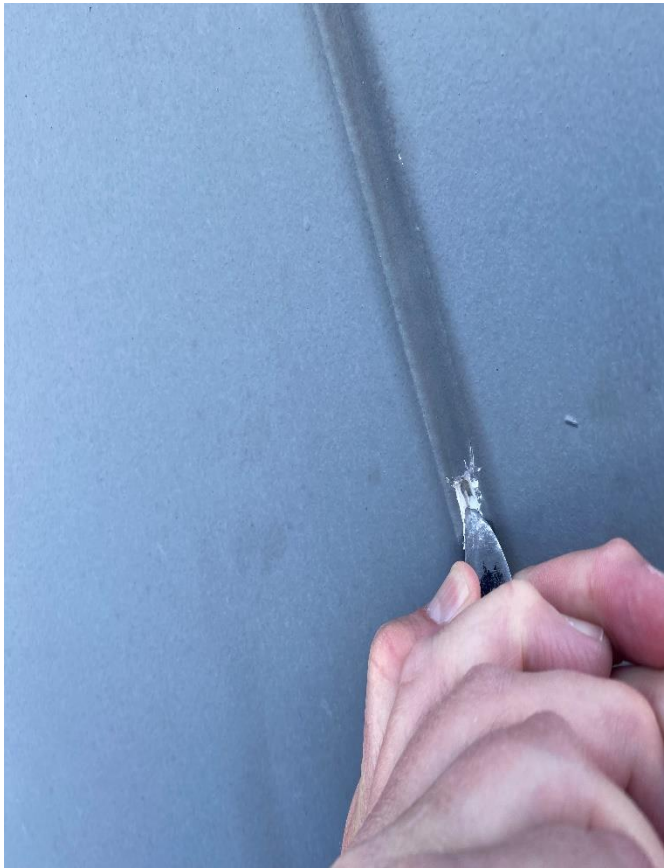
Photo 1

**Photo 1** – Close up of failed joint between fibre cement to fibre cement joints. (Unit 13)

**Photo 1** – No bond breaking tape used between fibre sheets, so sealant has adhered to base of joint resulting in 3-sided adhesion which doesn't allow the sealant to move as intended. This results in the sealant either tearing within itself (cohesive failure) or pulling off the substrate (adhesive failure) depending upon what is weakest. Not installed correctly.

**Photo 1** – cut out failed sealant, clean joint edges, install suitable bond breaking tape to base of joints, prime joint edges and seal with Sikaflex MS.

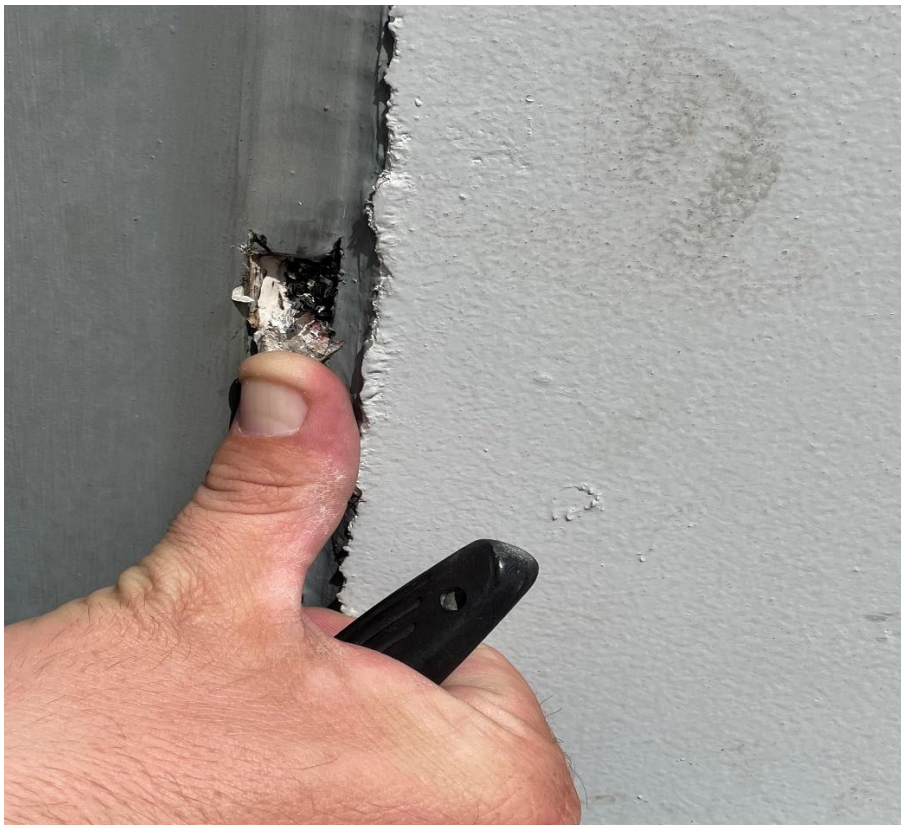
Photo 2

**Photo 2** – Joint sealant failing between concrete panel & fibre cement cladding.

**Photo 2** - lack of good joint design (triangular not rectangular/square), no bond breaking tape and incompatible material (bitumen flashing tape). Flashing tape has been wrapped around onto precast panel leaving little room for sealant to be adhered to the concrete. Poor joint design and not installed correctly.

**Photo 2** – more investigation needs to be done to determine if the fibre cement has been installed correctly at this junction and what the alternate solution may be.
