# **STRUCTURAL REPORT**

## Detailed Seismic Assessment

252 High Street  
Hutt Central  
Lower Hutt

DOCUMENT HISTORY	
Document	24 02 27 223139 CBP bn - DSA Report_252 High Street
Current revision	1
Date	5 March 2024
Status	Final Issue
Previous Revisions	
0	01/03/2024 Draft Issue

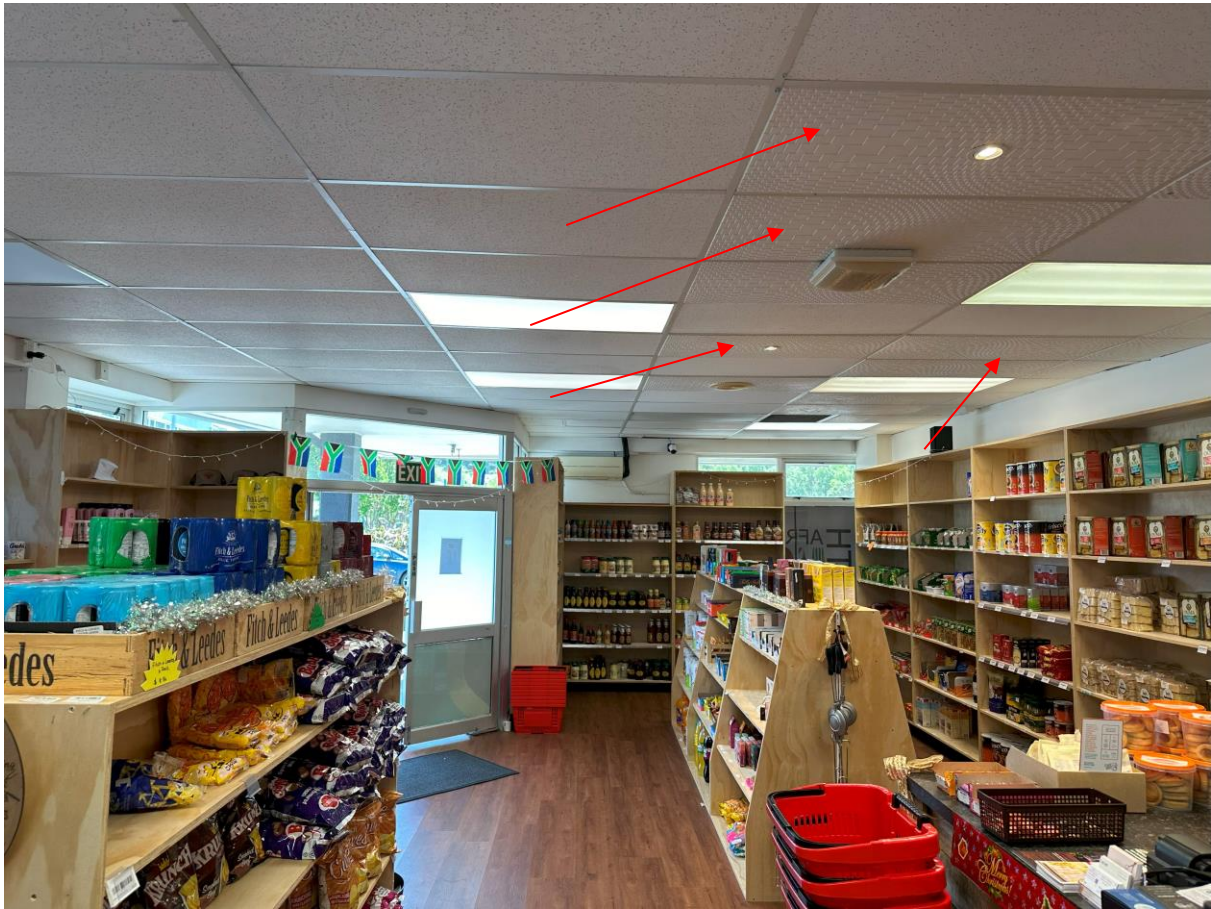
- The visual inspection of the building found that some heavy ‘plaster’ ceiling tiles are present in some locations. These pose a risk to life-safety in a seismic event and are recommended to be removed and replaced with lightweight ‘mineral fibre’ tiles, as seen elsewhere in the building. We note that these heavy tiles are only in isolated locations, not throughout the entirety of the building.

- The heavy 'plaster' ceiling tiles observed on site pose a risk to life safety in an earthquake and are scored at less than 34%NBS. See figure 5.1 for a photo of these tiles.

Included	Score	Mode of Failure
Heavy ceilings or lightweight ceiling system above space class I, II or IV (refer Table A4 of the Guidelines)	<34%NBS	Heavy tiles falling into space below. Pictured in figure 5.1 below.
Canopies	>34%NBS	
Parapets	>34%NBS	
Heavy external walls along the north boundary	>34%NBS

**Figure 5.1: Heavy 'plaster' ceiling tiles, indicated with red arrows, which are recommended to be removed.**

In the short-term we recommend that the heavy plaster ceiling tiles are removed from the suspended ceiling and replaced with light-weight tiles.

1. Remove the heavy plaster ceiling tiles and replace these with lightweight tiles.
2. Commission a seismic strengthening investigation with a scope to provide strengthening concepts to enhance the building strength to an acceptable level, no less than 67%NBS.
