REPORT

This report covers the structural damage sustained by the Sheer Adventure Workshop building at 78 Byron St, as a result of the series of earthquakes including the Darfield Earthquake that struck at 4:36am on 4<sup>th</sup> September, 2010 and the Lyttelton Earthquake that struck at 12.51 pm on the 22<sup>nd</sup> of February, 2011. The Sheer Adventure Workshop building consists of the original western warehouse structure and the eastern lean-to addition.

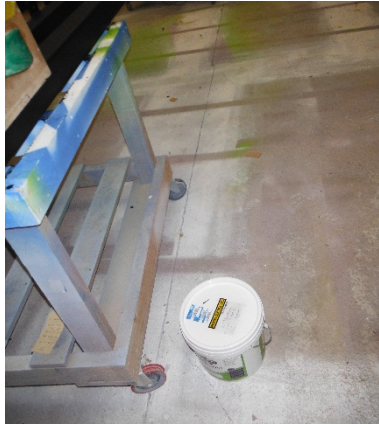
| Damaged Item | Location | Example | Recommended Repair |
|---|---|---|---|
| 1.1. Cracking and spreading at slab construction joints | South section of eastern structure | | Chase channels each side of crack and install dowels across crack to prevent future lateral spreading of slab. |

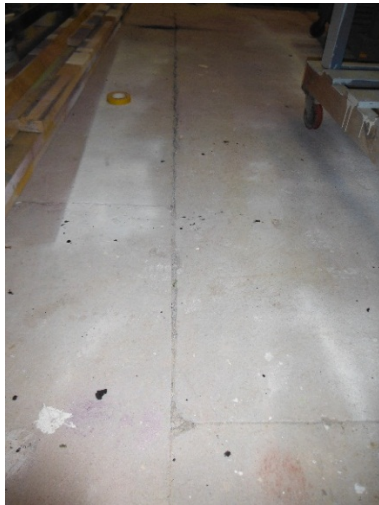
| Damaged Item | Location | Example | Recommended Repair |
|---|---|---|---|
| 1.2. Differential settlement of slab | South section of eastern structure | | Remove section of slab that has lifted. Re-level ground. Install new slab with epoxy dowels into adjacent slab sections. |

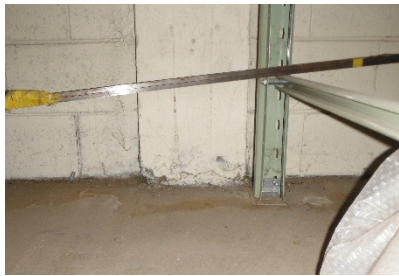
| Damaged Item | Location | Example | Recommended Repair |
|---|---|---|---|
| 3.2. Cracking and spalling of concrete column at slab level | Occurs at several locations in the western structure | | Remove concrete and observe column at base to ensure no signs of distress. If no signs of distress, repair concrete encasement of column per repair specification. |

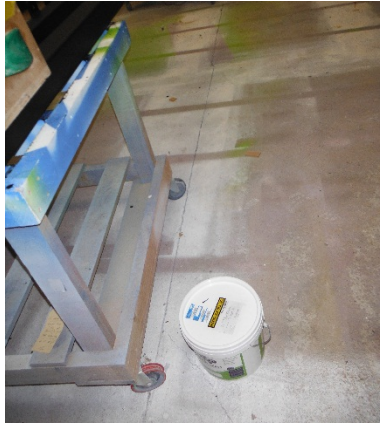
| Damaged Item | Location | Example | Recommended Repair |
|---|---|---|---|
| 1.1. Cracking and spreading at slab construction joints | South section of eastern structure<br><br>See damage map photo 1. | | Chase channels each side of crack and install dowels across crack to prevent future lateral spreading of slab. |
