# LONG TERM MAINTENANCE PLAN UPDATE

GRACEFIELD BUSINESS PARK  
BODY CORPORATE

4 NOVEMBER 2020

50 Gracefield Road, Wellington

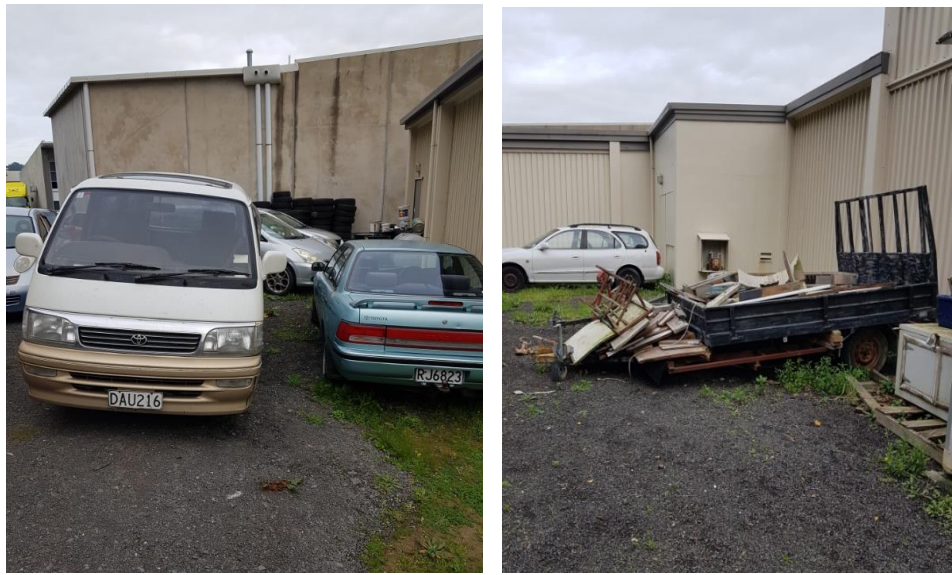
We have also noted that during the site survey the ground behind the mechanical garage was soft under foot which could indicate insufficient drainage or other issues to the area; but this would require further investigation to confirm. A lot of vehicles and car parts were stored in this area which is blocking the driveways between the North and Central Blocks.

*Figure 4: Vehicles in the Northern Block yard*

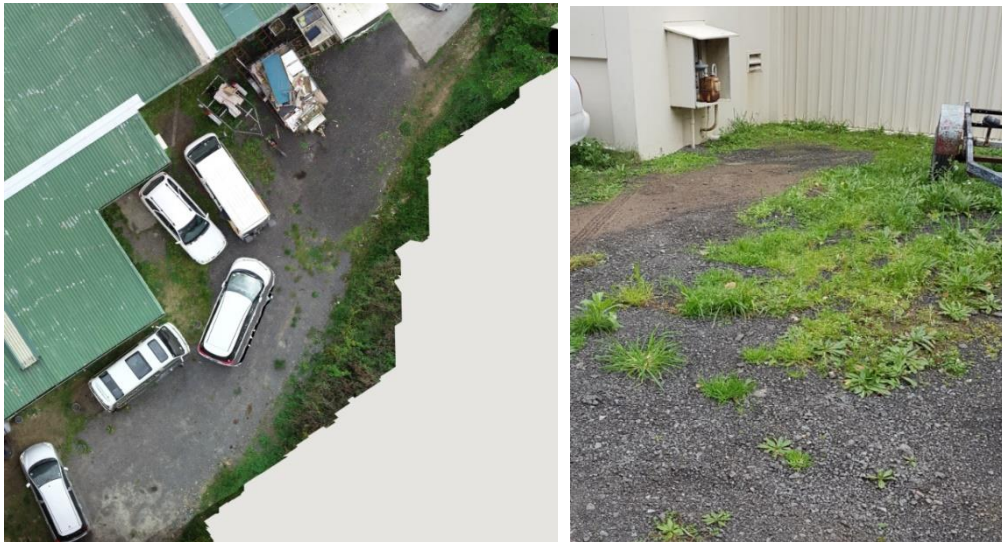
*Figure 5: Conditions of grounds at the Northern Block yard*

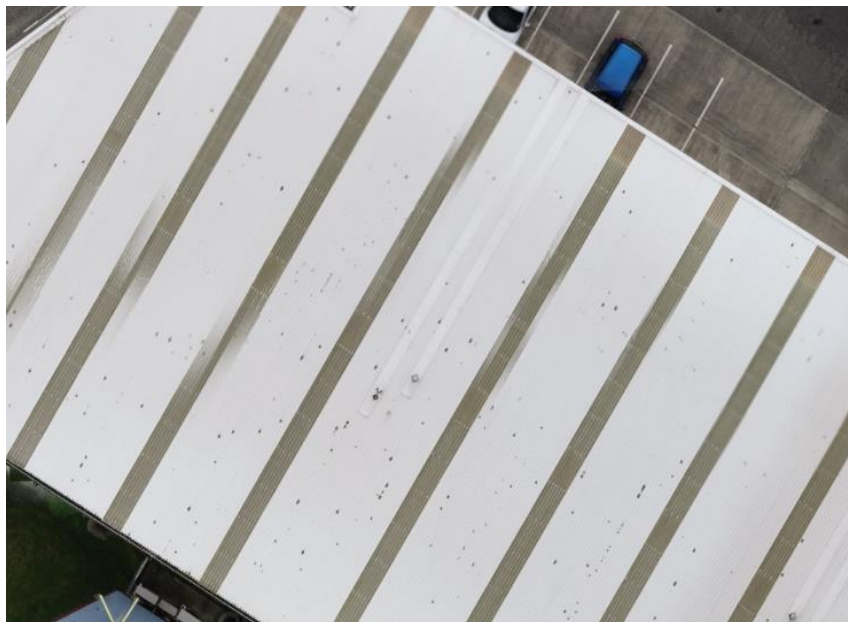
From our review there are visual signs of lichen growth. An annual wash cycle is recommended. However, a full roof and spouting replacement has been allowed for in 2033.

*Figure 6: The Southern block roof with some visible lichen growth.*

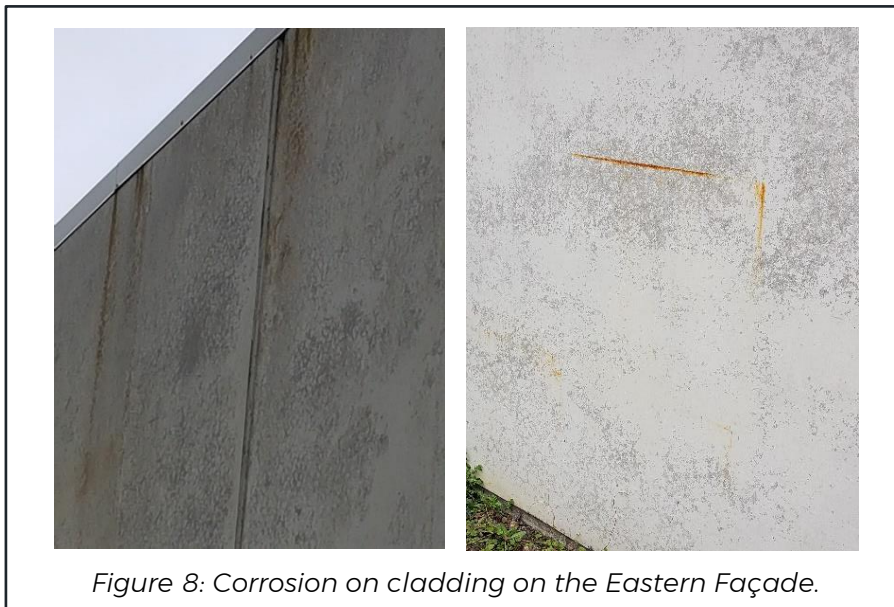
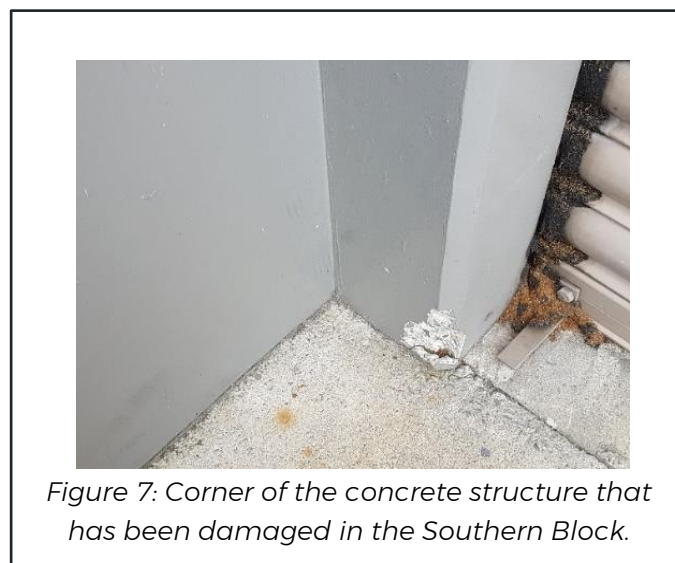
The unpainted concrete cladding on the Eastern Facade appears to be in satisfactory condition, however there are some signs of corrosion from the bolts along the beam box which should be addressed. Some areas are also wearing quickly due to orientation against prevailing weather conditions which may require earlier recoating.

From our visual observations, if annual wash cycles are undertaken, full replacement and refurbishment will not be required in the next 15 years. The exception being for areas not previously rectified where water has penetrated the cladding.

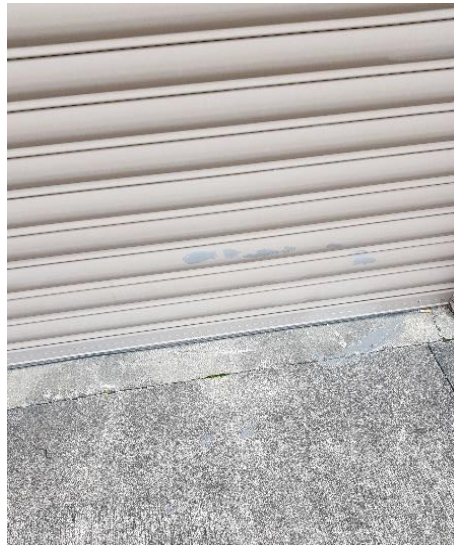
*Figure 9: Minor paint chipping on the garage on the North Facade.*

The soffits and garage doors appear to also be in excellent condition, we have allowed for these to be painted in the same cycle as the cladding. The next paint cycle is planned for 2028 and we have included an allowance in the Maintenance Plan for the erection of scaffolding and mechanical access around the fire escape stairwell as a provision in the exterior painting costs.

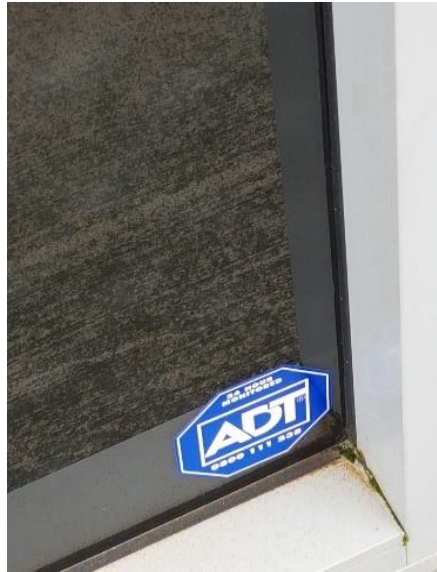
The windows in the Southern Block are single glazed aluminium in concrete surround. These windows have been detailed well and we do not expect them to be leaking but would benefit from an annual wash to extend their life.

*Figure 11: Window from the Southern Block with some build up in the corner.*

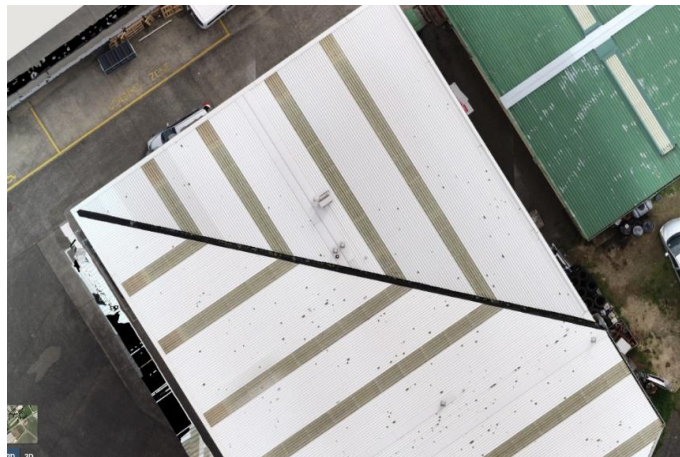
From our review there are visual signs of lichen growth. An annual wash cycle is recommended. However, a full roof and spouting replacement has been allowed for in 2033.

*Figure 15: The roof of the Central block appears to be in good condition.*

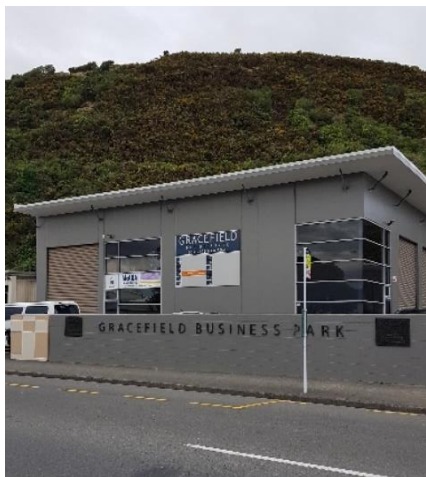
*Figure 17: The Central block recently painted in excellent condition.*

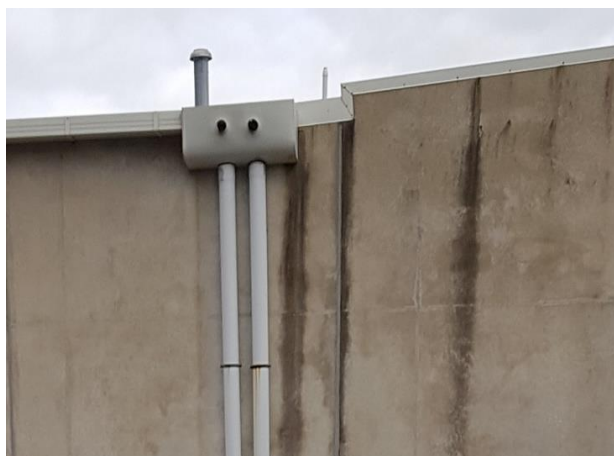
The unpainted cladding on the Northern Façade appear to be in satisfactory condition, with visible water stains running down the walls. We recommend giving the panels an annual wash to maintain the integrity of the cladding.

*Figure 16: The northern facade of the Central block with visible water stains on the cladding.*

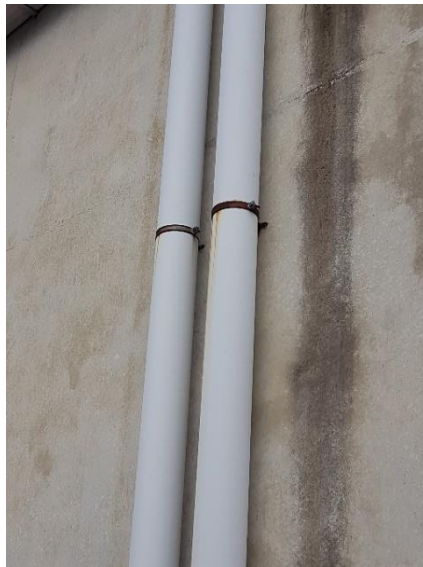
The downpipes in the North Façade of the Central block appear to be in satisfactory condition however the pipe brackets appear to show excessive corrosion and should be replaced within the near term to prevent total failure of the downpipe system.

*Figure 19: Rusty pipe brackets located on the North facade.*

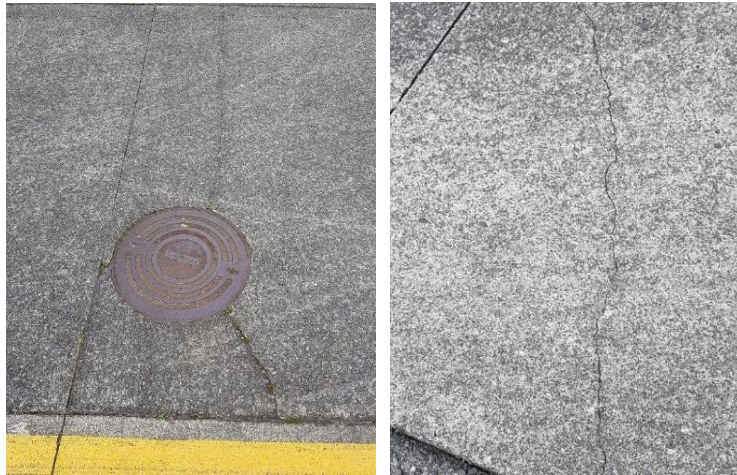
Generally, the hard surface improvements around Central Block are in satisfactory condition. However, there are some areas that have minor cracks that will need remedial work. We have made an allowance to repair the surface layer on a 5-year basis starting from 2022.

*Figure 20: Concrete near Central Block showing some minor cracks.*

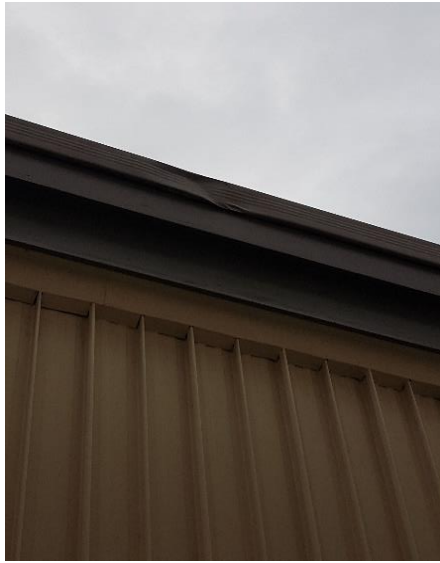
*Figure 23: Box guttering with a dent in the Northern block.*

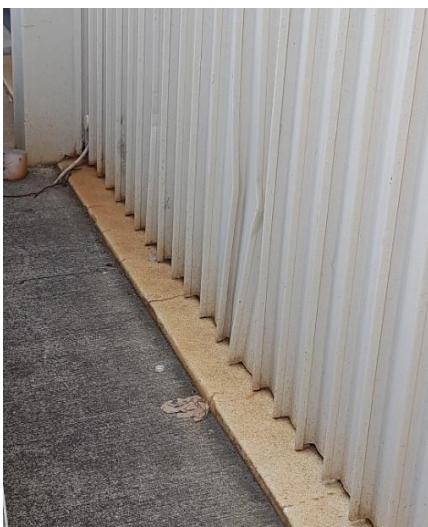
The exterior walls are a mixture of Hardiflex Panels, concrete and profiled iron cladding. The integrity of the cladding itself is in satisfactory condition but have noted some paint peeling; there is an allowance in the plan to repaint in 2028. We have also noted corrosion to specific areas of the cladding; we suggest remedial action be taken to prevent further corrosion to this area.

*Figure 24: The Northern Block showing the profile iron cladding which is dented and signs of rusting at the bottom.*

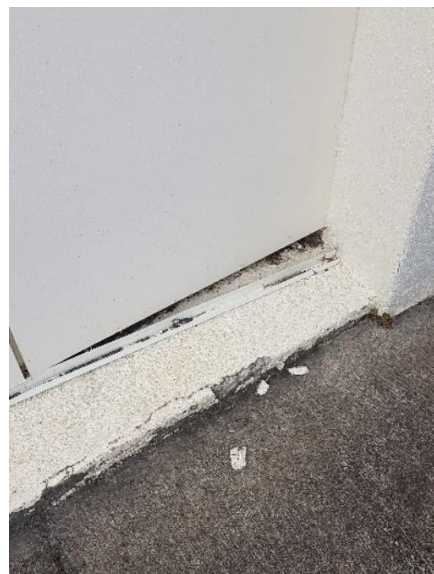
*Figure 25: Damaged titan board on the Western façade.*

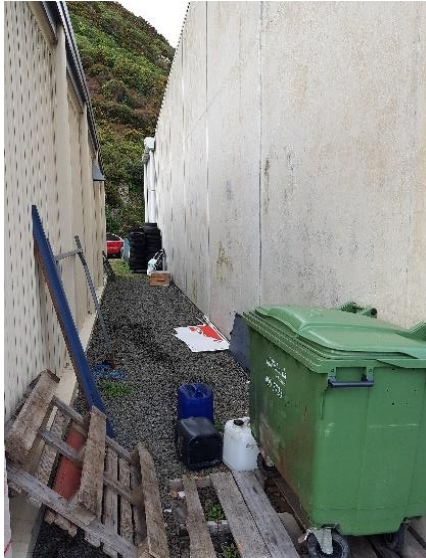
*Figure 26: Rubbish between the Central and Northern block.*

Various items have been left between the Northern and Central blocks. We recommend removing these items and storing them elsewhere or disposing them completely.

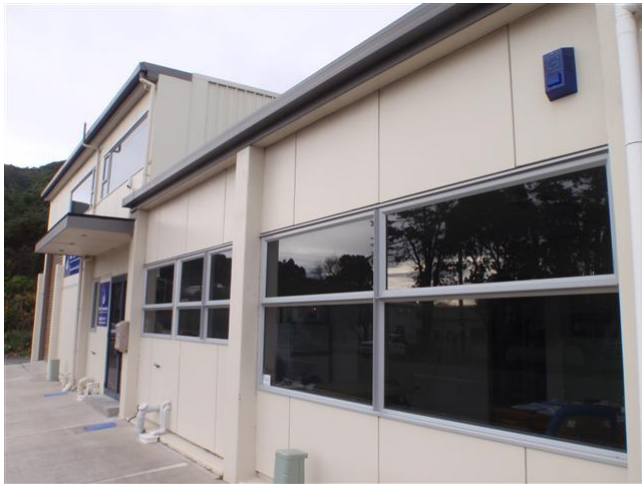
Figure 28: *Single glazed aluminium framed window on the West Façade. Windows are in good condition and were detailed well during construction.*

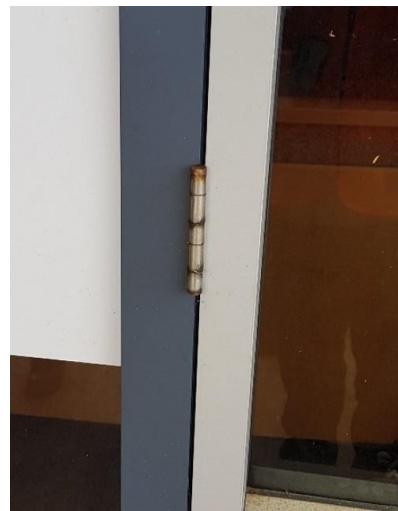
Figure 27: *The front door located on the Western facade with signs of corrosion to the hinges.*

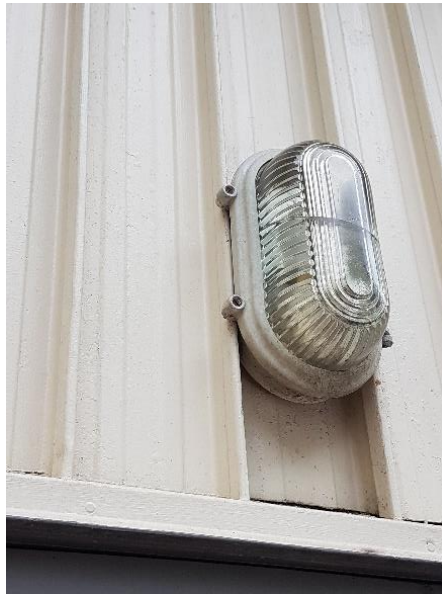
*Figure 30: Bulkhead light with a crack.  
(Tenant owned).*
