| Memo to Contractor | | | | |
| Project 4 Tennyson Street – Te Aro | | | | Reference |
| <b>Subject Main Switchboard</b> | | | | |

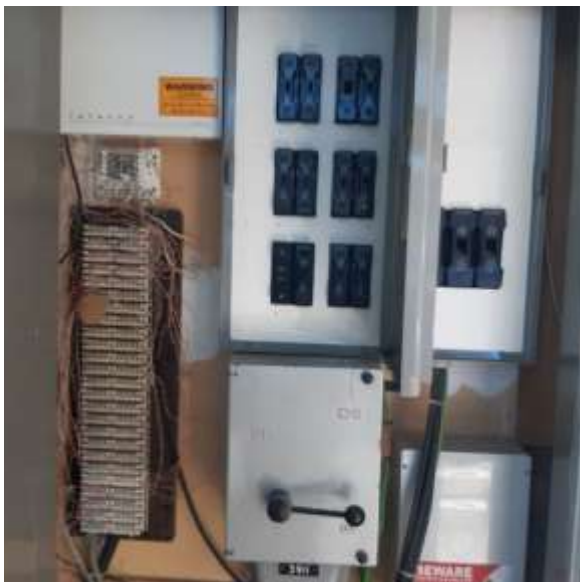
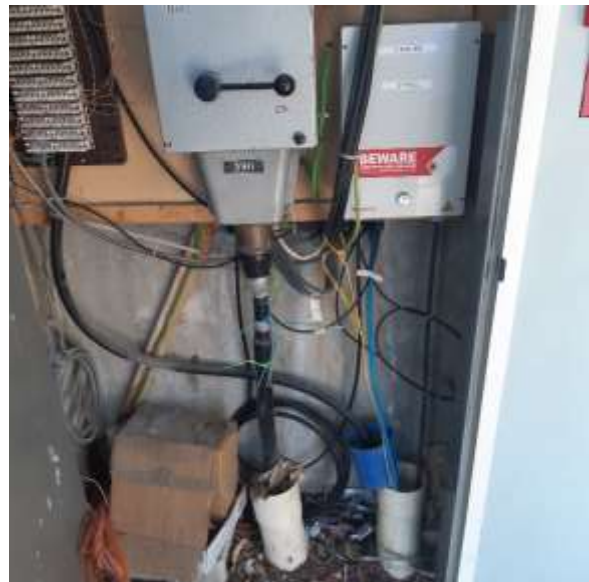
| Memo to Contractor | | | | |
|---|---|---|---|---|
| <p><b>Overview</b></p> <p>There are six tenancies that occupy the commercial premises located between 4 Tennyson Street and 5 Alpha Street.</p> <p>These being :</p> <ul style="list-style-type: none"> <li>• Dataworld Cabling</li> <li>• Phantom Bill Stickers</li> <li>• Inside Design</li> <li>• Moore and deLisle</li> <li>• Te Wanago O Aotearoa</li> <li>• Millars Electrical</li> </ul> <p>The main switchboard for the site is located in a cupboard adjacent to the entry in the Dataworld tenancy on the Alpha Street frontage.</p> <p>Electrical supply for the switchboard is derived from the Wellington Electricity Lines underground 400v network in Alpha Street using a paper lead type cable. This cable is terminated in a 200 amp fuse switch. A four way 63 amp TPN HRC fuse cabinet plus a single set of 100 amp HRC fuse bases and carriers are supplied from the 200 amp fuse switch. The HRC fuses provide overload and overcurrent protection to tenancy sub main cabling. We are unsure of the final configuration of distribution boards within some of the tenancies as there are five sets of sub main fuses yet there are six tenancies. Further investigation is required to ascertain exact configuration.</p> <p>The main fuse switch is probably approaching the end of its useful life as the mechanical mechanism can freeze in its current position if not regularly maintained. This will result in the installation not being able to be isolated or livened as the case may be.</p> <p>Labelling of sub main cables is poor with only one tenancy identified.</p> <p>Switchboard cup board is occupied with rubbish.</p> <p>There is no electricity retailer metering installed on the main switchboard which intermates that each tenancy is fitted with its own electricity retailer metering.</p> | | | | |

It was not possible to verify the current ratings of any of the HRC fuse links installed in the main switchboard equipment. Should it be necessary to verify the fuse ratings on the main switchboard, a planned total outage would have to be carried out.

1. Replace existing main fuse switch with a new main switchboard.
  - a. This would involve getting Wellington Electricity to dig up street , isolate the incoming mains cable and installing a new mains cable up to main switchboard.
  - b. There will need to be a full day of shutdown to do this work
2. Complete audit of sub main cabling.
3. Permanently label all sub main cabling at main switch board.
4. Clean out switchboard cupboard.
