# STEVEN YOUNG & ASSOCIATES LTD

## 69 WAIONE STREET, PETONE – 6 BUILDING COMPLEX

We have been engaged by Eddie Hawkins to review and summarise a Detailed Seismic Assessment report prepared by Spencer Holmes for the complex at the above address.

## Detailed Seismic Assessment

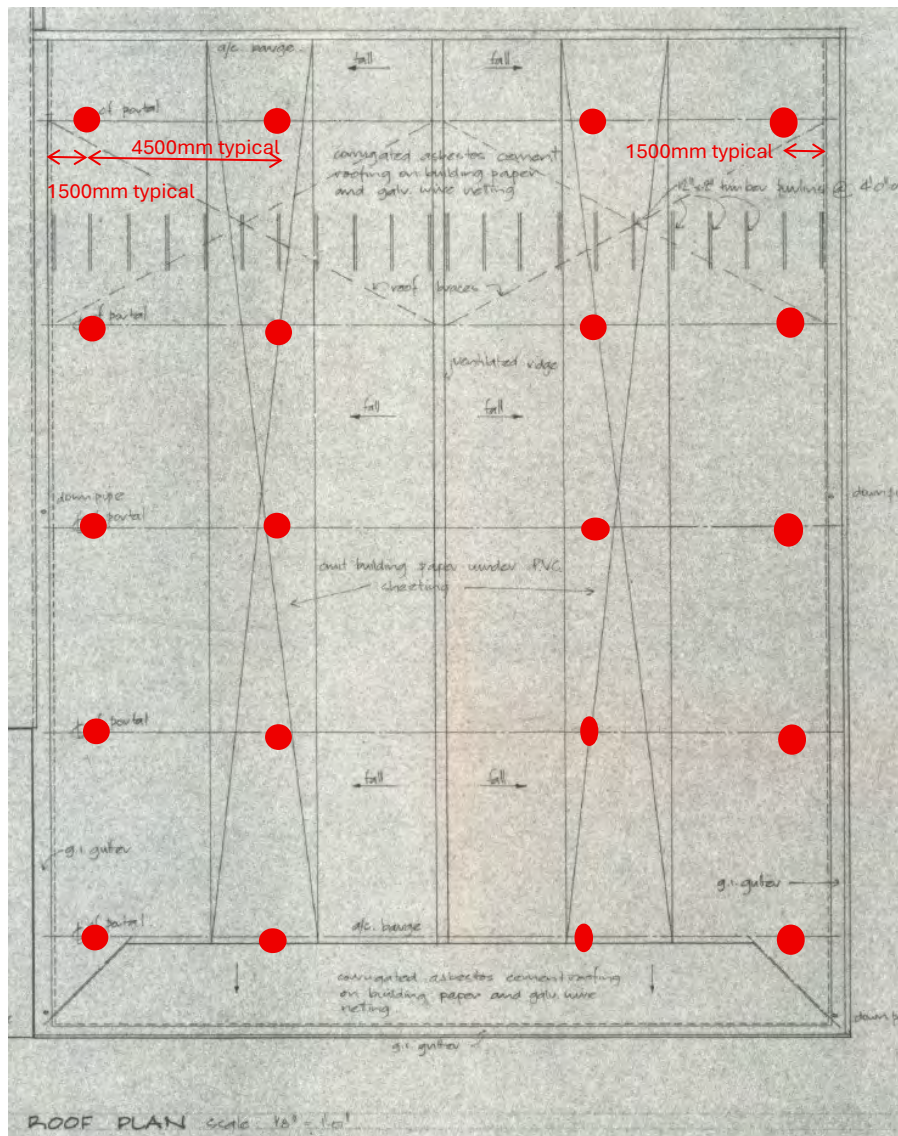
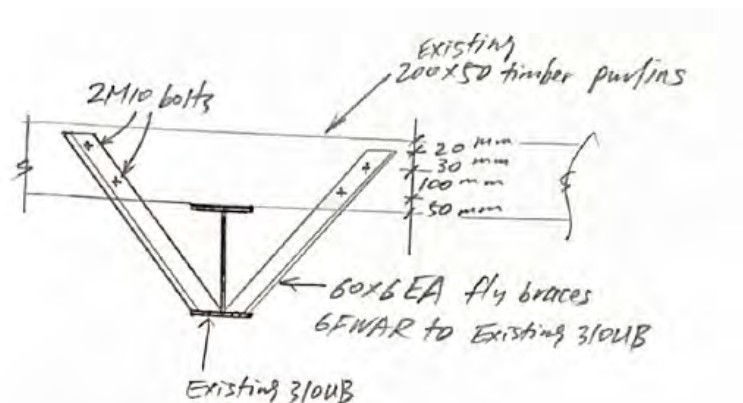
**Proposed roof strengthening plan of building #1 – 69 Waione Street**

| BUILDING 1 | SPENCER HOLMES ASSUMPTIONS | SYAL ADJUSTMENTS | REMEDIAL WORK | REMEDIED NBS | FINAL STATUS |
|---|---|---|---|---|---|
| BUILDING 1 | 50%NBS, which is limited by the rating in longitudinal direction. The assessment used a ductility of 1 and assumed a pin base for portal frames. | Ductility could be at least 1.5 because the columns of portal frames are steel encased. In addition, the bases of the portal columns have some fixities because of the presence of the hold-downs and the axial load. We also identified a need for providing more fly-braces. | Fly braces added | 70%NBS | Not EQ Risk |

● Fly brace locations

Roof plan showing the fly-brace locations

Fly-brace details

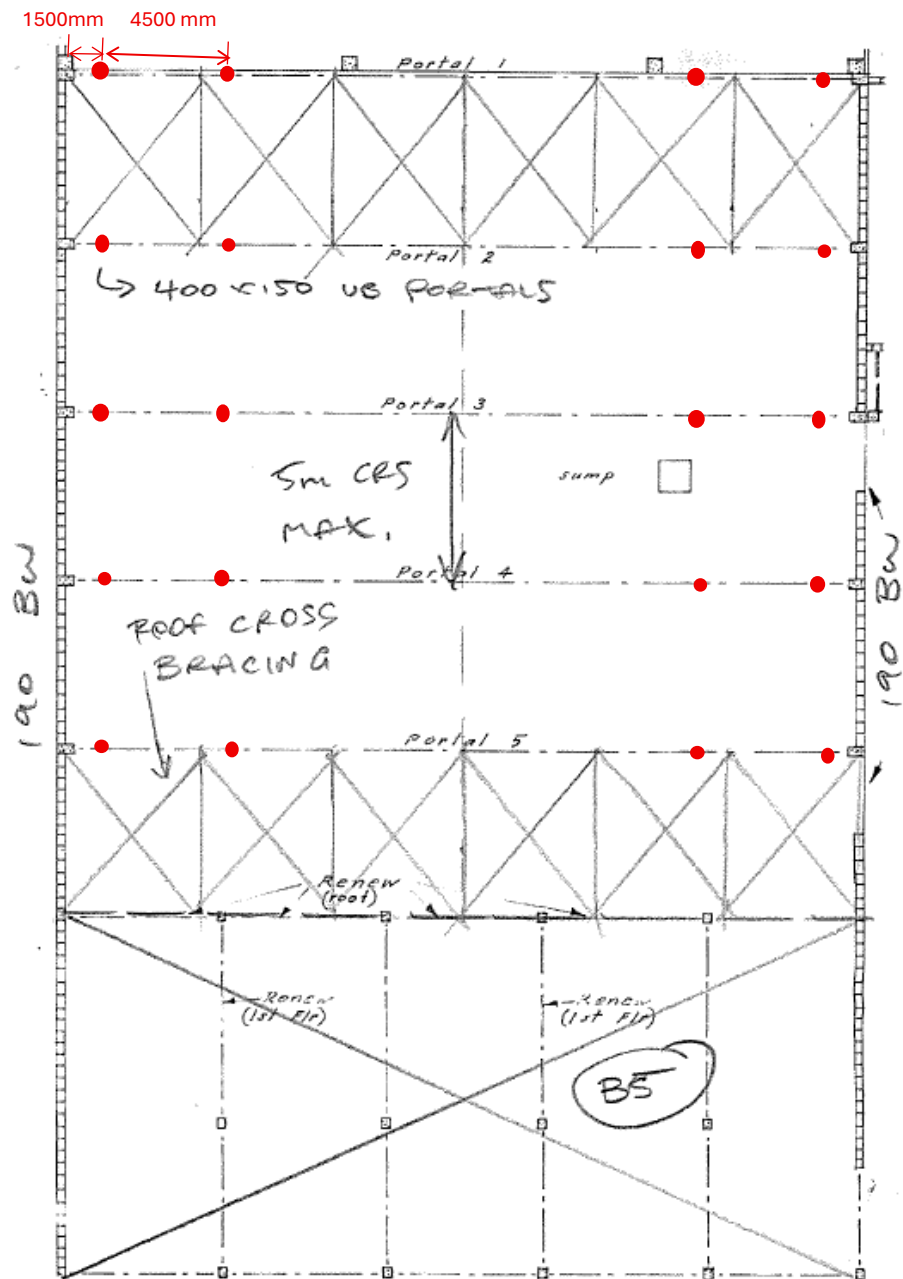
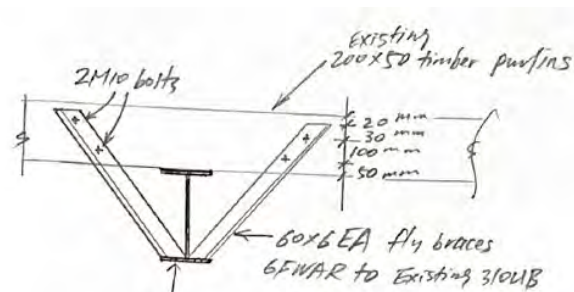
Proposed roof strengthening plan of building #2 – 69 Waione Street

| BUILDING 1 | SPENCER HOLMES ASSUMPTIONS | SYAL ADJUSTMENTS | REMEDIAL WORK | REMEDIED NBS | FINAL STATUS |
|---|---|---|---|---|---|
| BUILDING 2 | 40%NBS. The assessment assumed that the block panels span one-way vertically, leading to an overestimated loading action (the truth is the block panels span two ways) by 32%. In addition, the top beams are continuous at column supports but the moment demand was calculated using a simply beam assumption, leading to an increased moment action by 50%. | As such, we adjusted the moment demand of the top beam and the adjusted moment action is about 50% of SH's value. As such, we concluded a rating of over 70%NBS. We also identified a need for providing more fly-braces. | Fly braces added | 70%NBS | Not EQ Risk |

● Fly brace locations

Roof plan showing the fly-brace locations

Fly-brace details

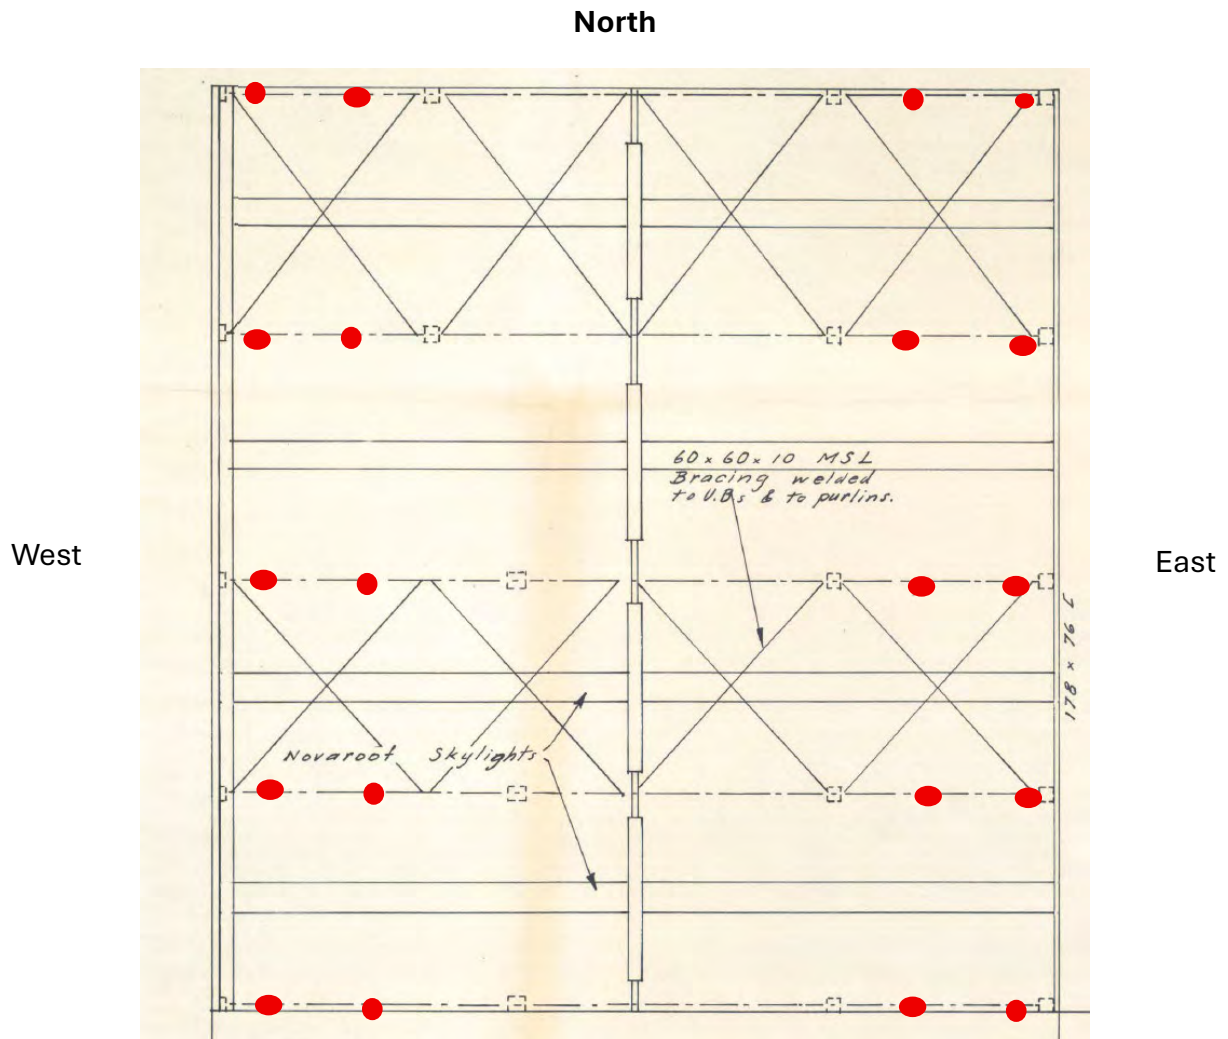
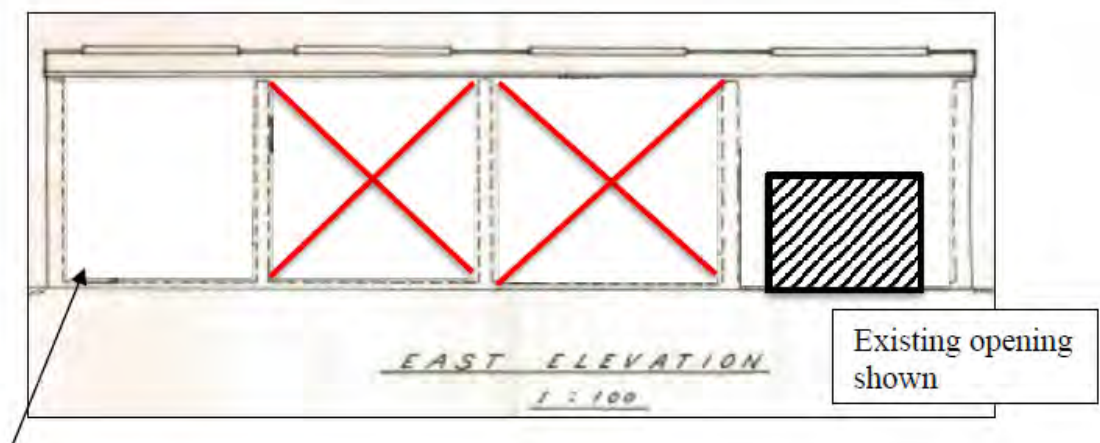
**Proposed roof strengthening plan of building #3 – 69 Waione Street**

| BUILDING 1 | SPENCER HOLMES ASSUMPTIONS | SYAL ADJUSTMENTS | REMEDIAL WORK | REMEDIED NBS | FINAL STATUS |
|---|---|---|---|---|---|
| BUILDING 3 | 30%NBS. The assessment identified a critical issue - the lack of bracing systems in eastern wall. | SYAL also identified that there are not adequate fly-braces to portal rafters. As such, it is suggested that fly-braces be added to portal rafters and cross braces be added to the eastern wall. | Cross braced frames are added to the eastern wall. Fly-braces are added. | 70%NBS | Not EQ Risk |

**Note: 1.5 from the knee joint and 6m from the knee joints**

● Fly brace locations

**Roof plan showing the proposed strengthening**

— Braces are 60x60x10EA

**East wall elevation showing the proposed strengthening using cross braces**

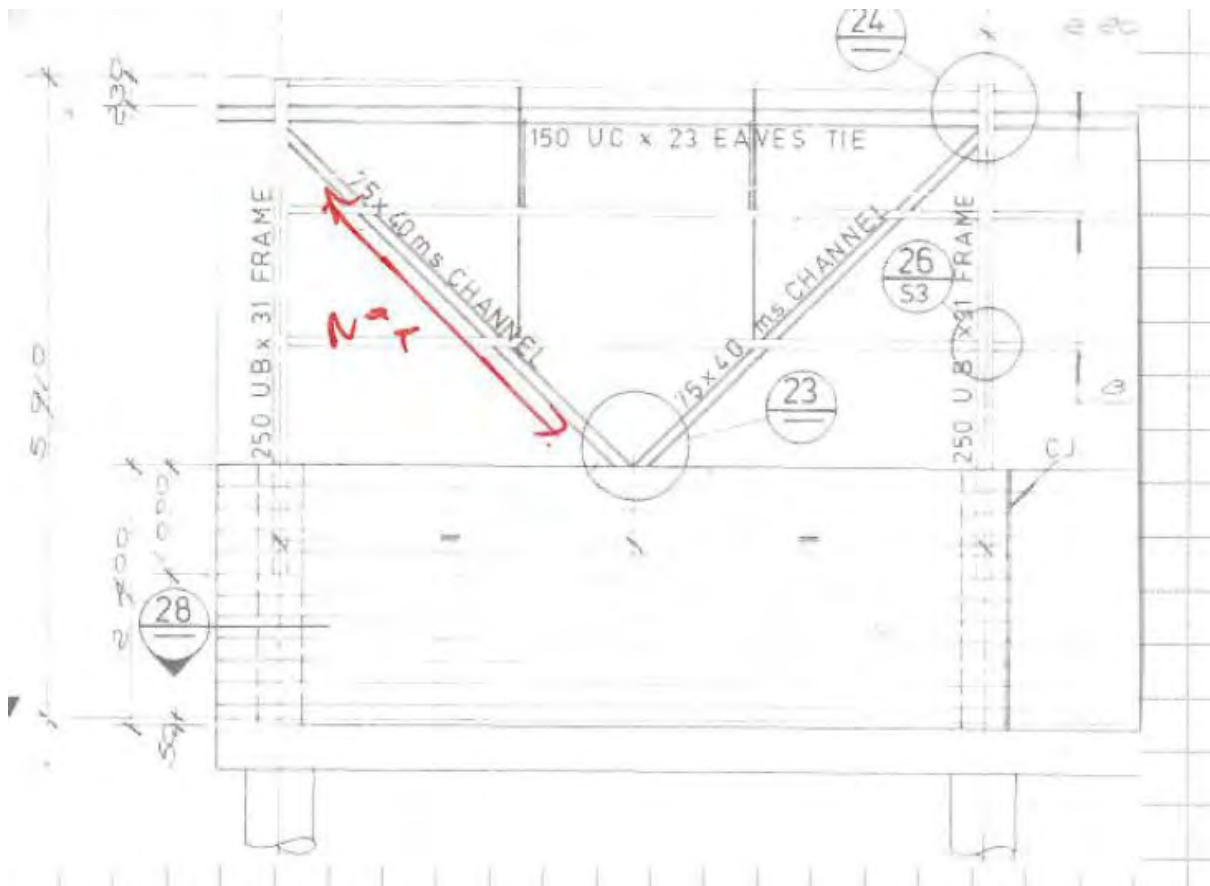
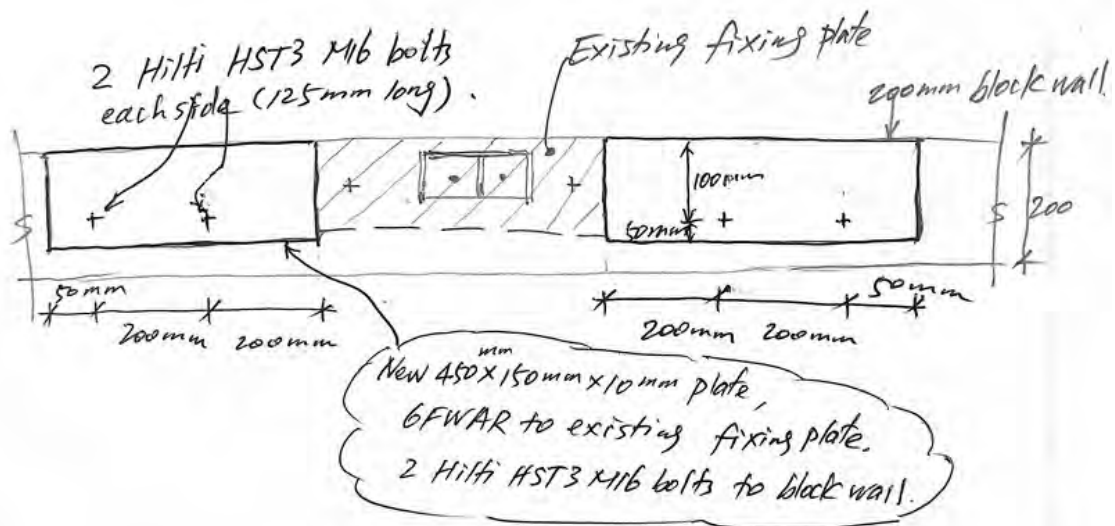
**Proposed retrofit for building #4 of 69 Waione Street**

| BUILDING 1 | SPENCER HOLMES ASSUMPTIONS | SYAL ADJUSTMENTS | REMEDIAL WORK | REMEDIED NBS | FINAL STATUS |
|---|---|---|---|---|---|
| BUILDING 4 | 60%NBS. The assessment did not reduce the live load based on the floor area, leading to significantly overestimated seismic mass. | As such, we adjusted the seismic mass (by about 50%). It is recommended that the V brace connection to block infills be strengthened and more fly-braces be added to portal rafters, similar to building #1. | Fly braces added. V brace connection to block infills be strengthened. | 70%NBS | Not EQ Risk |

**Existing elevation showing the details from V braces to block wall (In totally, 4 sets)**

**Plan showing the proposed retrofit of the fixing details from V braces to block wall**

**Note: Add the missing fly-braces (Add one fly brace 1.5 meter from the knee on each side of the roof rafter)**
