# Geotechnical Appraisal Report

## 20 Waianga Place, Omapere

Ground and site feasibility for proposed development Gumboots Consulting Engineers reference 1057

Revision Nº	Prepared By	Description	Date
А	Kelly Wright	Geotechnical Appraisal Report	02 June 2020

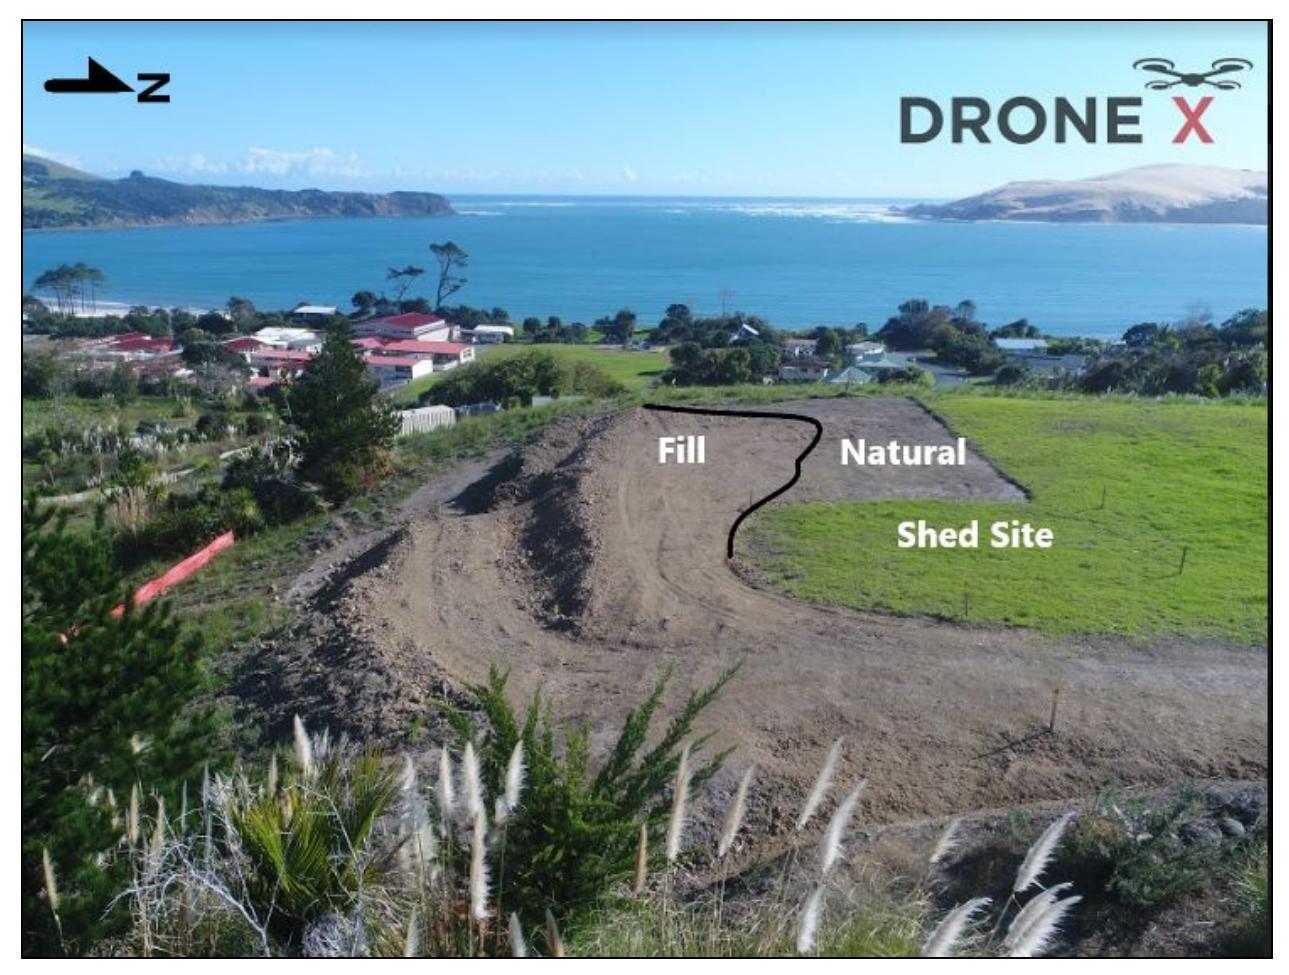
Figure 3 - Existing Site Plan (adapted from the DroneX Survey).

Earthworks had commenced at the time of our site visit. Specifically to the southern half of the Lot, initial site clearing was observed within the wider lot save the proposed new shed platform, as designated by four pegs Indicative of the proposed footprint. Depicted in Figure 3 below.

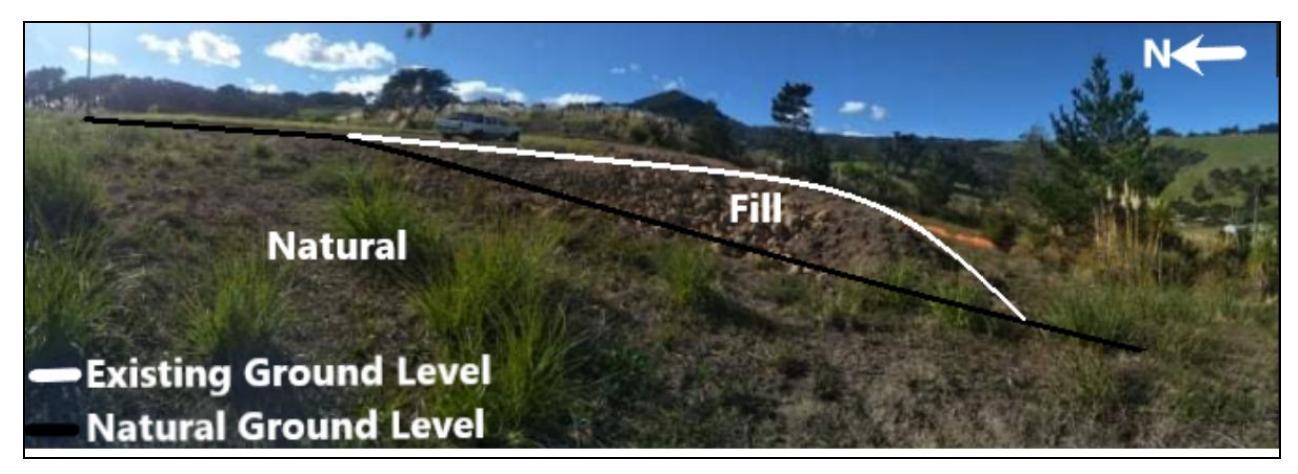
Figure 4 - Existing Site Plan (adapted from the DroneX Survey).

Additional Fill<sup>2\*</sup> material is notably present along the southern portion of the property. The natural land fall within this aspect is generally lower to that of the northern side.

Consequently, the placed fill in this instance created a flattish gradient in contrast to the original land grade.

All in all, the precedent works are outside of the critical area considered within this appraisal. Therefore, the aforementioned is considered as informative within this context. However, subject to critical attention within a development context.

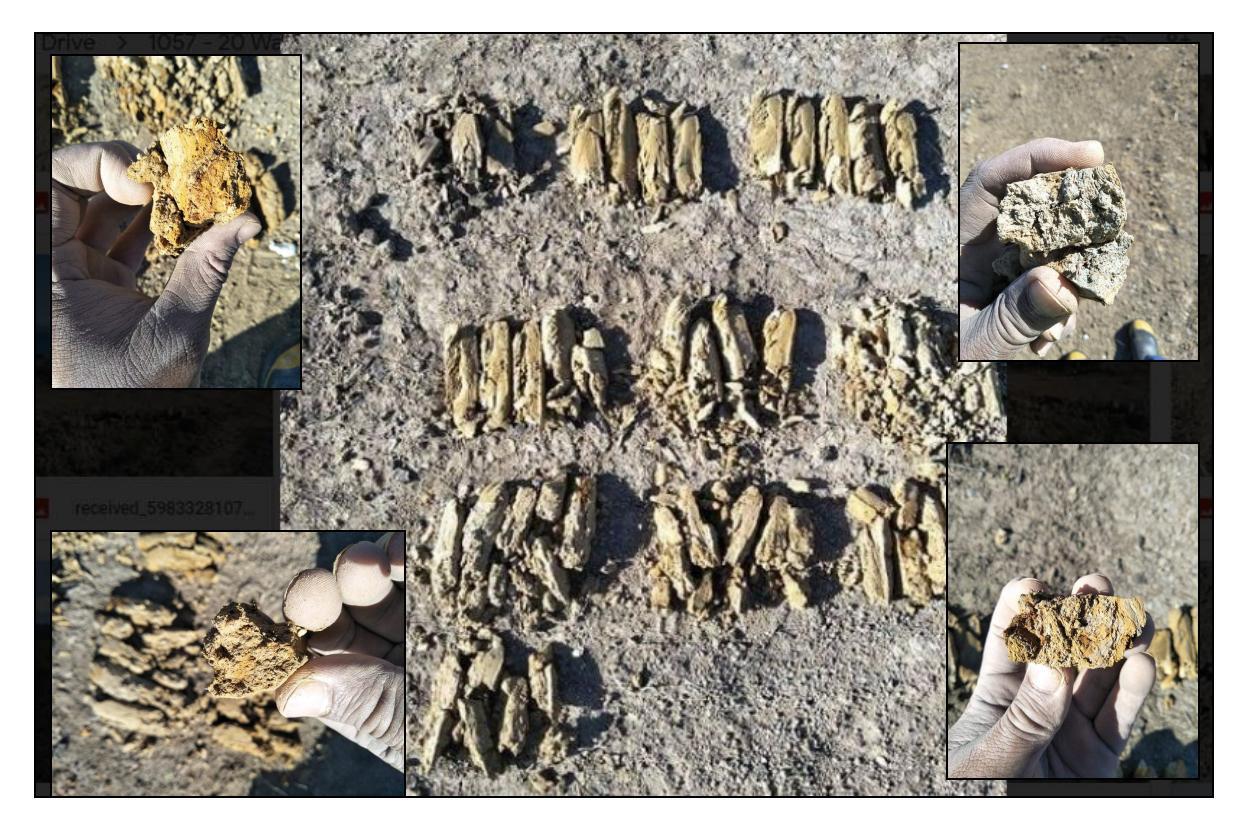
Figure 7 - Natural Soils Onsite (adapted from the DroneX Survey).

The natural (cohesive) subsoils encountered generally comprise very stiff, grey with orangish brown streaks within shallow depths down to 1.00 metre. As depicted in Figure 7 and Figure 8 respectively.

Beneath this, soils became more clayey, stiff, moist to very moist and creamy with varying concentration pockets of fine subangular gravel inclusions.

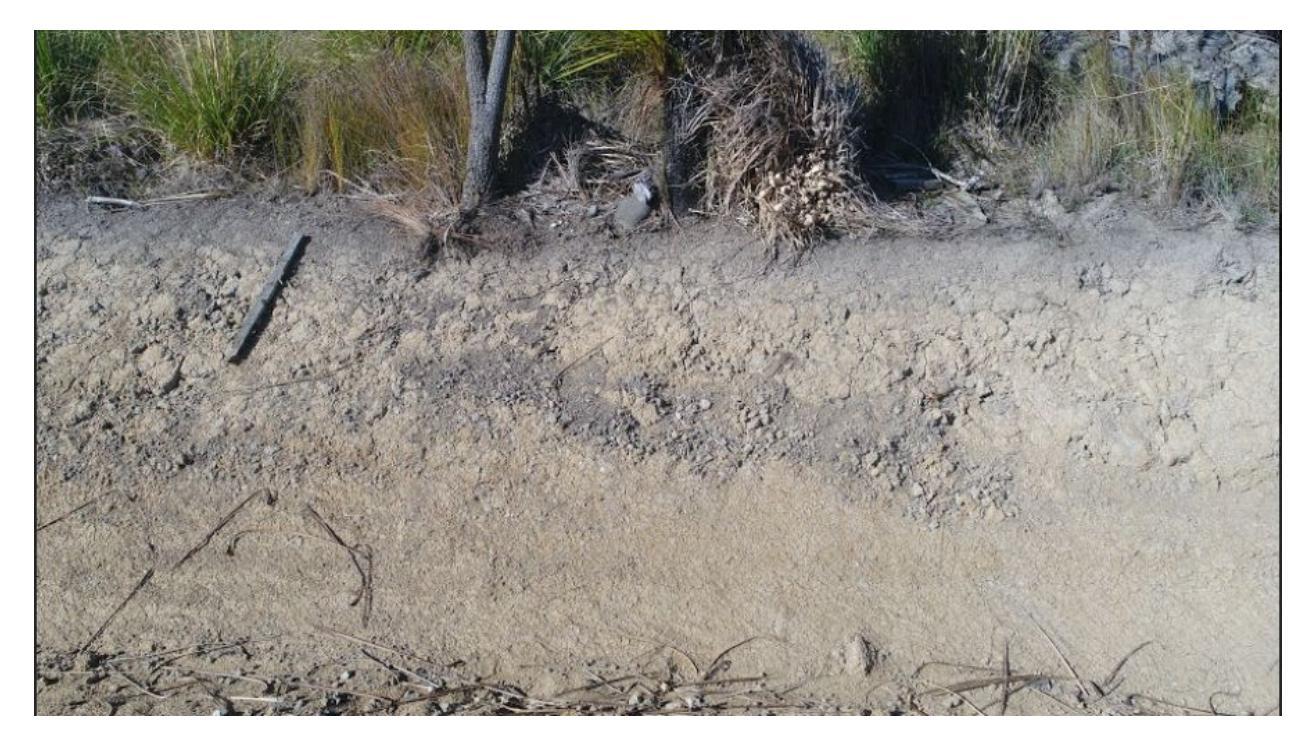
Figure 8 - Natural Soils Stratification Onsite (adapted from the DroneX Survey)

As depicted in Figure 8, erratic soil compositions can be expected as a consequence of the former. Further reference can be made from Photos 40 - 41.

More likely soil mantle stratification specific to the property are depicted in Photos 40 - 41.

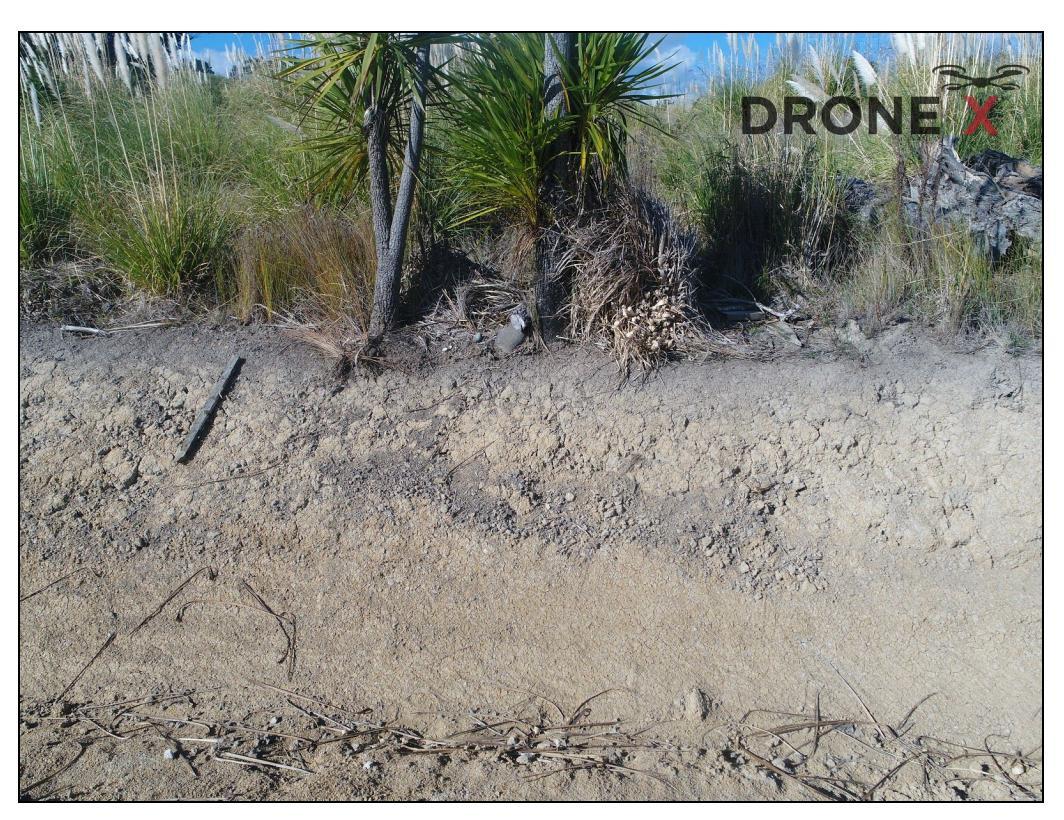
Photo 41 - As above.
