Centuria Funds Management (NZ) Limited

**GEOTECHNICAL SUITABILITY REPORT FOR  
PROPOSED SUBDIVISION**

124 Tauroa Street, Whangarei

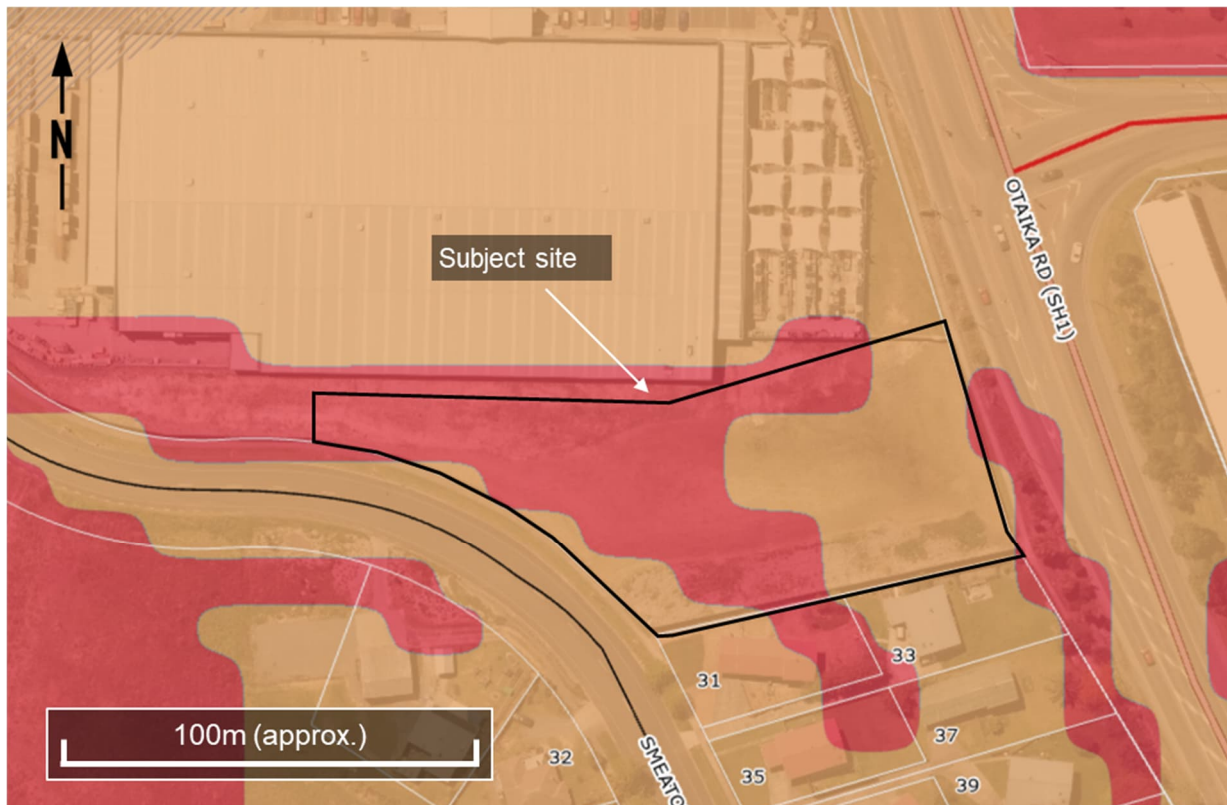
A review of relevant WDC<sup>1</sup> and NRC<sup>2</sup> GIS mapping was undertaken for the site. The review identified that the site is mapped as within the high and moderate slope instability zones (Figure 3). The proposed building platform is largely located within the moderate instability zone. The site is not mapped as susceptible to any other natural hazards by either territorial authority. The property has available connections to council reticulated services. Further discussion of servicing the site is addressed further in a separate LDE Civil Infrastructure Report (reference 18155, dated 20/12/22).

Figure 3: WDC mapped slope instability at the site. The site is situated across both the high (red) and moderate (orange) instability zones.

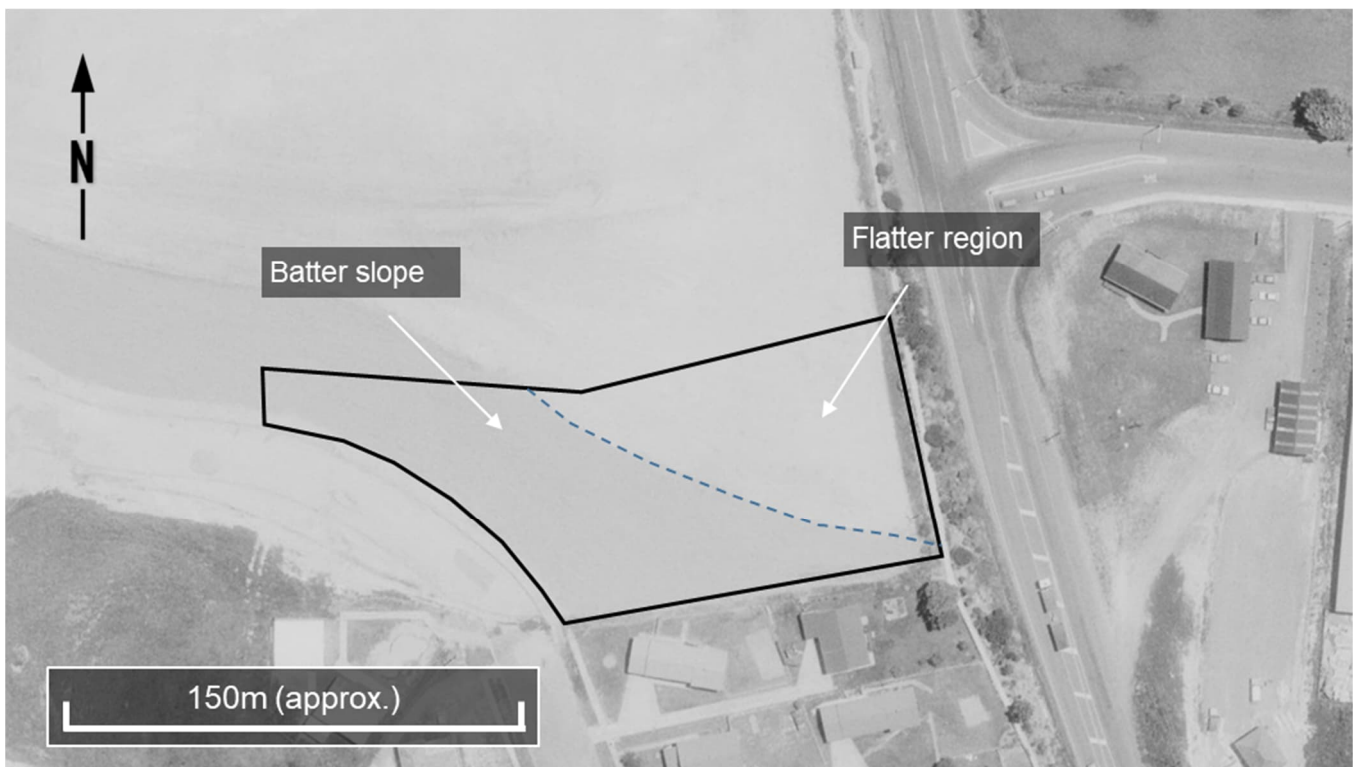
Figure 5: 1986 Retrolens imagery depicting the site cleared with earthworks having occurred.

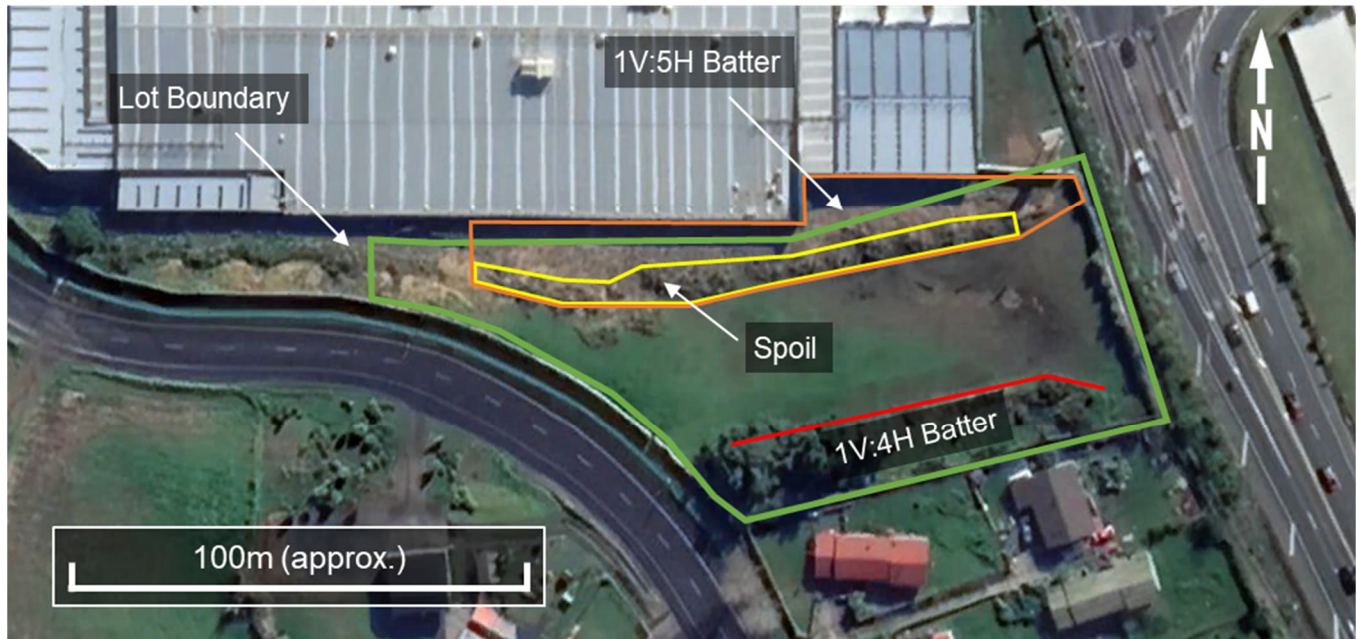
Figure 6: 2022 Google Earth imagery of the site. The 1V:5H cut batter formed at the time of Bunnings construction is outlined in orange. Spoil placed in 2021 from clearing of the site is outlined in yellow, with the approximate extent of the toe of the cut batter at the south of the site shown in red.

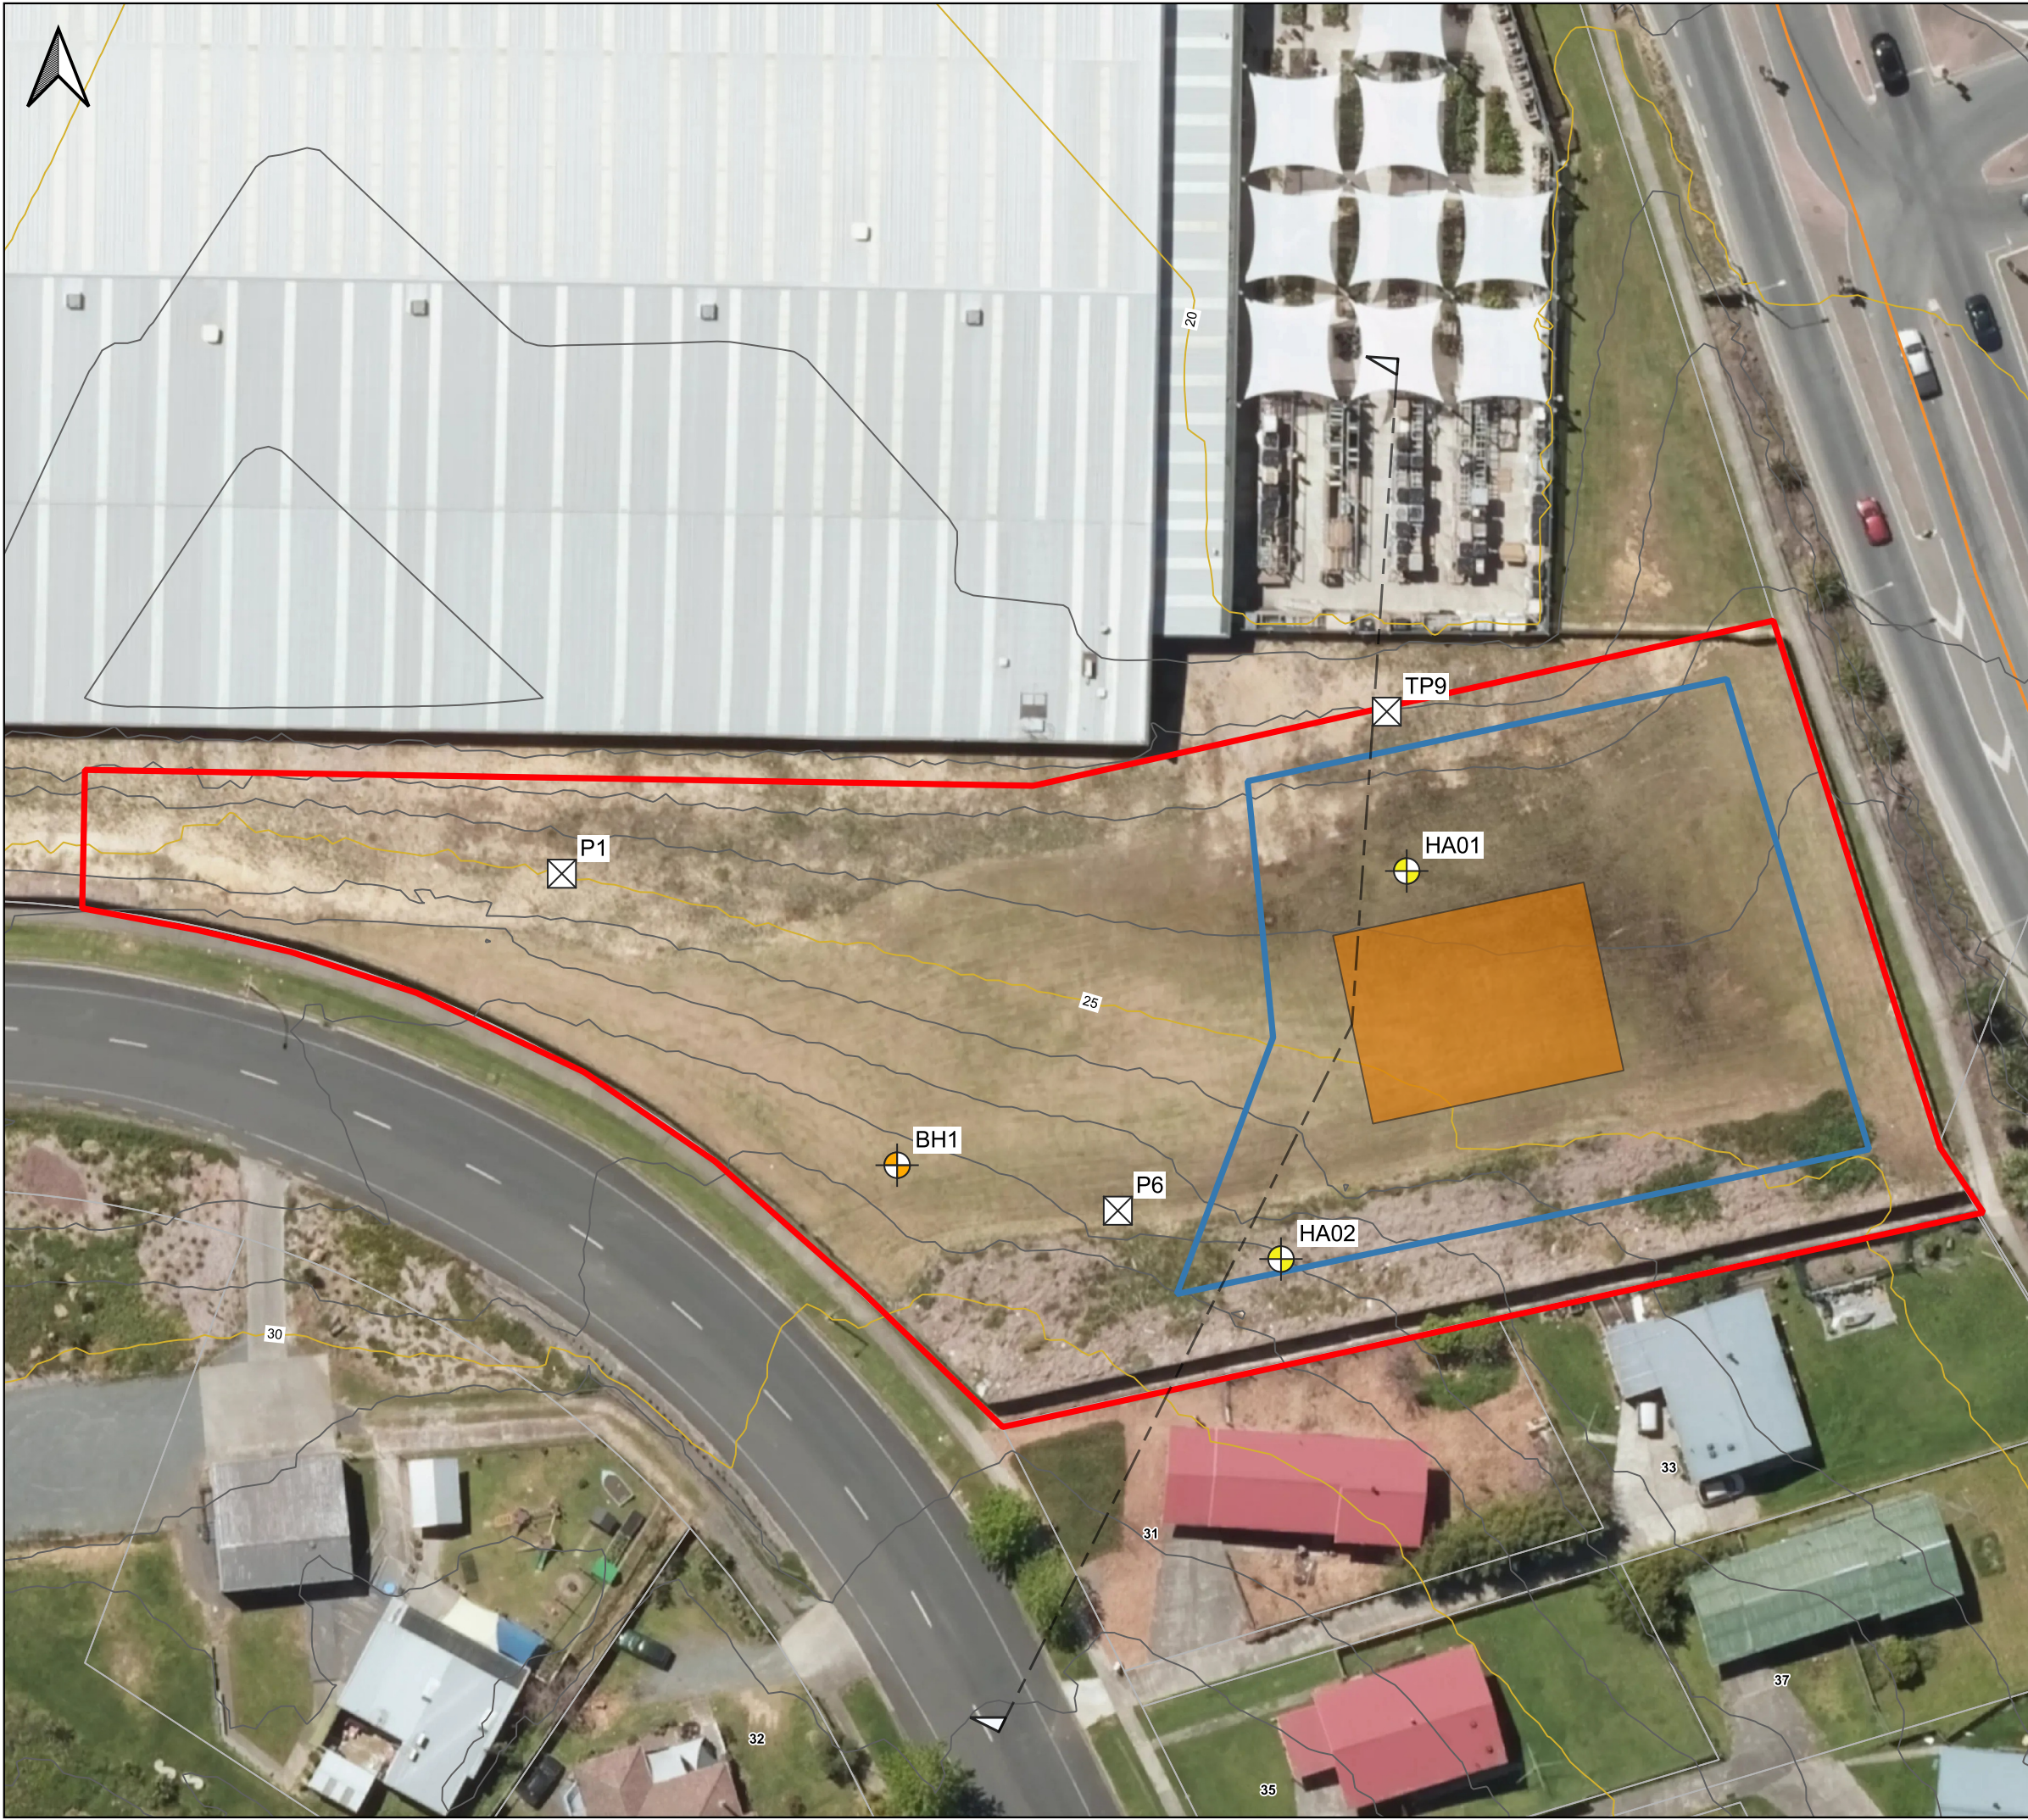
DRAWING TITLE  
Geotechnical Investigation Plan

The location of the cross section is shown on the investigation plan in Appendix B and printouts of the stability analyses are attached to this report in Appendix D.

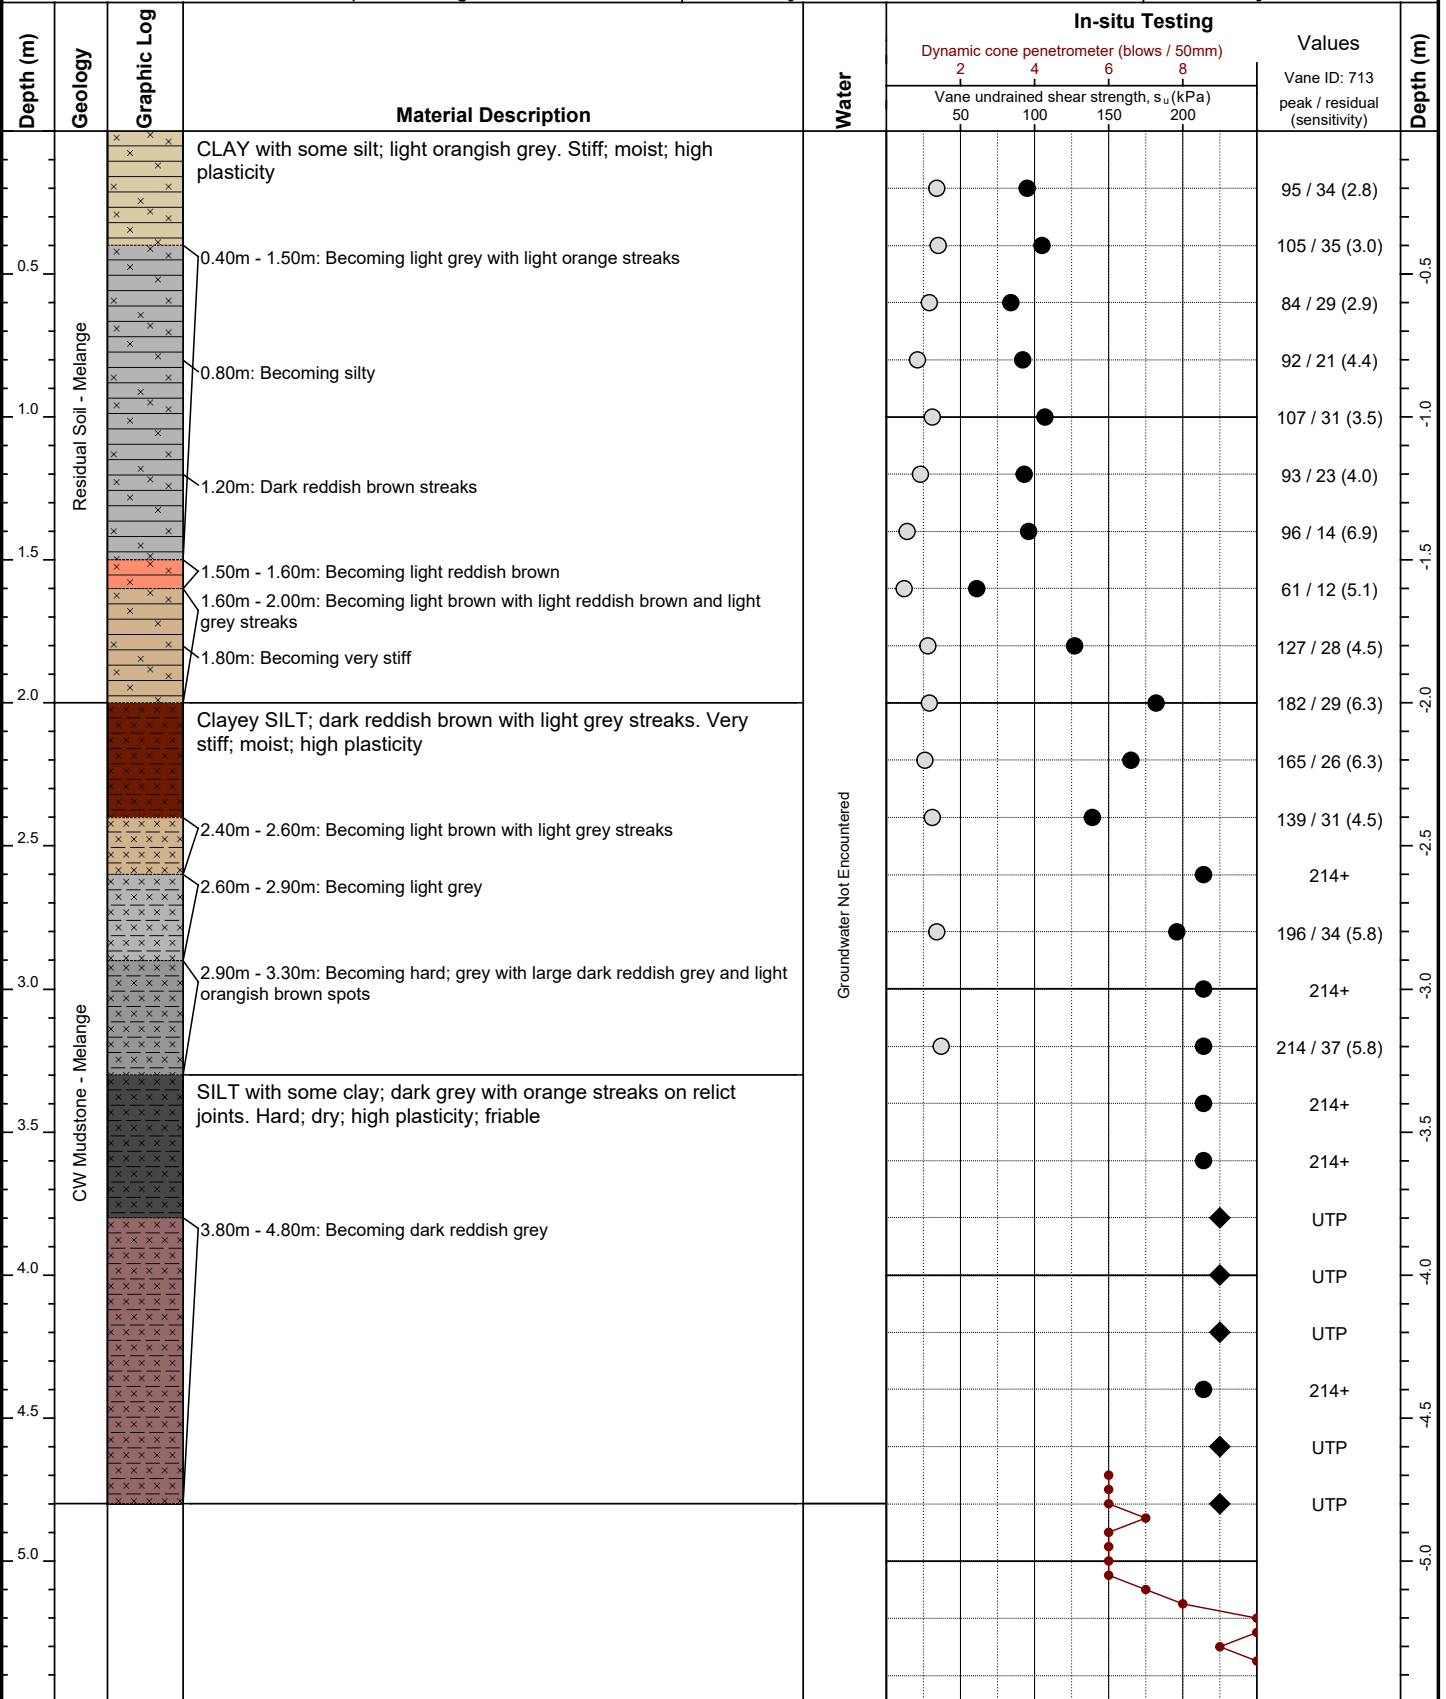
The soils beneath the building site were moist to wet down to 1.7m depth, becoming dry below this. In HA01 a wet horizon was encountered between 1.6 and 2.0m, becoming moist below this.

**Hole Depth:** 4.80m **Termination:** Auger spinning on hard material at 4.7m

**Remarks:** Material sticky between 1.6m and 2.0m.
