Centuria Funds Management (NZ) Limited

**GEOTECHNICAL SUITABILITY REPORT FOR  
PROPOSED SUBDIVISION**

124 Tauroa Street, Whangarei

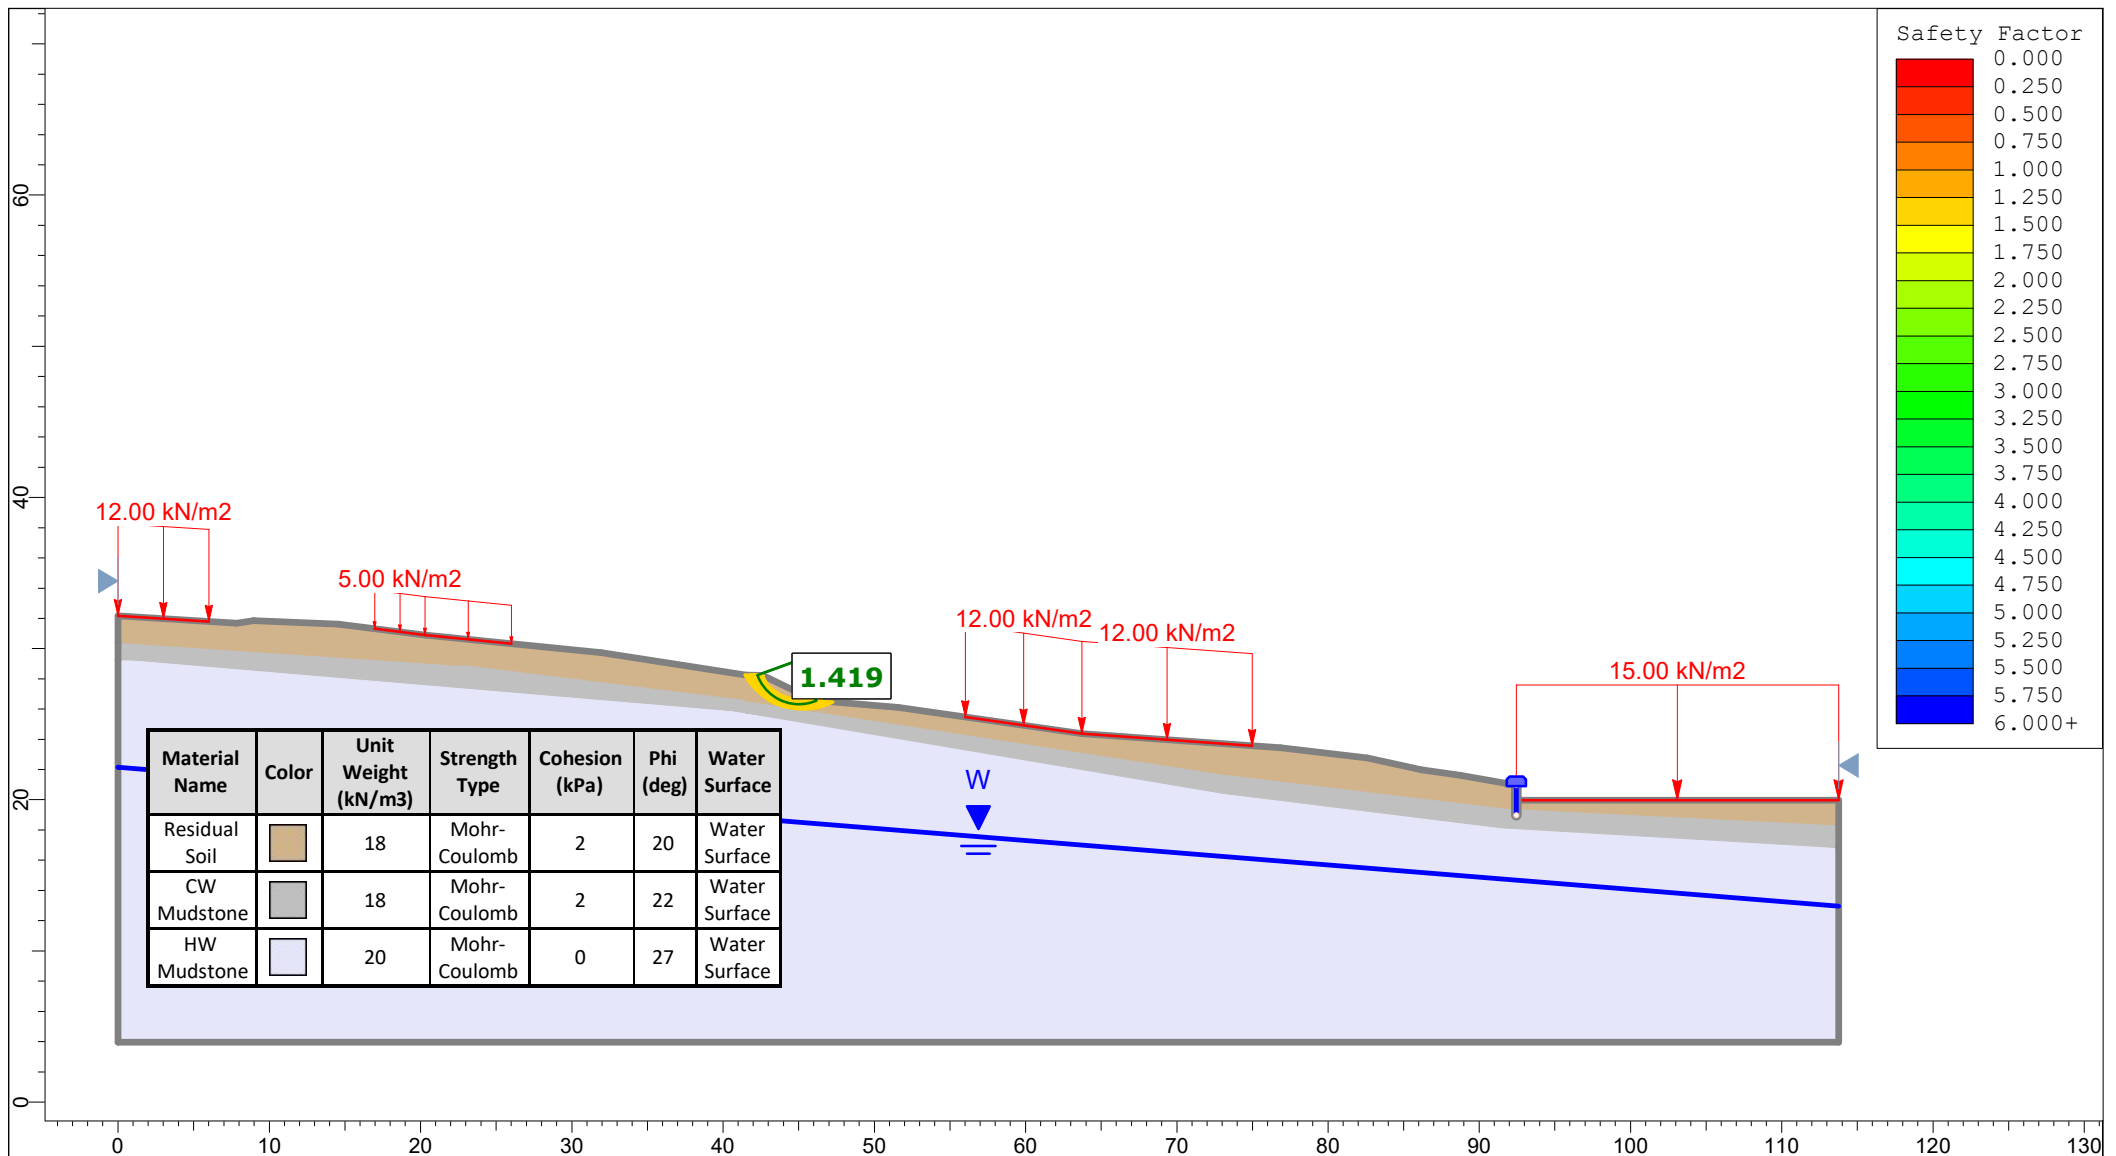
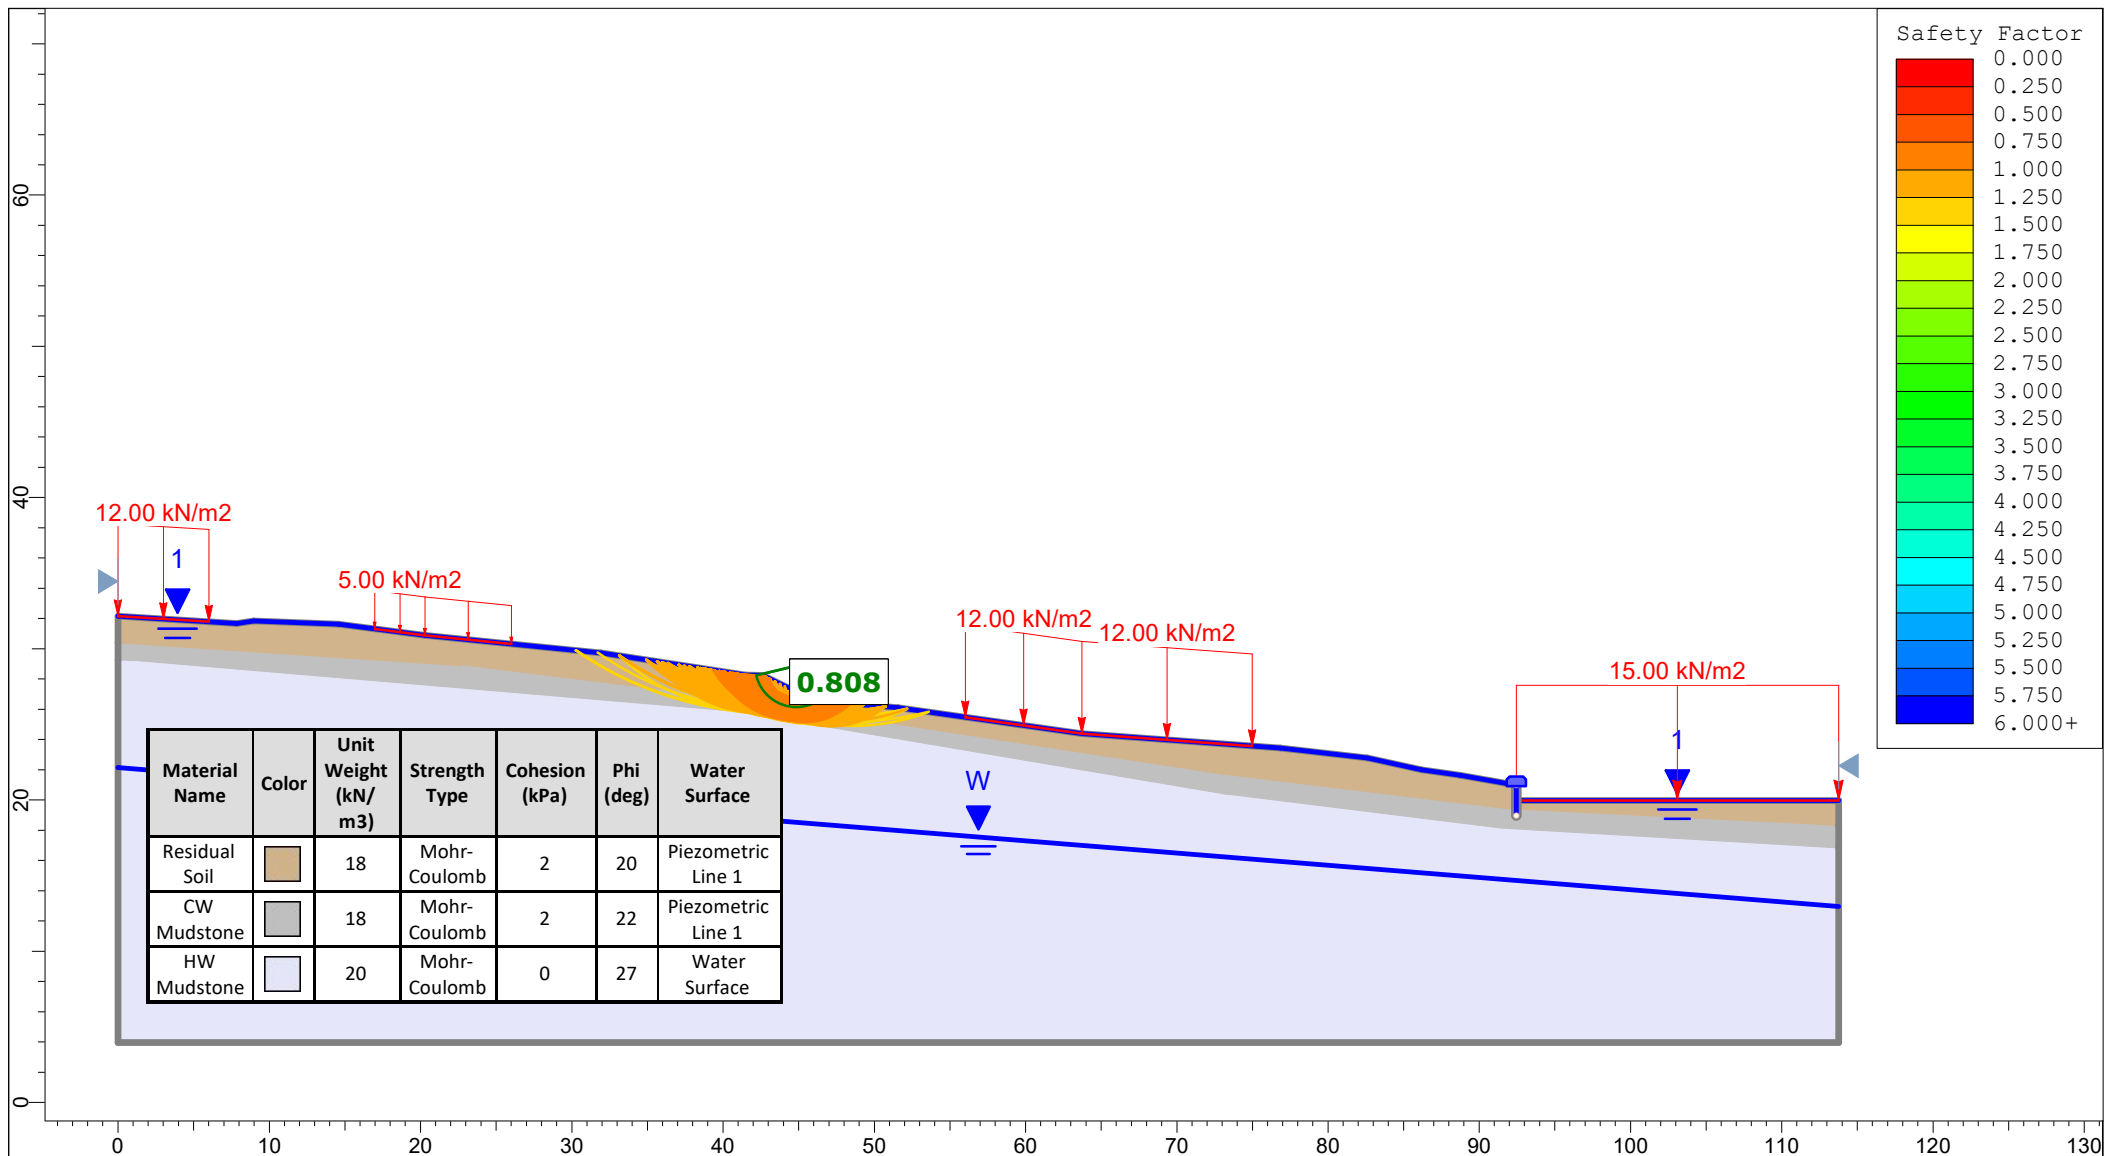
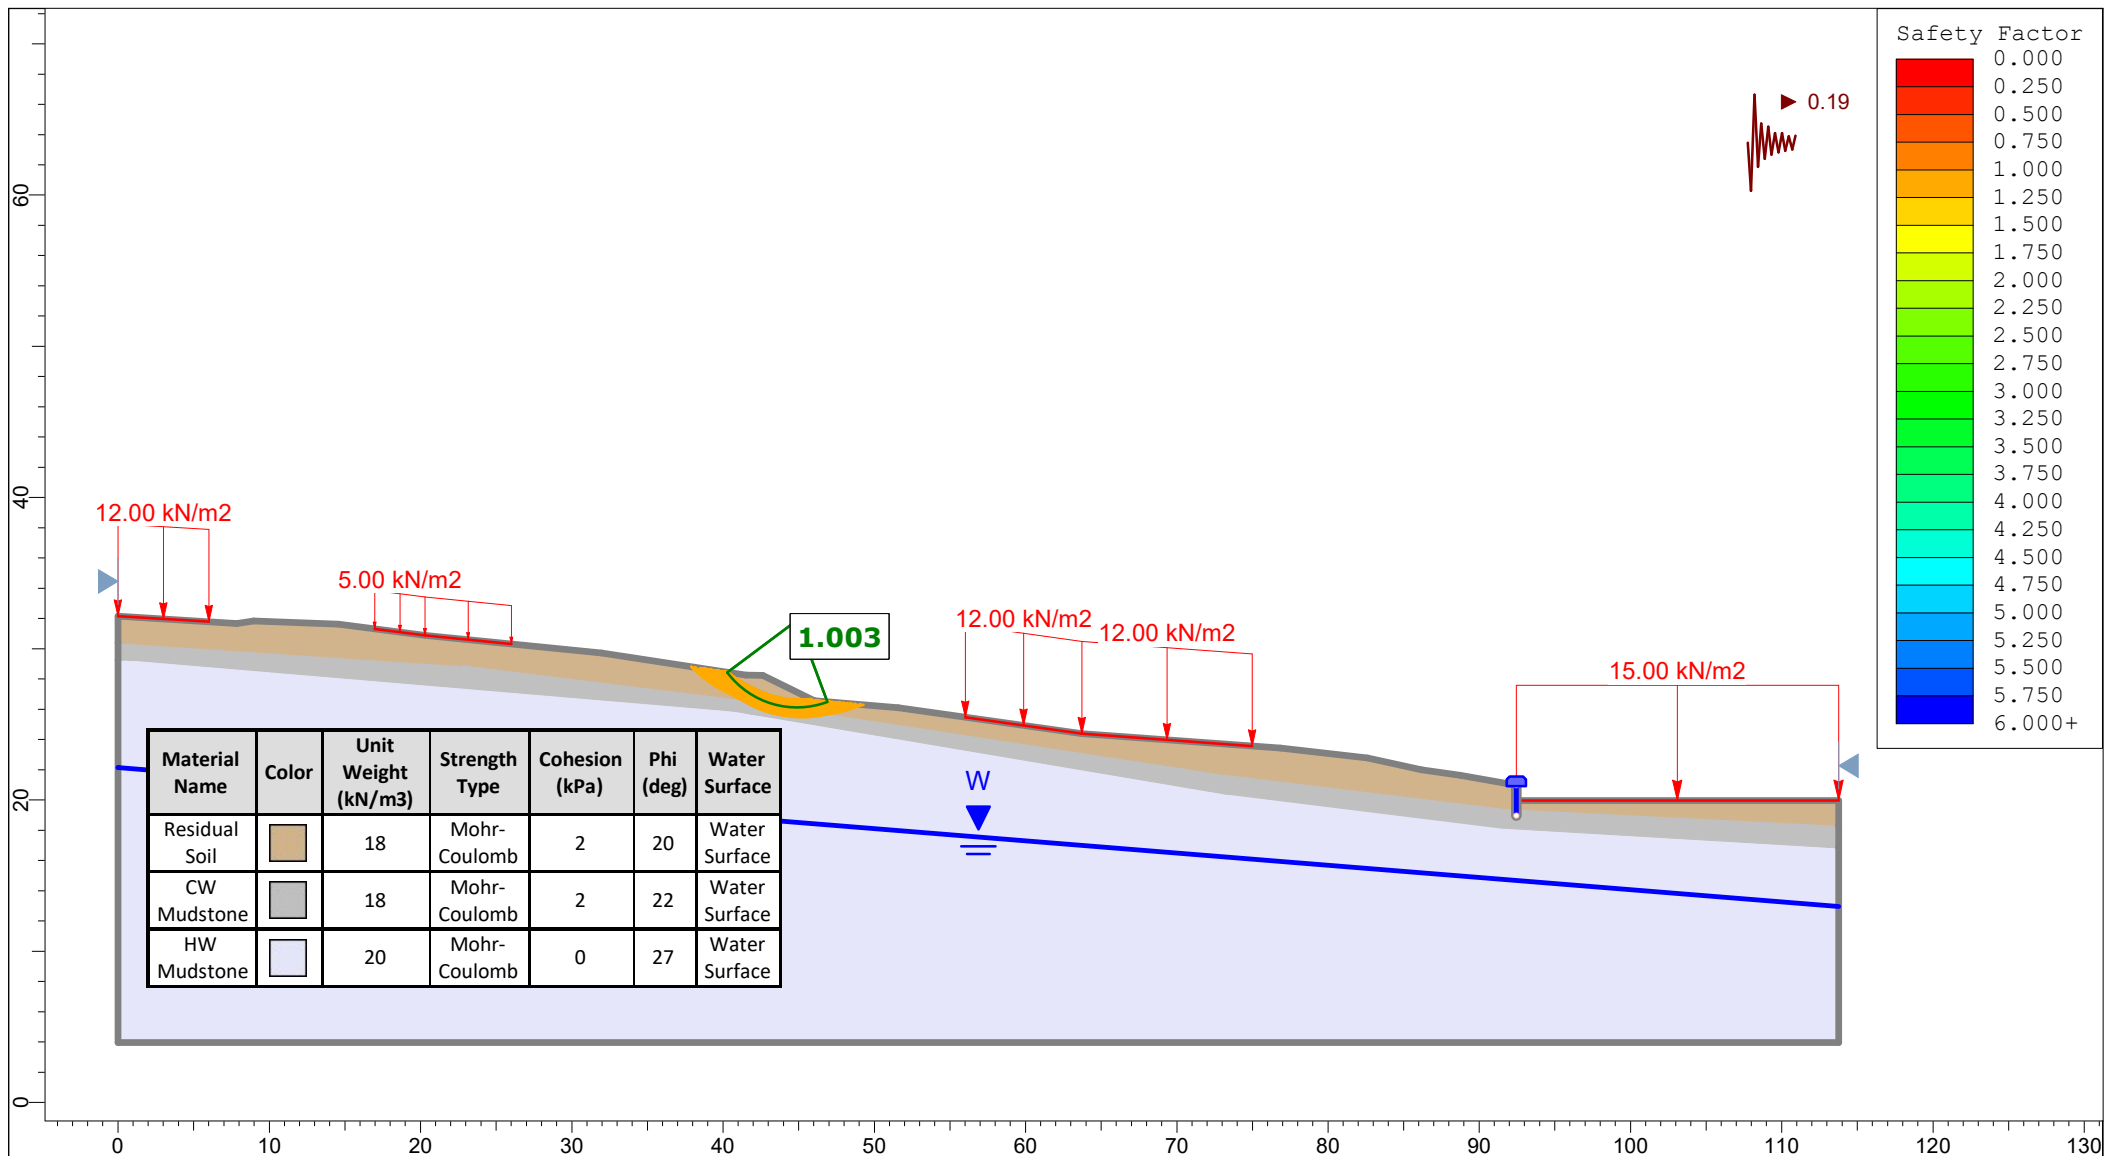
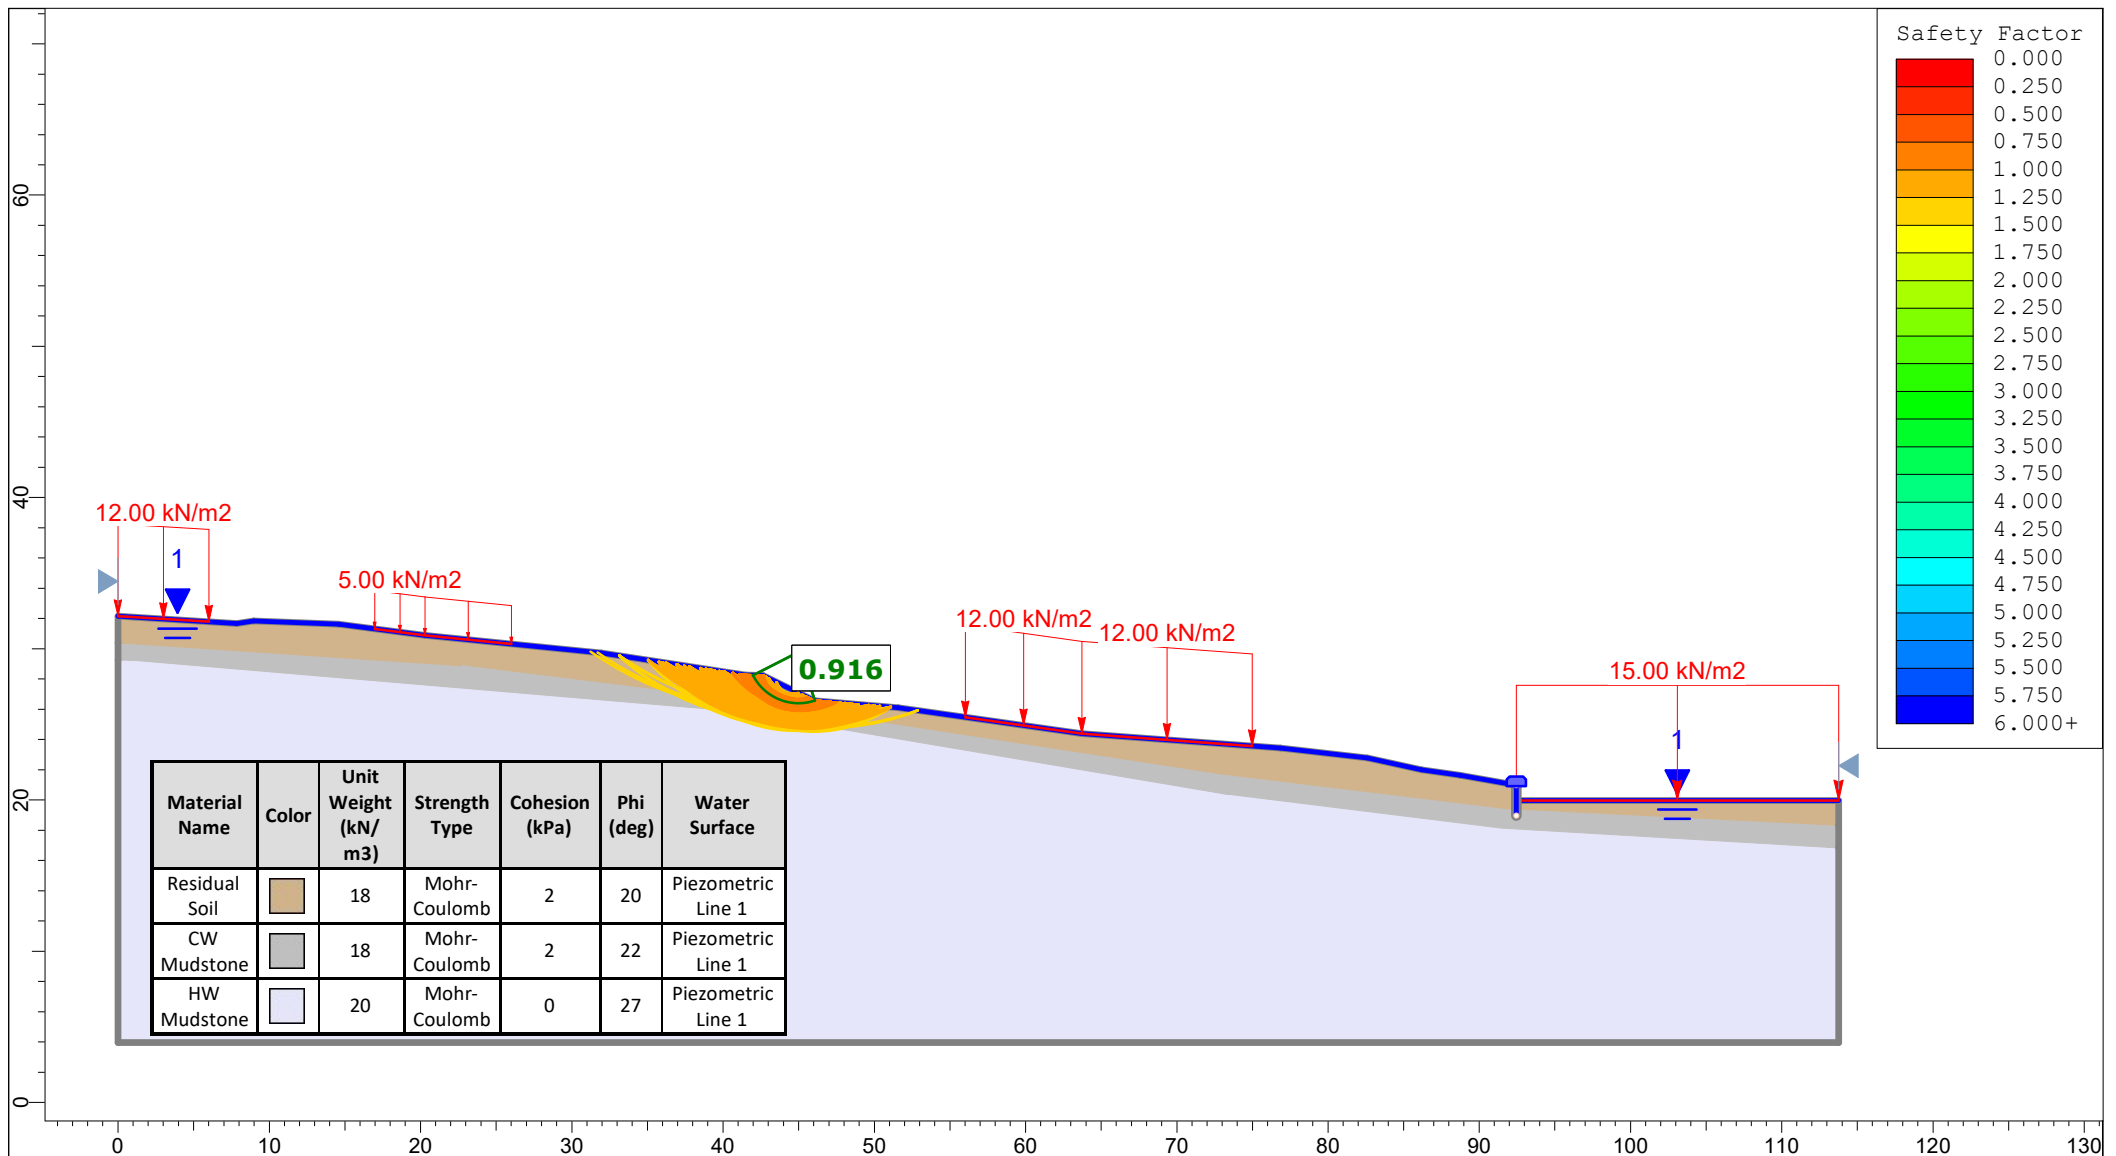
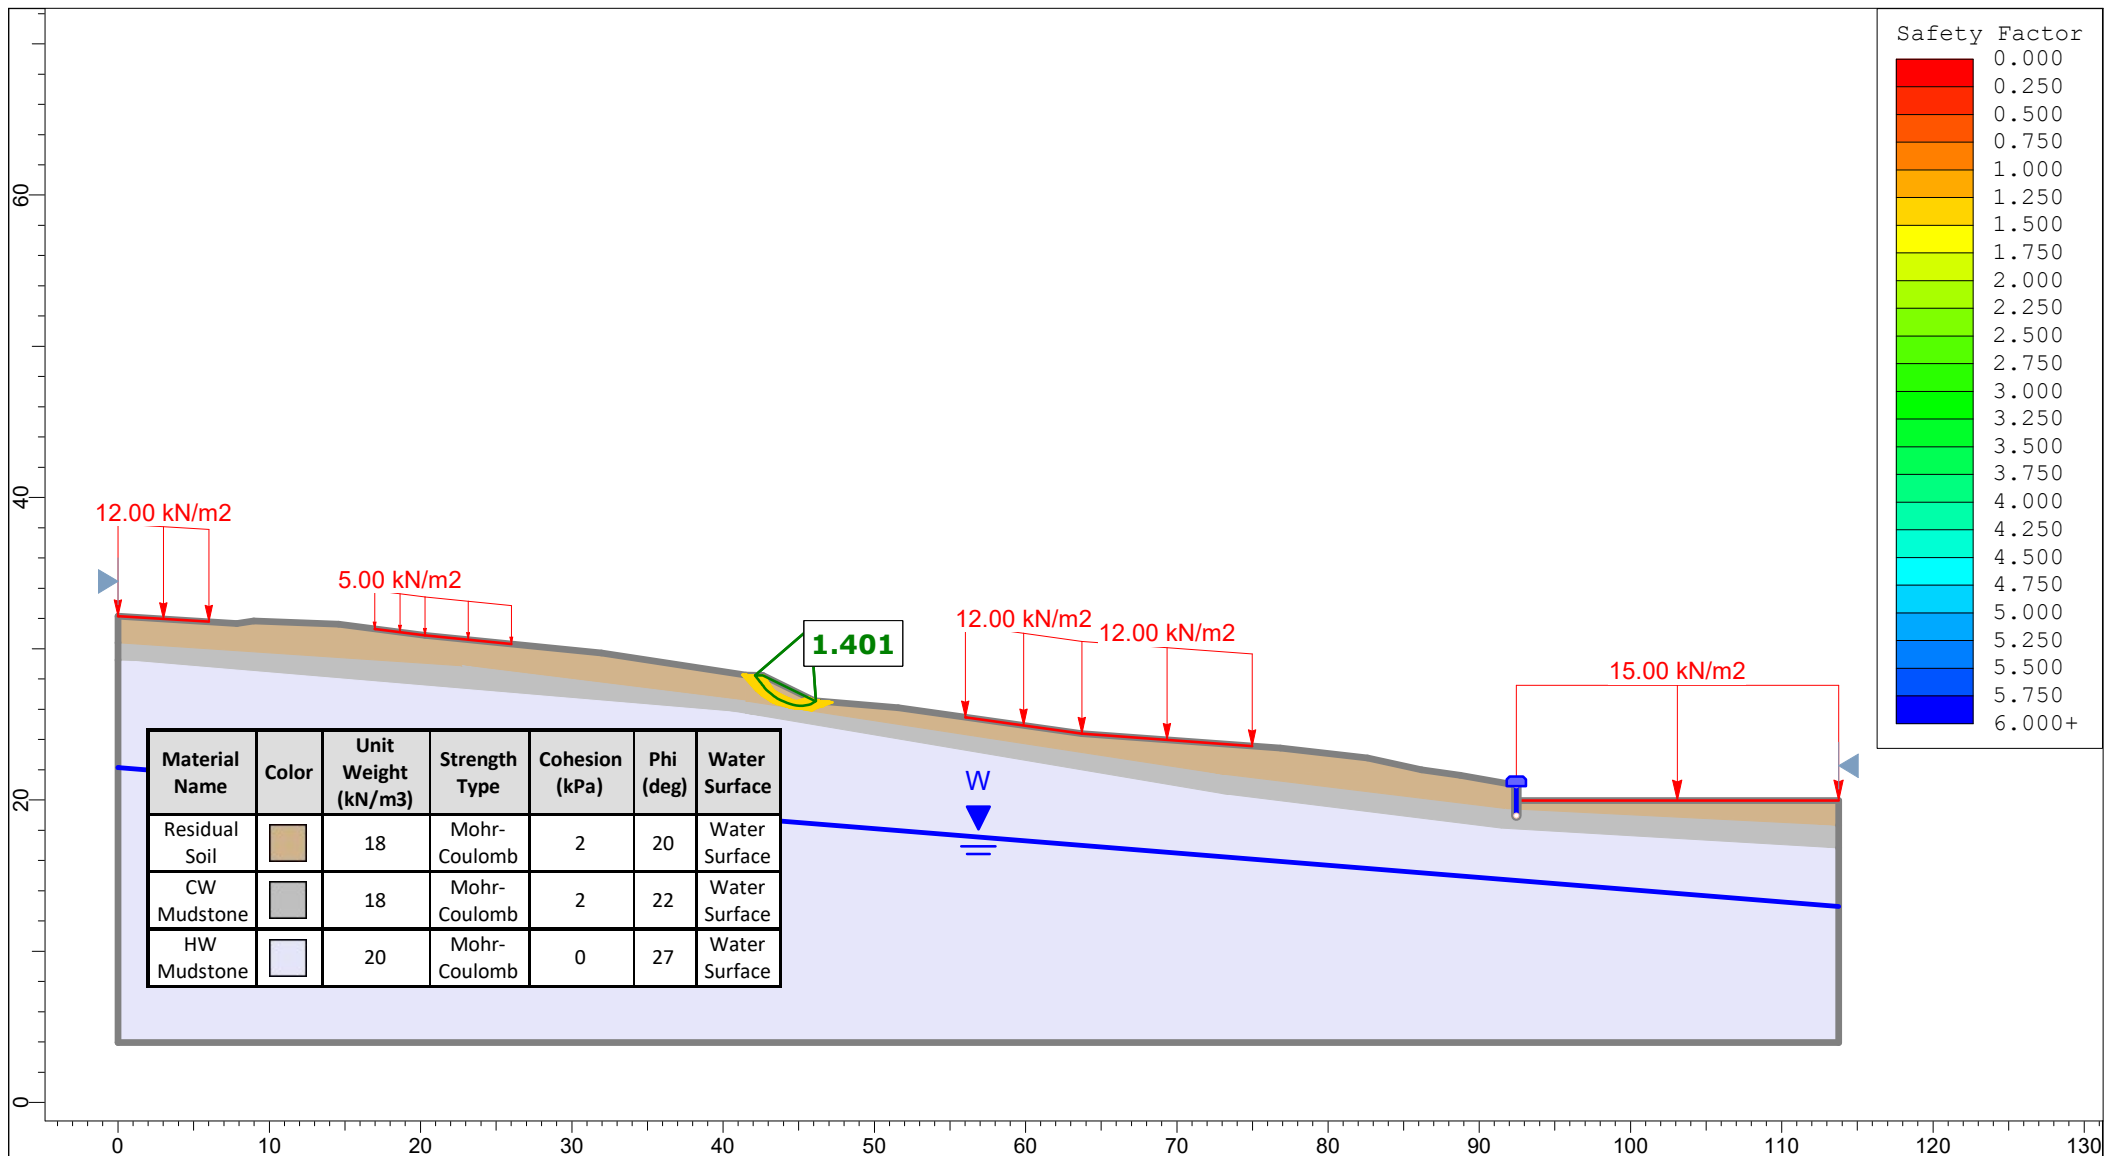
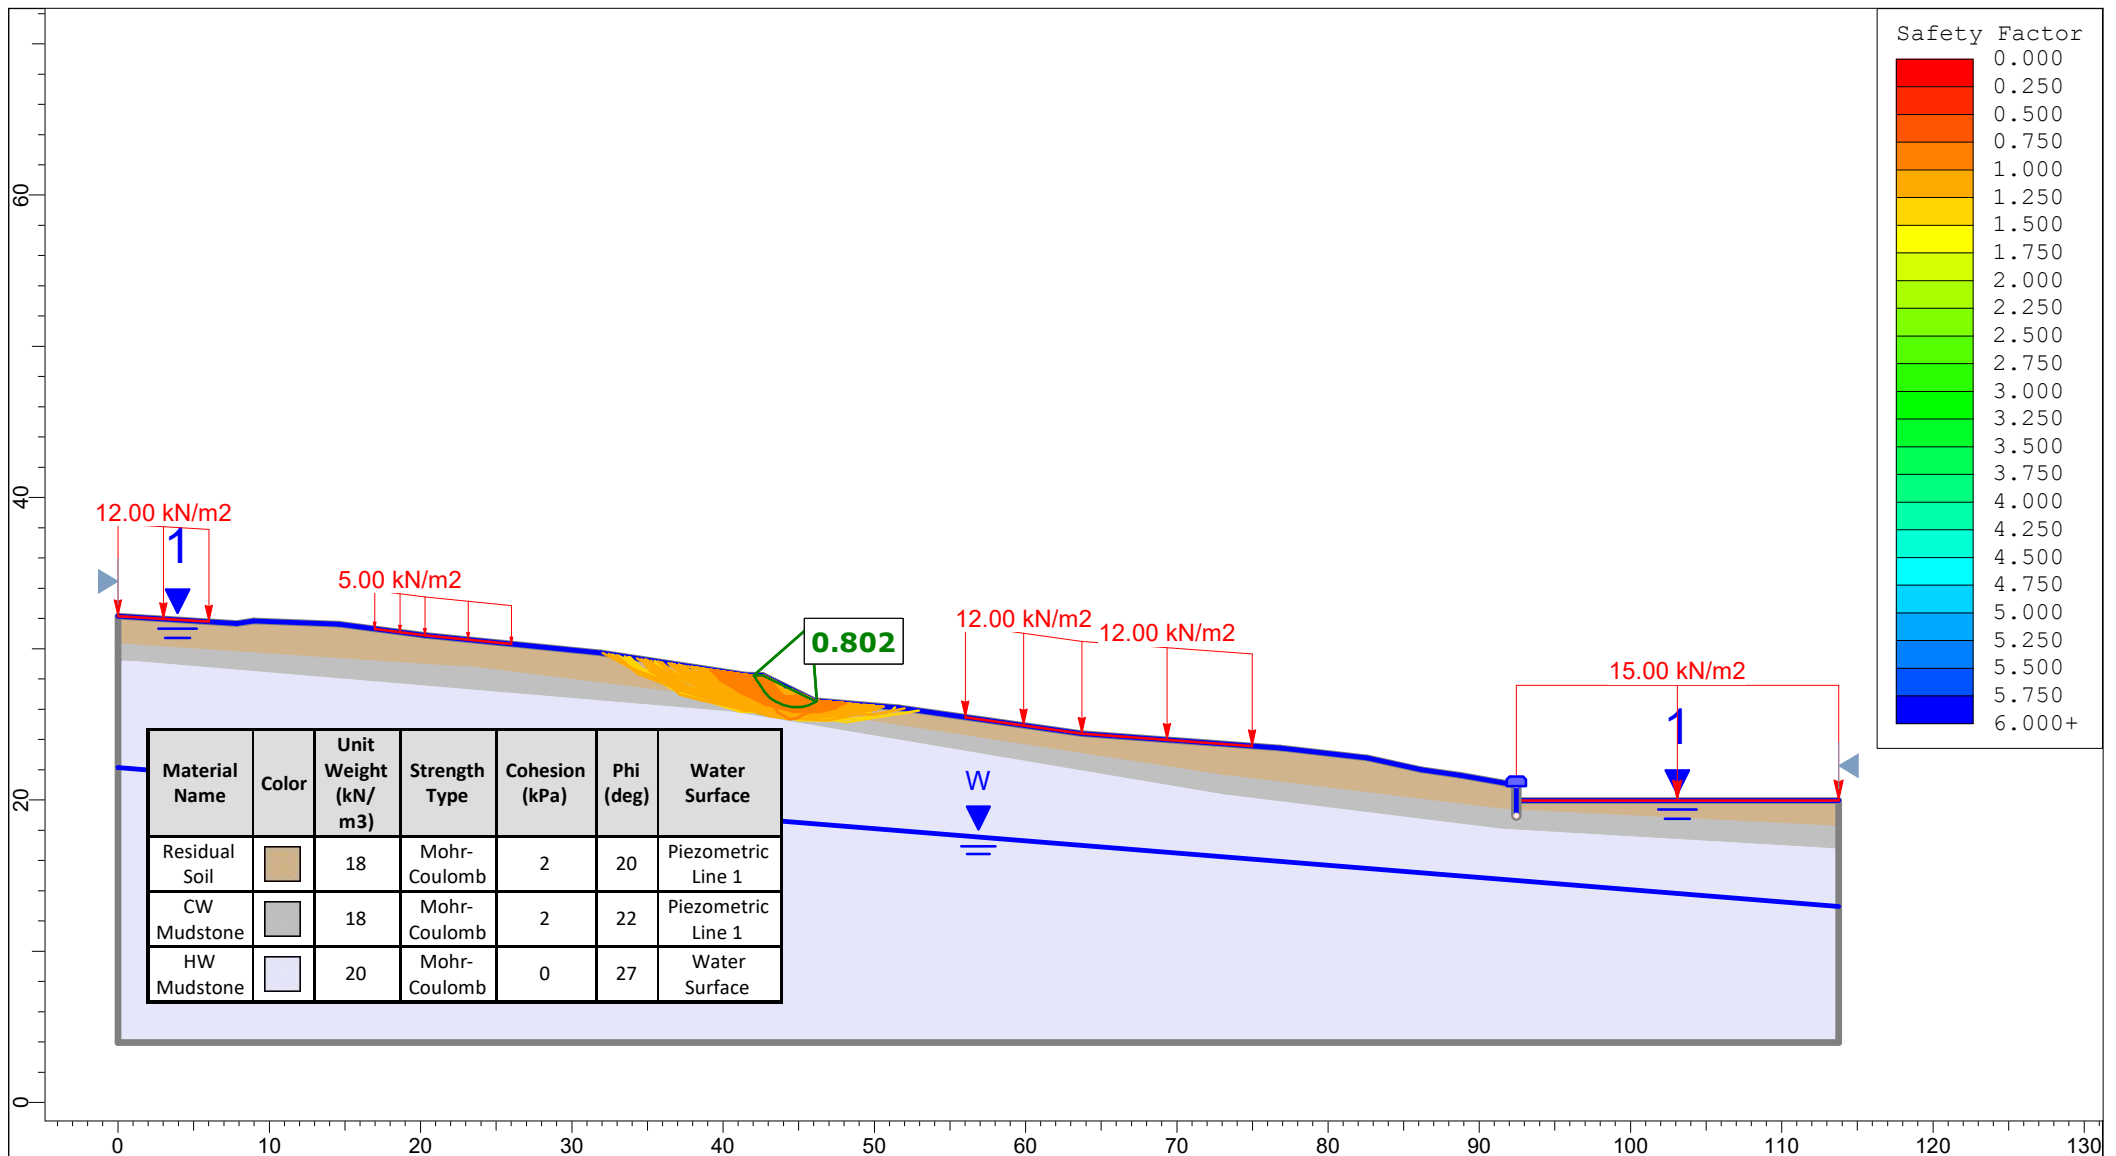
### **STABILITY ANALYSES**

Results of the numerical slope stability analysis and generally accepted Factors of Safety are presented below in Table 2. Modelling of the slope indicates that slope failures are modelled to occur in all scenarios at within the cut batter at the southern boundary of the site. In none of the scenarios are these failures modelled to enter the proposed building platform, including the low probability complete saturation scenario.

At the time of LDE's site investigations, the cut batter at the south of the site had not failed in the recent exceptionally wet summer and Cyclone Gabrielle intense rainfall event. We therefore consider that the adopted soil parameters in the slope stability analysis to be conservative and that for the modelled development the proposed building platform is stable.

If future developments are likely to exceed surcharges modelled in this analysis, cut slopes are formed, or fill is to be placed higher than 1m above existing grade additional assessment and stability analysis shall be required.
